Appendix C
Pilot Basin Study Interim Report
Ephesus Subwatershed

Pilot Basin Study Report – Ephesus Subwatershed

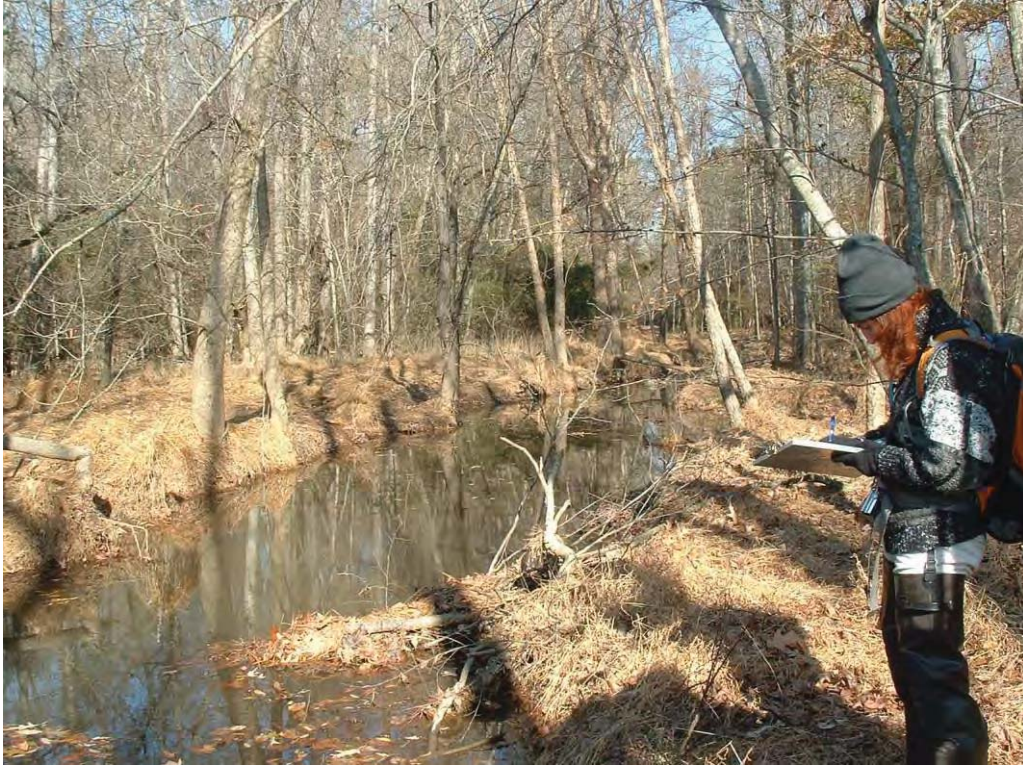
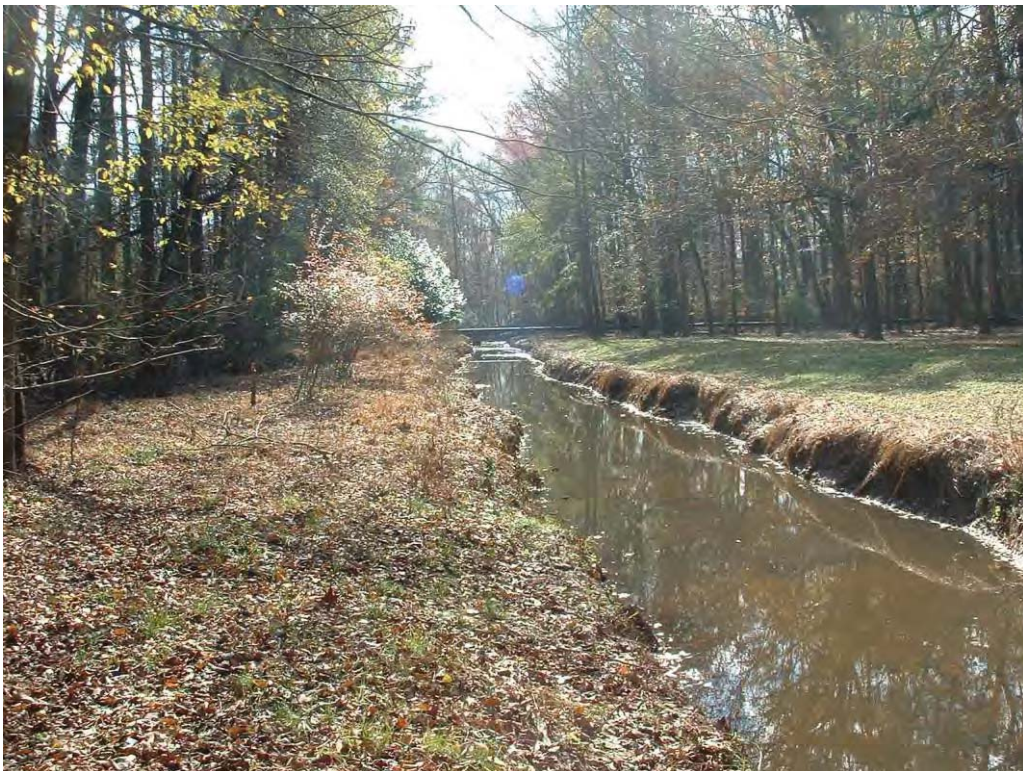
Exhibit C-1. Photos of Reach A

Reach A, comprising 2000 feet at the downstream end of the main stem, is generally in good condition even though it was likely channelized at some point in the past. Most of the reach is within a wooded floodplain on Town property or on large residential lots with deep back yards. The stream exhibits little entrenchment, is beginning to re-establish some sinuosity, and has a forested floodplain relatively free of invasive species. Much of the reach is within the floodplain of Little Creek, with some wetland areas on either side of Tracy Branch. The right overbank floodplain on the most upstream portion of the reach has been cleared and is mowed up to the stream bank. There is slight incision at the upstream end of the reach. This portion of the stream is shown in Exhibit C-1.

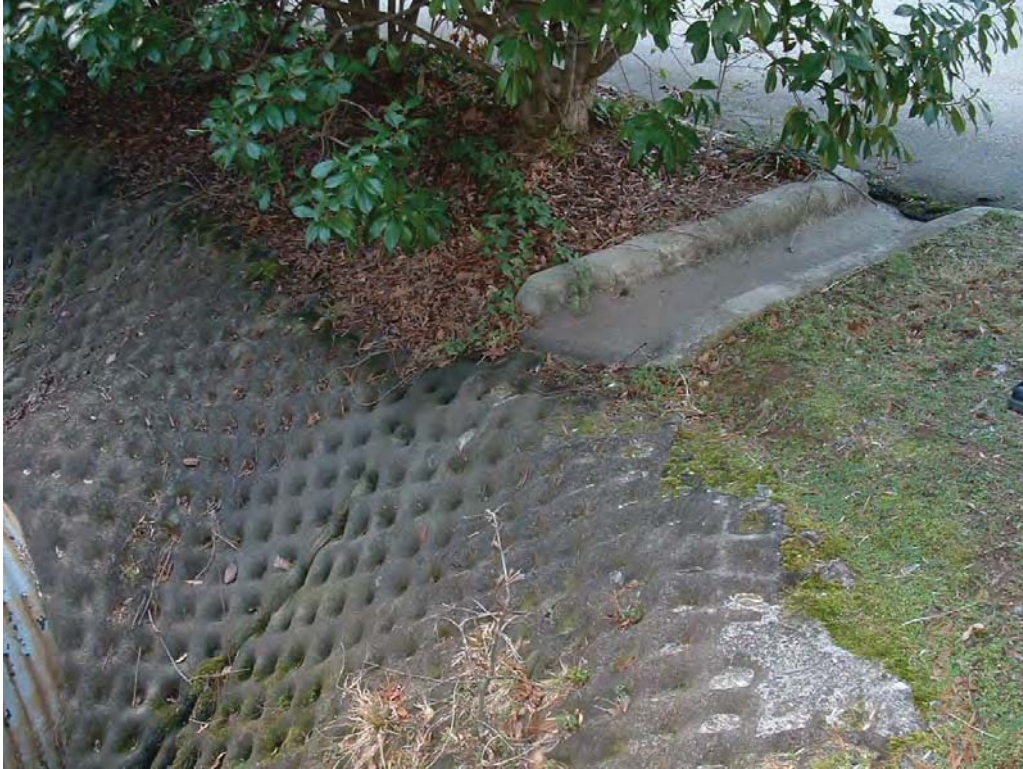
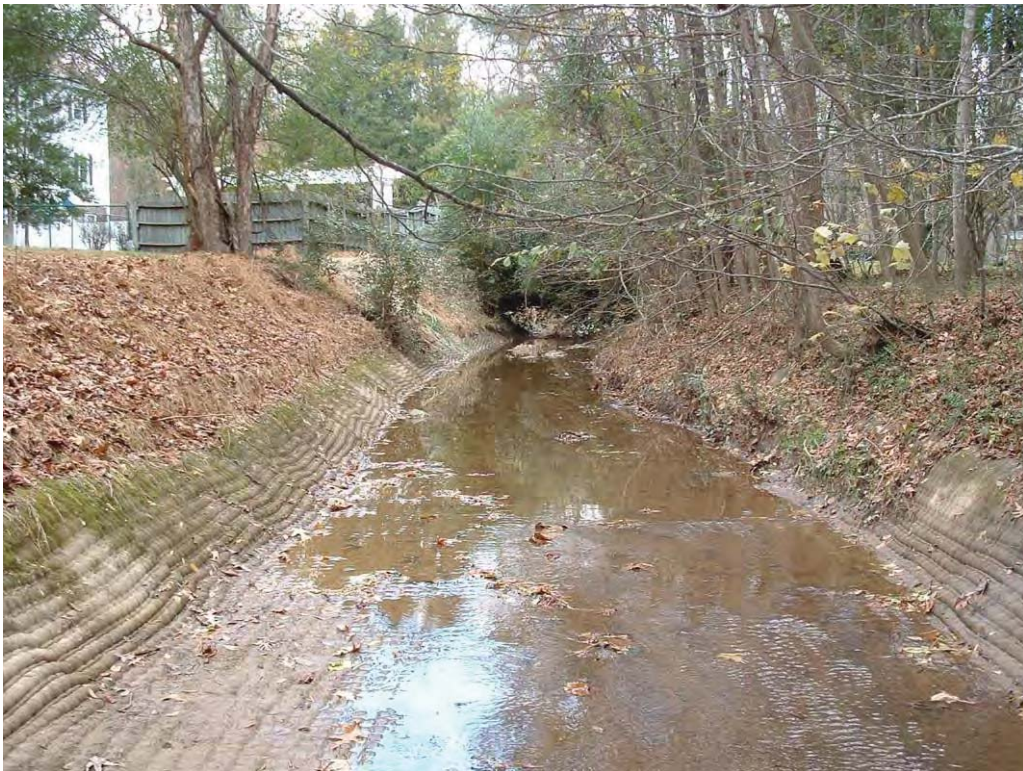
Exhibit C-2. Photos of Concrete Channel Lining

from residential development. The concrete was formed as an articulated mat, in a manner which allows for some permeability in the depressions. This construction method helps to limit buildup of hydrostatic pressure as the ground behind the concrete becomes saturated during rainfall events. Some photos of the concrete liner are shown in Exhibit C-2. A number of the culverts along the branch were apparently sized for extreme storm events, as indicated by significant sedimentation within some culverts and/or in the inlet and outlet areas, depicted in Exhibit C-3.

looking upstream from downstream end of concrete lined reach

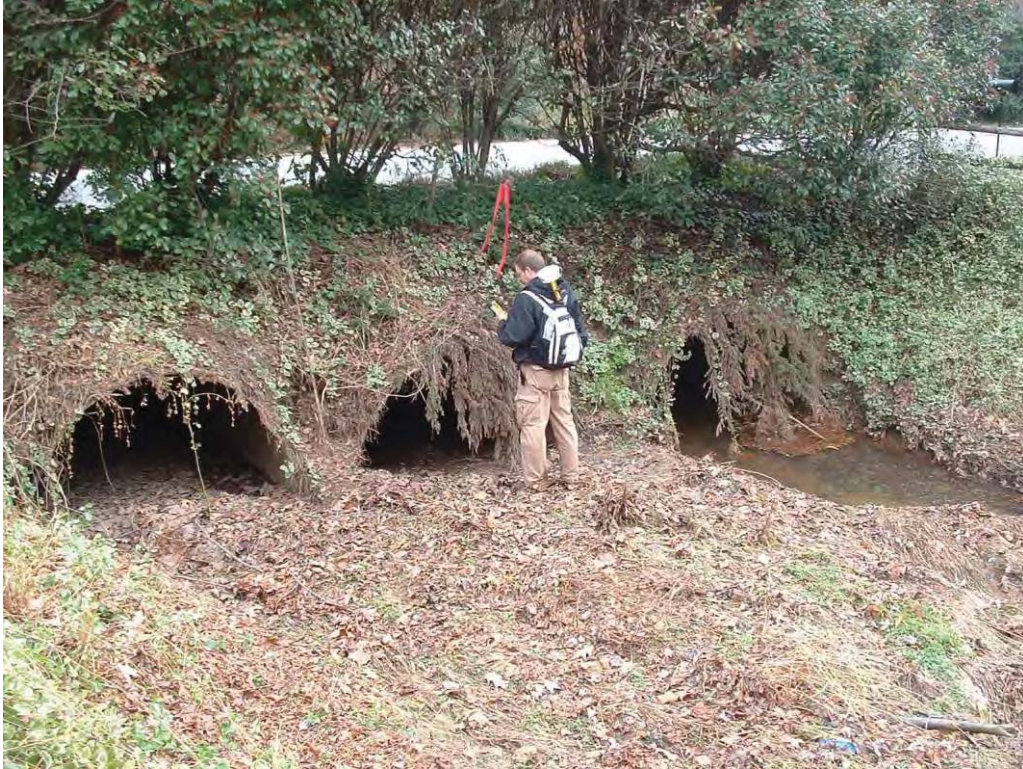
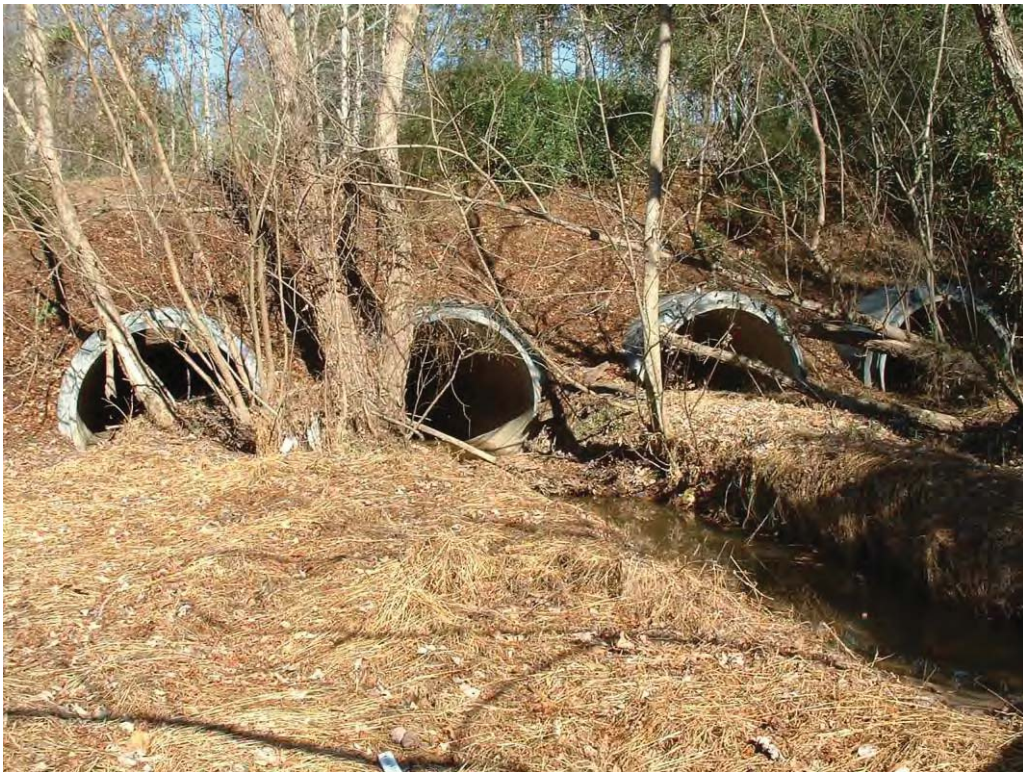
Exhibit C-3. Photos of Sedimentation at Culverts

In contrast to most of the reach, the lower and upper ends of Reach B exhibit little to no sediment deposition. The lower portion may be periodically scoured out when water backs up behind a problematic OWASA sewer aerial. Based on survey data at culvert crossings, the upper portion of the reach, between Lynnwood Drive and Ephesus Road, is considerably steeper than the downstream reaches, such that velocities are probably too high to allow sediment to settle out.

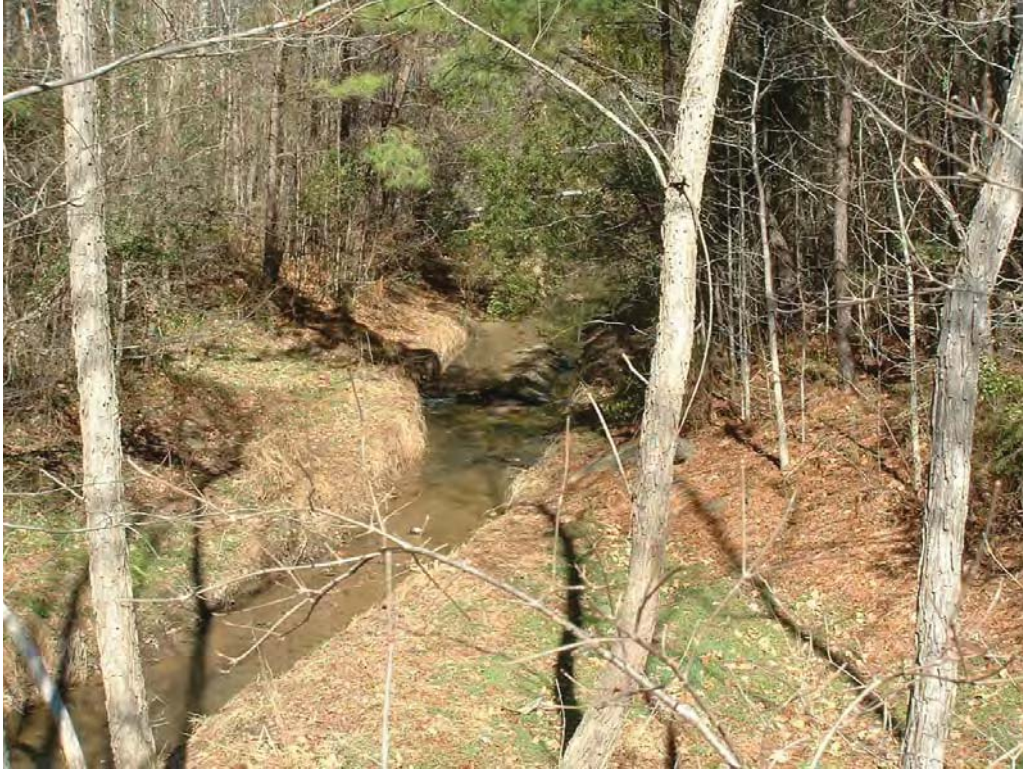
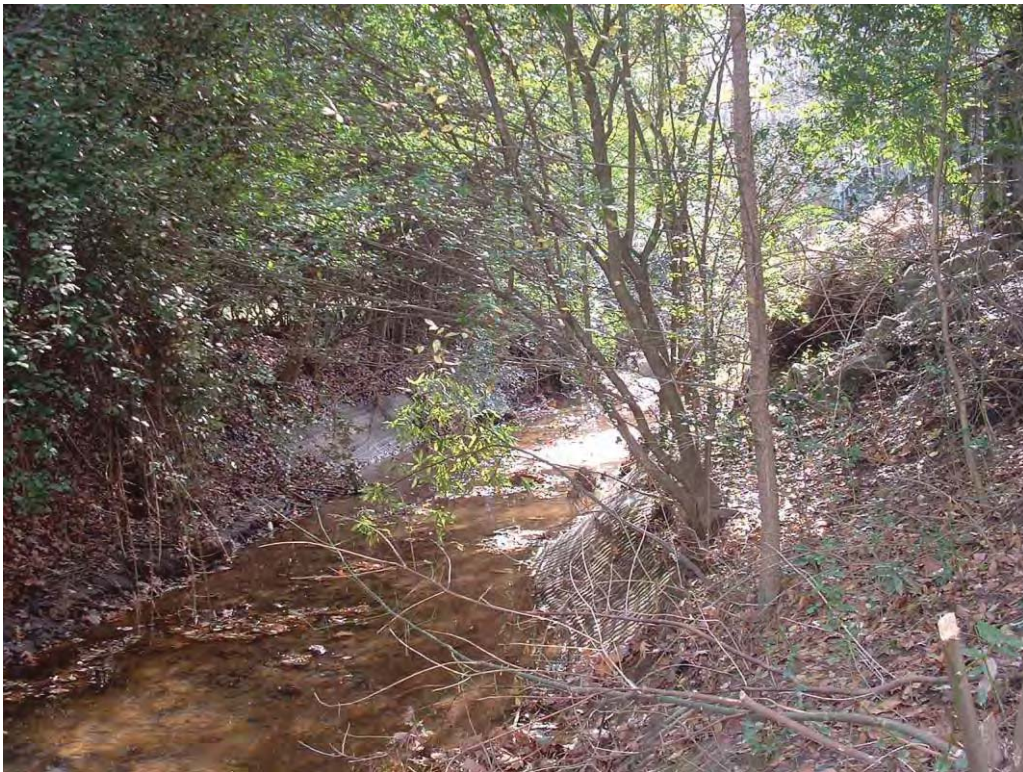
Exhibit C-4. Photos of Reach B Concrete Lined Channel

Portions of Reach B reach exhibit reasonably good morphology in spite of the artificial lining. The typical concrete channel cross-section has a 10-foot wide bottom and is about six to eight feet deep. The concrete typically lines the bank up to a height of two to two-and-a-half feet, allowing growth of a canopy on the upper banks in some areas. Sediment has been deposited on portions of the wide concrete channel bottom, forming an intermediate floodplain with a narrow, low flow channel meandering through it. In some areas, the concrete is only evident at the bottom of portions of the low flow channel and the stream looks like a natural stream. However, the concrete prevents the development of a hyporheic zone of exchange between surface water and ground water, which is critical for nitrogen processing and some types of aquatic life. Some photos of Reach B are shown in Exhibit C-4.

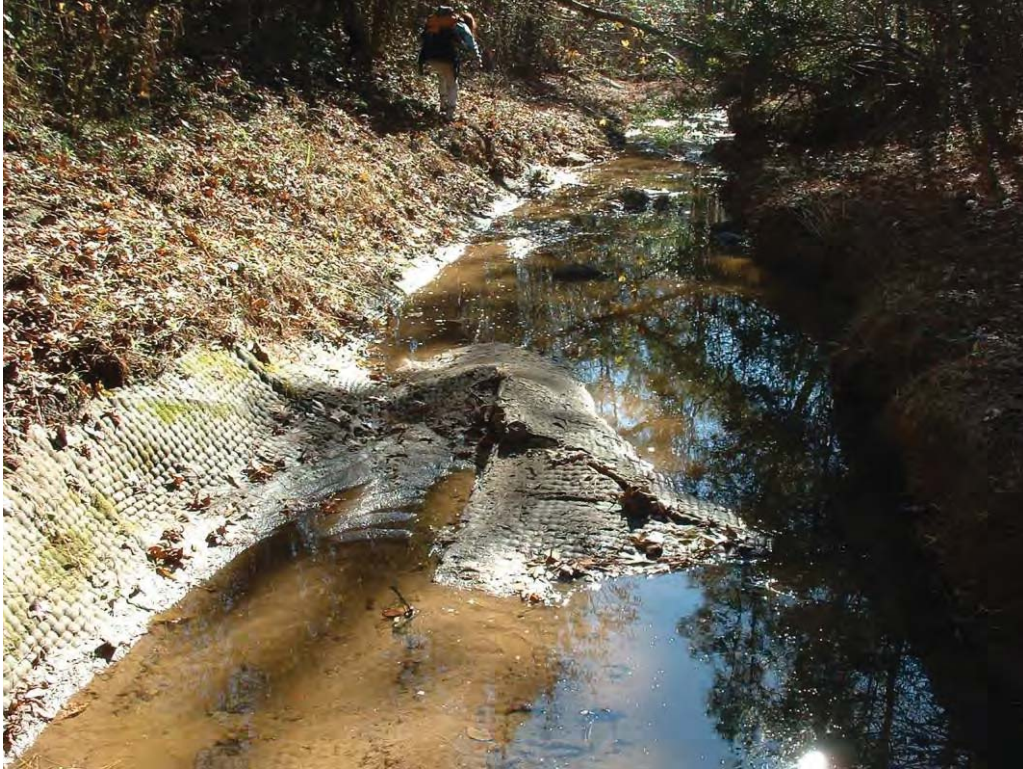
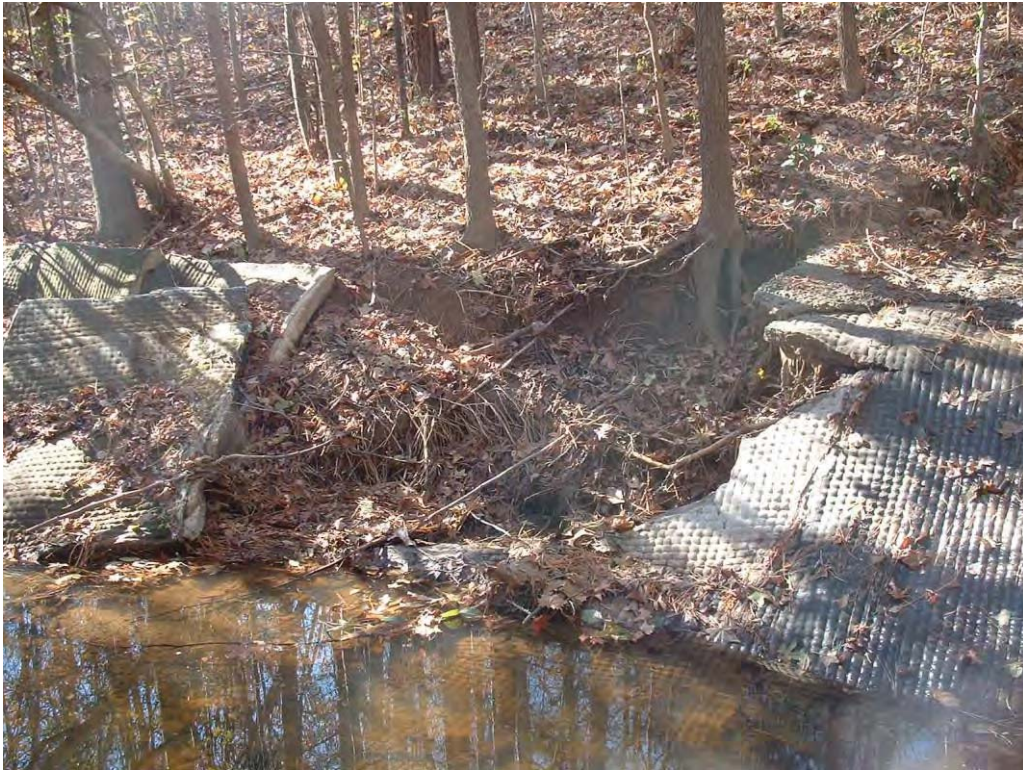
Exhibit C-5. Photos of Failing Sections of Channel Lining

Most of the concrete lining is in very good condition. However, it is buckling along the stream bottom in a few areas. There is one major failure of the bank lining just downstream of the confluence with Tributary 8. Photos of this area are shown in Exhibit C-5.

The downstream end of this tributary is routed through a 62-foot length of 36” concrete pipe discharging directly to the bank of Tracy Branch. The only significant bank failure along the lined portion of Tracy Branch is just below the outlet for Tributary 8 (shown in Exhibit C-8) and appeared to have occurred not long before the stream reconnaissance in 2008. The culvert serves no obvious purpose (e.g., road, driveway, etc.) and may have been installed as a grade control measure or under a construction access drive or staging area at some point. The tributary outlet is two to three feet above the streambed of Tracy Branch. Photos of the downstream reach and the discharge point are shown in Exhibit C-12.

1. Repair failed area of concrete lining on Tracy Branch right bank below confluence of Tributary 8. A localized repair could be done with concrete, but a more comprehensive approach would be to replace the failing concrete with gabion mattress for the entire reach from Lynnwood to Boxwood. The project would also have some limited water quality benefits by allowing surface water/groundwater exchange in the channel bottom. The channel is located on private property.

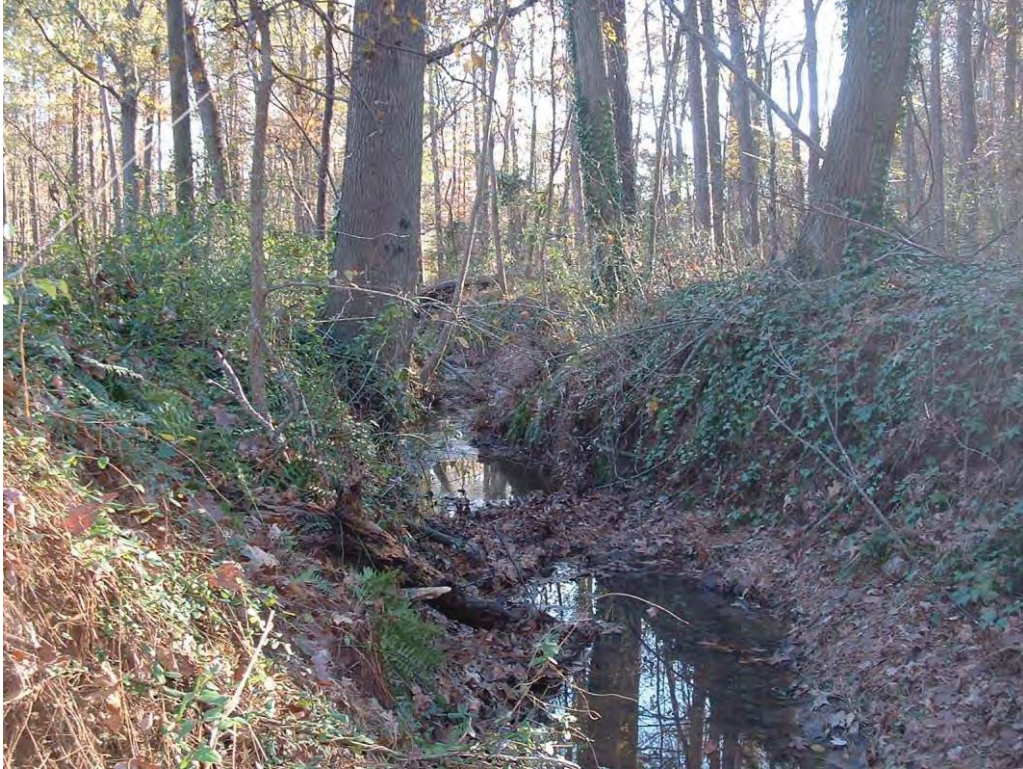
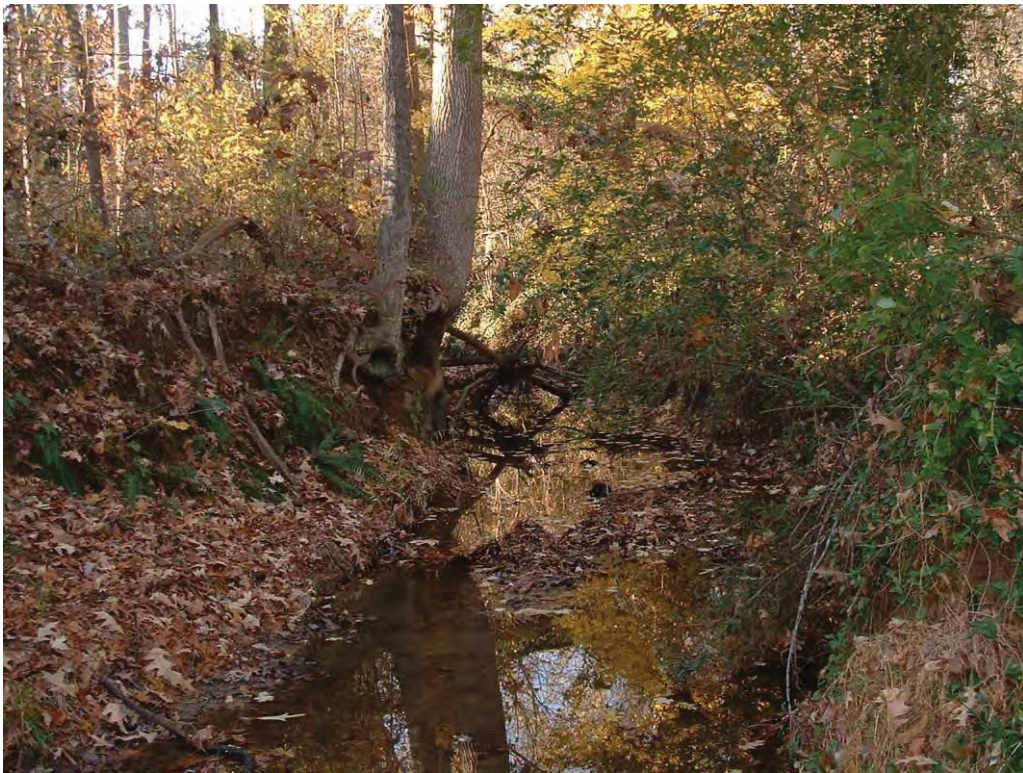
Exhibit C-6. Photos along Reach C

Reach C is north of Ephesus Church Road and most of the reach is moderately to severely entrenched. The stream flows through a small town park and between relatively deep lots fronting along Landerwood and Overland Drives. Riparian areas generally are not maintained as part of the owners' back yards. Ivy and other invasive species are rampant in some areas. The park area, at the lower end of the reach, is a relatively wide and flat floodplain, and the stream is less entrenched there than in the upper portions. Moving upstream from the park, the stream gradually becomes more narrow and deep. Downstream of Fountain Ridge Road, the stream is almost 10 feet deep and only four to six feet wide at the bottom. Photos along the Reach C are shown in Exhibit C-6.

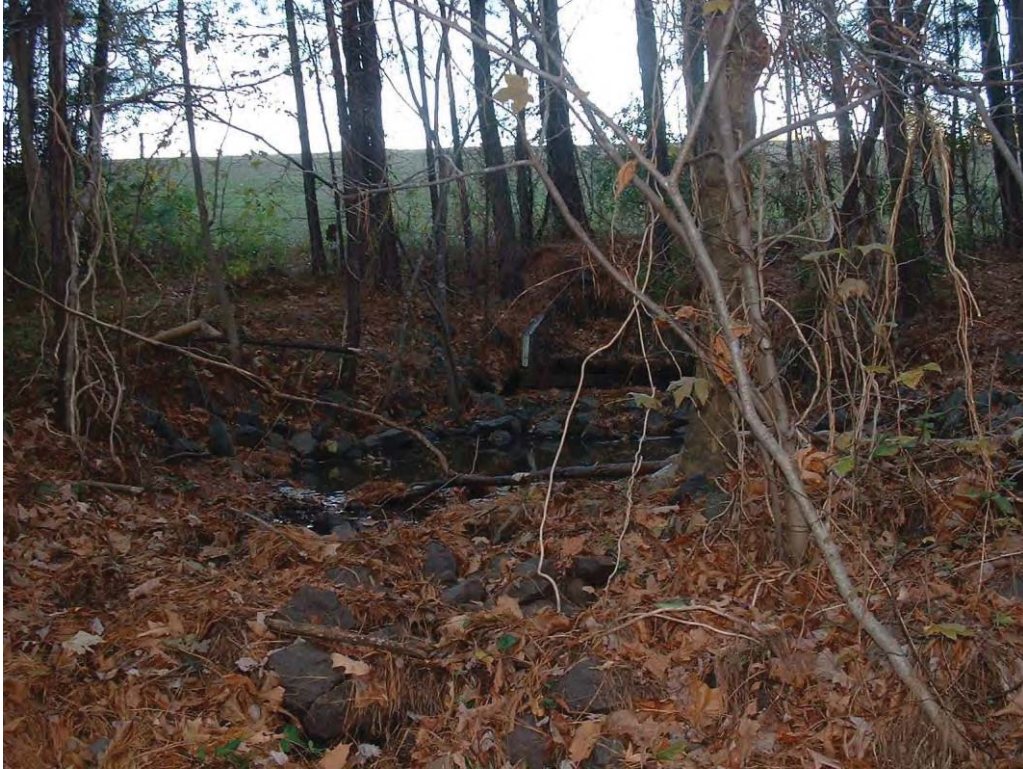
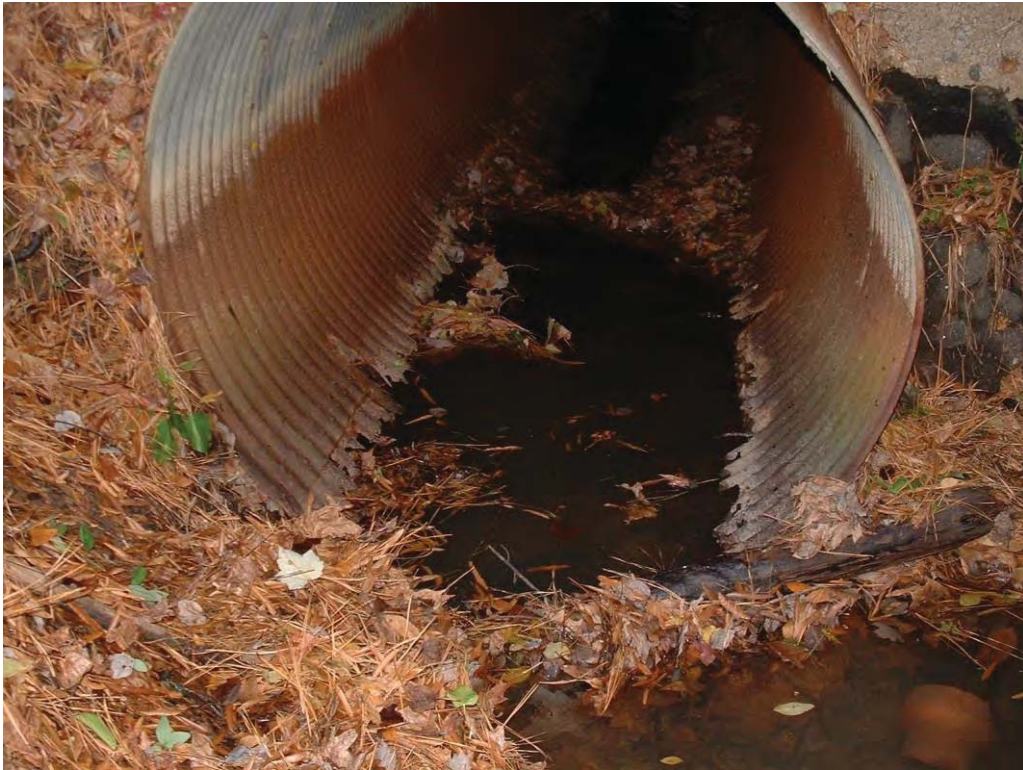
Exhibit C-7. Photos of Colony Lake Outlet and Replaced Fountain Ridge Culvert

At the upper end of Reach C is a 4.5-acre lake owned and maintained by the Colony Lake Homeowners Association. The main outlet is a riser discharging through a 30" concrete pipe. The owners have constructed a rip-rap lined stilling basin to dissipate energy and slow velocities in an effort to stem the erosion occurring below the discharge point. An OWASA aerial crossing, mounted on a large beam at a point about forty feet downstream of the lake outlet, further exacerbates the channel stability problems in the reach between the discharge point and Fountain Ridge Road. The bottom of the corrugated metal pipe (CMP) culvert under Fountain Ridge Road observed during stream walks was eroded out and the channel bottom was a few inches below the pipe. The culvert was replaced in March 2010 as an emergency construction project due to failure of the road, caused by a non-functional subdrain system. Although the road failure in this case was not caused by the eroded pipe, the observed pipe condition is typical of many older CMPs, where the deterioration of structural integrity may represent a threat to public safety. Photos of the lake pipe outlet and the new Fountain Ridge culvert are shown in Exhibit C-7.

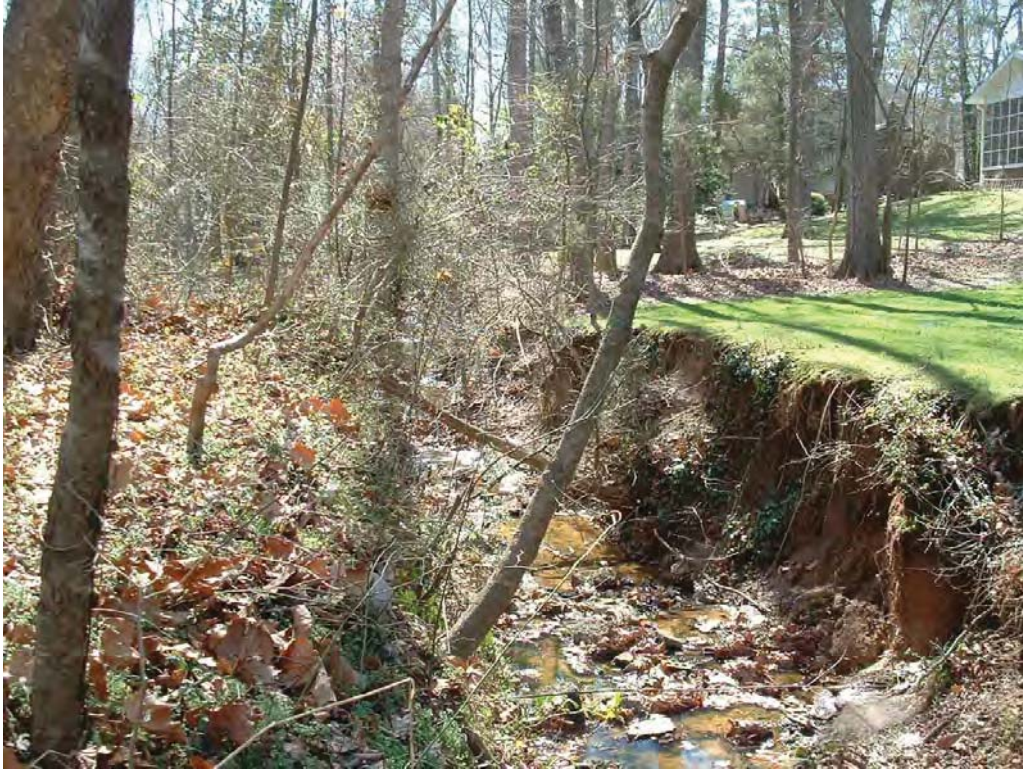
Severe entrenchment and bank erosion characterize the 370 feet of open channel at the downstream end of Tributary 3, which drains the area between Emory Drive and Churchill Drive above LeClair Street. The photos in Exhibit C-8 show the perched outlet at the culvert under LeClair Street and the erosion downstream. The tributary includes 1500 feet of open and piped

Erosion on Tributary 3; Looking downstream from culvert outlet

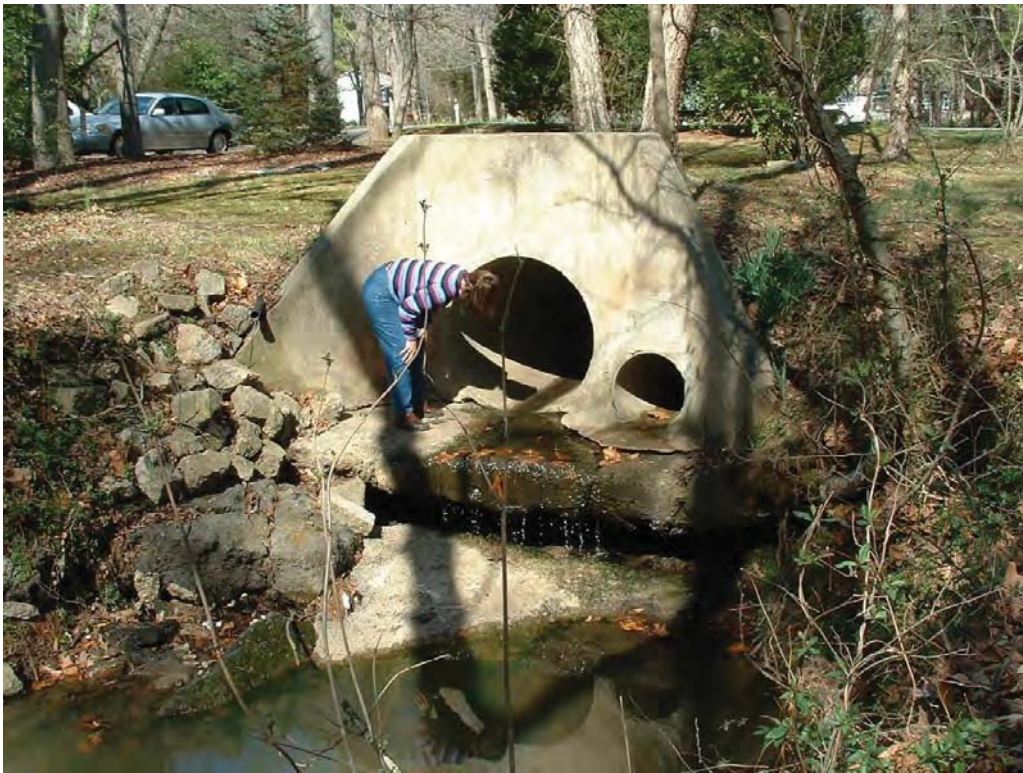
Perched outlet for culvert under LeClair Street

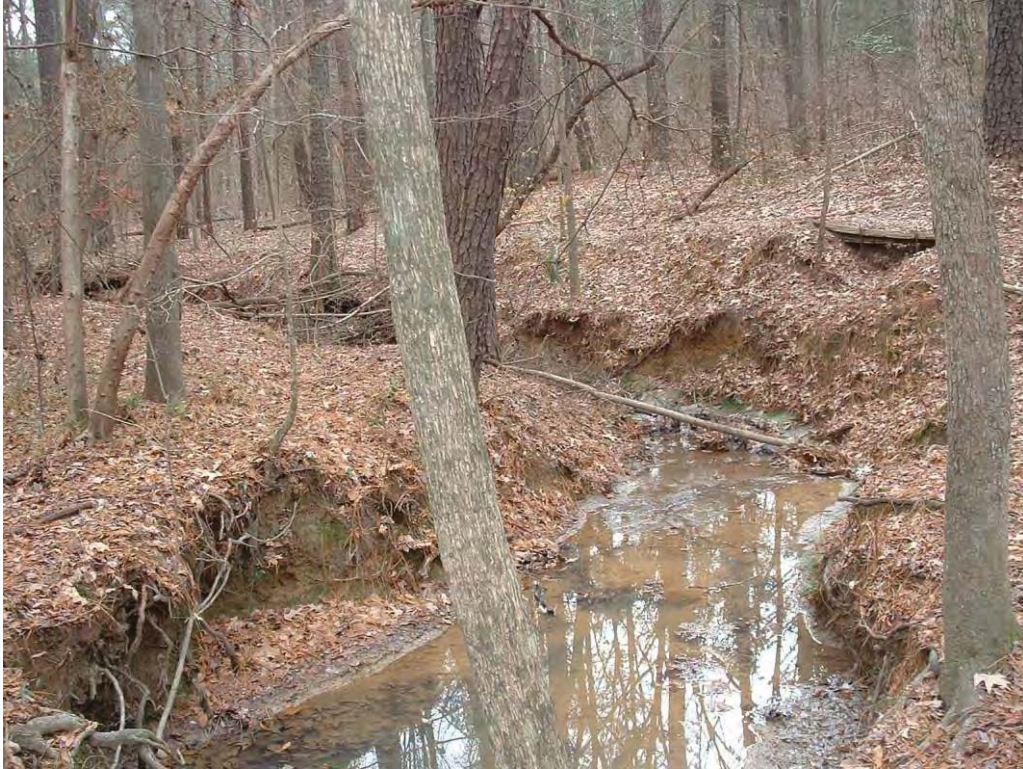
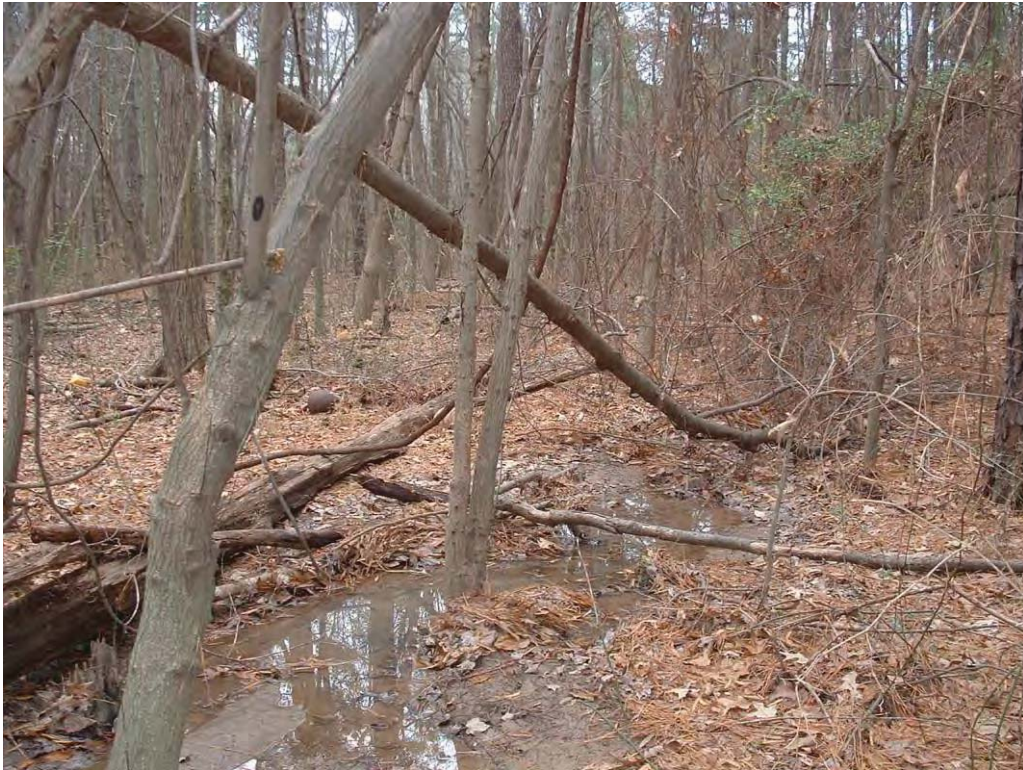
Exhibit C-9. Photos of Tributary 8

Tributary 8 is the longest and largest of the tributaries to Tracy Branch, draining about 1/5 of the watershed and flowing a distance of about 4500 feet. The FEMA flooding mapping for Tracy Branch extends up this tributary instead of along the main stem. The neighborhoods along Forsyth and Adelaide Walters Drives drain to the upstream end of Tributary 8. From there the tributary flows south through the American Legion and Town of Chapel Hill properties towards Ephesus Church Road. Photos of the Tributary 8 stream conditions are shown in Exhibit C-9.

In spite of the undisturbed nature of the heavily forested land adjacent to the stream, the upstream reaches of Tributary 8 exhibit evidence of moderate to severe incision and bank erosion. Several knickpoints were observed and there are also reaches where the stream has aggraded. In one area, so much sediment has collected that the stream channel is no longer readily discernible. There are problems with minor trash dumping at the upstream end of Tributary 8, as well as some evidence of debris dumps and abandoned “campsites” along the reach in undeveloped properties.

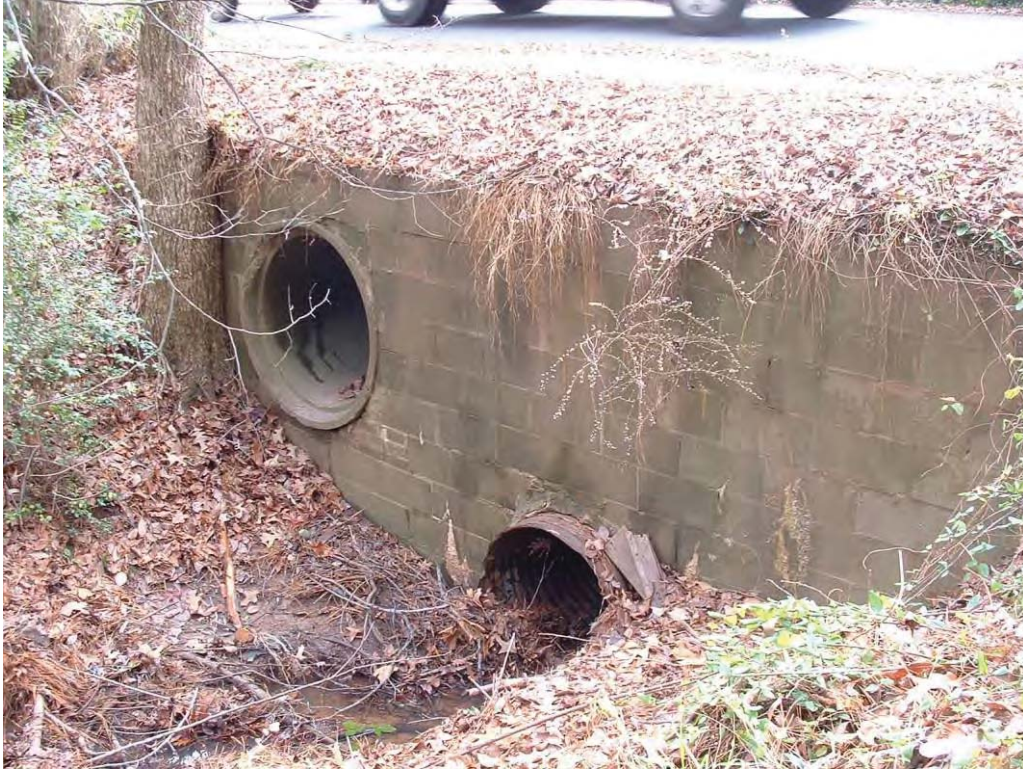
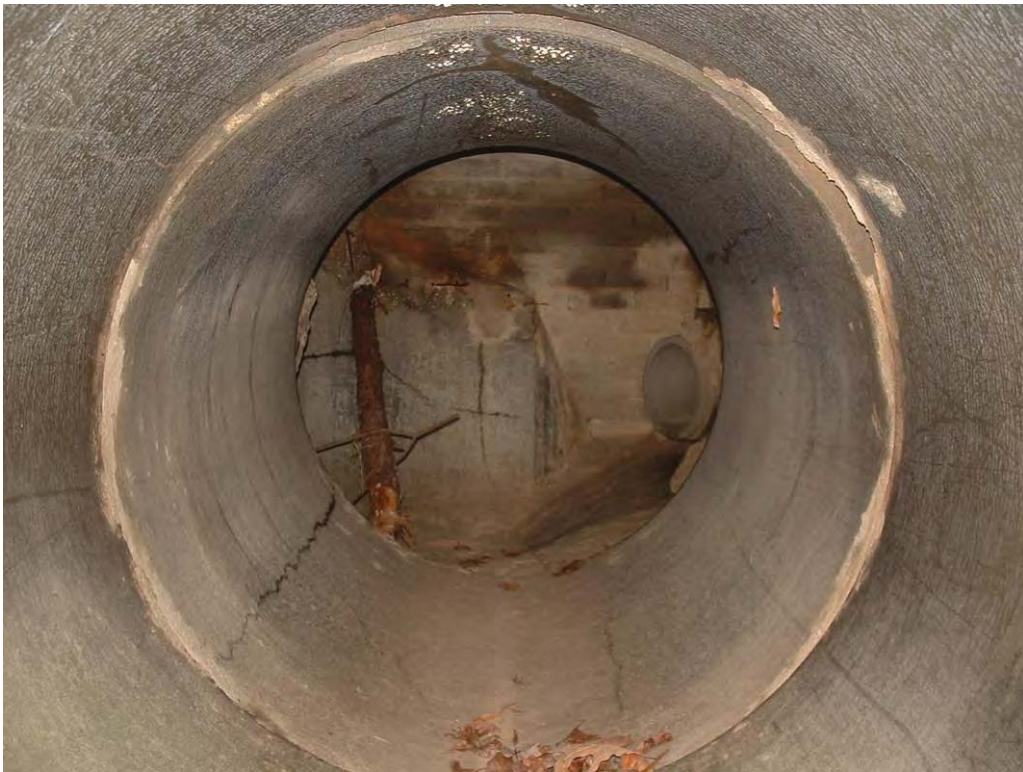
Exhibit C-10. Photos of Tributary 8 Culverts at Ephesus Church Road

The stream has two separate culvert systems under Ephesus Church Road and through downstream properties, with outlets from both systems located behind the home at 609 Tinkerbell Road. There is an older system handling the low flows, and a newer system with an inlet placed at a higher elevation upstream of Ephesus Church Road which was apparently

constructed to provide additional drainage capacity. Some photos of the culvert system are shown in Exhibit C-10 and C-11. Each culvert is roughly 500 feet long. No records of the pipe alignments were available for this study and the alignments could not be determined from surface observations. In spite of the upgrade, the culvert system nevertheless remains undersized, during field reconnaissance, one upstream homeowner described frequent problems with flooding. The flood history of homes in this area has not been documented, but twelve homes are at least partially mapped within the FEMA 1% annual chance floodplain. Additionally, the photos show evidence that the low flow system is possibly being undermined. Flow below the pipe invert elevation can be observed in one of the curb inlets along Tinkerbell. A complaint was received from the homeowner at 604 Tinkerbell in 2004 about deterioration of his driveway, presumably over the low flow culvert from Ephesus Church Road. The driveway appears to have been repaired by the homeowner and the property has changed ownership since then.

2. Replace or upgrade culvert on Tributary 8 at Ephesus Church and Tinkerbell Roads. The existing low flow culvert is eroding and should be replaced with a larger culvert. Partial daylighting could be considered in conjunction with buyout of 605 Tinkerbell Road, where the basement level is at risk of flooding. Restoration of the downstream portion of the stream could also be incorporated into this project. Unless a 1% annual chance design storm is used for the culvert sizing, upstream homes may still be at risk of flooding when Ephesus Church Road is overtopped. Results of a rudimentary analysis of the impacts of replacing the existing 30” CMP with a 48” RCP are shown in Tables C-4 and C-5. Additional survey and an adequate determination of the alignment of the existing system would have to be undertaken at the design phase in order to more comprehensively analyze and project the impacts of a proposed improvement. Replacement of the culvert would require dedication of easements from several private property owners.

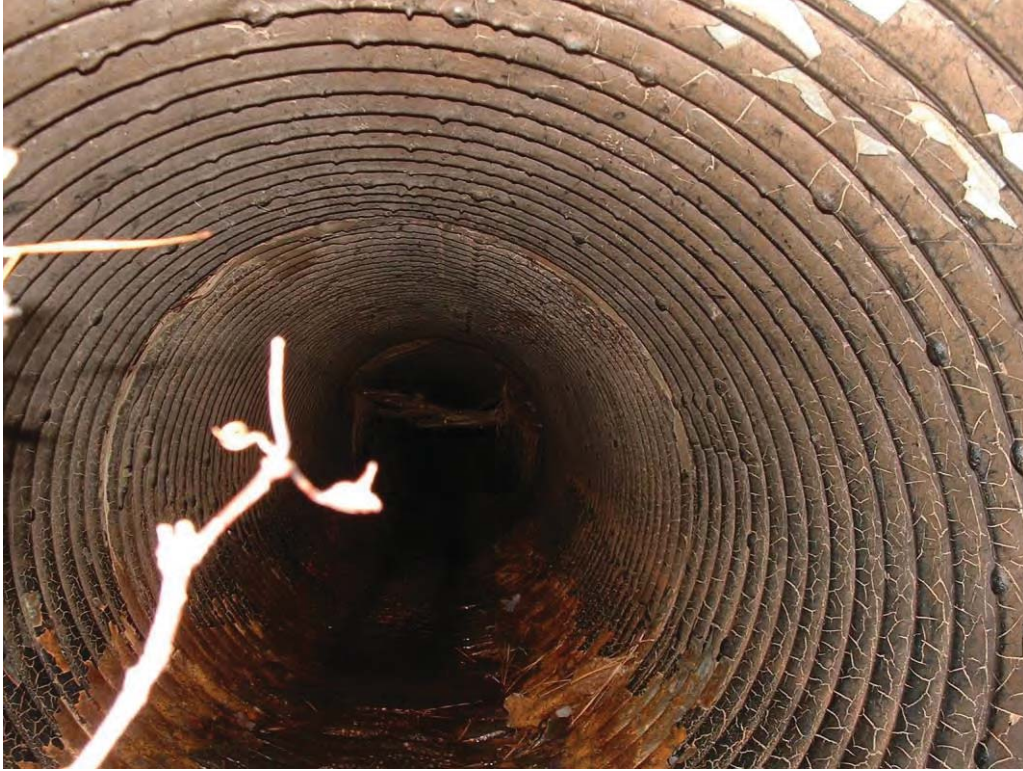
deterioration in culvert

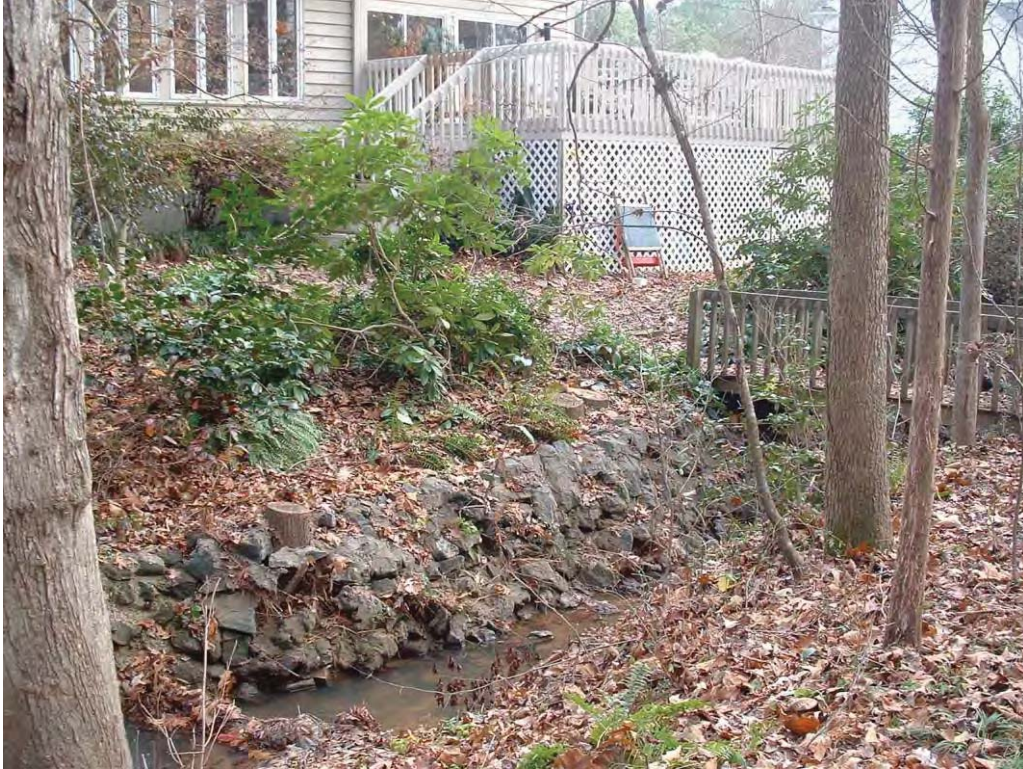
Stream conditions are mixed in the 600 feet of open channel on Tributary 8 downstream of the Ephesus Church Road/Tinkerbell Road culvert. The reach is moderately incised, but there is strong sinuosity and evidence of good riffle/pool sequences. However, one homeowner has reinforced the channel with riprap to stem erosion that is eating away his backyard. At least nine roof/unknown 4” to 6” drain pipes are discharging along this reach and there is a large infestation of bamboo in one area along the left bank.

streambank reinforced by homeowner

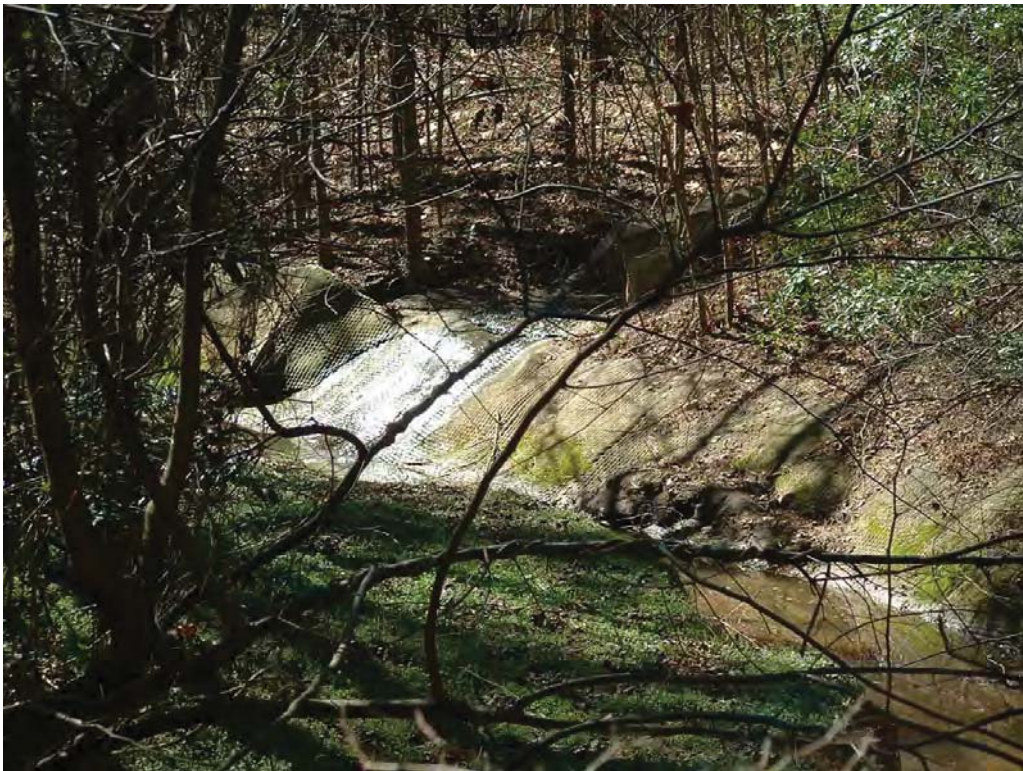
discharge from Tributary 8 into Tracy Branch (prior to concrete failure)

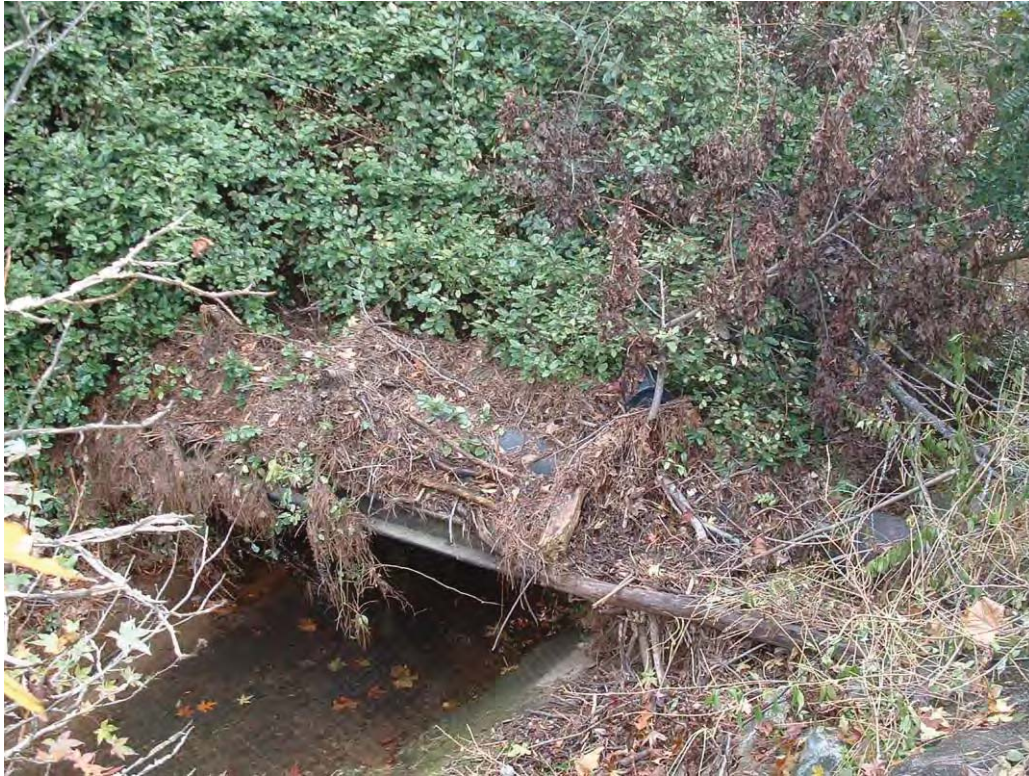
Of particular concern in this subwatershed are the number and the size of some of the sanitary sewer aerial crossings. Although the aerals are only a pollution source if they leak or burst, they have potential to significantly impact channel morphology and in some instances can also increase flooding. OWASA policy allows for the option of supporting an aerial crossing on a steel beam instead of with pier supports. Two particularly problematic crossings of this type are located on Tracy Branch. The southern one, located near the downstream end of the concrete lining, potentially causes considerable hindrance to channel flows in major storm events and lies a few hundred feet downstream of one of the more floodprone areas in the watershed. The northern crossing, about 80 feet downstream of the outlet from Colony Lake, also affects channel flow in larger storms and possibly exacerbates the ongoing erosion along that reach. Photos of these aerial crossings are shown in Exhibit C-13.

aerial crossing on Reach B

3. Remove sewer aerial near the end of the concrete reach, replace beam with pier supports or concrete blocks buried in the bank, or encase pipe in steel. The objective is to reduce the obstruction to flows caused by the existing structure and associated vegetation. Channel is located on private property and sewer line is owned by OWASA.
4. Purchase one of the flood-prone homes on Colony Woods Drive in the area of previous drainage complaints in order to construct an appropriately sized channel to accommodate stormwater through the reach. A BMP sufficiently sized for the upstream drainage area could be incorporated with the project.
