Appendix C
Pilot Basin Study Interim Report
Ephesus Subwatershed

Pilot Basin Study Report – Ephesus Subwatershed

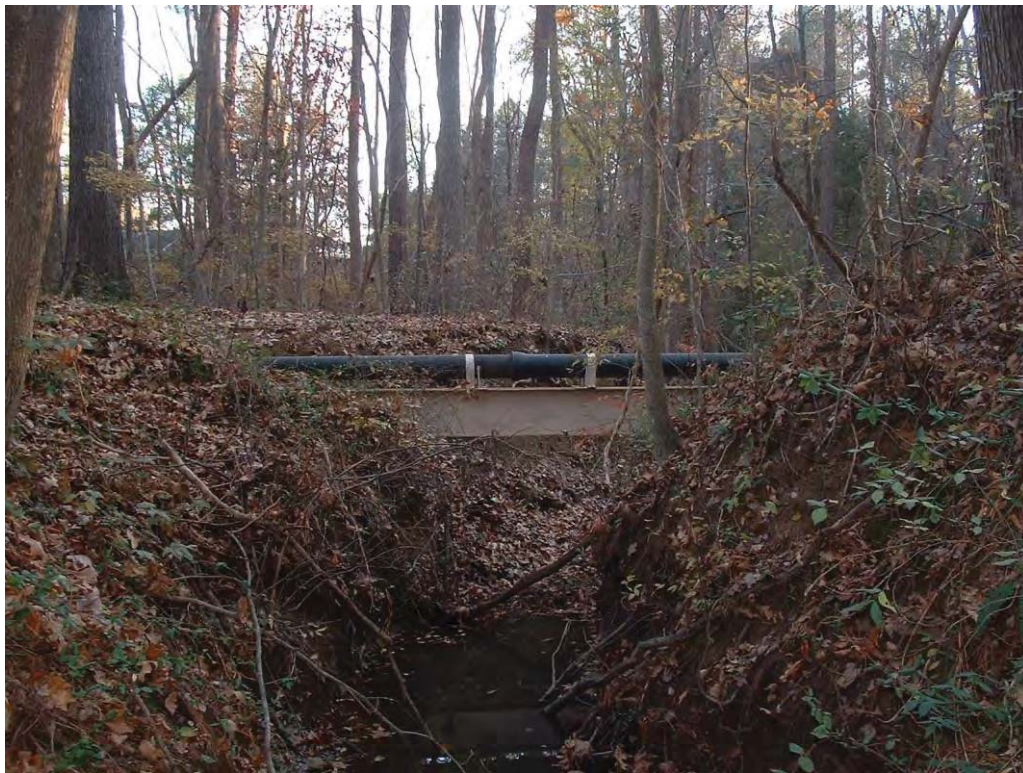
Of particular concern in this subwatershed are the number and the size of some of the sanitary sewer aerial crossings. Although the aerals are only a pollution source if they leak or burst, they have potential to significantly impact channel morphology and in some instances can also increase flooding. OWASA policy allows for the option of supporting an aerial crossing on a steel beam instead of with pier supports. Two particularly problematic crossings of this type are located on Tracy Branch. The southern one, located near the downstream end of the concrete lining, potentially causes considerable hindrance to channel flows in major storm events and lies a few hundred feet downstream of one of the more floodprone areas in the watershed. The northern crossing, about 80 feet downstream of the outlet from Colony Lake, also affects channel flow in larger storms and possibly exacerbates the ongoing erosion along that reach. Photos of these aerial crossings are shown in Exhibit C-13.

aerial crossing on Reach C
