APPENDIX C

Raw Data Forms for Final Sites

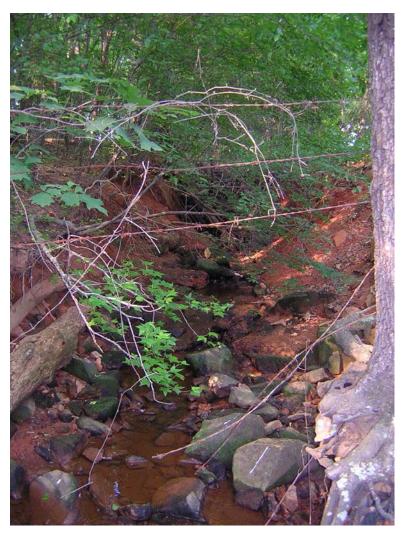
STREAM NAME: BOLIN CI	REEK	DATE	E: 5/30/07			MAP SHEET #: 4
PHOTO NUMBERS:		LANI	OMARK: LA	KE WEST OF OLI) NC 86	SKETCH ON BACK
GPS ID START: IJ04 DESCRIPTION:			GPS ID I	END: IJ04		
RAIN IN LAST 24 HOURS	Heavy rain ☐ Steady rain				☐ Heavy ra	in □ Steady rain □ Intermittent
X None	Intermittent Trace		X Clear		☐ Trace	☐ Overcast ☐ Partly cloudy
SURROUNDING LAND USE:	☐ Industrial ☐ Commerce ☐ Golf course ☐ Park		Urban/Res Crop	sidential □ Sub □ Past		X Forested ☐ Institutional ☐ Other:
BASE FLOW WIDTH AS % CHANNEL	0-25% 25-50 % 50%-75% 75-100%		(clear, no	CLARITY Cleaturally colored) (chemicals, dyes	☐ Opaque	(suspended matter) ☐ Stained (milky)
DOMINANT SUBSTRATE X Silt/clay (fine or slick) ☐ Sand (gritty) ☐ Gravel (0.1-2.5") ☐ Cobble (2.5 -10") ☐ Boulder (>10") ☐ Bed rock	Width: Bottom	5(33 0.5(ft)	OBSERVED IMI Outfall Confluence Impacted b Stream cros Channel mo Utility imps Beaver Other	uffer ssing od

CHANNEL DYNAMICS	☐ Bed scour ☐			Notes		
☑ Downcutting☑ Widening☑ Headcutting☑ Aggrading	Bank failure	Slope i Chann Unkno	elized			RGE AMOUNTS OF BANK EROSION CISED- COULD DO POSSIBLE OUTFALL
QUALITATIVE IMPAIRMEN	T RATING: Low Dod	erate	X Severe	CHANNEL EV □ VI (Simo		STAGE: I II III IV V 03)

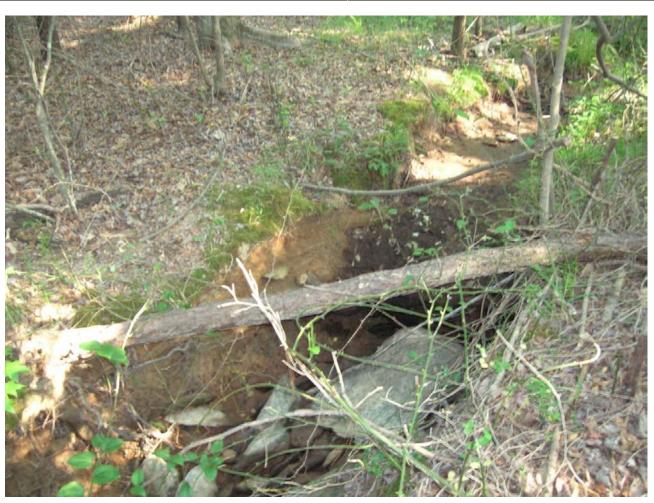
STREAM NAME: UT	DATE: 5	: 5/31/07 MAP SHEET #: 7
PHOTO NUMBERS: 1118-1122	LANDM	MARK: ROGERS AND EUBANKS SKETCH ON BACK
GPS ID START: BD 27 DESCRIPTION:	"	GPS ID END: BD 28 DESCRIPTION:
RAIN IN LAST 24 HOURS ☐ Heavy rain ☐ Steady rain None ☐ Intermittent ☐ Trace SURROUNDING LAND USE: ☐ Industrial ☐ Commerce ☐ Golf course ☐ Park	Σ	PRESENT CONDITIONS ☐ Heavy rain ☐ Steady rain ☐ Intermittent X Clear ☐ Trace ☐ Overcast ☐ Partly cloudy Urban/Residential ☐ Suburban/Res X Forested ☐ Institutional Crop ☐ Pasture ☐ Other:
BASE FLOW WIDTH	(WATER CLARITY ☐ Clear ☐ Turbid (suspended matter) ☐ Stained (clear, naturally colored) ☐ Opaque (milky) ☐ Other (chemicals, dyes) NA
X Silt/clay (fine or slick)	.1(f .5(f 0.1(ft)	(ft)
CHANNEL DYNAMICS Downcutting Widening Headcutting Aggrading Bed scour Bank failure Bank scour Sed. deposition	Slope fai Channeli Unknow	NOTES SOME FLOW FROM YARDS MAY BE CAUSING HEADCUTS ALSO SIGNS OF RILLS CHANNEL EVOLUTION STAGE: DID HID HID IV DV

QUALITATIVE IMPAIRMENT RATING: Low X Mode	erate \square	$\square \text{ Severe } \square \text{ VI } (Simon \ et. \ al., 2003)$

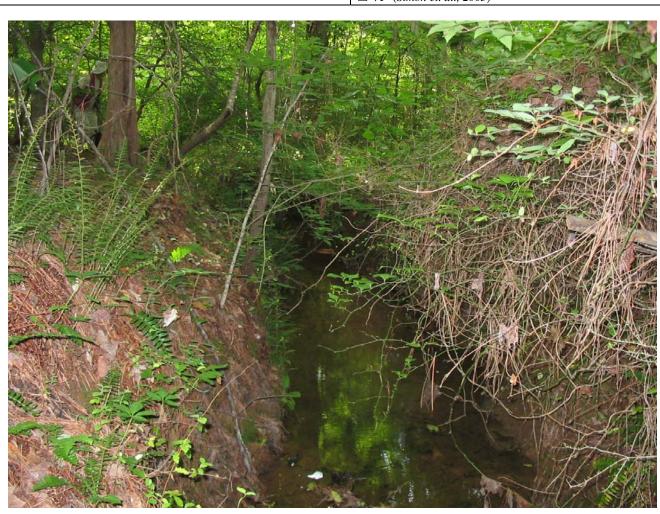
STREAM NAME: UT	DATE: 6 /2	/5/07		MAP SHEET #: 9
PHOTO NUMBERS: 1087	LANDMA	RK: UP STRM CIRCADIA	N WAY	SKETCH ON BACK
GPS ID START: TA 1 DESCRIPTION: BRIDGE OVER CIRCADIAN WAY	-	PS ID END: TA 4 ESCRIPTION: FOOT BRIE	OGE	
RAIN IN LAST 24 HOURS ☐ Heavy rain ☐ Steady rain ☐ None ☐ Intermittent ☐ Trace		RESENT CONDITIONS Clear	☐ Heavy ra ☐ Trace	in ☐ Steady rain ☐ Intermittent ☐ Overcast ☐ Partly cloudy
SURROUNDING LAND USE:	rcial 🗆 Urt	ban/Residential X Subu pp □ Pasti		☐ Forested ☐ Institutional ☐ Other:
BASE FLOW WIDTH AS % CHANNEL WIDTH □ 0-25% □ 25-50 % □ 50%-75% X 75-100%	(cl	VATER CLARITY X Clear lear, naturally colored) Other (chemicals, dyes)	☐ Opaque	(suspended matter) ☐ Stained (milky)
☐ Silt/clay (fine or slick) I Sand (gritty) 2 Gravel (0.1-2.5") ☐ Cobble (2.5 -10") Width: Bottom 4.5 Top 10. Water Surface 3.5	5(f (f 0(f 5(f	ft) Confluence Impacted by Stream cros Channel mo	uffer ssing od acts

CHANNEL DYNAMICS Downcutting Widening Headcutting Aggrading Bed scour Bank failure Bank scour Sed. deposition] Slope failu] Channelize] Unknown	ed 1	ATER DRAIN	
QUALITATIVE IMPAIRMENT RATING: Low Mod	derate \square S	Severe

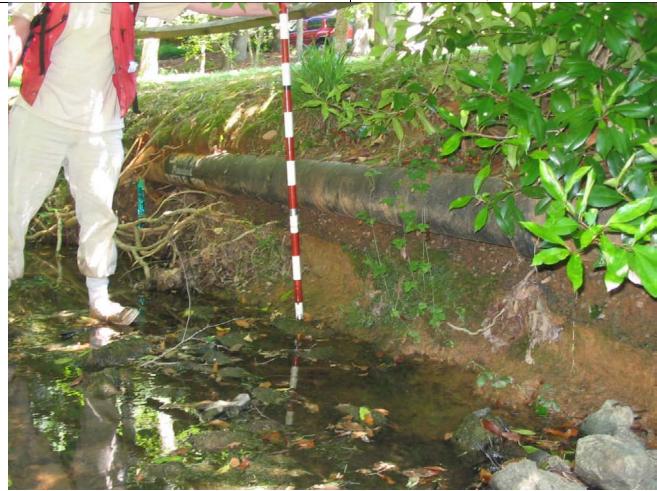
STREAM NAME: UT BELOW GATES FARM RD DATE:			TE: 6/5/07			MAP SHEET #: 14
PHOTO NUMBERS: 1093-1095 LANDI			MARK: GA	TES FARM RD		SKETCH ON BACK
GPS ID START: TA-5	<u>.</u>		GPS ID I	END:		
DESCRIPTION: NEAR GATES FARM RD	ı		DESCRIP	ΓΙΟN:		
RAIN IN LAST 24 HOURS Heavy rain	☐ Steady rain		PRESENT	CONDITIONS	□ Heavy ra	in □ Steady rain □ Intermittent
X None	t □ Trace		X Clear		☐ Trace	☐ Overcast ☐ Partly cloudy
SURROUNDING LAND USE: Golf con	al □ Commerci urse □ Park		Urban/Res Crop	sidential X Subu ☐ Pastu		☐ Forested ☐ Institutional ☐ Other:
BASE FLOW WIDTH AS % CHANNEL WIDTH D 0-25% D 25-50 % D 50%-75% X 75-100%			(clear, na	CLARITY X Cleaturally colored) (chemicals, dyes)	☐ Opaque	(suspended matter) \square Stained (milky)
DOMINANT SUBSTRATE CHANNEL	DIMENSIONS AT RI	FFLE		OBSERVED IMP	ACTS	
☐ Gravel (0.1-2.5")	Sottom 7.0_ Cop 11.0_ Vater Surface 7.0_		(ft) (ft) (ft)	Stream cros Channel mo Utility impa Beaver	uffer – Cat l ssing od	litter dump site

o: Low bank/Max E	BKF=_		Other- scou	r from incre	ased SW
	k failure	Slope f Channe Unkno		Notes		
QUALITATIVE IMPAIRMENT RATING:	X Low X Moder	ate [□ Severe	CHANNEL EV □ VI (Simo		STAGE: I II III X IV V 93)

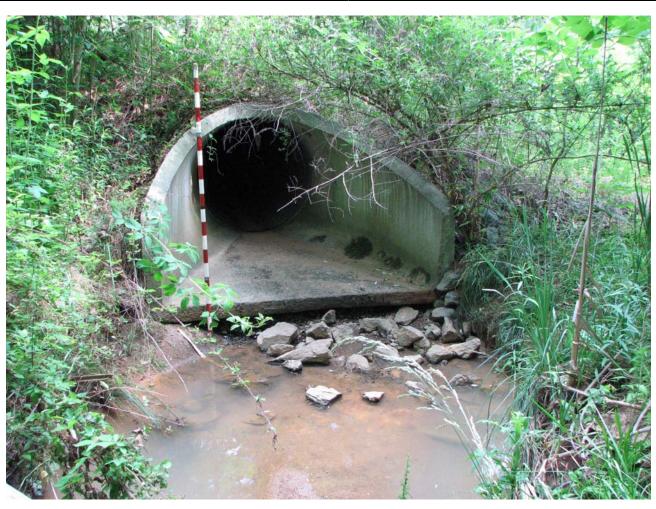
STREAM NAME: UT TO JO	OLLY BRANCH	DATE	E: 6/5/07			MAP SHEET #: 16
PHOTO NUMBERS: 0418		LAND	MARK: SM	IITH MIDDLE SC	HOOL	SKETCH ON BACK
GPS ID START: IJ 34 DESCRIPTION:			GPS ID I	END: IJ 34 TION:		
RAIN IN LAST 24 HOURS X None SURROUNDING LAND USE:	Intermittent Trace	cial X	□ Clear	conditions sidential X Subt	☐ Trace	in ☐ Steady rain ☐ Intermittent ☐ Overcast ☐ Partly cloudy X Forested ☐ Institutional ☐ Other:
AS % CHANNEL X	0-25% 25-50 % 50%-75% 75-100%		(clear, no	CLARITY Cle nturally colored) (chemicals, dyes	☐ Opaque	(suspended matter) ☐ Stained (milky)
X Silt/clay (fine or slick) X Sand (gritty) □ Gravel (0.1-2.5") □ Cobble (2.5 -10") □ Boulder (>10") □ Bed rock	Width: Bottom 2.5_ Top 2.75 Water Surface 2.1_	5	(ft) (ft) (ft)	OBSERVED IMI Outfall Confluence Impacted b Stream cros Channel mo Utility impa Beaver Other – Pip	uffer ssing od acts	
CHANNEL DYNAMICS Downcutting Widening Headcutting Aggrading	Bed scour Bank failure Bank scour Sed. deposition	Slope f Channo Unkno	failure elized own	NOTES RCP AT MIDDI UNDERCUT BY I GOOD BMP PO	LE SCHOOL N FLOW TENTIAL	EEDS ENERGY DISSIPATION BEING

QUALITATIVE IMPAIRMEN	T RATING: Low X Mode	erate	□ Severe	□ VI (Simo

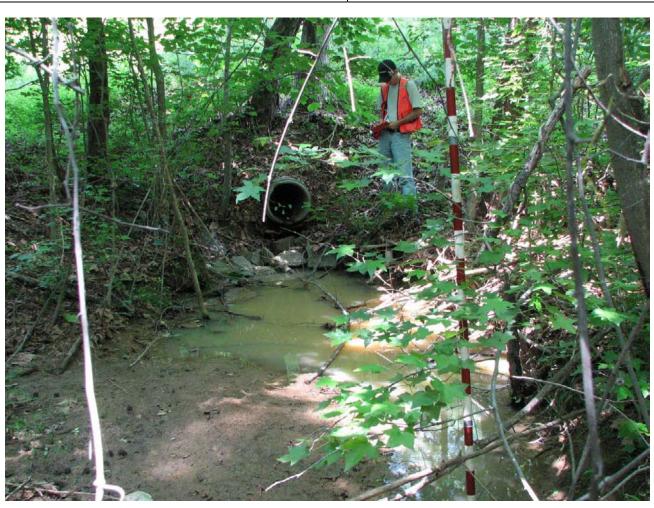
STREAM NAME: UT JOLLY BRANCH	DATE: 6/5/0'	1	MAP SHEET #: 17
PHOTO NUMBERS: 396-398	LANDMARK:		SKETCH ON BACK
GPS ID START: IJ 26		D END:	
DESCRIPTION:	DESCI	RIPTION:	
RAIN IN LAST 24 HOURS ☐ Heavy rain ☐ Steady rain	PRESE	ENT CONDITIONS	in Steady rain Intermittent
X None	□ Cle	ar \square Trace	☐ Overcast X Partly cloudy
SURROUNDING LAND USE: ☐ Industrial ☐ Commerce ☐ Golf course ☐ Park	cial X Urban/ □ Crop	Residential ☐ Suburban/Res ☐ Pasture	X Forested ☐ Institutional ☐ Other:
BASE FLOW WIDTH AS % CHANNEL WIDTH □ 0-25% □ 25-50 % X 50%-75% □ 75-100%	(clear	R CLARITY ☐ Clear X Turbio naturally colored) ☐ Opaque er (chemicals, dyes)	d (suspended matter) ☐ Stained (milky)
DOMINANT SUBSTRATE CHANNEL DIMENSIONS AT R	RIFFLE	OBSERVED IMPACTS	
X Silt/clay (fine or slick)	(ft)	Outfall Confluence Impacted buffer Stream crossing Channel mod Utility impacts Beaver Other	
Widening	Slope failure Channelized Unknown	SEDIMENT DEPOSITION INCISION OF STREAM OLD BMP IS FAILING	USING OVERLAND EROSION AND

QUALITATIVE IMPAIRMENT RATING: Low Mod	erate Seve	\square VI (Simon et. al., 20	03)

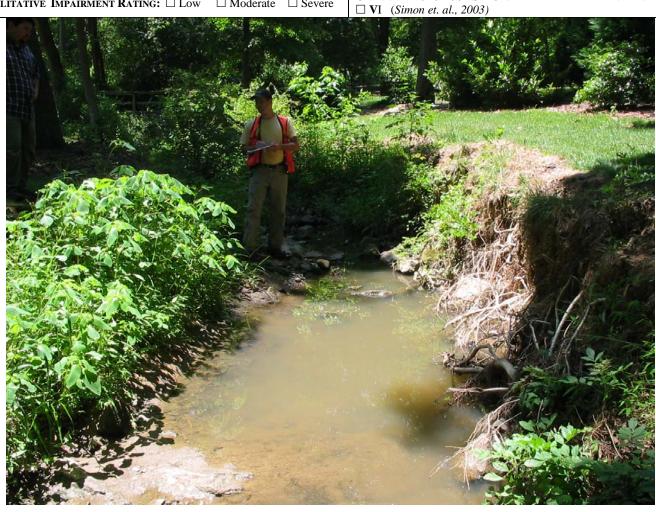
STREAM NAME: UT		DATE:	: 6/6/07			MAP SHEET #: 20
PHOTO NUMBERS: 1111-1112	.2 (TONY)	LAND	MARK: ES	TES		SKETCH ON BACK
GPS ID START: BD 44 DESCRIPTION:			GPS ID I	END: BD 47 FION:		
RAIN IN LAST 24 HOURS ☐ HO	Heavy rain X Steady rain Intermittent ☐ Trace		PRESENT X Clear	CONDITIONS	☐ Heavy rai	in ☐ Steady rain ☐ Intermittent ☐ Overcast ☐ Partly cloudy
	☐ Golf course ☐ Park		Urban/Res Crop	idential □ Sub □ Pas		☐ Forested ☐ Institutional ☐ Other:
BASE FLOW WIDTH AS % CHANNEL WIDTH)-25% !5-50 % !0%-75% !5-100%		(clear, na	CLARITY Clauturally colored (chemicals, dye	') □ Opaque	1 (suspended matter) ☐ Stained (milky)
X Silt/clay (fine or slick) ☐ Sand (gritty) X Gravel (0.1-2.5") ☐ Cobble (2.5 -10") ☐ Boulder (>10") ☐ Bed rock	Width: Bottom 6 Top 10 Water Surface 2 Depth: Max BKF 1.0 B:H Ratio: Low bank/Max 1 Bed scour Bank failure Bank scour	((ft) _(ft) (ft) _(ft) ailure	OBSERVED IM Outfall Confluence Impacted I Stream cro Channel n Utility imp Beaver Other NOTES MASS BANK F	buffer- YARE possing nod pacts) WORK

QUALITATIVE IMPAIRMENT	RATING: Low Mode	erate [□ Severe		evolutiuon S non et. al., 200	STAGE:

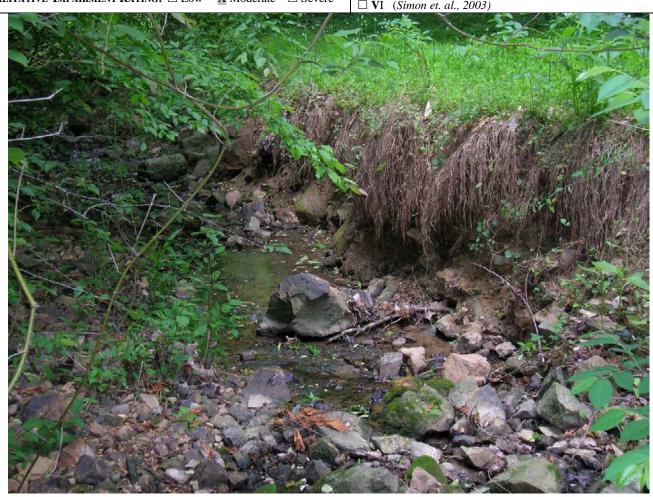
STREAM NAME: UT BOLIN	Ň	DATE	E: 5/8/07			Мар Sheet #: 20
PHOTO NUMBERS: 23		LANI	OMARK:			SKETCH ON BACK
GPS ID START: BD 11 DESCRIPTION:			GPS ID I DESCRIP			
RAIN IN LAST 24 HOURS None SURROUNDING LAND USE:	Intermittent X Trace		□ Clear		Γrace n/Res	n □ Steady rain □ Intermittent X Overcast □ Partly cloudy Y Forested □ Institutional □ Other:
AS % CHANNEL	0-25% 25-50 % 50%-75% 75-100%		WATER (Turbid ((suspended matter) □ Stained
DOMINANT SUBSTRATE Silt/clay (fine or slick) Sand (gritty) Gravel (0.1-2.5") X Cobble (2.5 -10") Boulder (>10") Bed rock CHANNEL DYNAMICS Downcutting Widening Headcutting Aggrading	CHANNEL DIMENSIONS AT R Height: Low bank Width: Bottom Top Water Surface Depth: Max BKF B:H Ratio: Low bank/Max Bed scour Bank failure Rank scour	3.2 13 17 1.4 0.6	(ft)(ft) failure elized	Observed Impacts Outfall Confluence Impacted buffer Stream crossing Channel mod Utility impacts Beaver Other NOTES

QUALITATIVE IMPAIRMEN	TRATING: Low X Mode	erate	☐ Severe	CHANNEL EVOLU □ VI (Simon et.		TAGE: \Box I \Box II \Box III \Box IV \Box V

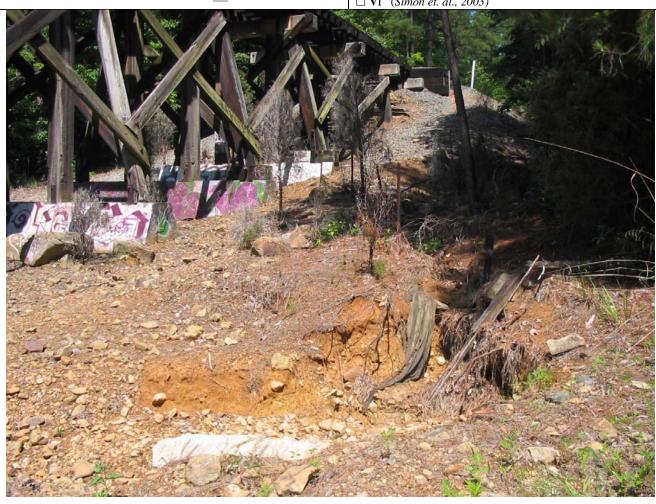
Constant Marie Till		Diam				M. a Carrage #. 20
STREAM NAME: UT		DATE:				MAP SHEET #: 20
PHOTO NUMBERS: 1105		LAND	MARK: OF	F CARDIFF PL		SKETCH ON BACK
GPS ID START: TA 19			GPS ID I	END:		
DESCRIPTION: SCOUR OF	FRR FILL		DESCRIPT	TION:		
RAIN IN LAST 24 HOURS	Heavy rain X Steady rain		PRESENT	CONDITIONS	☐ Heavy ra	in ☐ Steady rain ☐ Intermittent
□ None □	Intermittent Trace		X Clear		☐ Trace	☐ Overcast ☐ Partly cloudy
SURROUNDING LAND USE:	☐ Industrial ☐ Commerce ☐ Golf course ☐ Park		Urban/Res Crop	sidential X Subr □ Past		☐ Forested ☐ Institutional ☐ Other:
BASE FLOW WIDTH AS % CHANNEL	0-25% 25-50 % 50%-75% 75-100%		(clear, na	CLARITY Cle turally colored) (chemicals, dyes)	☐ Opaque	(suspended matter) ☐ Stained (milky) NA-NO FLOW
DOMINANT SUBSTRATE 1 Silt/clay (fine or slick) ☐ Sand (gritty) 2 Gravel (0.1-2.5") ☐ Cobble (2.5 -10") ☐ Boulder (>10") ☐ Bed rock	CHANNEL DIMENSIONS AT R Height: Low bank Width: Bottom Top Water Surface Depth: Max BKF B:H Ratio: Low bank/Max	(ft (ft (ft (ft)	t) (t) (t)	OBSERVED IMF Outfall Confluence Impacted b Stream cros Channel me Utility impa Beaver Other- SW	uffer ssing od acts

CHANNEL DYNAMICS Downcutting Widening Headcutting Aggrading	Bank failure	Slope fa Channel Unknov	lized	NOTES SIGNIFICANT SO SITE FOR POTES SEWER SMELL	NTIAL RETEN	NTION
QUALITATIVE IMPAIRMEN	T RATING: Low X Mode	erate [☐ Severe	CHANNEL EV ☐ VI (Simo		STAGE: \square I \square II $\overline{\mathbb{X}}$ III \square IV \square V
	A STATE OF THE STA	- 1			OF STREET

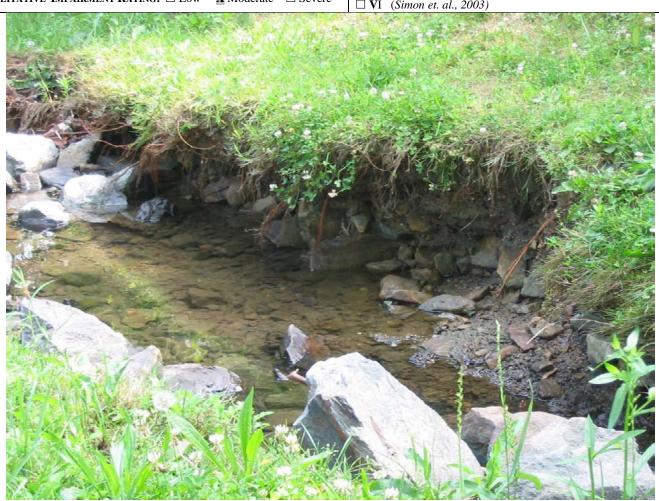
STREAM NAME: UT		DATI	E: 6/7/07			MAP SHEET #: 23
PHOTO NUMBERS: 1117- PIPED CH 1118-11120 DEGRADED		DMARK: BI	ROAD ST.		SKETCH ON BACK	
GPS ID START: TA 29			GPS ID I	END: TA 30		
DESCRIPTION: PIPED ST	NO GPS		DESCRIP	TION: DEGRADI	ED STR	NO GPS
RAIN IN LAST 24 HOURS	Heavy rain ☐ Steady rain		PRESENT	CONDITIONS	☐ Heavy ra	in □ Steady rain □ Intermittent
X None	Intermittent Trace		X Clear		☐ Trace	☐ Overcast ☐ Partly cloudy
SURROUNDING LAND USE: Industrial Commercial Variable Commercial Variable Variab			Urban/Res Crop	idential \square Sub		☐ Forested ☐ Institutional ☐ Other:
AS % CHANNEL WIDTH	0-25% 25-50 % 50%-75% 75-100%		(clear, no	CLARITY X Cleaturally colored (chemicals, dye) 🗆 Opaque	(suspended matter) ☐ Stained (milky)
DOMINANT SUBSTRATE Silt/clay (fine or slick) Sand (gritty) Gravel (0.1-2.5") Cobble (2.5 -10") Boulder (>10") Bed rock CHANNEL DYNAMICS Downcutting Widening Headcutting Aggrading	CHANNEL DIMENSIONS AT R Height: Low bank 1.3 Width: Bottom 4.0 Top 5.0 Water Surface 3.0 Depth: Max BKF 1.3 B:H Ratio: Low bank/Max Bed scour Bank failure Rank scour	(ft) (ft) (ft) (ft) (ft) BKF=	failure elized	BE DAYLIGHTI	e buffer ossing nod oacts REAM OF BRO ED TA 29 OF BROAD ST	AD ST STREAM IS PIPED AND COULD STREAM IS DEGRADED AND COULD

QUALITATIVE IMPAIRMEN	TRATING: Low X Mode	erate	□ Severe		evolutiuon S non et. al., 200	
		A COLUMN	The Date of	The sound	を ひたかける 日本	STATE OF THE PROPERTY OF THE PARTY OF THE PA

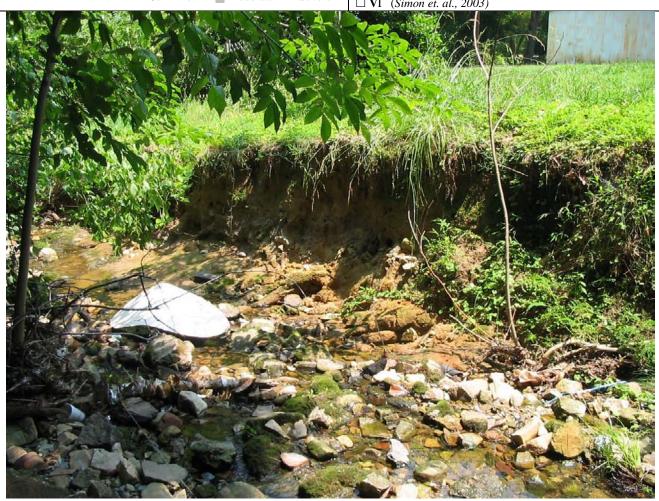
STREAM NAME: UT		DATE	: 6/7/07			MAP SHEET #: 24
Рното Numbers:1124-112	25	LAND	MARK:			SKETCH ON BACK
GPS ID START: TA 33			GPS ID I	END: TA 34		
DESCRIPTION:			DESCRIP	TION:		
RAIN IN LAST 24 HOURS	Heavy rain ☐ Steady rain		PRESENT	CONDITIONS	☐ Heavy ra	in ☐ Steady rain ☐ Intermittent
X None	Intermittent Trace		X Clear		☐ Trace	☐ Overcast ☐ Partly cloudy
SURROUNDING LAND USE:	☐ Industrial ☐ Commerce ☐ Golf course ☐ Park		Urban/Res Crop	idential □ Sub □ Pas		☐ Forested ☐ Institutional ☐ Other:
BASE FLOW WIDTH AS % CHANNEL X	0-25% 25-50 % 50%-75% 75-100%		(clear, na	CLARITY X Cleaturally colored (chemicals, dye) 🗆 Opaque	(suspended matter) ☐ Stained (milky)
DOMINANT SUBSTRATE Silt/clay (fine or slick) Sand (gritty) Gravel (0.1-2.5") Cobble (2.5 -10") Boulder (>10") Bed rock CHANNEL DYNAMICS Downcutting Widening Headcutting Aggrading	Width: Bottom 10.0 Top 20.0 Water Surface 8.0 Depth: Max BKF 1.4 (B:H Ratio: Low bank/Max Bed scour Bank failure Rank scour	(ft) (ft) (ft) (ft) (ft)	elized	OBSERVED IM Outfall Confluenc Impacted I Stream cro Channel m Utility imp Beaver Other- SC NOTES ENTIRE REACE BANK FROM S	e puffer possing nod pacts OUR from SV	x 5 to 6 ft.eroding vertical

QUALITATIVE IMPAIRMENT RATING: Low Moderate Sever				□ VI (Sim	on et. al., 200	STAGE:
	A MANUAL COLLAND		- C D

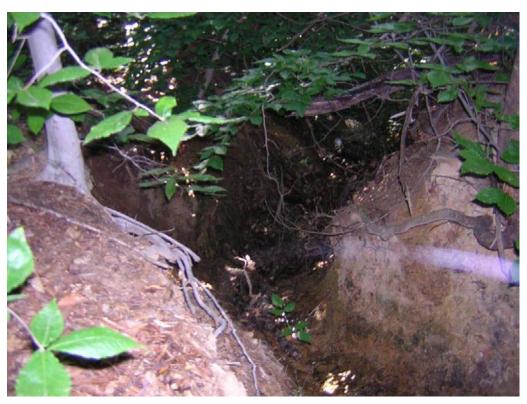
STREAM NAME: UT MILL RACE DATE: 3		E: 5/21/07			MAP SHEET #: 25-24	
PHOTO NUMBERS: 2976-2979	9	LAND	MARK: HI	LLSBOROUGH ST	Γ	SKETCH ON BACK
GPS ID START: IJ 43			GPS ID I	END: IJ 43		
DESCRIPTION:			DESCRIP	ΓΙΟN:		
RAIN IN LAST 24 HOURS \square H	Heavy rain ☐ Steady rain		PRESENT	CONDITIONS	☐ Heavy rai	in ☐ Steady rain ☐ Intermittent
□ None X In	ntermittent Trace		X Clear		☐ Trace	☐ Overcast ☐ Partly cloudy
	☐ Industrial ☐ Commerc☐ Golf course ☐ Park		Urban/Res Crop	idential X Subu □ Past		X Forested ☐ Institutional ☐ Other:
BASE FLOW WIDTH AS % CHANNEL WIDTH	0-25% 5-50 % 0%-75% 5-100%		(clear, na	CLARITY Cleaturally colored) (chemicals, dyes	☐ Opaque	(suspended matter)
X Silt/clay (fine or slick) ☐ Sand (gritty) ☐ Gravel (0.1-2.5") ☐ Cobble (2.5 -10") ☐ Boulder (>10") ☐ Bed rock	Width: Bottom Top Swater Surface	3-10 3-6 3-6 0.5 0.2	_(ft) _(ft) _(ft) _(ft) _(ft) _(ft)	OBSERVED IMI Outfall Confluence Impacted b Stream cros Channel me Utility imp Beaver Other	uffer ssing od acts

CHANNEL DYNAMICS Downcutting Widening Headcutting Aggrading	Bank scour Sed. deposition	Slope f Channe Unkno	elized own	DEEP GULLY FO POSSIBLE STEI EVEN CULVERT	ORMED P-POOL OR EI FREPLACEMI	SING MASSIVE EROSION ON HILLSIDE NERGY DISSIPATION ENT STAGE: I II X III IV V
QUALITATIVE IMPAIRMENT RATING: Low Moderate Severe UI (Simon et. al., 2003)

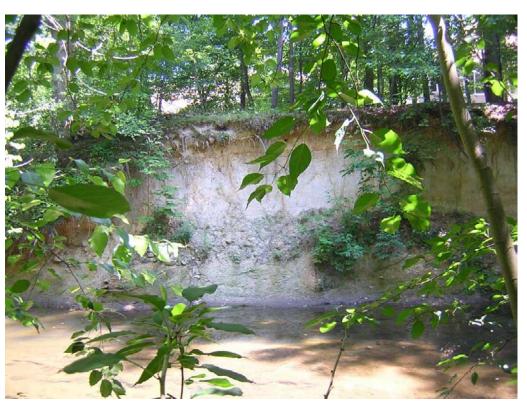
STREAM NAME: BOLIN CR	EEK	DATE:	E: 2/21/07			MAP SHEET #: 25
Рното Numbers: 3015-302	16	LAND	MARK: BO	AARK: BOLINWOOD DR SKETCH ON BACK		
GPS ID START: IJ53 DESCRIPTION:			GPS ID I DESCRIPT	END: IJ53 TION:		
_ ,		ial X U	X Clear Urban/Res		☐ Trace urban/Res	in ☐ Steady rain ☐ Intermittent ☐ Overcast ☐ Partly cloudy X Forested ☐ Institutional
BASE FLOW WIDTH AS % CHANNEL	☐ Golf course ☐ Park 0-25% 25-50 % 50%-75% 75-100%		(clear, na	☐ Pass CLARITY X Cle sturally colored) (chemicals, dyes)	ar □Turbid □ Opaque	☐ Other: (suspended matter) ☐ Stained (milky)
X Silt/clay (fine or slick) X Sand (gritty) X Gravel (0.1-2.5") □ Cobble (2.5 -10") □ Boulder (>10") X Bed rock	Width: Bottom Top Water Surface	5-20_(ft) _20(ft _20(ft _20(ft _20(ft	t) t) t)	Observed Im Outfall Confluence Impacted b Stream cro Channel m Utility imp Beaver Other	e ouffer ssing od	
CHANNEL DYNAMICS Downcutting Widening Headcutting Aggrading	Bank failure	Slope fa Channel Unknov	lized	NOTES MAJOR BANK I POSSIBLE BANI	K STABILIZA'	TION

QUALITATIVE IMPAIRMENT RATING: Low Moderate Severe				volutiuon \$ on et. al., 200	STAGE: I II III IV V V 33)

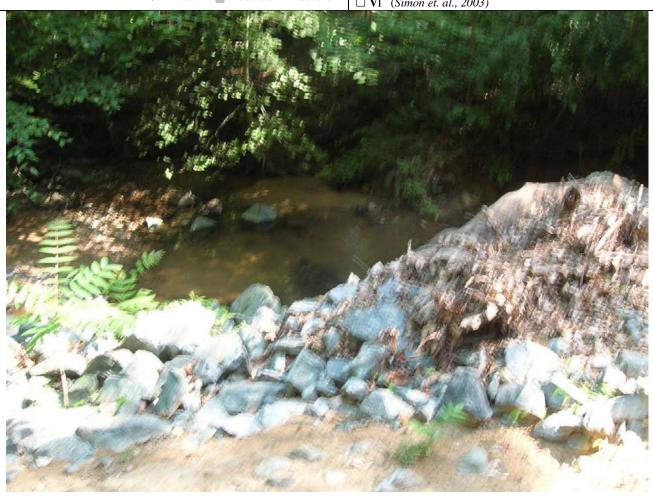
STREAM NAME: COLE SPI	RINGS BR.	DATE	E: 6/21/07			Мар Sheet #: 26
Р ното N имвекs: 1231,12	32	LANI	DMARK:			SKETCH ON BACK
GPS ID START: BD 75			GPS ID 1			
DESCRIPTION:			DESCRIP	TION:		
RAIN IN LAST 24 HOURS	Heavy rain X Steady rain		PRESENT	CONDITIONS	☐ Heavy ra	in Steady rain Intermittent
□ None □	Intermittent Trace		X Clear		☐ Trace	☐ Overcast ☐ Partly cloudy
SURROUNDING LAND USE:	☐ Industrial ☐ Commerce ☐ Golf course ☐ Park		Urban/Res Crop	sidential ☐ Sub ☐ Past		☐ Forested ☐ Institutional ☐ Other:
AS % CHANNEL	0-25% 25-50 % 50%-75% 75-100%		(clear, no	CLARITY Clearturally colored) (chemicals, dyes	☐ Opaque	(suspended matter) ☐ Stained (milky)
DOMINANT SUBSTRATE ☐ Silt/clay (fine or slick) ☐ Sand (gritty) ☐ Gravel (0.1-2.5") ☐ Cobble (2.5 -10") ☐ Boulder (>10") ☐ Bed rock CHANNEL DYNAMICS	Width: Bottom 4 Top 14 Water Surface 2		_(ft) (ft)	OBSERVED IMI Outfall Confluence Impacted b Stream cro Channel m Utility imp Beaver Other NOTES	e ouffer ssing od acts

☑ Downcutting☑ Widening☐ Headcutting☐ Aggrading	☐ Bed scour ☐ Bank failure ☐ Bank scour ☐ Sed. deposition	Slope : Chann Unkno	elized	CULVERT FOR CONTRACTION		ADWAY ALONG SS LINE CAUSES
QUALITATIVE IMPAIRMEN	T RATING: Low X Mode	erate	□ Severe		volutiuon S on et. al., 200	STAGE: I II II II II IV V 03)
			1	E2 1	No. of the

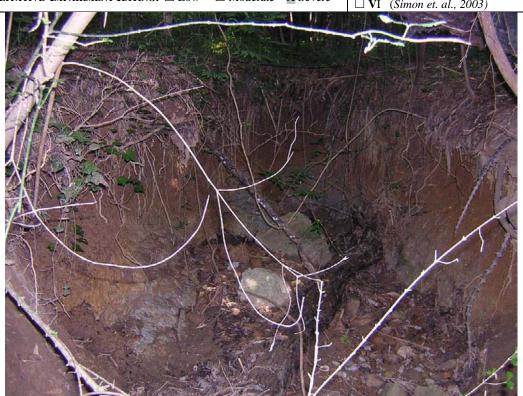
STREAM NAME: UT BATT	LE BRANCH	DATE	E: 6/22/07			MAP SHEET #: 30
PHOTO NUMBERS:NO PHOT	O	LAND	MARK:			SKETCH ON BACK
GPS ID START: IJ 64 DESCRIPTION:			GPS ID I	END: IJ 64 TION:		
RAIN IN LAST 24 HOURS None X SURROUNDING LAND USE:	Intermittent Trace	cial X	X Clear	sidential X Subt	☐ Trace	in ☐ Steady rain ☐ Intermittent ☐ Overcast ☐ Partly cloudy ✓ Forested ☐ Institutional ☐ Other:
BASE FLOW WIDTH AS % CHANNEL WIDTH	0-25% 25-50 % 50%-75% 75-100%		(clear, no	CLARITY ☐ Cle nturally colored) (chemicals, dyes	☐ Opaque	(suspended matter) ☐ Stained (milky)
DOMINANT SUBSTRATE X Silt/clay (fine or slick) □ Sand (gritty) □ Gravel (0.1-2.5") □ Cobble (2.5 -10") □ Boulder (>10") □ Bed rock	Width: Bottom	3-4 3 NA	(ft) (ft)	Observed IMI Outfall Confluence Impacted b Stream cros Channel me Utility imp	uffer ssing od	
CHANNEL DYNAMICS Downcutting Widening Headcutting Aggrading	Bed scour Rank failure	Slope f Channo Unkno	elized	LOTS OF SILT A	ND SEDIMEN	RESSING UP STEEP CHANNEL IT FROM BANK FAILTURE BURIED PIPE UPSTREAM

QUALITATIVE IMPAIRMENT RATING: Low Moderate Severe			CHANNEL EV □ VI (Sime		STAGE: I II III IV V 03)

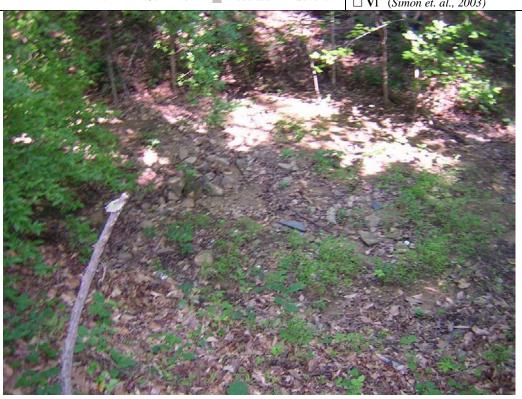
STREAM NAME: UT TO BOLIN CR	DATE: 6/21/07		MAP SHEET #: 30
PHOTO NUMBERS: 3032-3034	LANDMARK: ST	EEP HILLSIDE	SKETCH ON BACK
GPS ID START: IJ 60		END: IJ 60	
DESCRIPTION:	DESCRIP	TION:	
RAIN IN LAST 24 HOURS Heavy rain Steady rain	PRESENT	CONDITIONS	in ☐ Steady rain ☐ Intermittent
□ None X Intermittent □ Trace	X Clear	☐ Trace	☐ Overcast ☐ Partly cloudy
SURROUNDING LAND USE:	cial □ Urban/Re □ Crop		X Forested ☐ Institutional ☐ Other:
BASE FLOW WIDTH AS % CHANNEL WIDTH □ 0-25% □ 25-50 % □ 50%-75% □ 75-100%	(clear, n	CLARITY	I (suspended matter) ☐ Stained (milky)
2 Silt/clay (fine or slick) 1 Sand (gritty) ☐ Gravel (0.1-2.5") ☐ Cobble (2.5 -10") ☐ Boulder (>10") ☐ Bed rock Bith Ratio: Low bank/Max	(ft)(ft)(ft)(ft)(ft)	OBSERVED IMPACTS Outfall Confluence Impacted buffer Stream crossing Channel mod Utility impacts Beaver Other- old BMP	
CHANNEL DYNAMICS Downcutting Bed scour Bank failure Bank scour Aggrading Sed. deposition	Slope failure Channelized Unknown	NOTES OLD BMP – MAYBE LEVEL RETROFIT GULLY FORMATION ABOVE ROCK CHECK DAMS BELOW	2

QUALITATIVE IMPAIRMENT RATING: Low Mod	CHANNEL EVOLUTIUON S □ VI (Simon et. al., 20)	STAGE: \square I \square II \square III \square IV \square V 03)

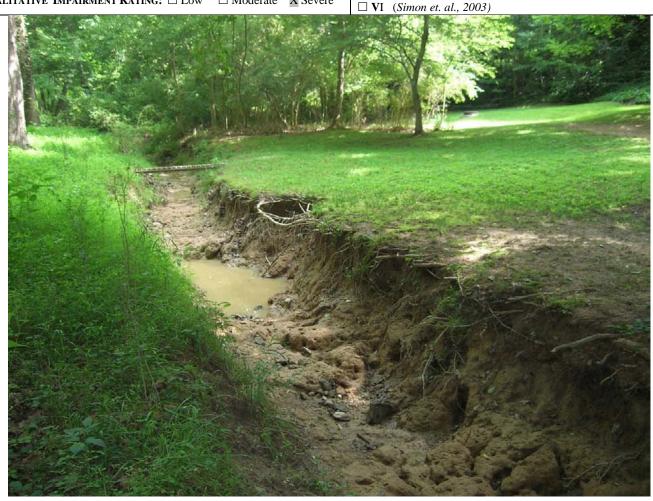
CPS ID START; BD 87 DESCRIPTION: GPS ID END: BD 88 DESCRIPTION: DESCRIPTION: Steady rain DESCRIPTION: Steady rain DESCRIPTION: PRESENT CONDITIONS Heavy rain Steady rain Intermittent Trace Clear Trace Overcast Partly cloudy SURROUNDING LAND USE: Industrial Golf course Park Crop Pasture Other:	STREAM NAME: BATTLE BR	R	DATE: 6/22/07		Map Sheet #: 34
DESCRIPTION: DESCRIPTION: Carr Channel Dimensions at RIFFLE Clear	Рното Numbers: 1271-1279	9	LANDMARK:		SKETCH ON BACK
None					
Sase FLOW WIDTH School Stained Stained	X None	ntermittent	☐ Clear	☐ Tra	Res Forested Institutional
CHANNEL DIMENSIONS AT RIFFLE Outfall Confluence Impacted buffer Stream crossing Channel mod Channel mod Utility impacts Beaver Other	BASE FLOW WIDTH AS % CHANNEL WIDTH	5-50 % 0%-75%	(clear, no	aturally colored) \Box Op	, •
□ Downcutting □ Bed scour □ Slope failure □ Channelized □ DITCH BUILT BY SS LINE	☐ Silt/clay (fine or slick) ☐ Sand (gritty) ☐ Gravel (0.1-2.5") ☐ Cobble (2.5 –10") ☐ Boulder (>10") ☐ Bed rock	Height: Low bank Width: Bottom Top Water Surface Depth: Max BKF	(ft)(ft)(ft)(ft)(ft)	Outfall Confluence Impacted buffer Stream crossing Channel mod Utility impacts Beaver

Aggrading Sed. deposition Unknown	Downcutting Widening Headcutting	Bank failure Bank scour		SEE PHOTOS	NE
QUALITATIVE IMPAIRMENT RATING: Low Moderate X Severe CHANNEL EVOLUTION STAGE: I II III IV V V (Simon et. al., 2003)		RATING: Low Mod	lerate X Severe	□ V I (Simon et. a
