APPENDIX B

Photo Log

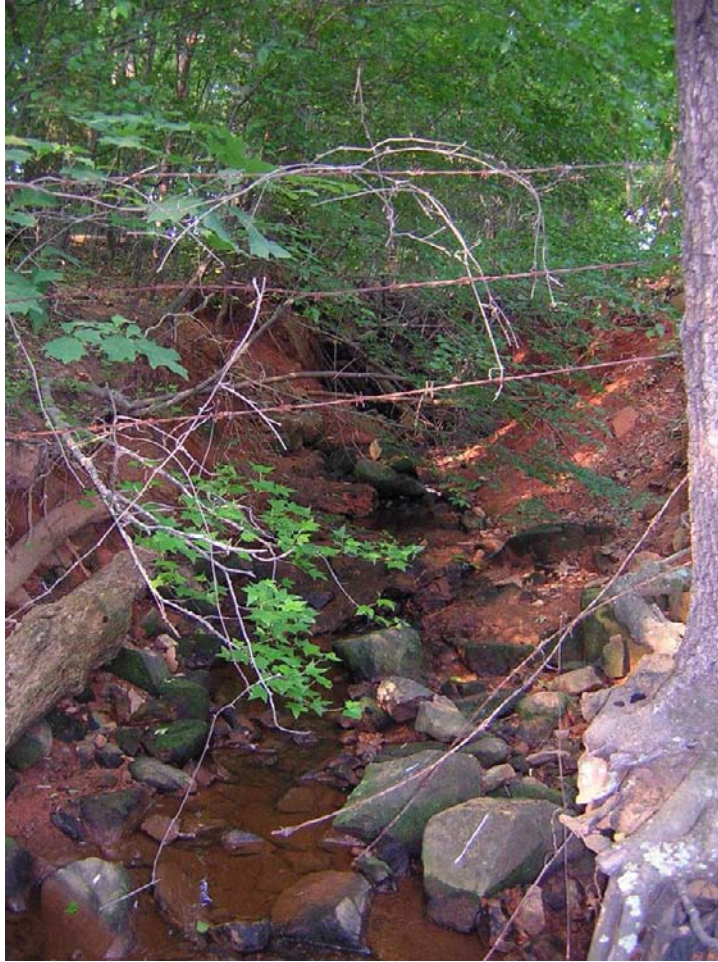
A degraded and eroding spillway on Bolin Creek just below the pond dam. Facing upstream towards the dam.

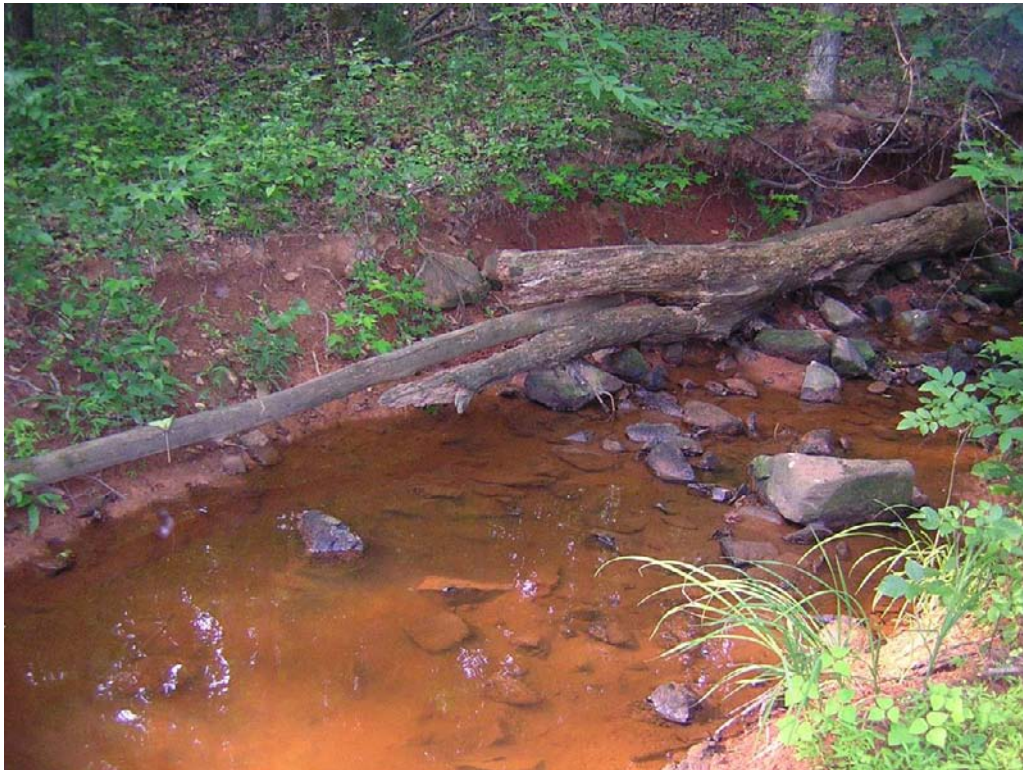
Downstream of the spillway, sediment has accumulated in the bed of Bolin Creek. Facing downstream.

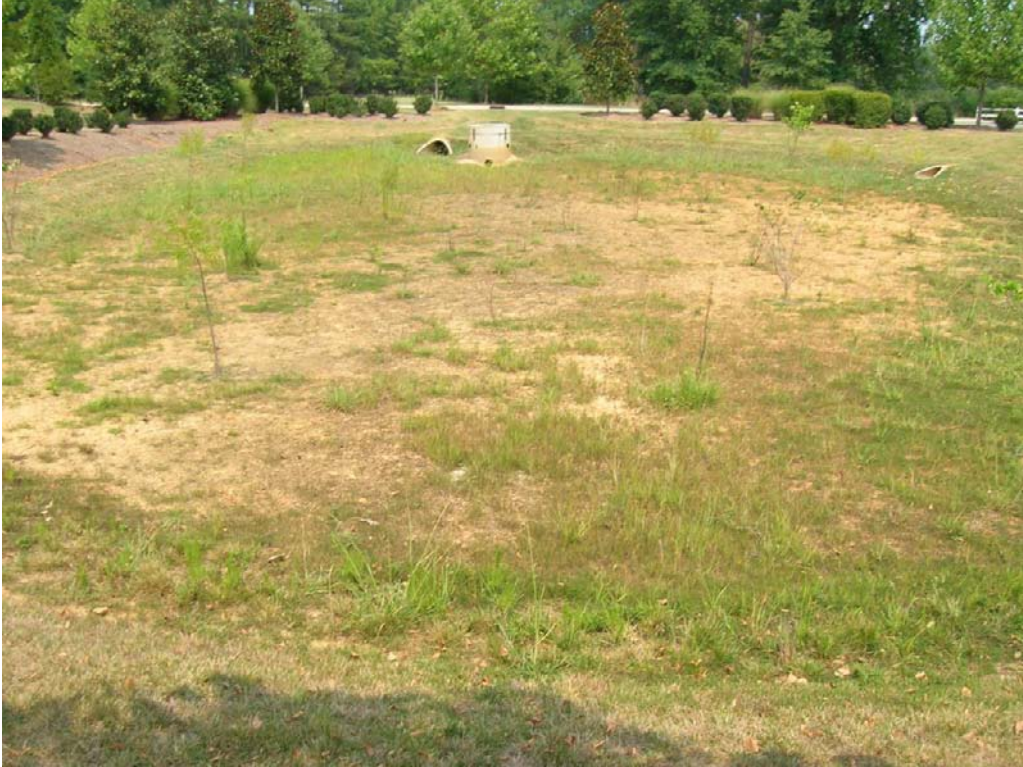
The existing stormwater basin. Note the lack of vegetation and the close proximity of the inlet pipe to the outlet structure.

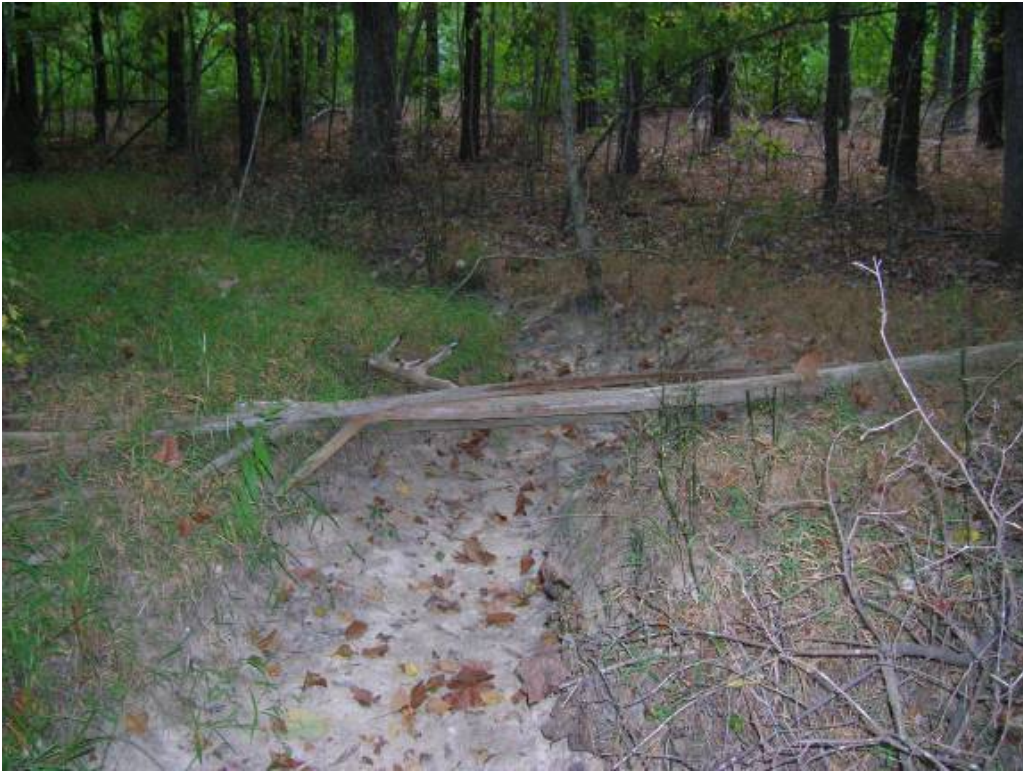
Upstream of the headcut at Site 3. Facing downstream.

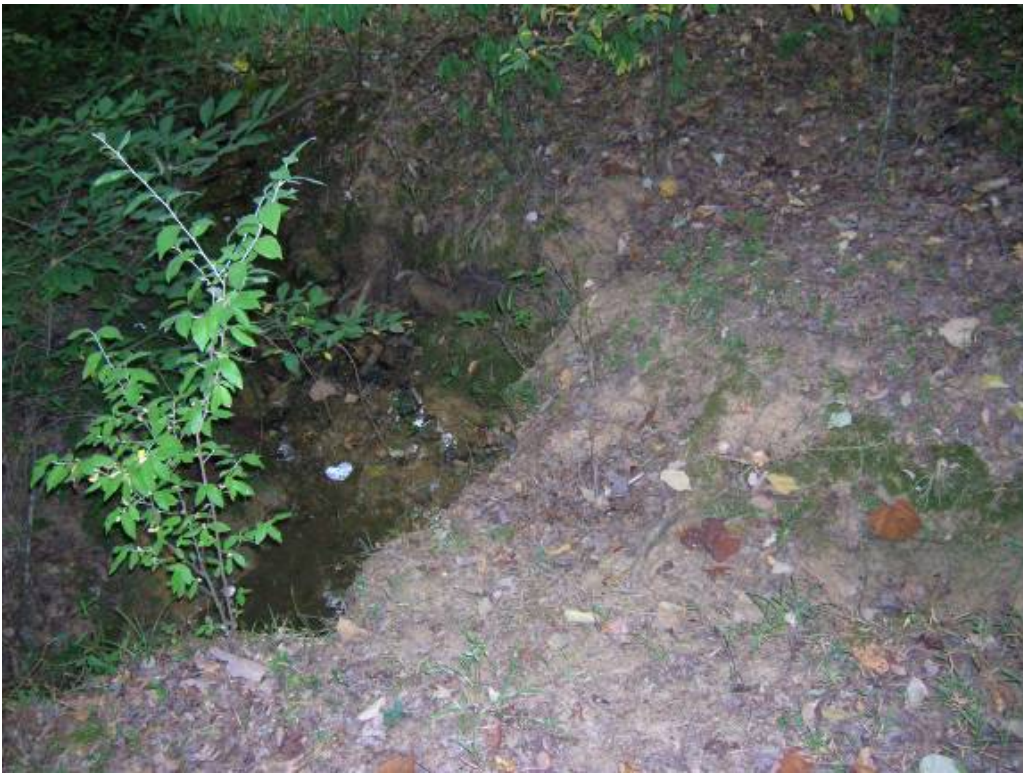
Downstream of the headcut, the channel is much more incised. Facing downstream.

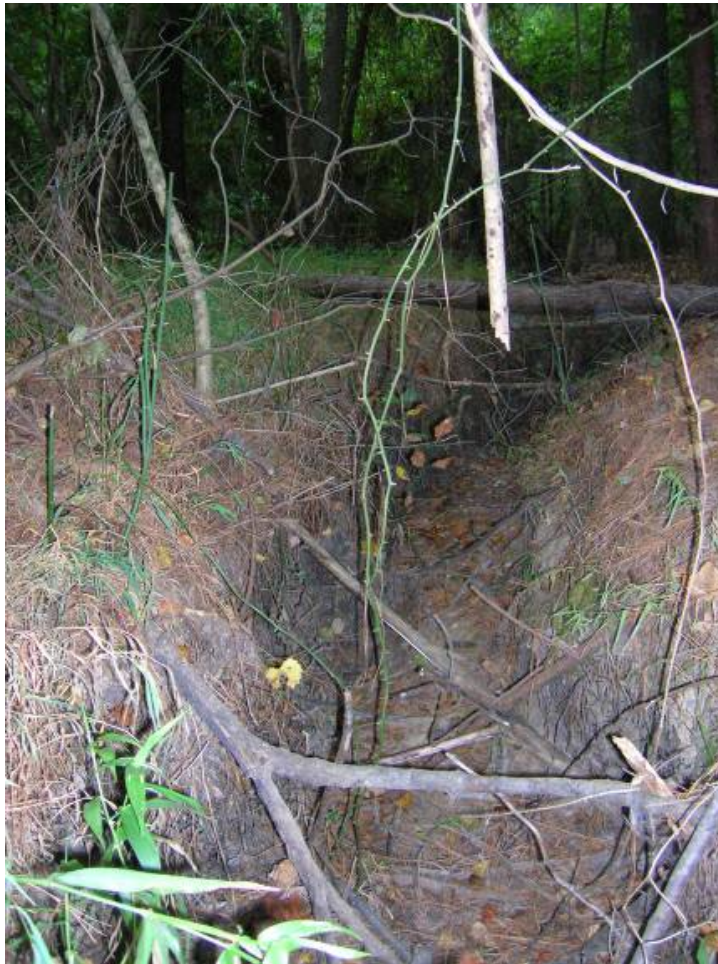
Downstream of the headcut. Facing upstream.

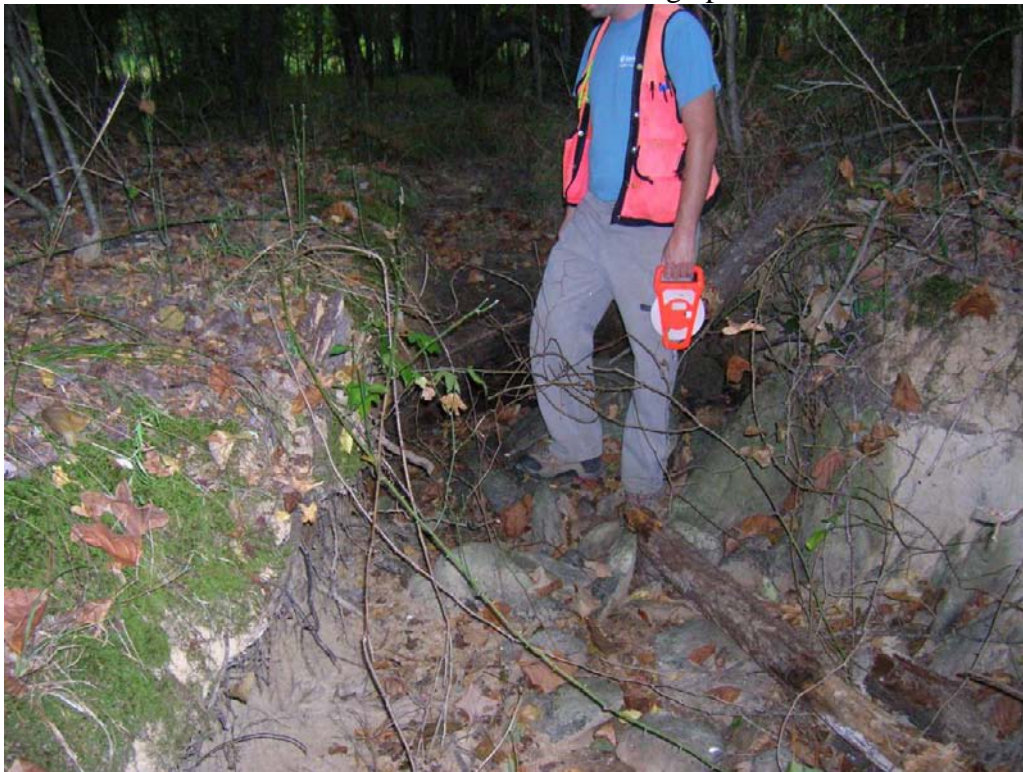
The actively eroding headcut. Note the difference in elevation of the stream bed upstream and downstream.
Facing upstream.

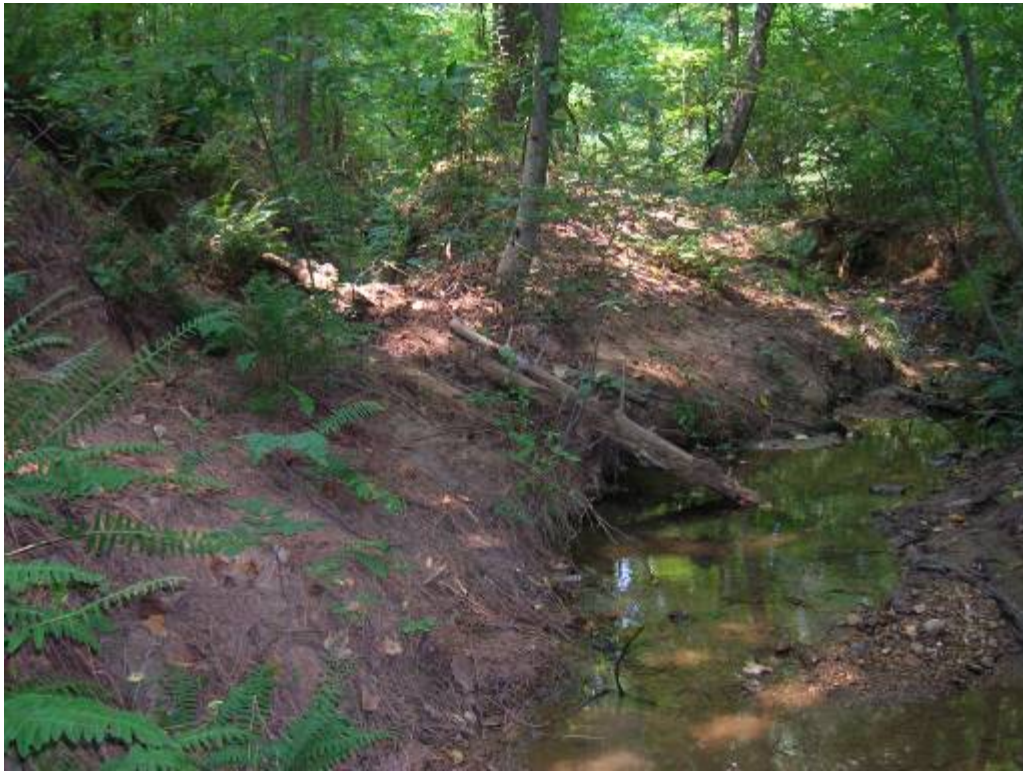
The stream into which the ditch at Site 4 leads. The ditch is on the left side of the photo. Facing upstream.

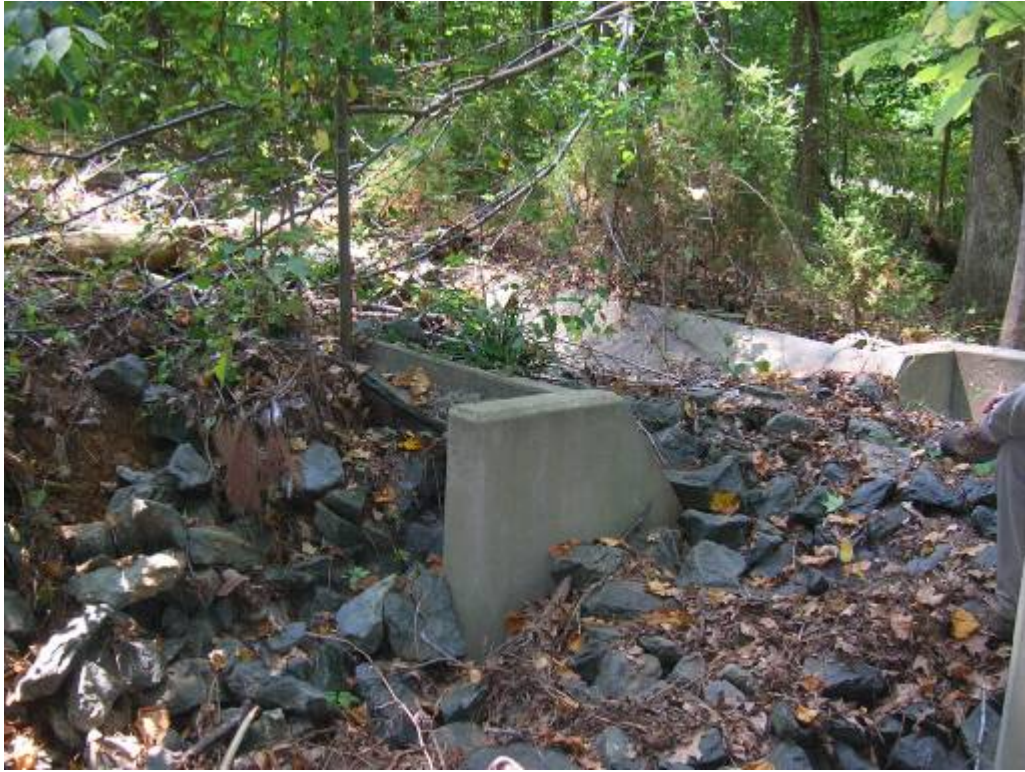
The concrete flow dissipation structure at Site 4.

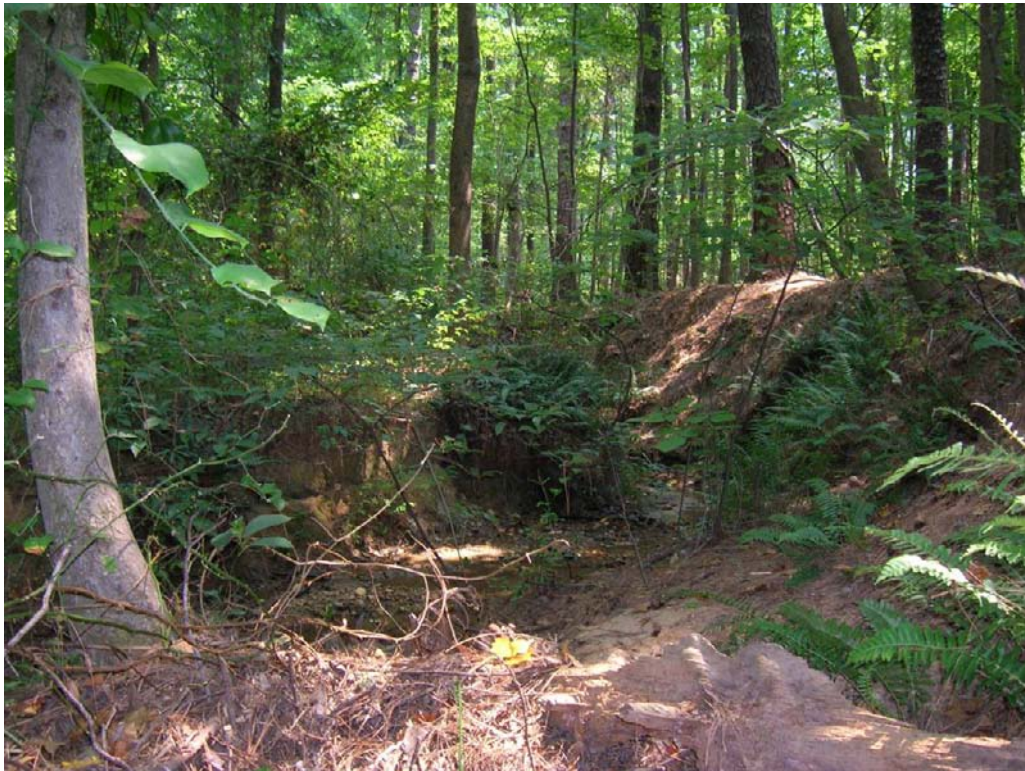
Facing downstream where the ditch from the dissipating structure meets the stream. Note the eroding, partially caused by the flow discharging from the ditch.

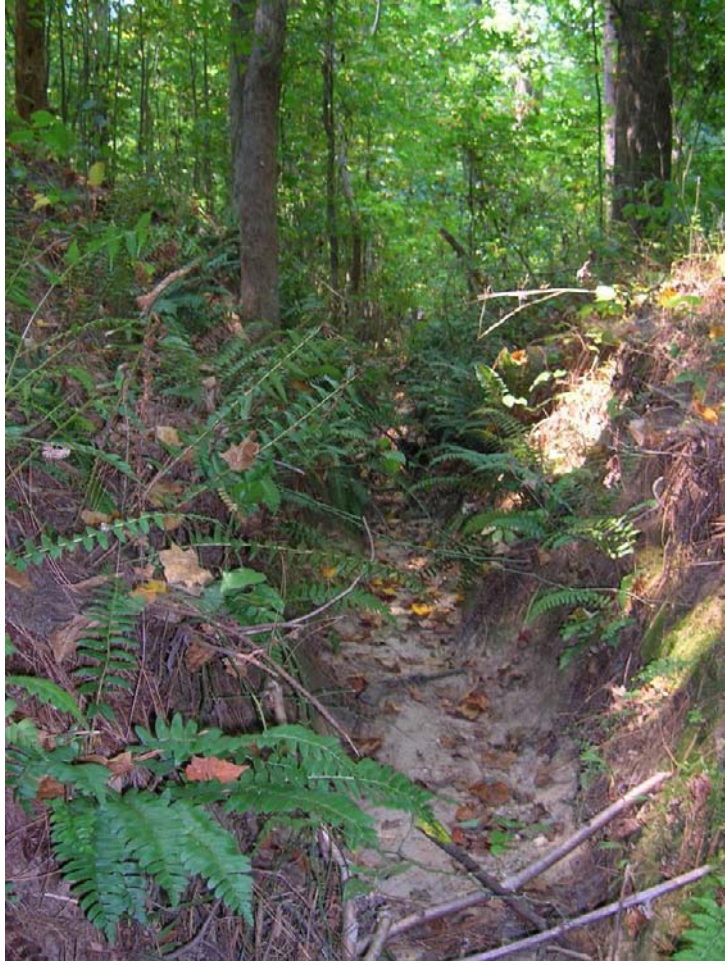
Looking upstream at the ditch.

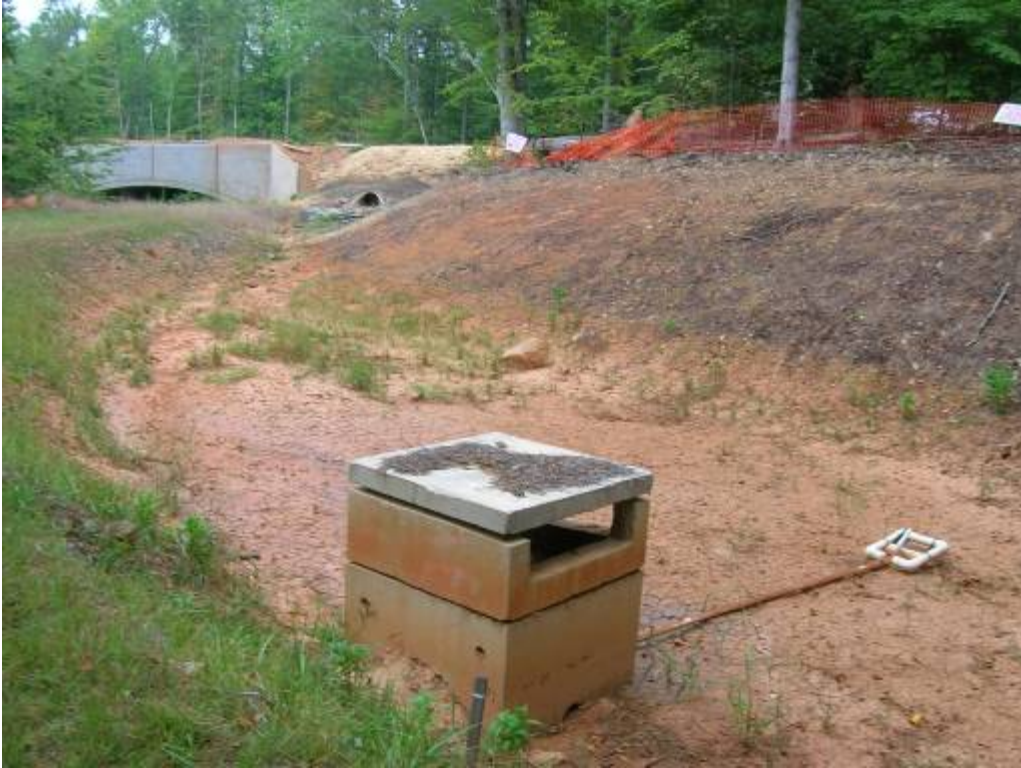
Site 5. The sediment basin outlet structure, facing northwest.

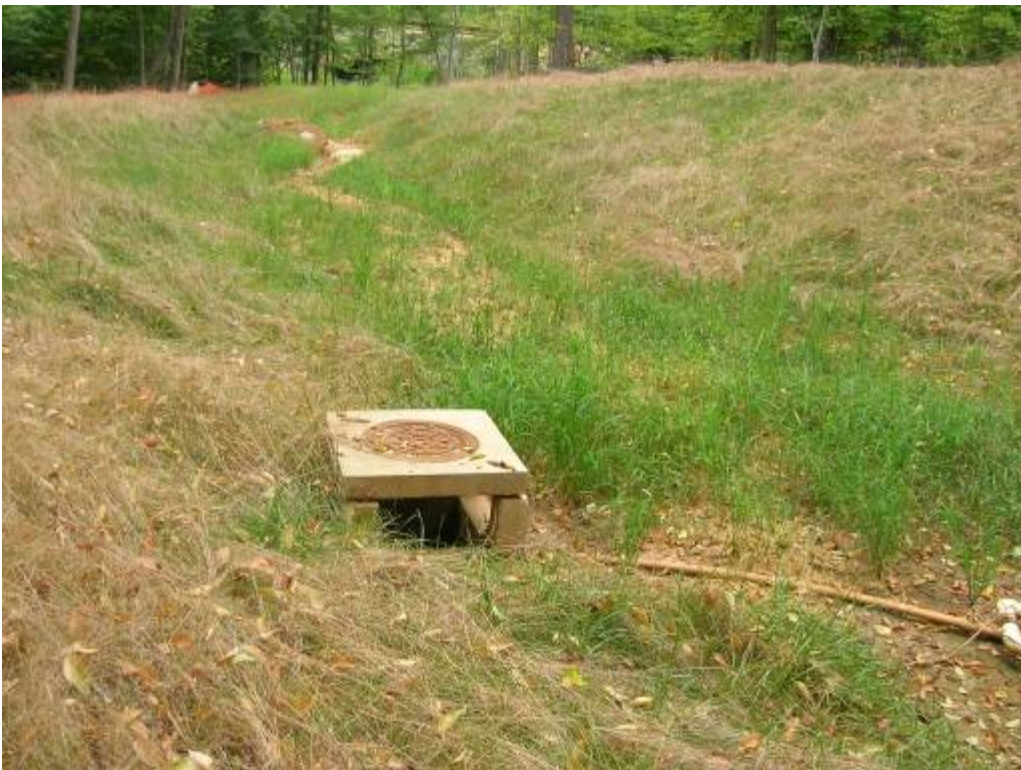
Another sediment basin at Site 6. Note the eroding grassy swale leading into the basin. Facing east.

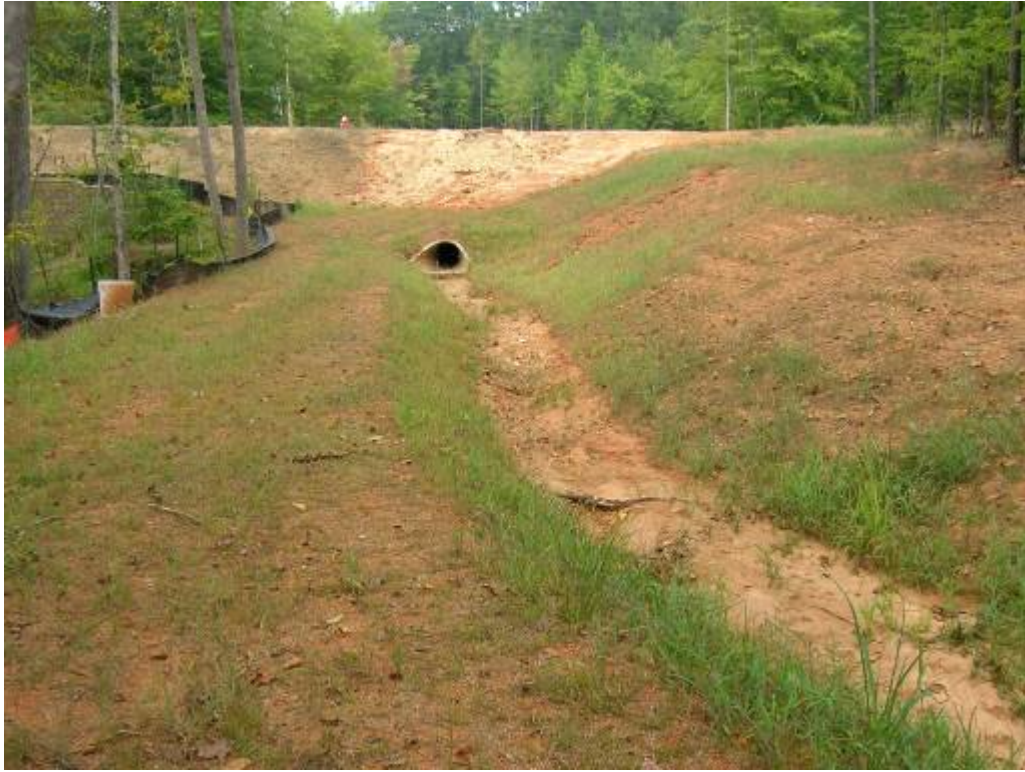
An eroding grassy swale, facing west.

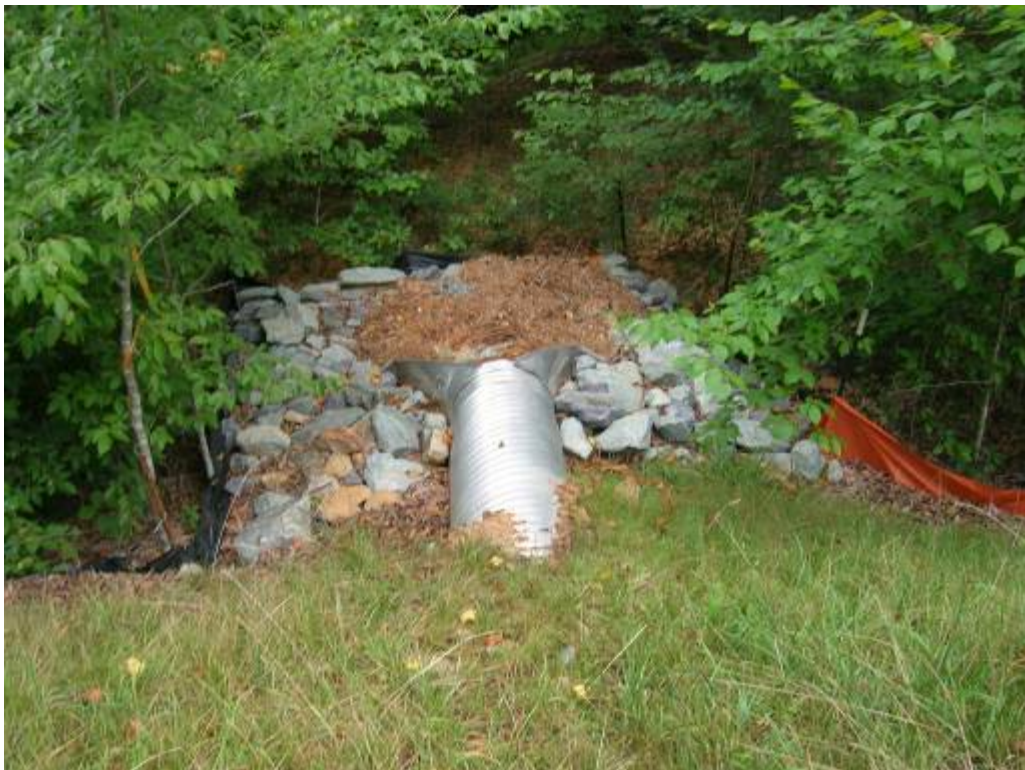
The stormwater outfall of the sediment basin at Site 5. Facing south.

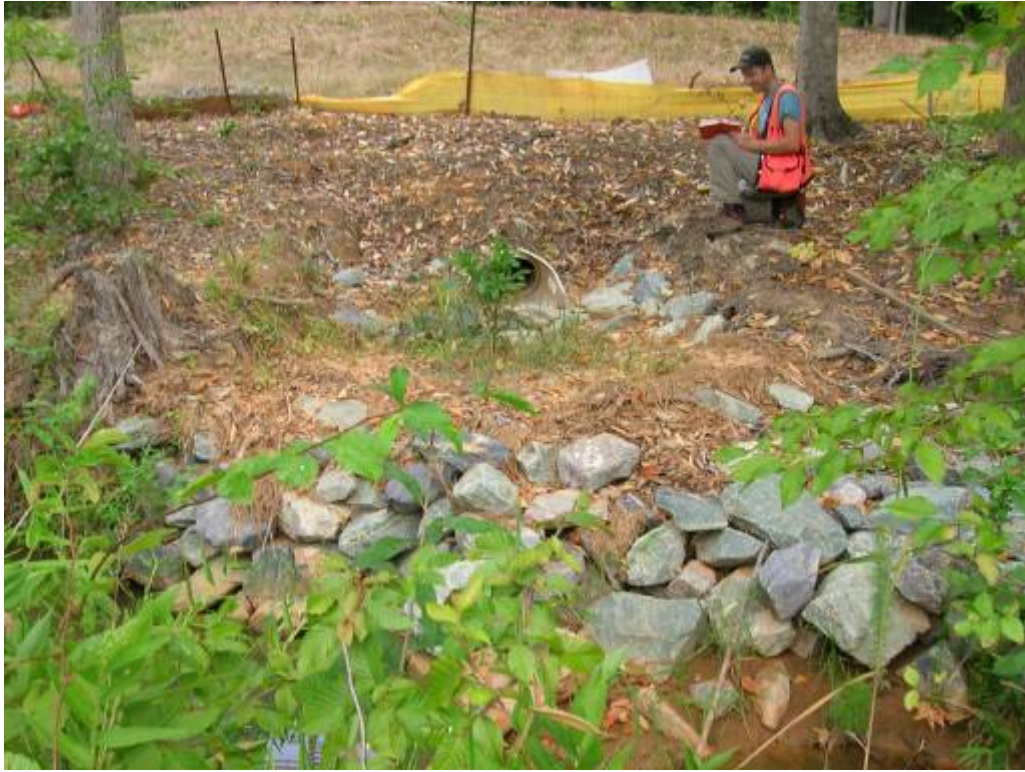
The second sediment basin at Site 6. The pipe outfall is only feet away from the stream, which is located at the bottom of the photo. Facing North.

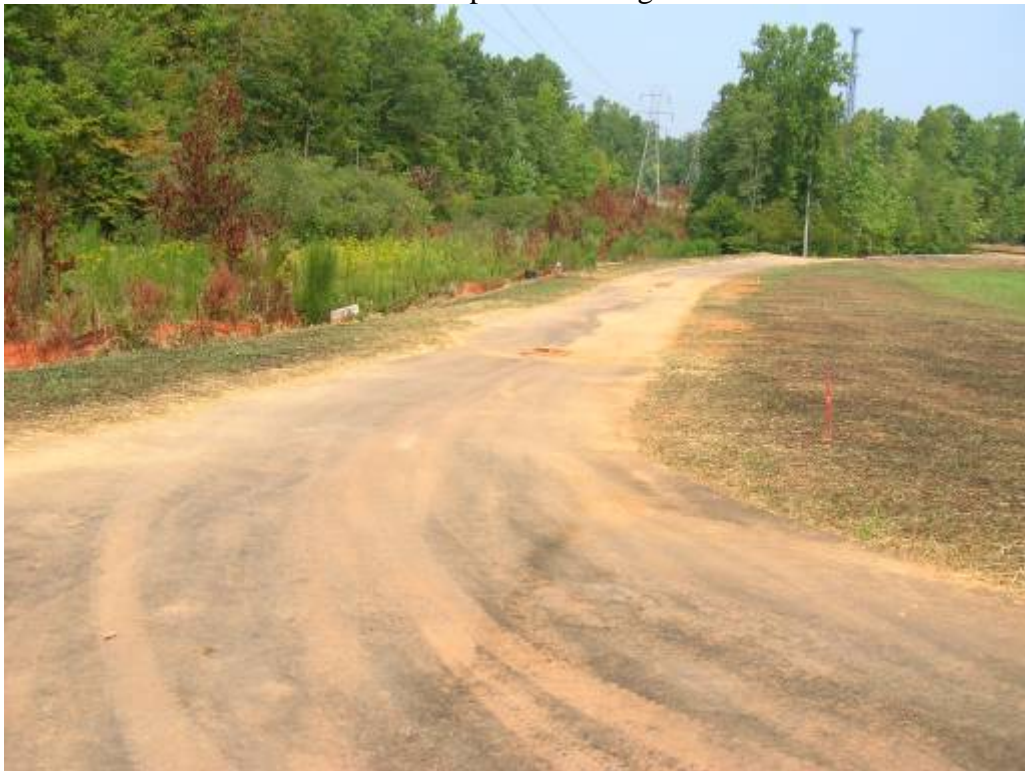
The private alley at Site 7. The potential area for bioretention is on the left side of the photo. Facing north.

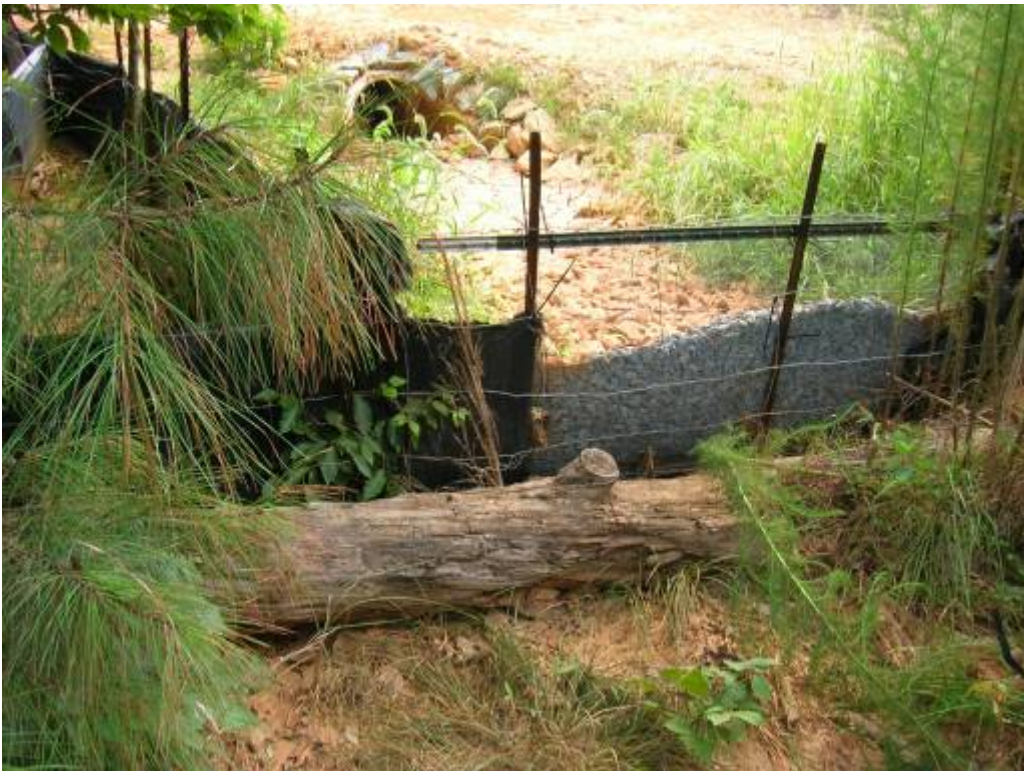
The current pipe and outlet at Site 7. Facing east.

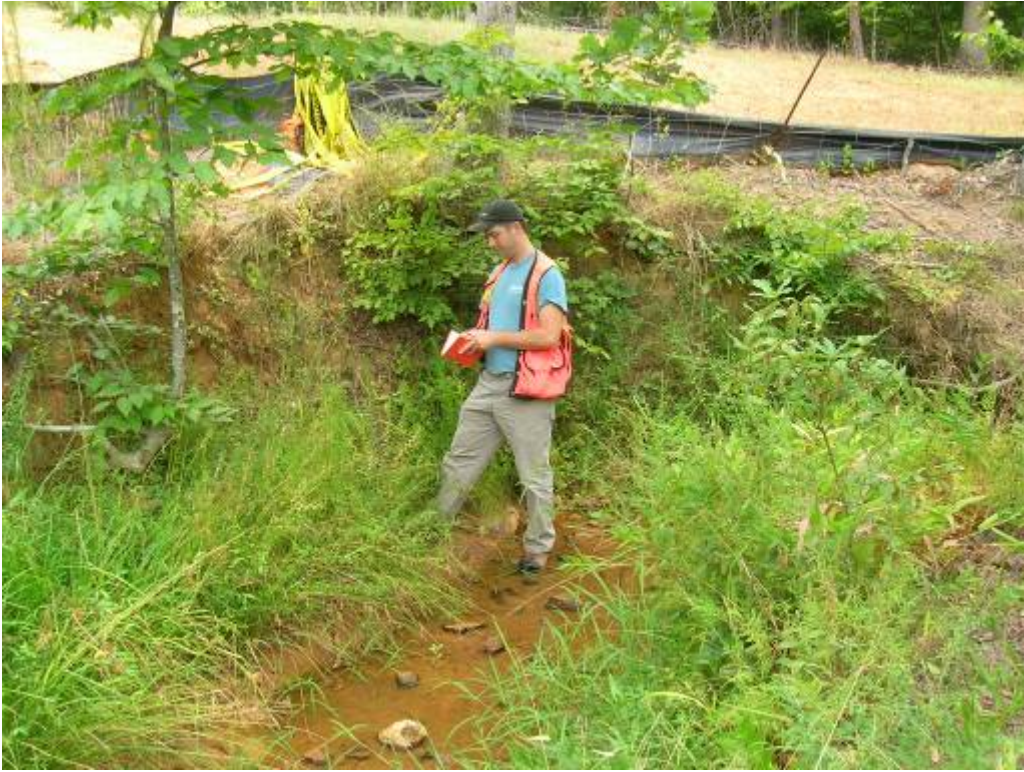
An eroding bank at Site 6. Facing north.

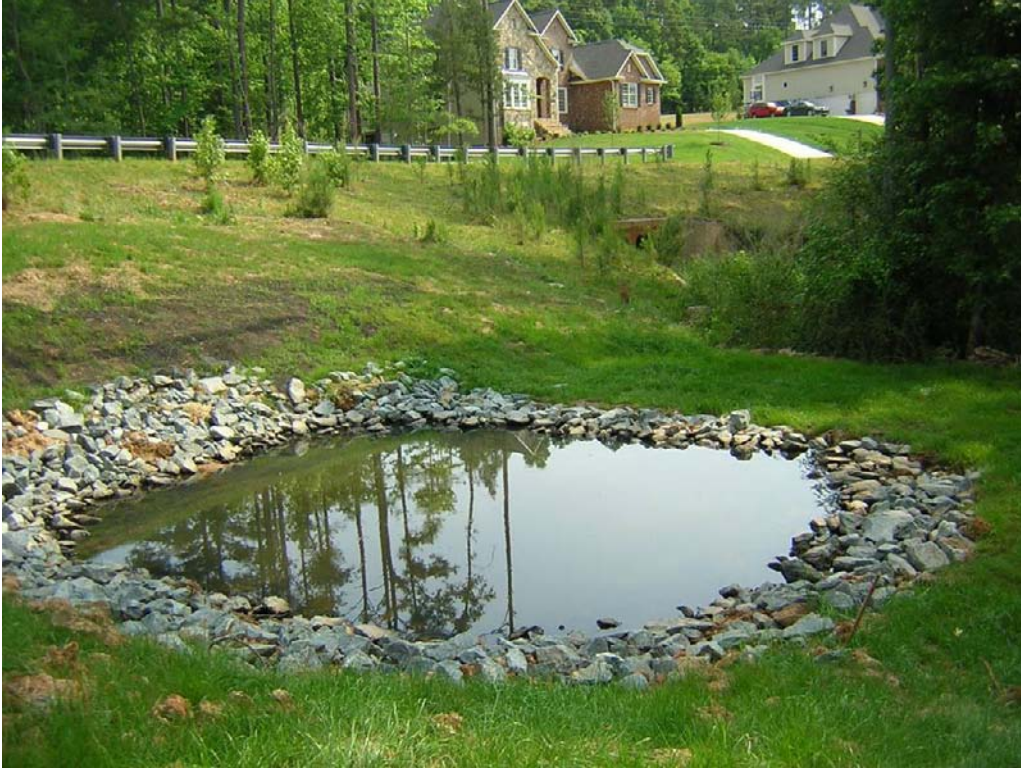
An existing stormwater basin at Site 8. Facing northeast.

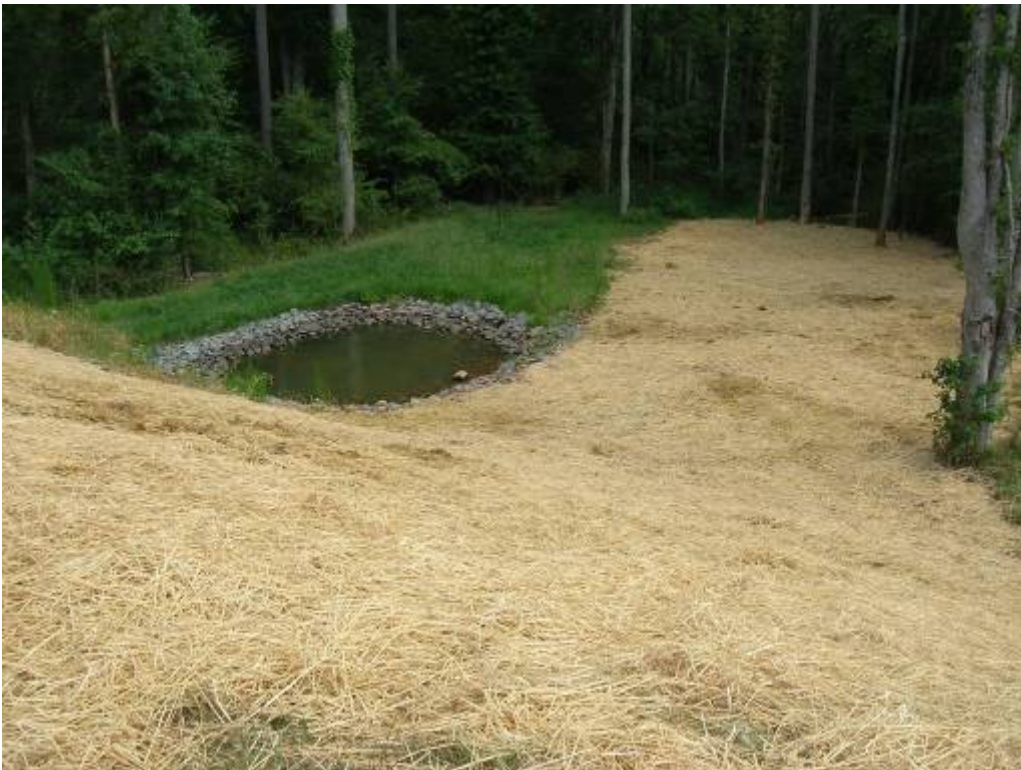
The stormwater basin one month later. The berm has been removed and the site re-seeded with grass.

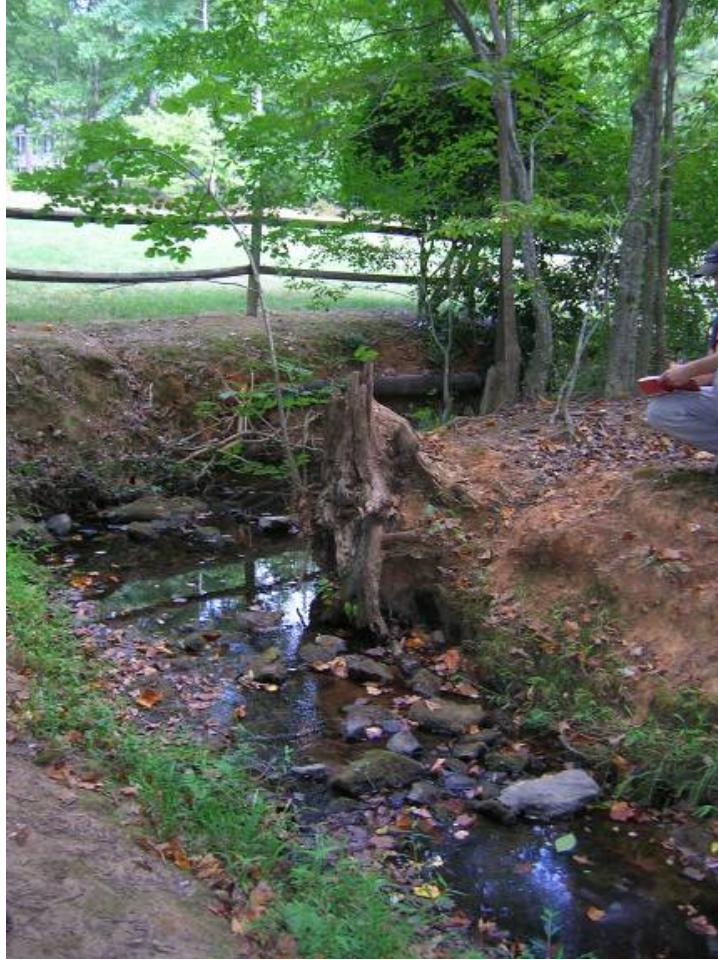
Eroding stream banks upstream of the Cobblestone Drive crossing. Facing downstream.

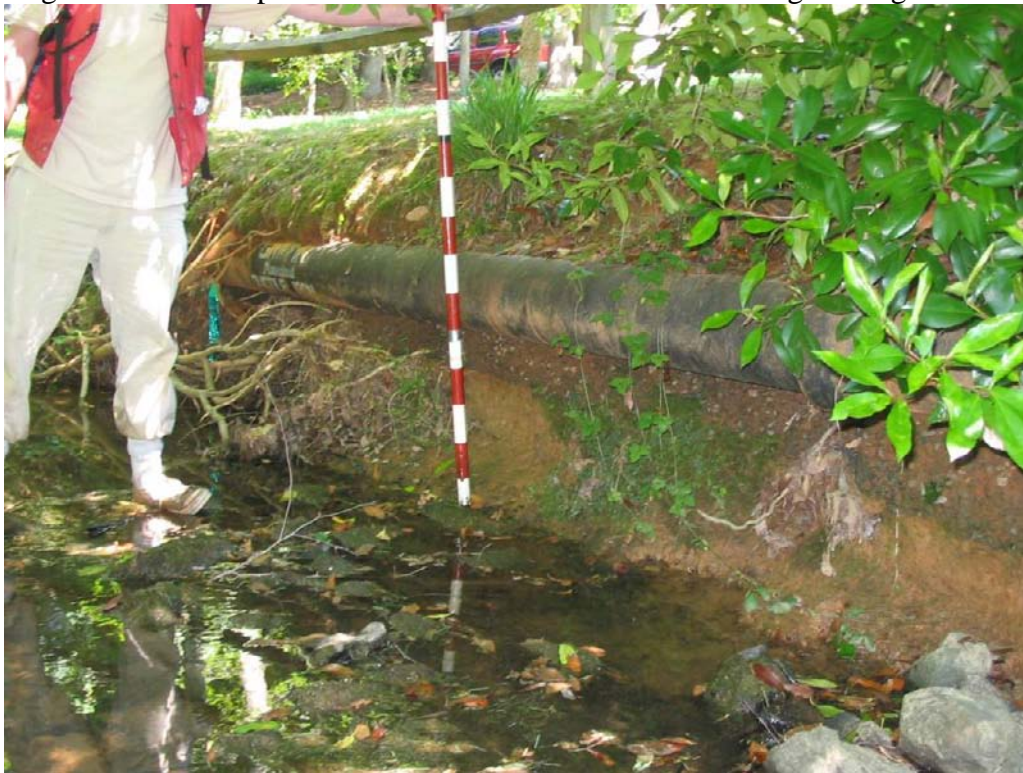
A utility line runs parallel with the streambank, just upstream of Cobblestone Drive crossing.

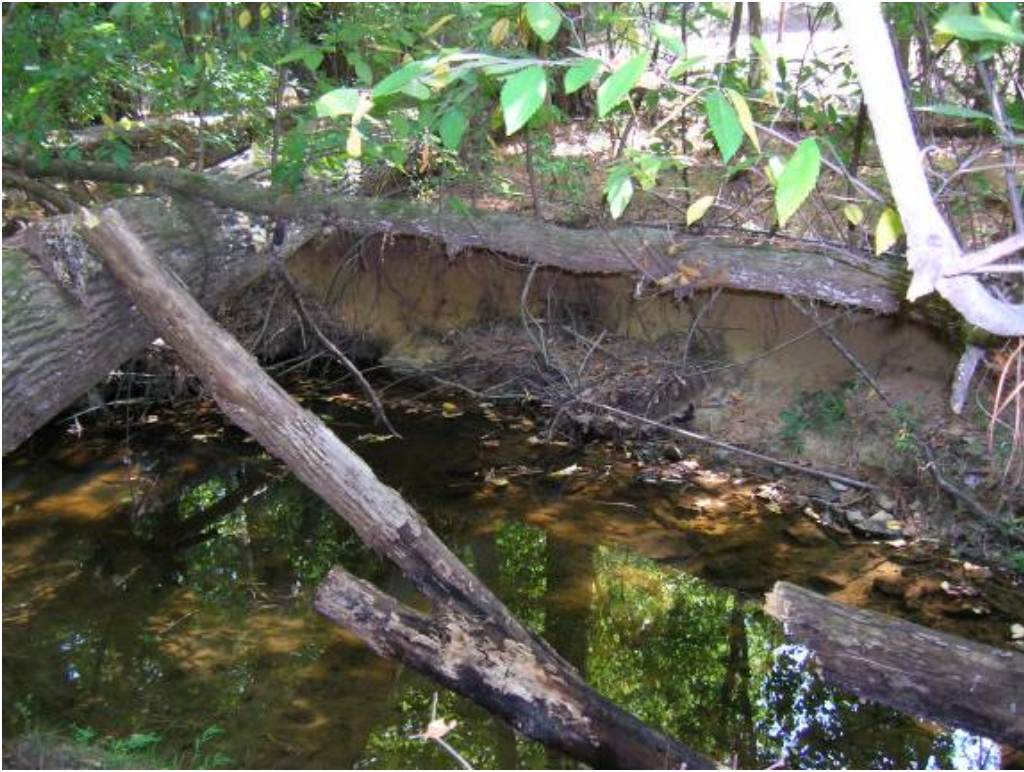
Eroding streambanks downstream of the road crossing. Facing towards right bank.

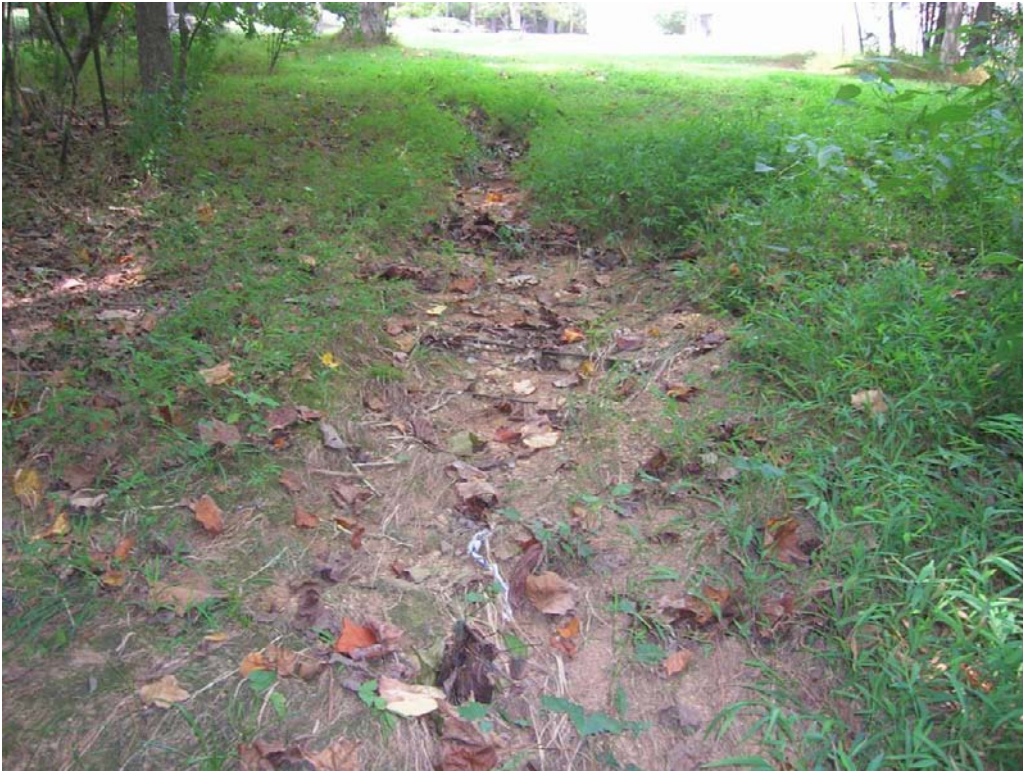
Scour areas are present across from a utility easement, behind the backyard of several houses. Facing west towards the houses.

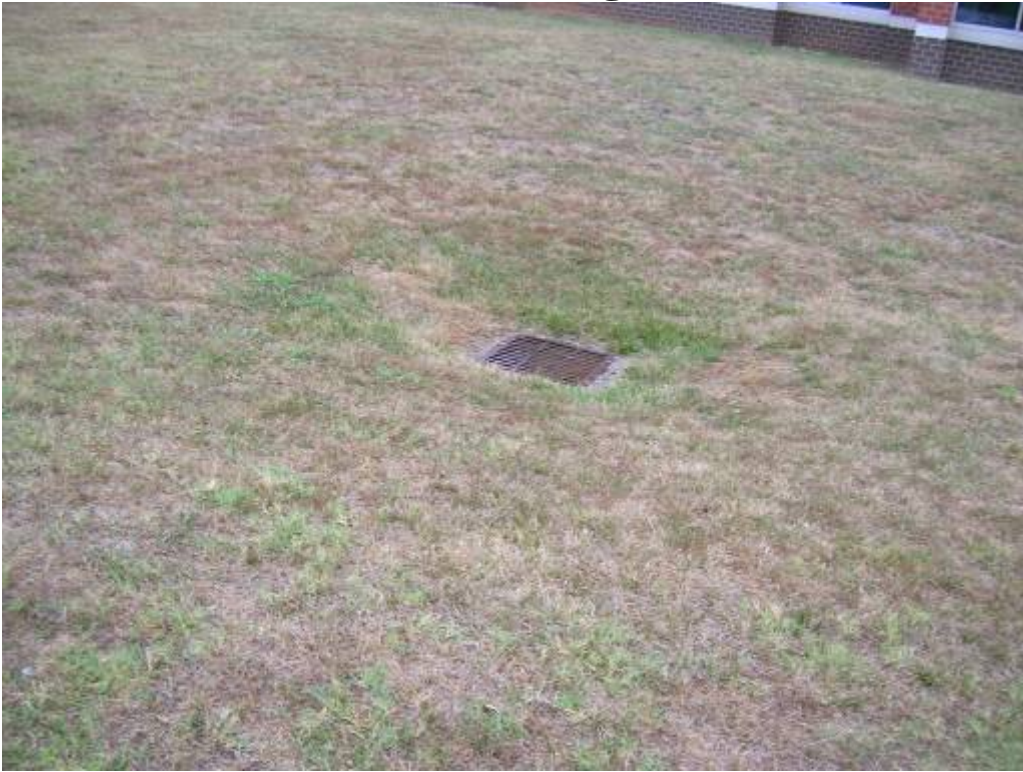
A drop inlet at the middle school. Each of these could be converted into a bioretention area.

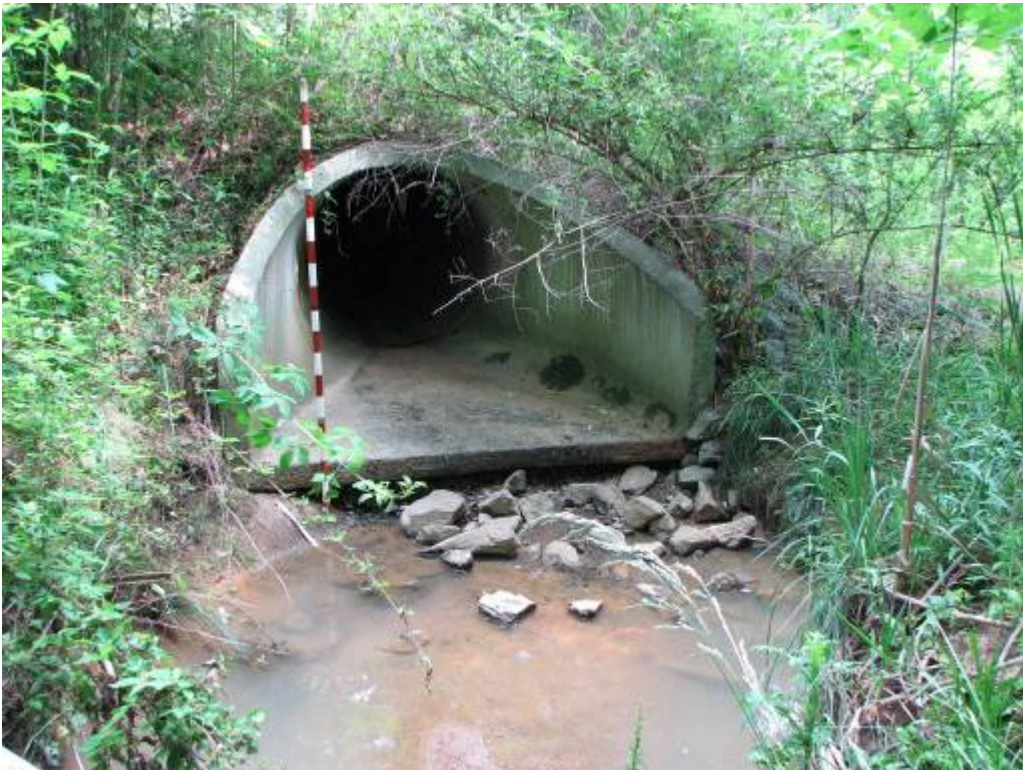
The pipe outlet discharging stormwater from the middle school. Facing south towards the middle school.

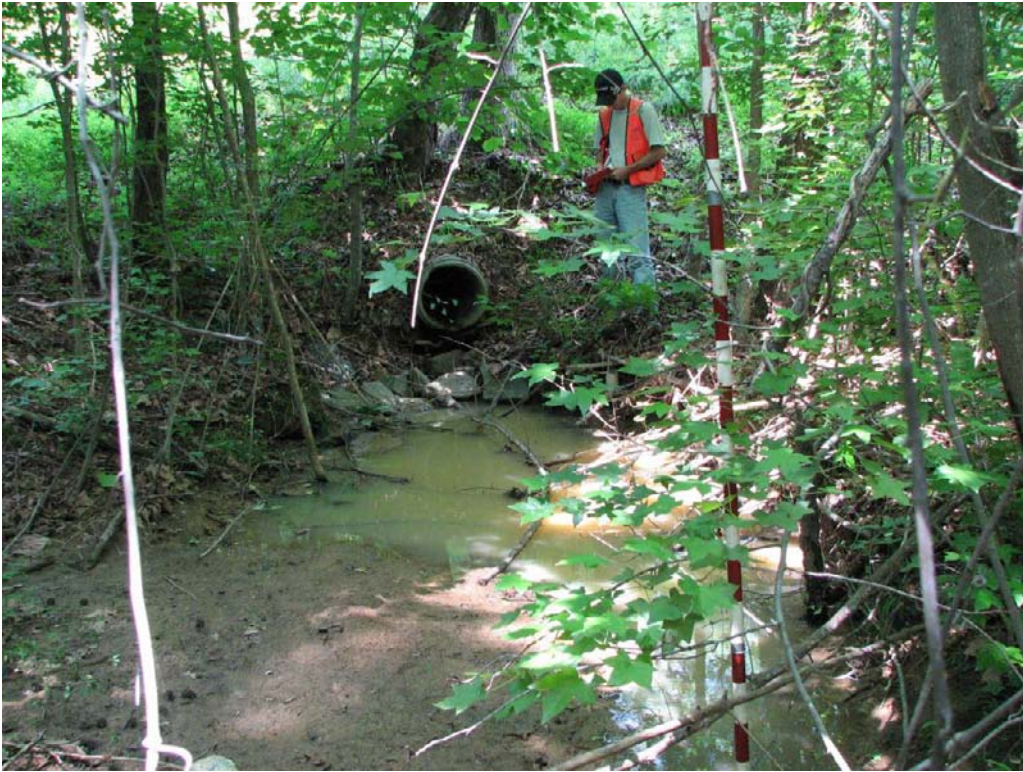
An existing sediment basin below a gravel driveway and culvert. Facing north towards the driveway.

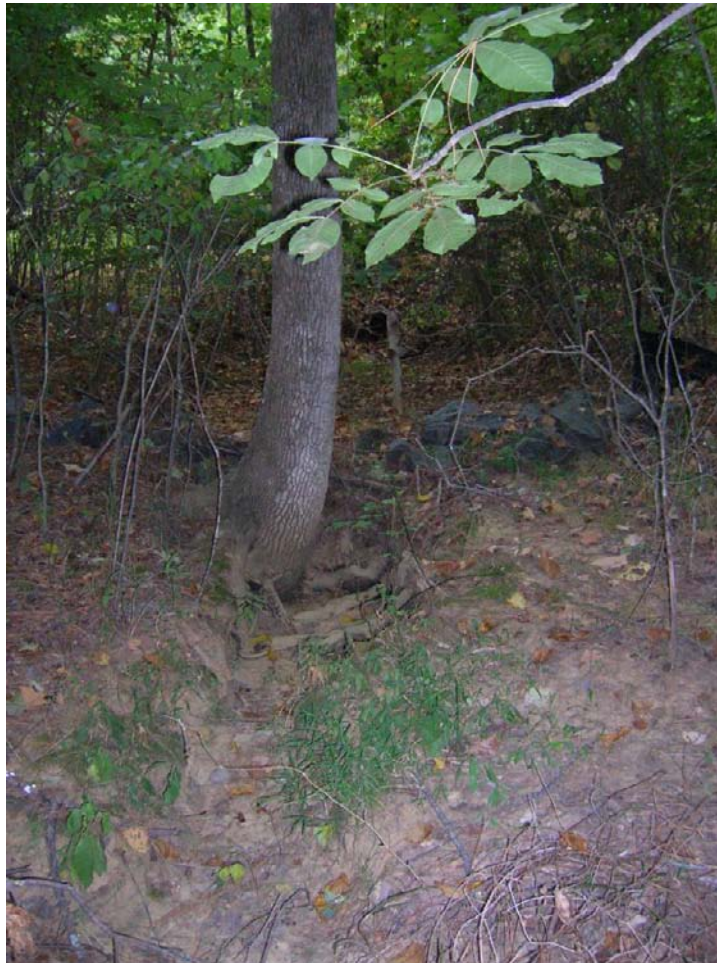
A view of the rip-rap berm around the basin. An eroding channel has formed below the basin. Facing north.
