APPENDIX B

Photo Log

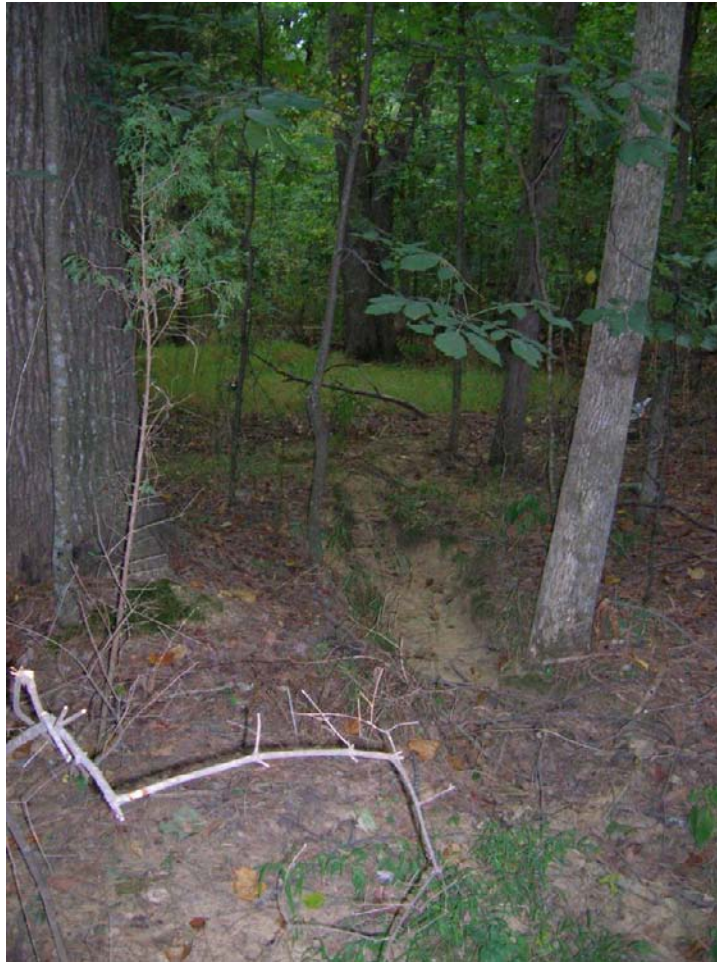
An eroding channel and headcut have formed in the floodplain of Jolly Branch.

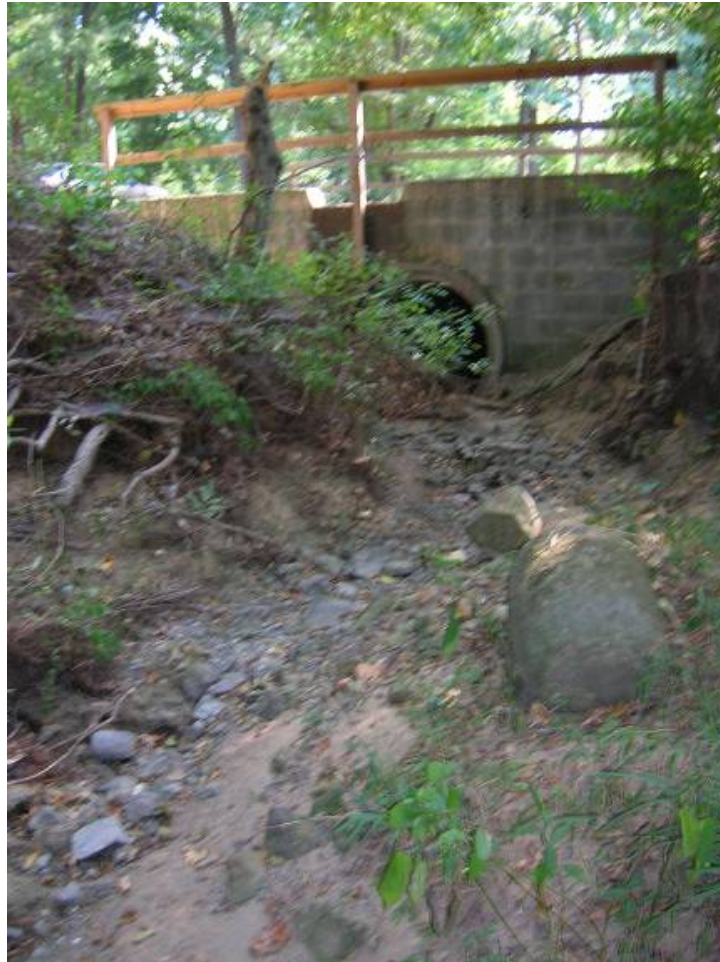
A driveway to an apartment complex crosses the stream. Facing downstream.

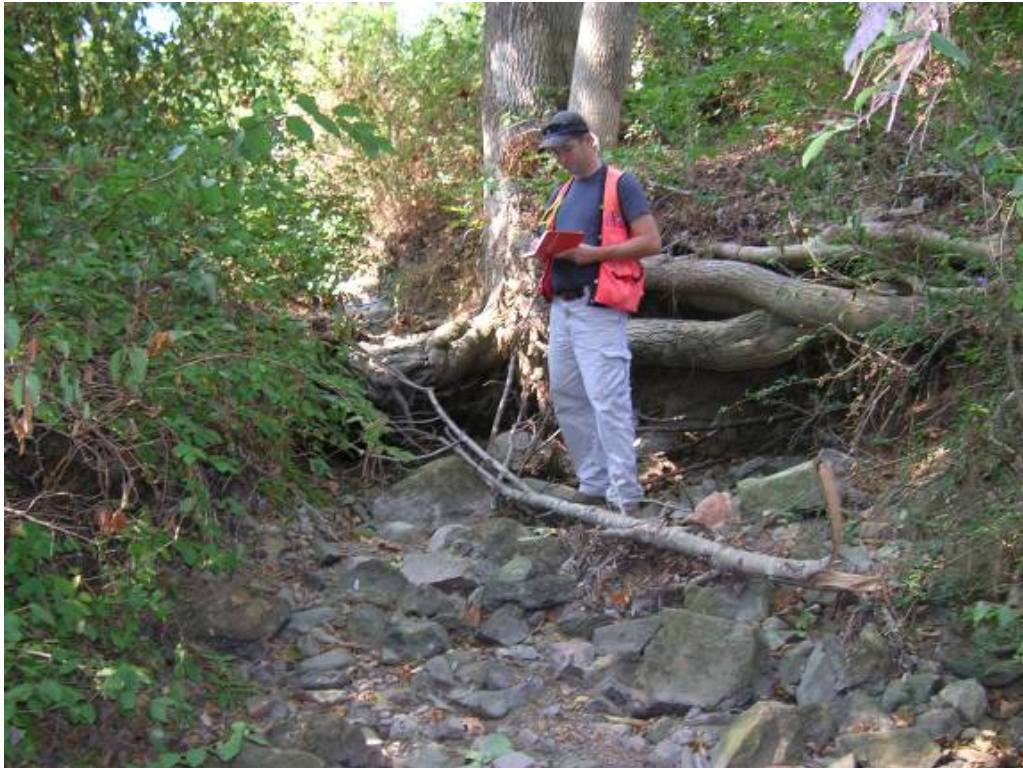
The stream is severely incised, and has degraded below the roots of several large trees. Facing upstream.

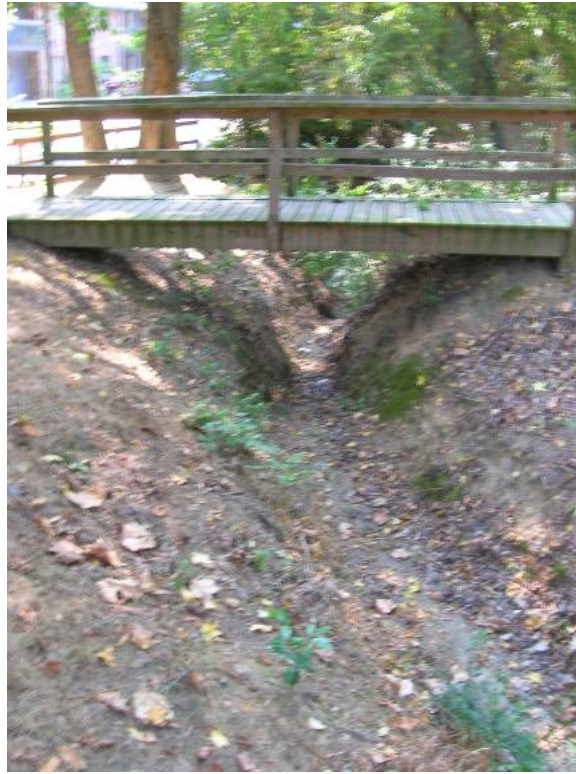
What was observed to be an ephemeral stream joins the main channel after flowing under Estes Drive Ext.
Facing downstream.

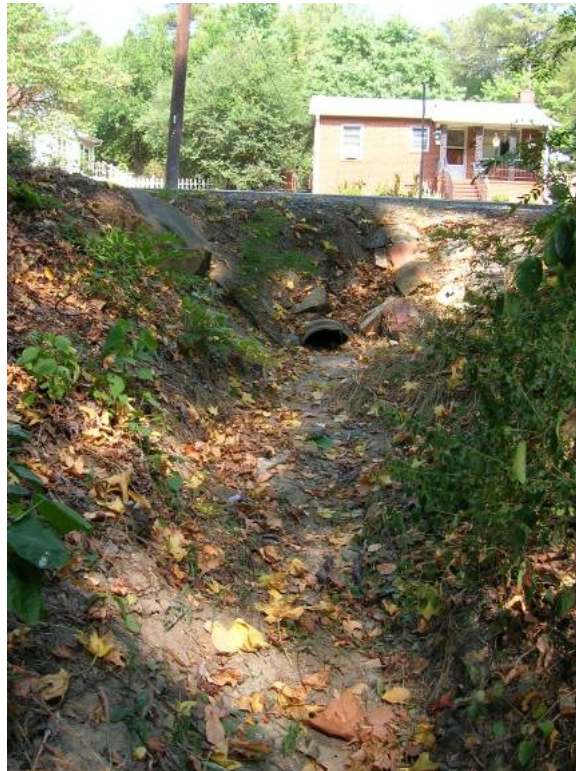
The ephemeral tributary facing upstream towards Estes Drive Ext.

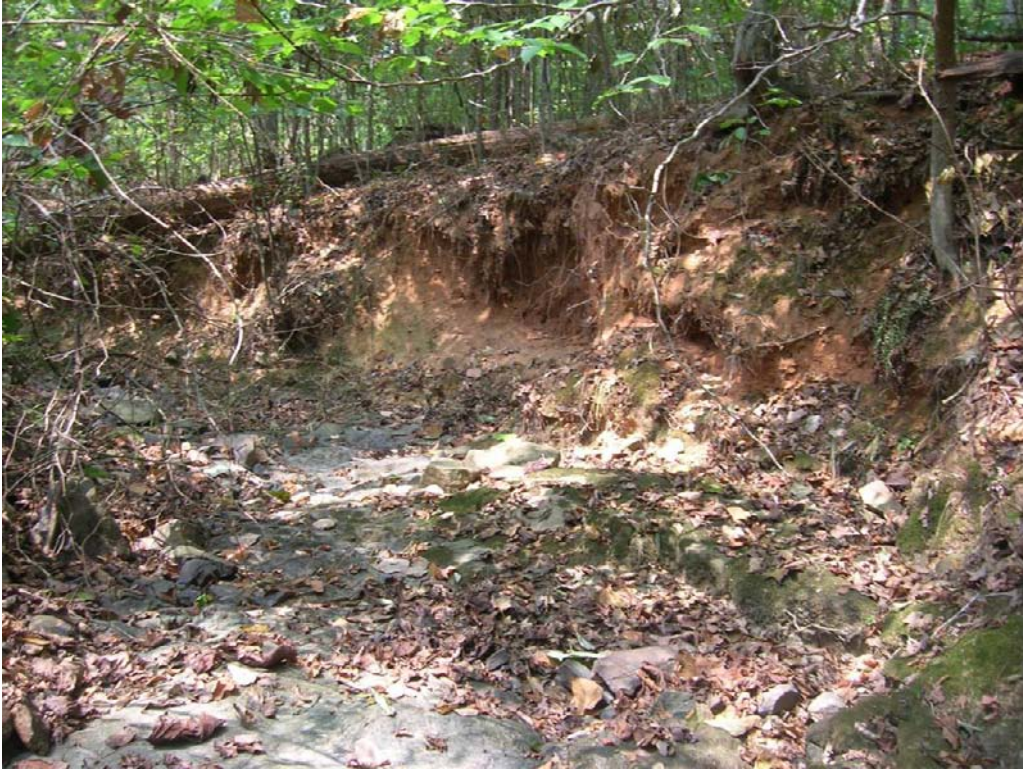
An eroding hillside at Site 17. Facing upstream.

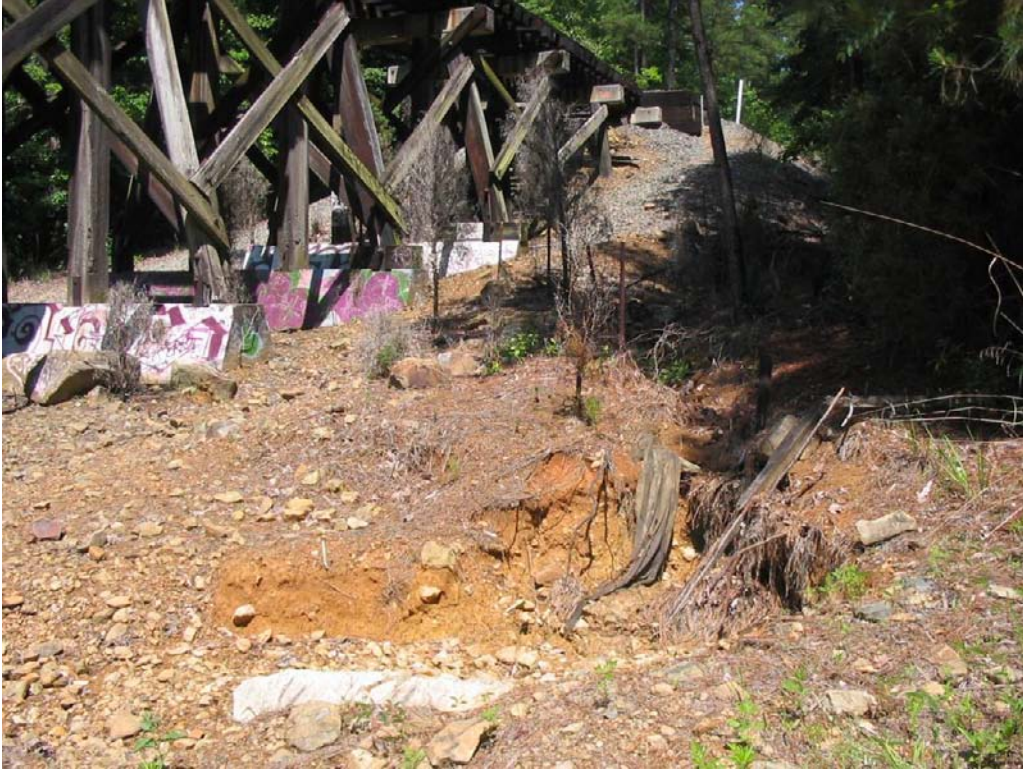
A view of the erosion occurring adjacent to a railroad trestle. Facing north.

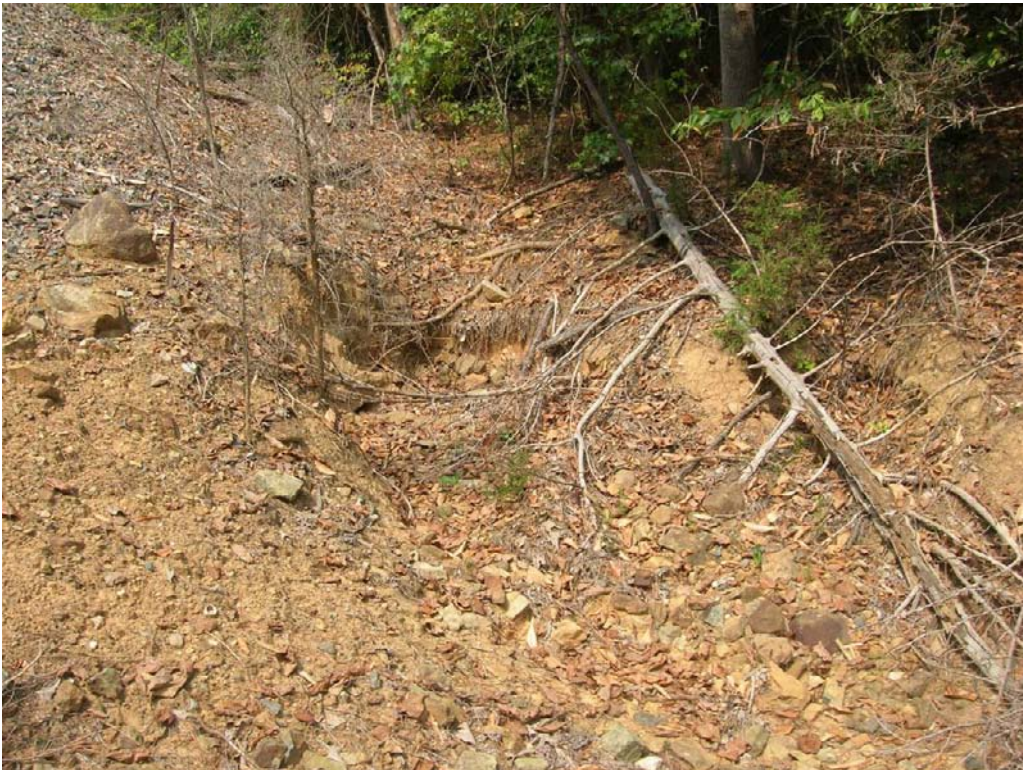
The erosion consists of two headcuts eroding uphill. Facing north.

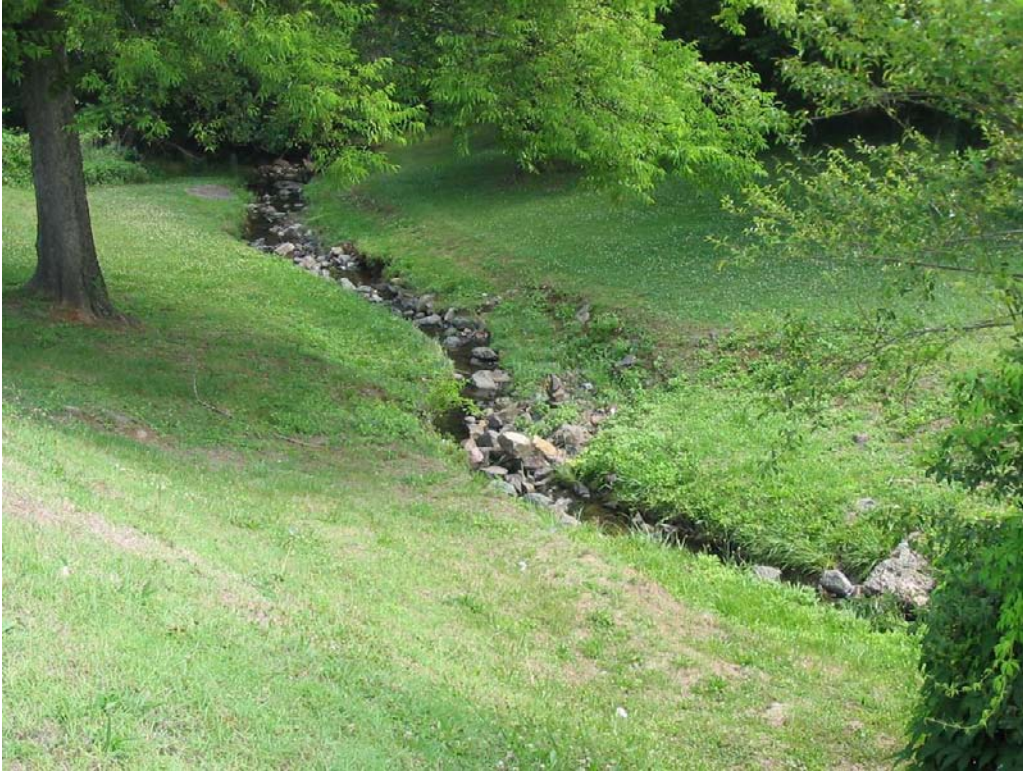
A view of the stream and surrounding park. Note the lack of riparian vegetation. Facing downstream.

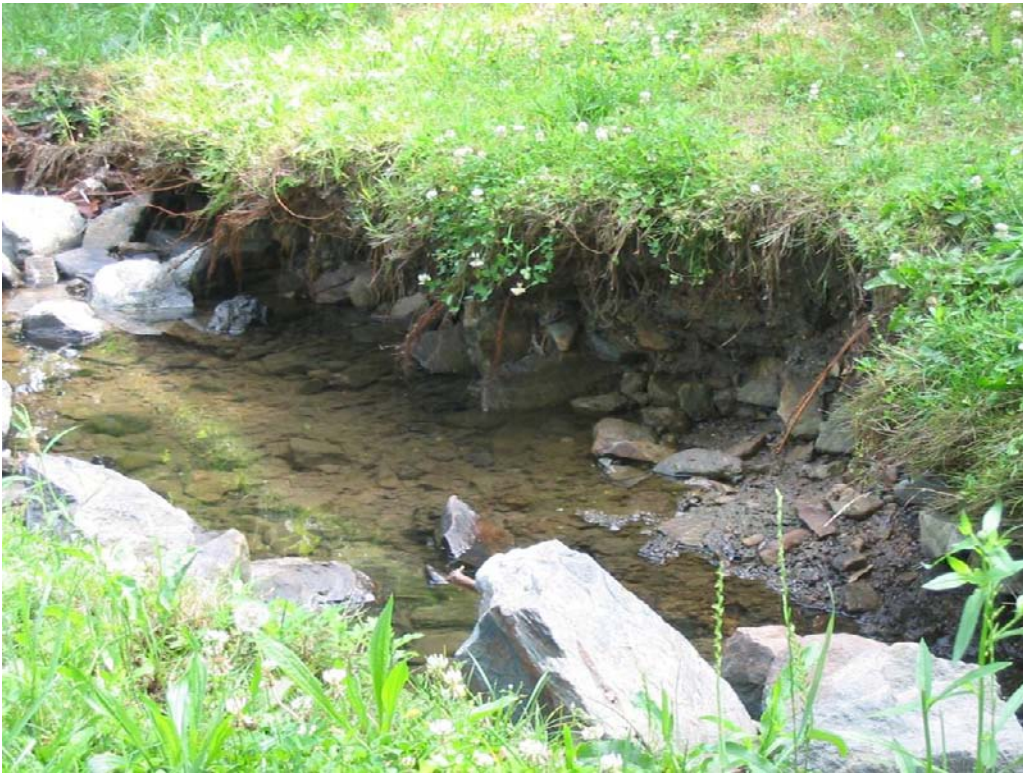
Mass wasting is occurring along this reach. Facing upstream.

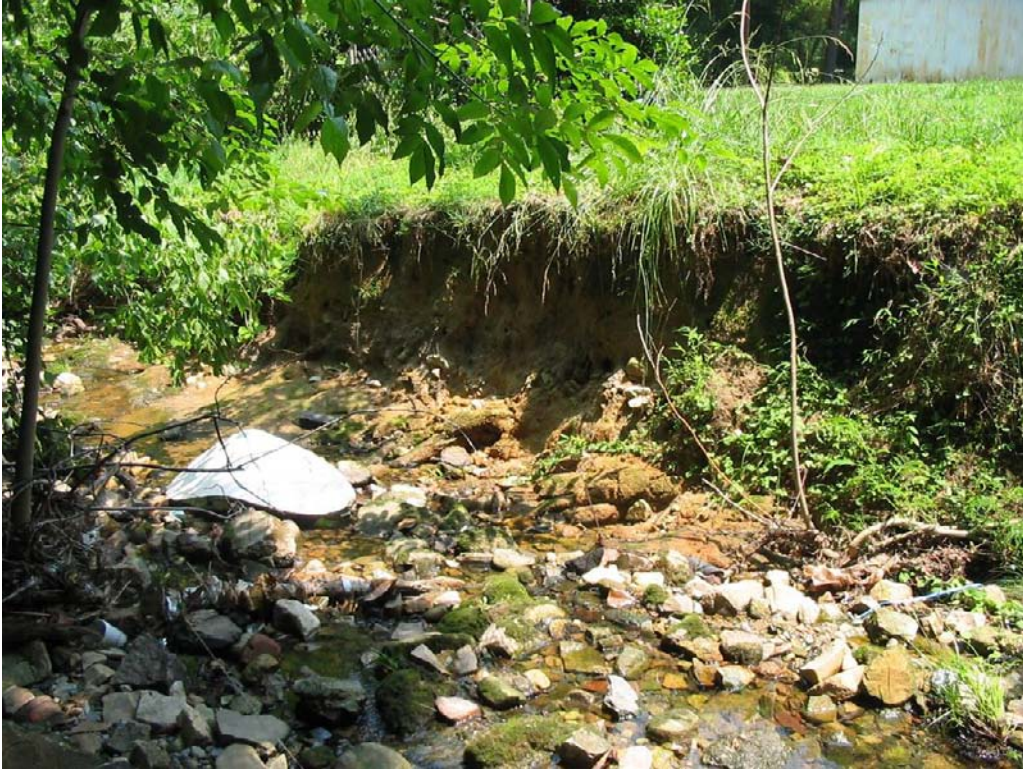
Severe bank erosion is occurring along this reach. Facing upstream.

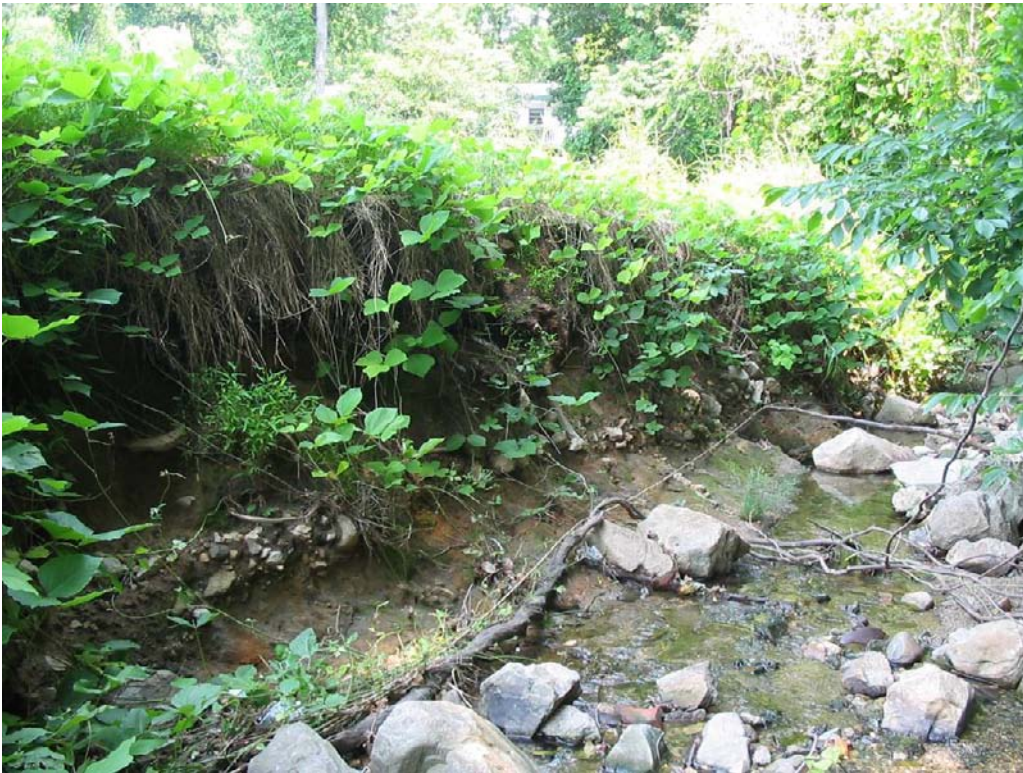
Another view of the incised channel and bank erosion. Kudzu dominates the floodplain of the stream. Facing downstream.

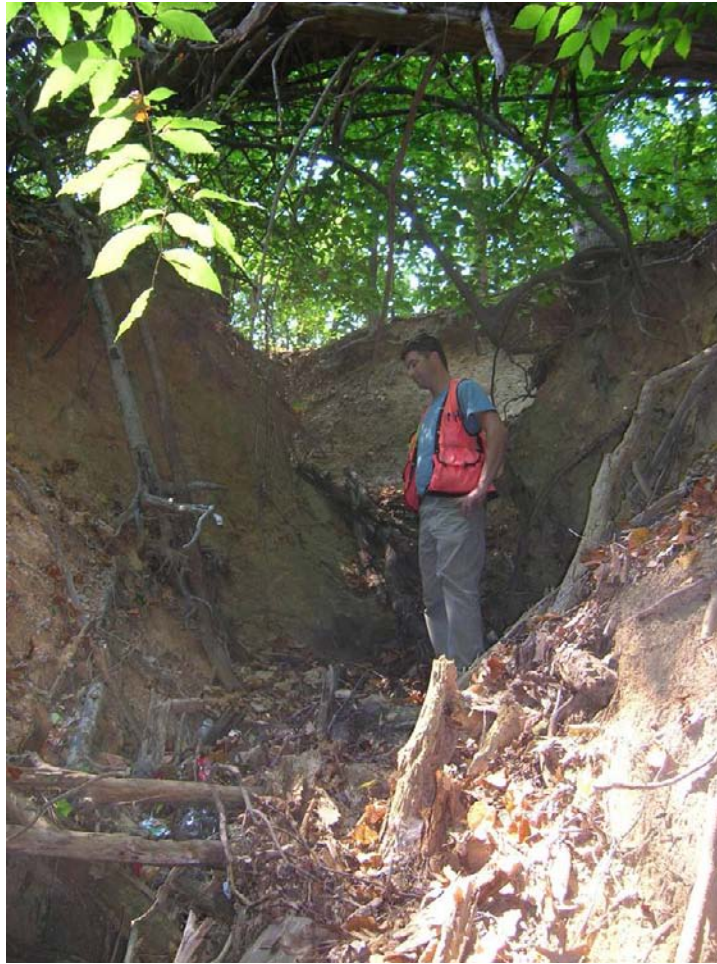
The gully at Site 21. Facing west towards Hillsborough Street.

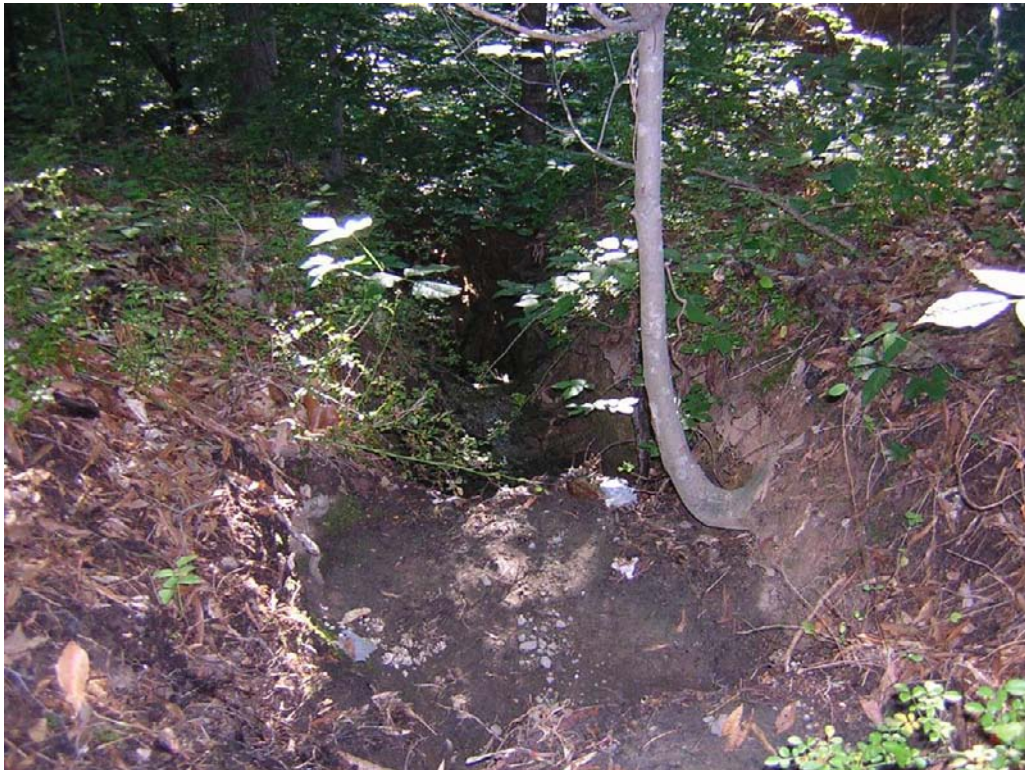
A view from the top of the gully looking downhill. Facing east.

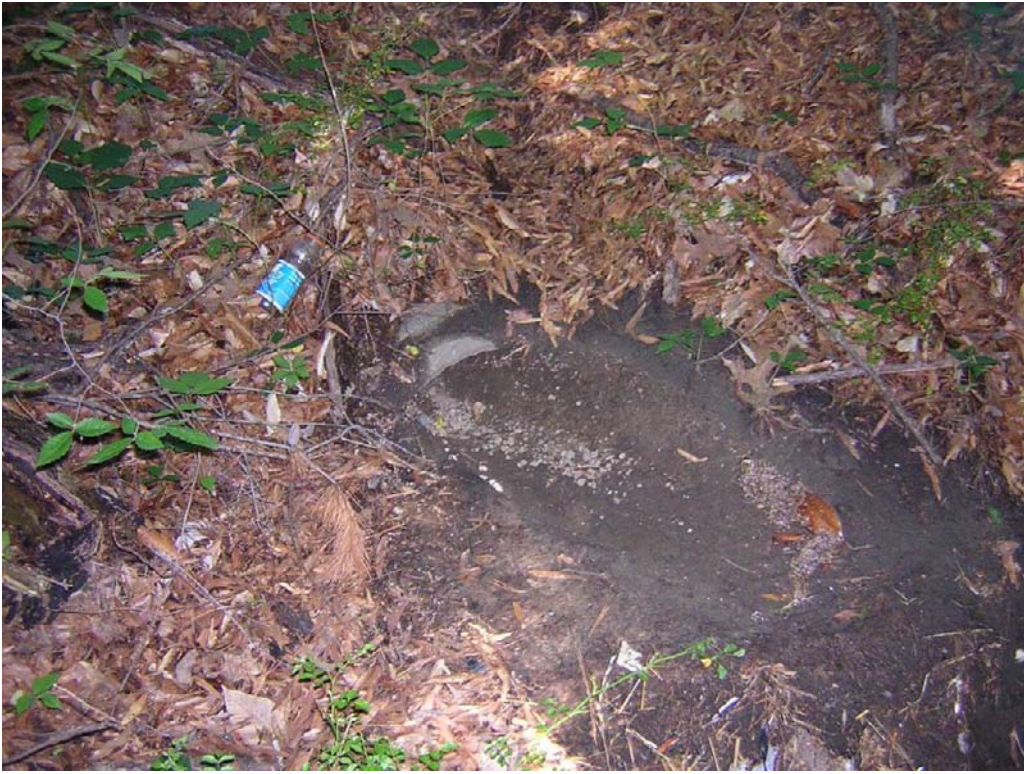
The stormwater outfall pipe from Hillsborough Street is almost completely buried. Facing northwest.

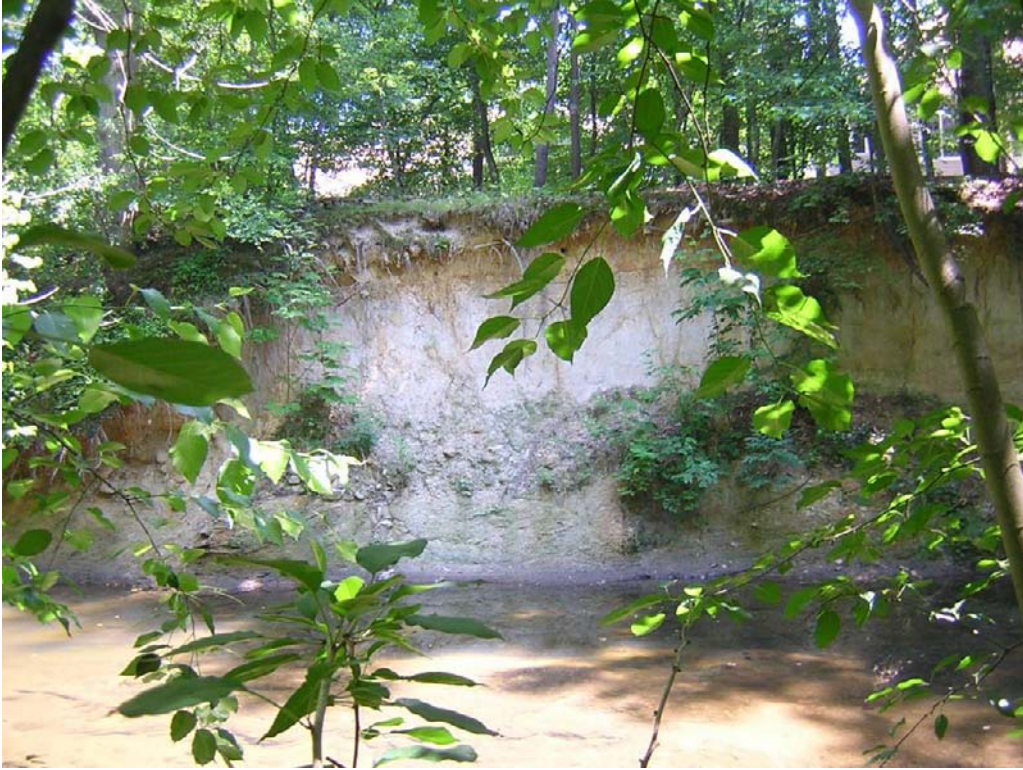
An eroding hillside along Bolin Creek is the primary feature at Site 22. The bank is approximately 18 feet high.

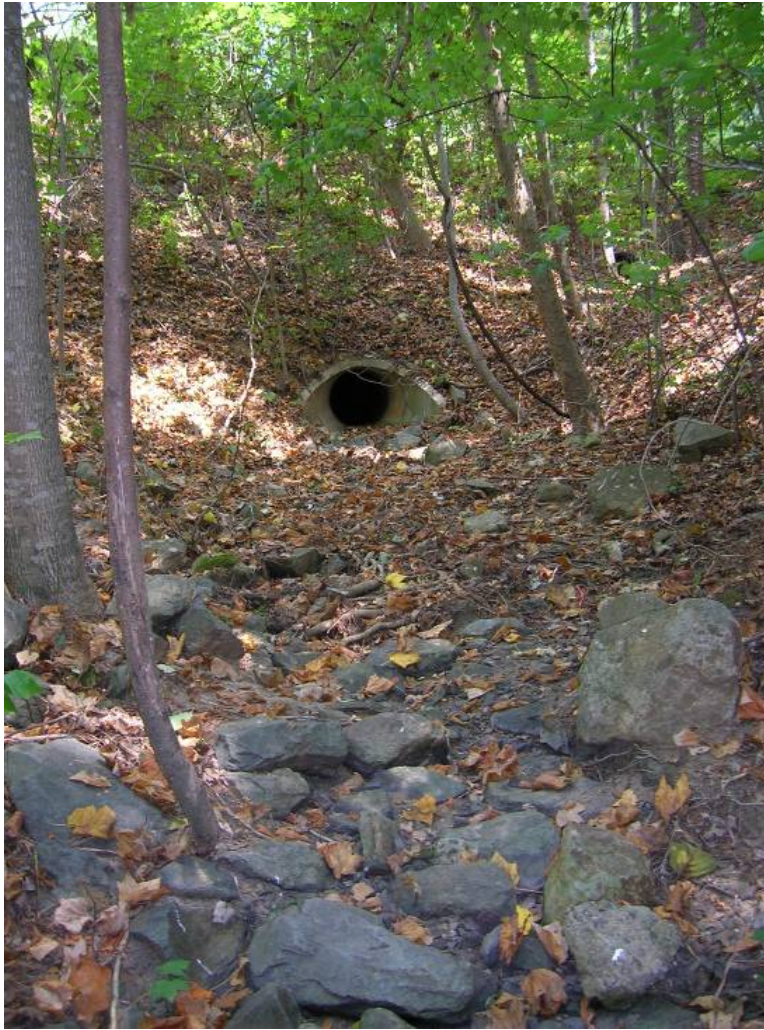
The stormwater outfall at Site 23, which flows into the existing basin. Facing north and upstream.

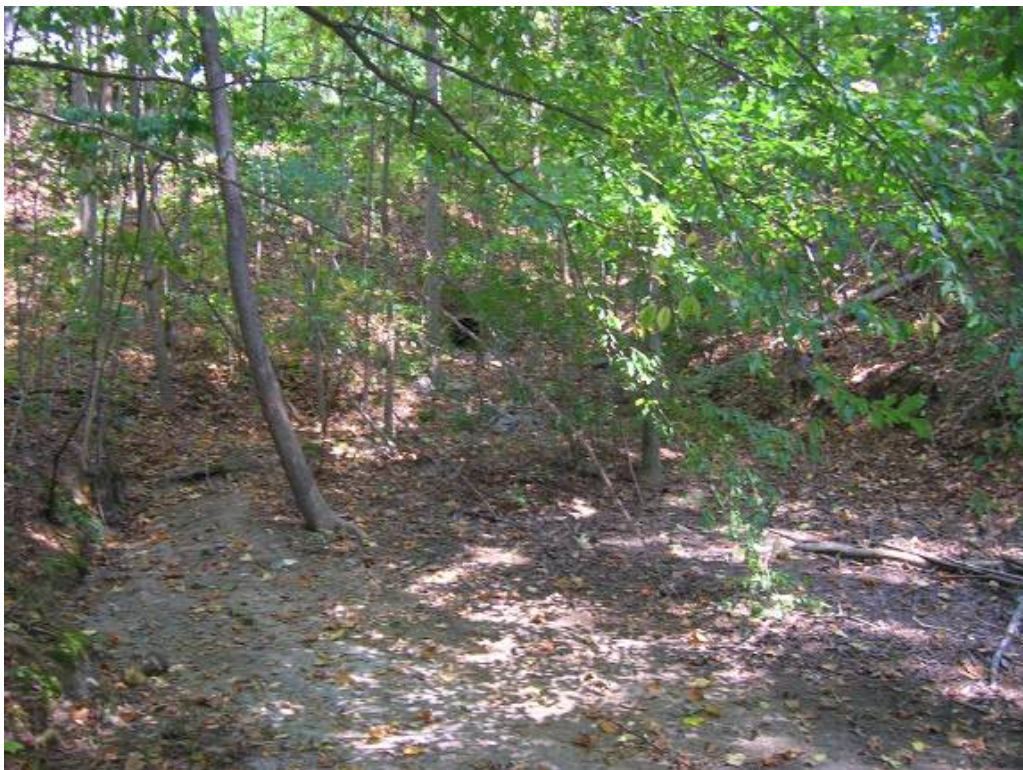
The basin provides a good location for a stormwater BMP retrofit. Facing northeast.

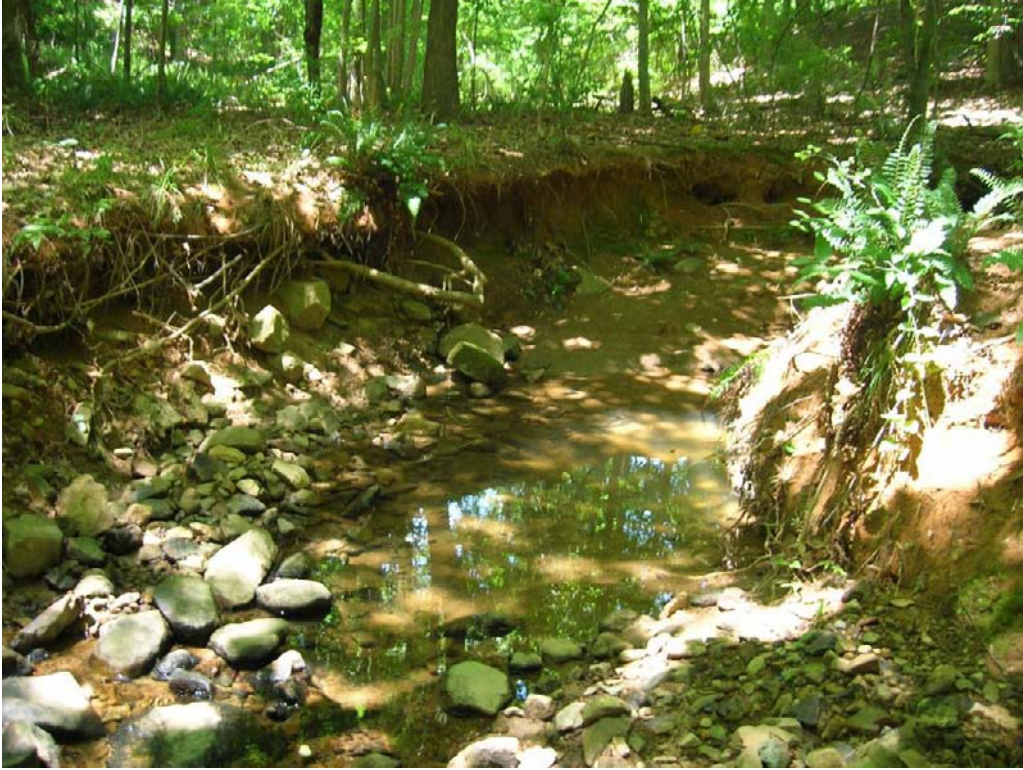
Cole Springs Branch is incised with undercut banks near Site 25. Facing downstream.

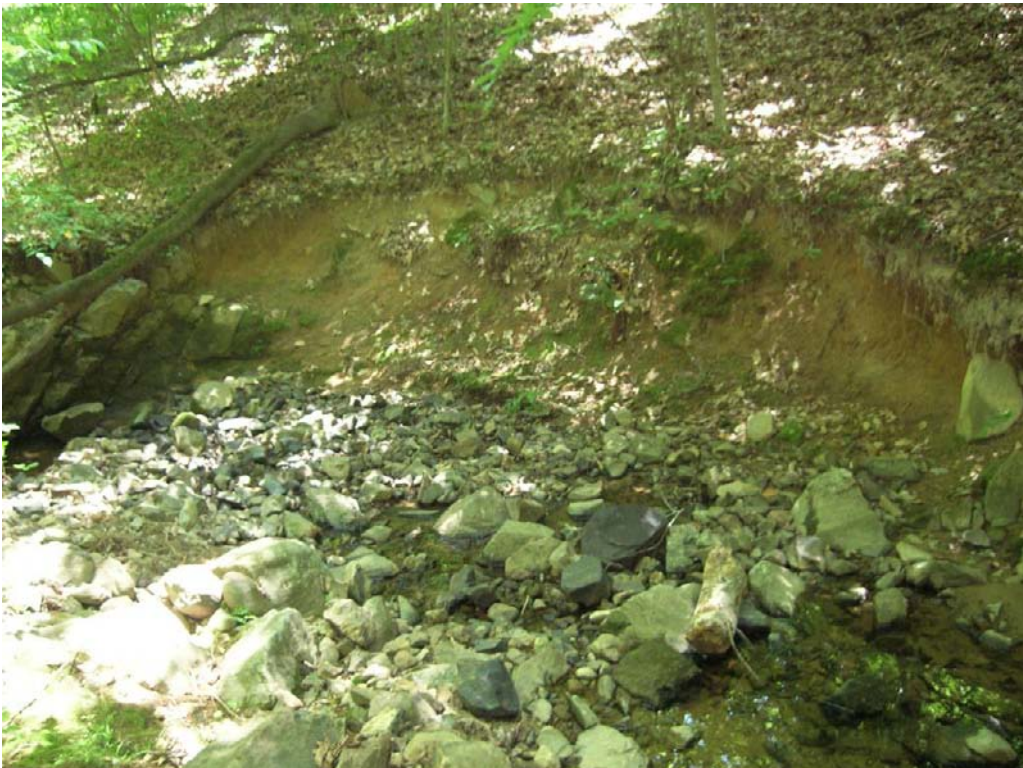
An eroding bank on Cole Springs Branch near Site 25. Facing downstream.

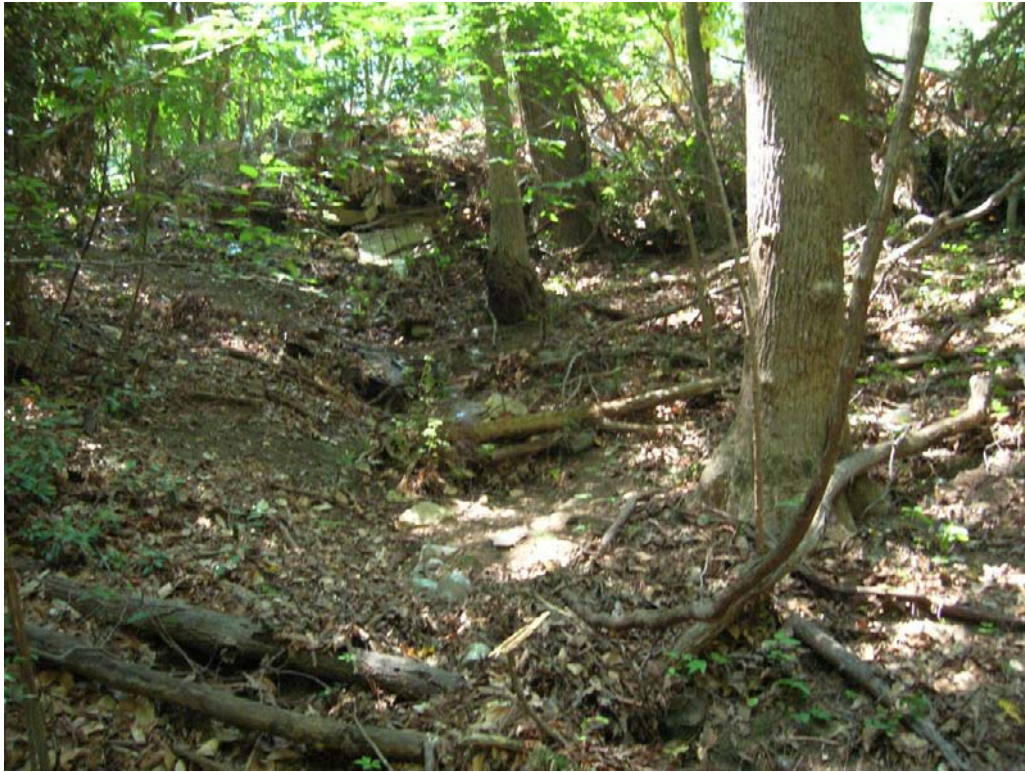
Fill has been placed in an ephemeral channel near Site 26.

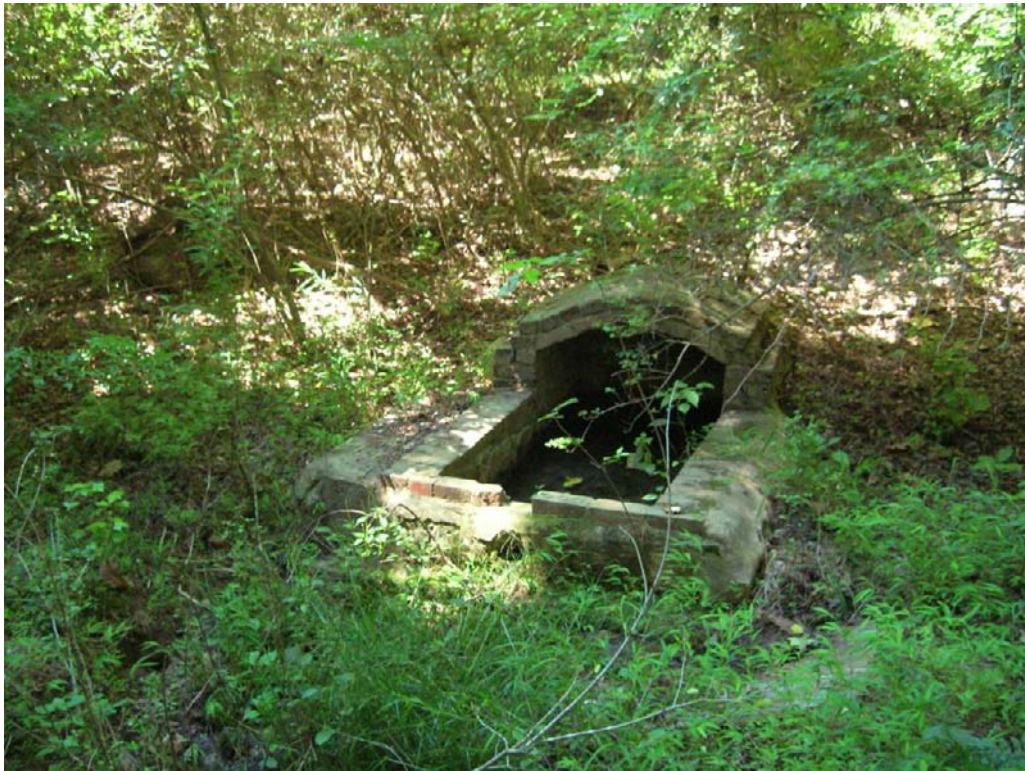
An old spring-head improvement near Site 26.

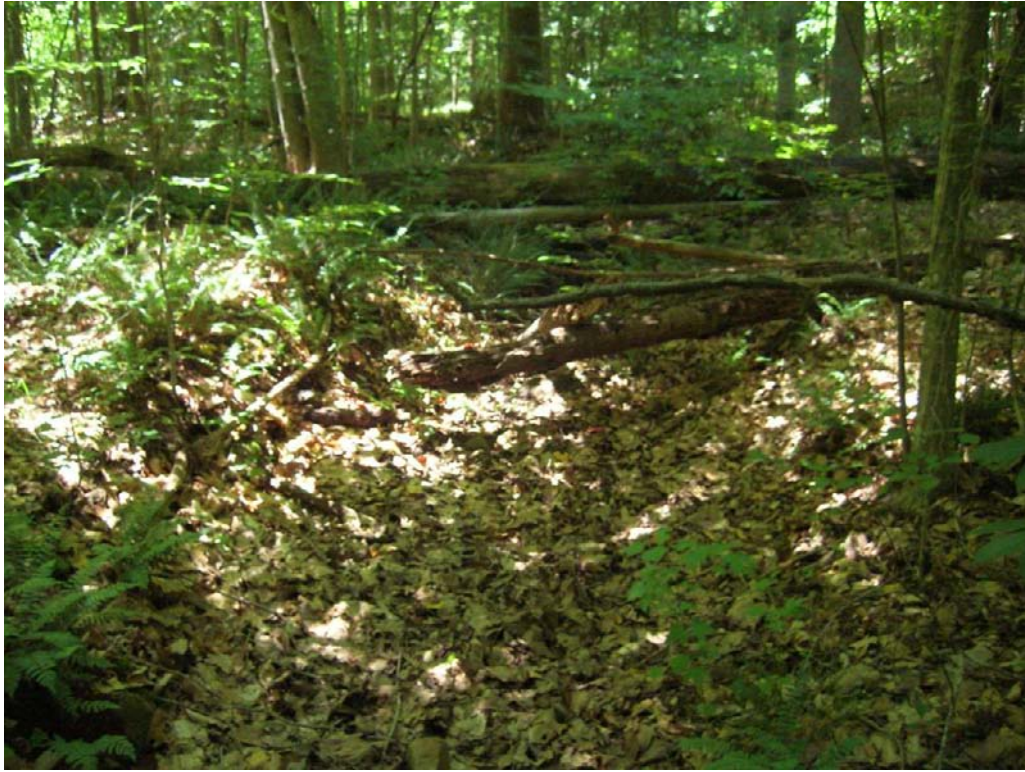
A relic stream channel in the floodplain near Site 27. This floodplain area provides a good location for side-channel BMPs.

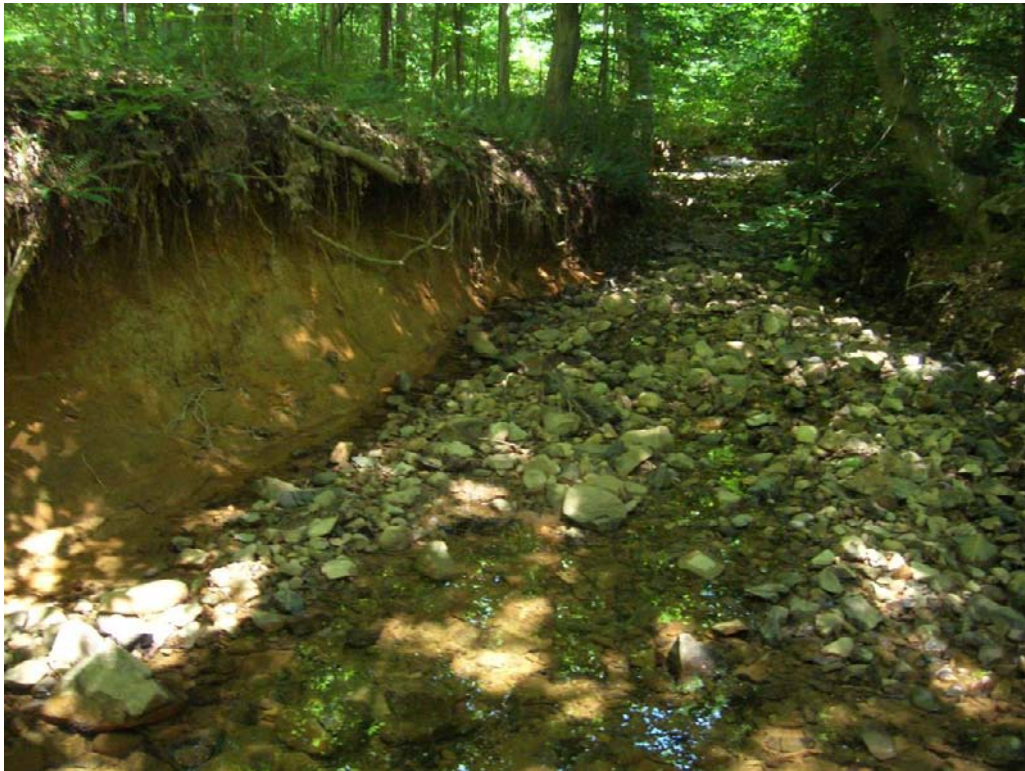
The stream channel near Site 27.

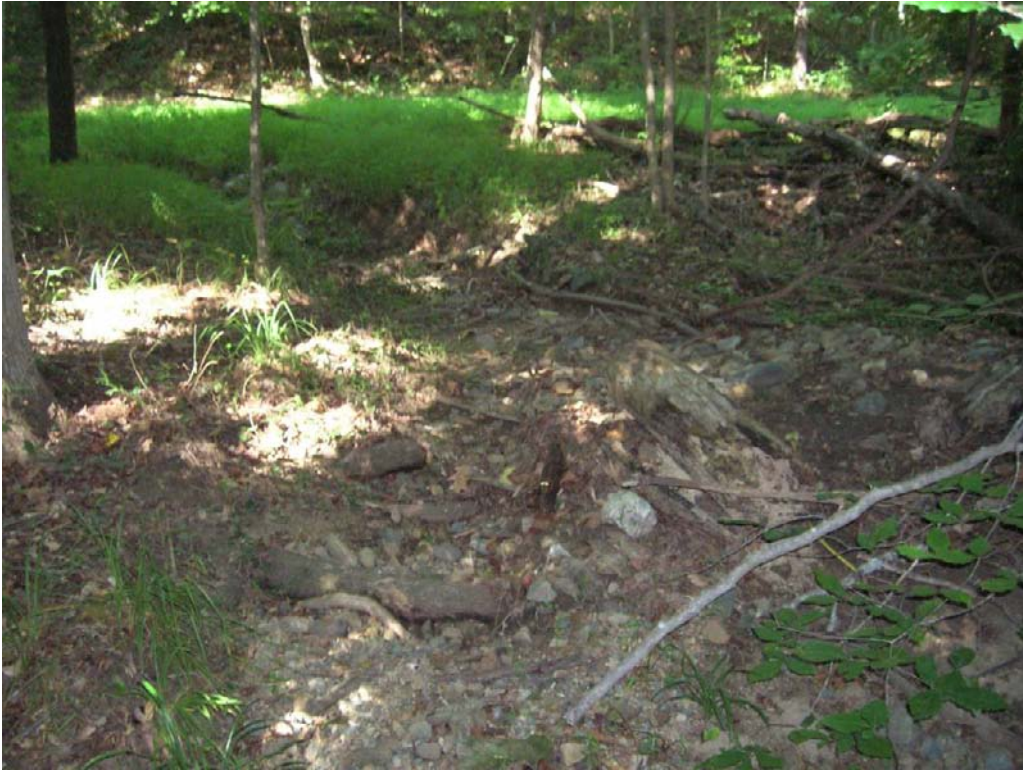
What was observed to be an ephemeral stream at Site 28. This could serve as the location for a bio-retention area.

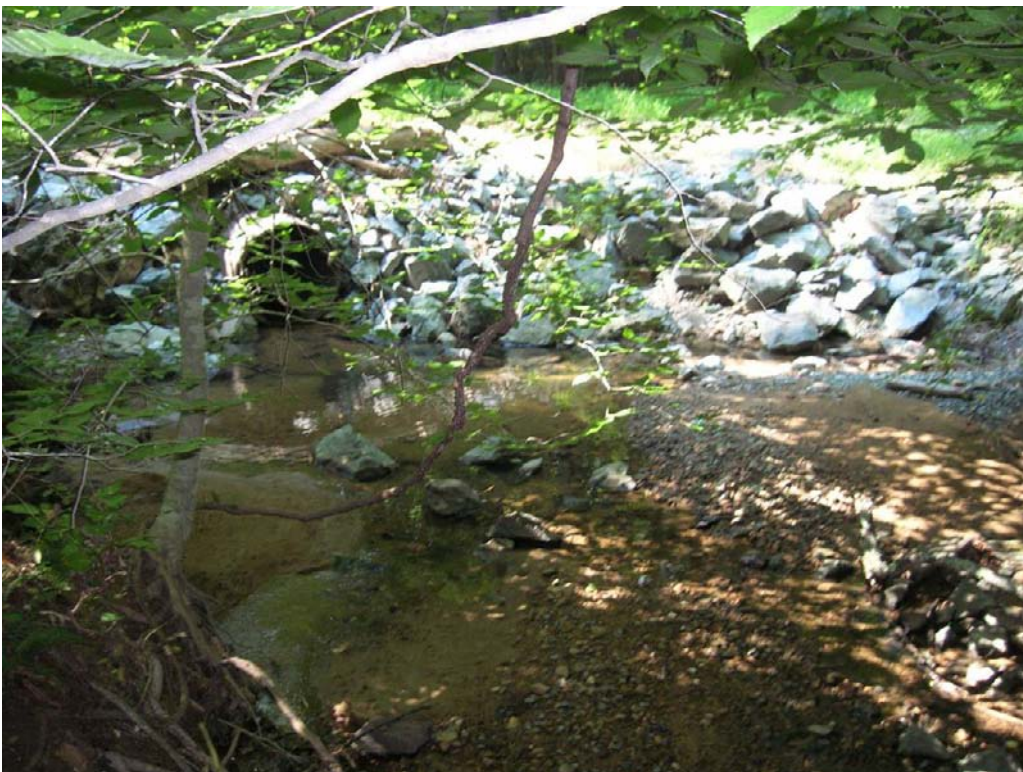
A utility crossing near Site 28 has caused mass wasting on the stream banks.

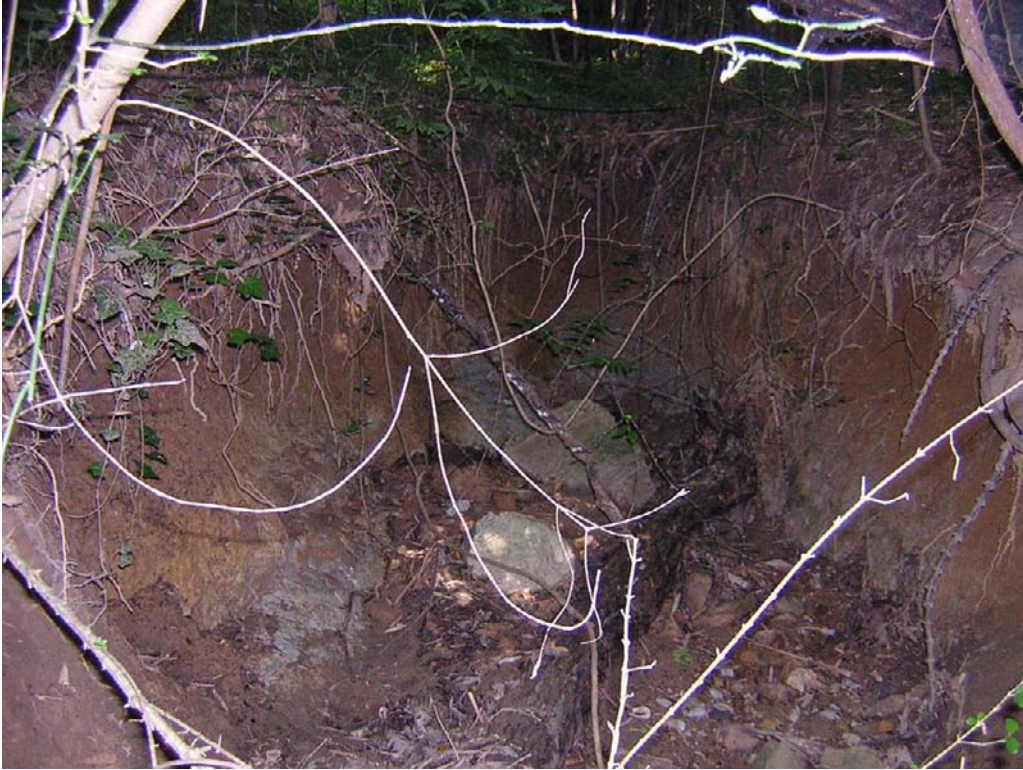
One of the headcuts present at Site 29. Looking upstream.

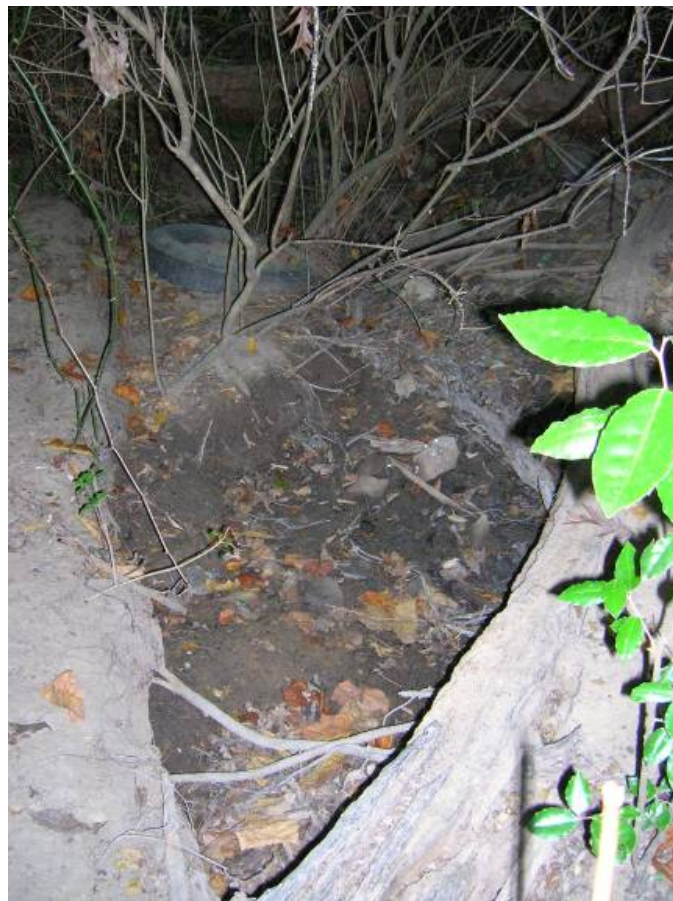
Another headcut area. Looking downstream

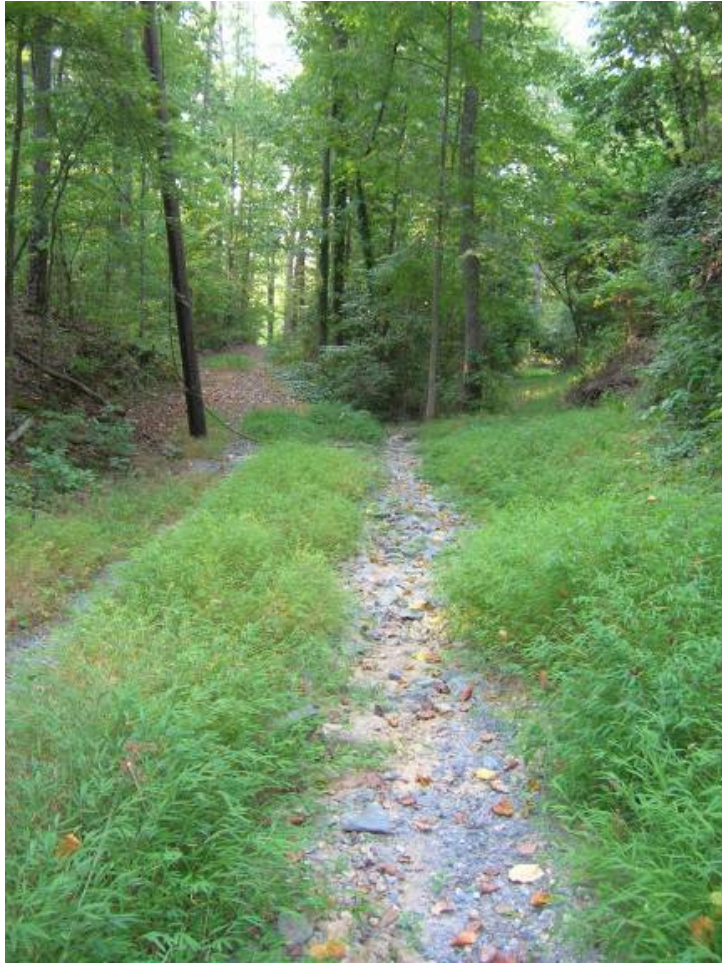
After flowing downhill, the stream flows across a utility easement road. Facing upstream and west.

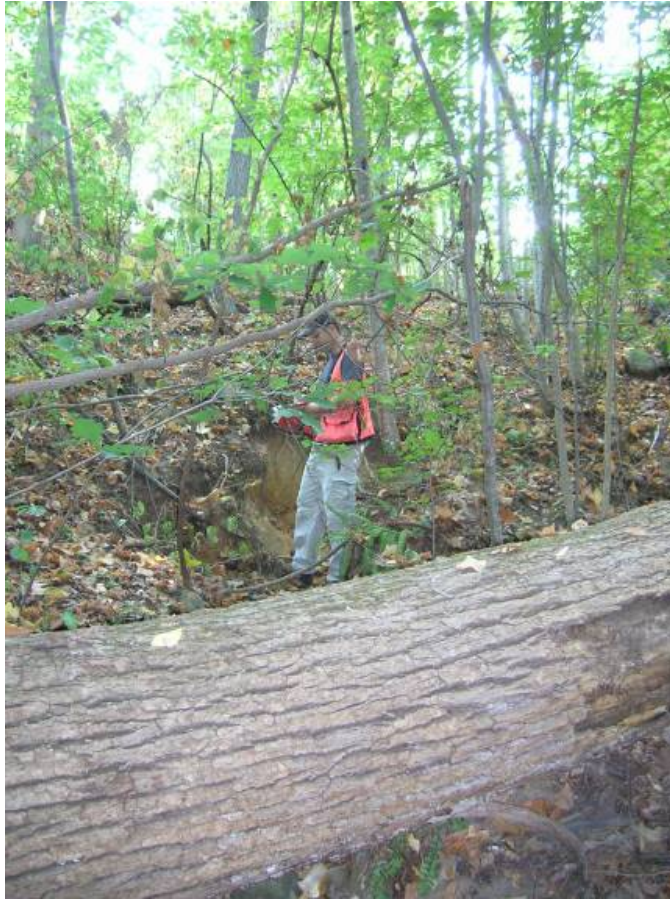
Flow from the stormwater outfall is causing hill erosion before flowing into the existing BMP. Facing northeast.
