APPENDIX B

Photo Log

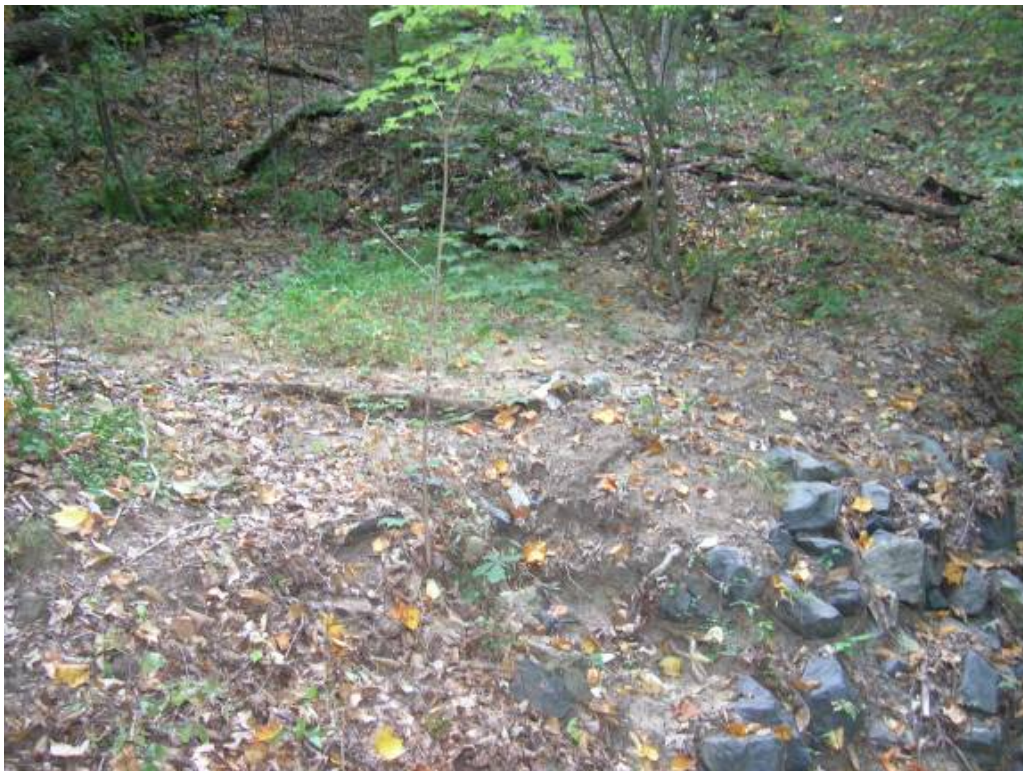
The existing BMP has filled in since its construction. Facing southeast.

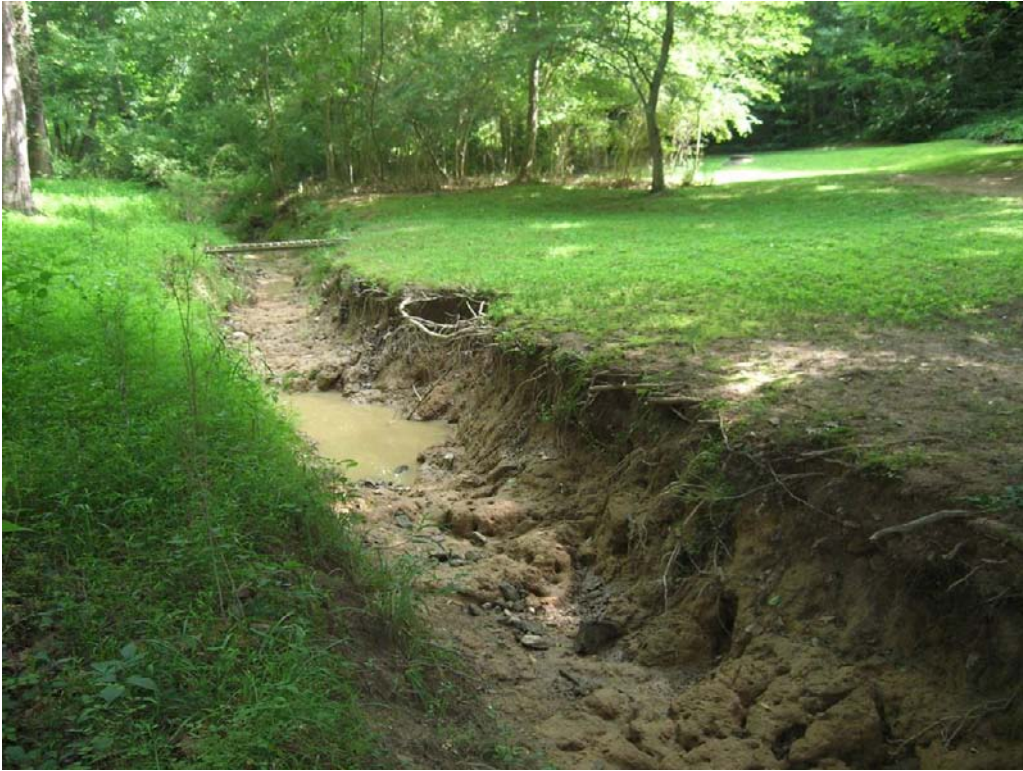
A ditch was dug in the floodplain of Battle Branch. On the right side of the photo is a residential backyard. The left side of the photo is the floodplain and utility easement along Battle Branch. Facing downstream.

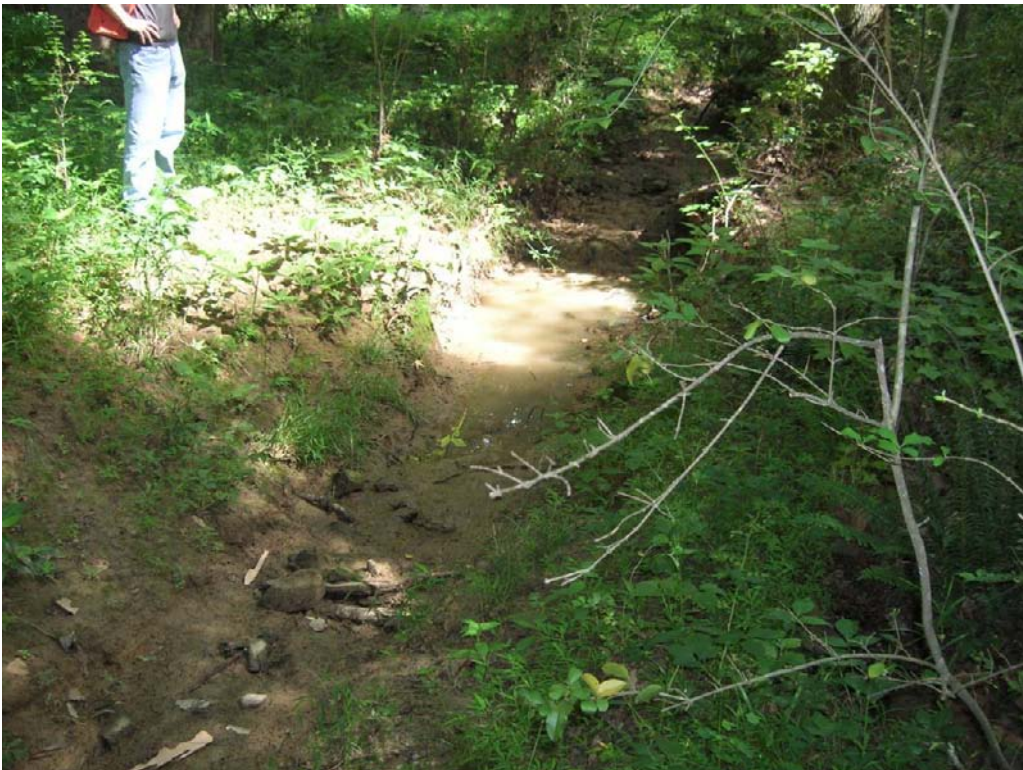
A view of a stormwater scour area flowing from the paved roads of a residential area into the floodplain ditch.

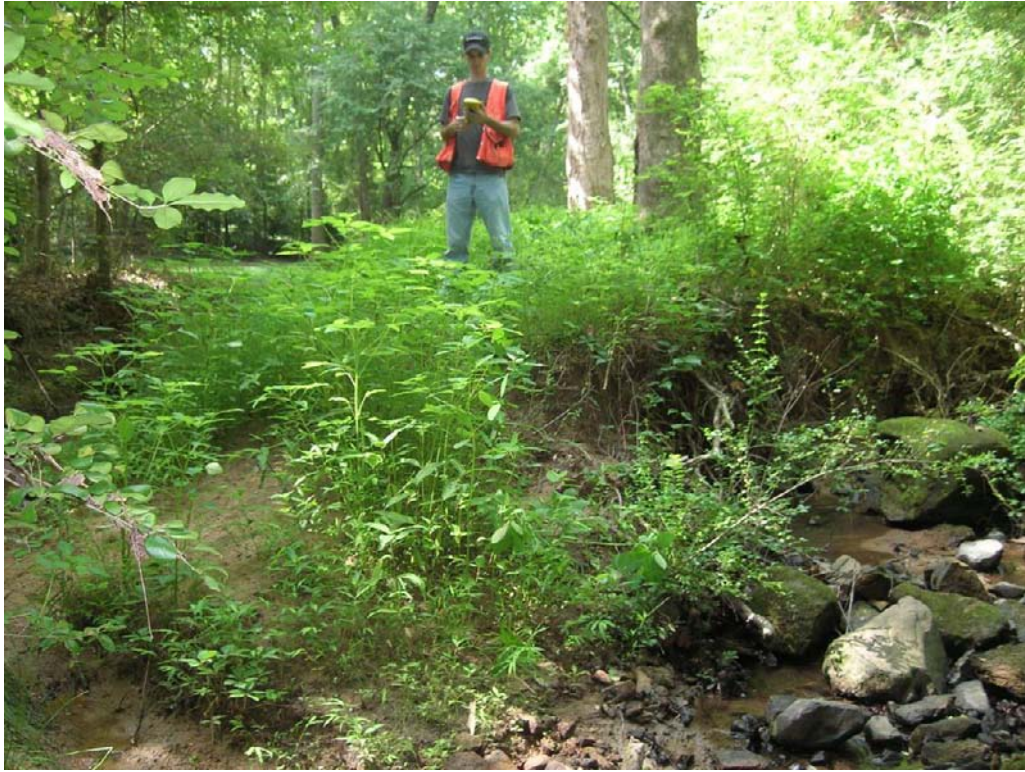
The confluence of the floodplain ditch with Battle Branch. Facing upstream.

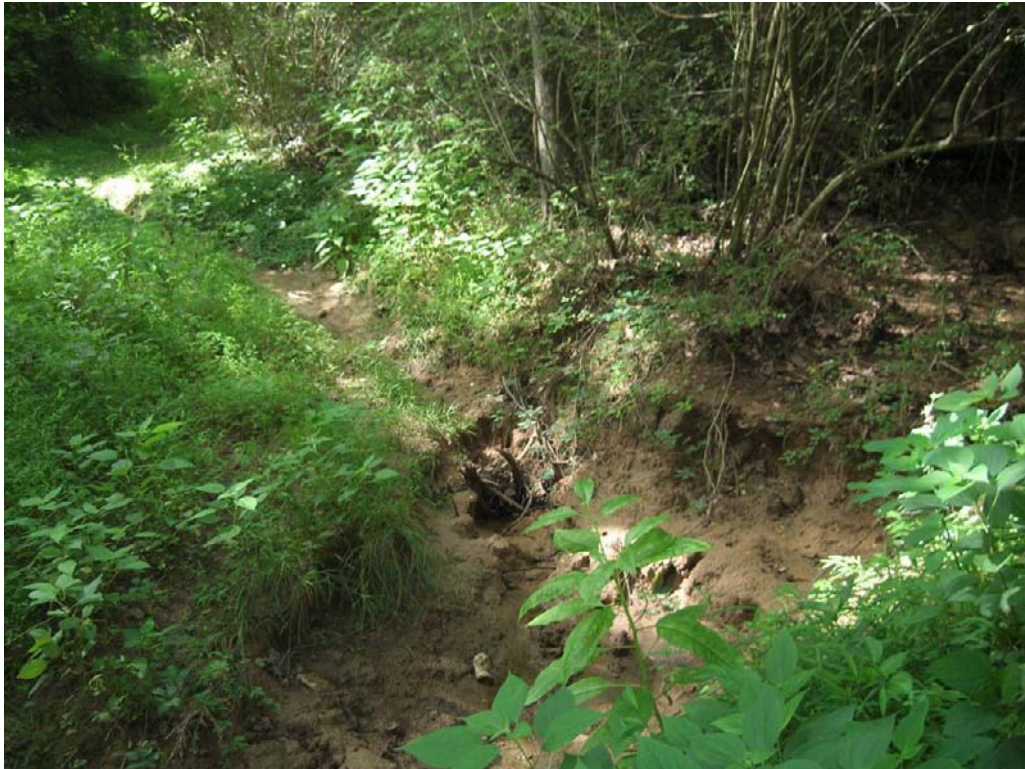
The upstream end of the floodplain ditch, where it is met by stormwater flowing from the nearby road.

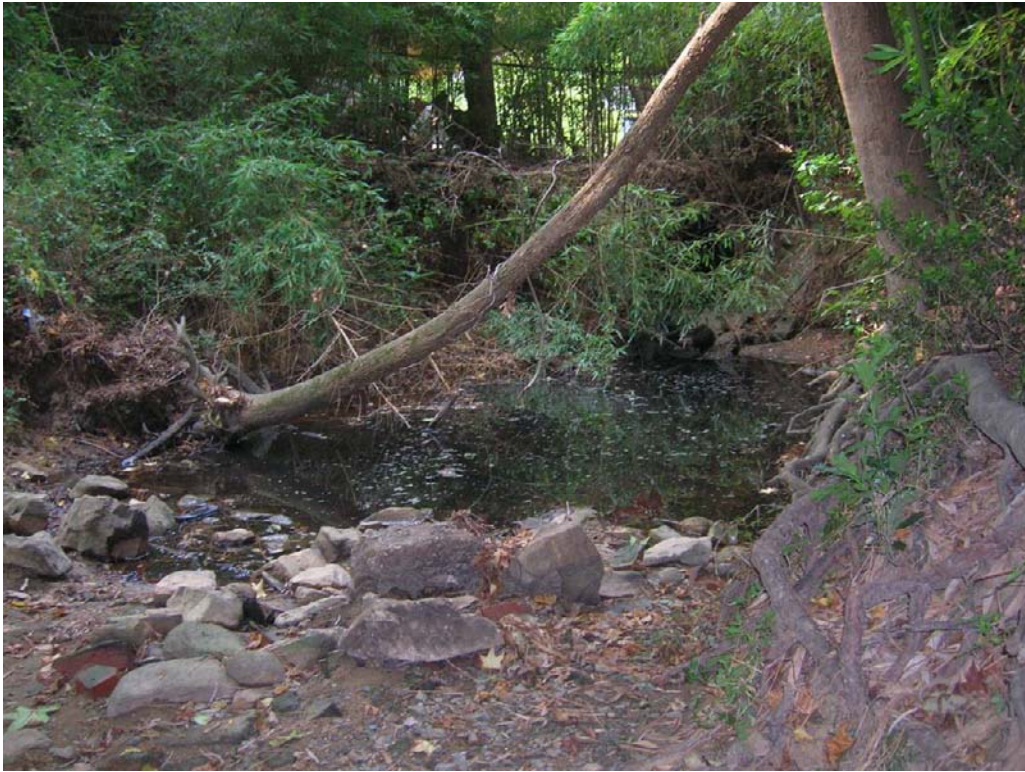
The upstream end of a channelized stream, where a stormwater outfall discharges into a large pool. Facing upstream.

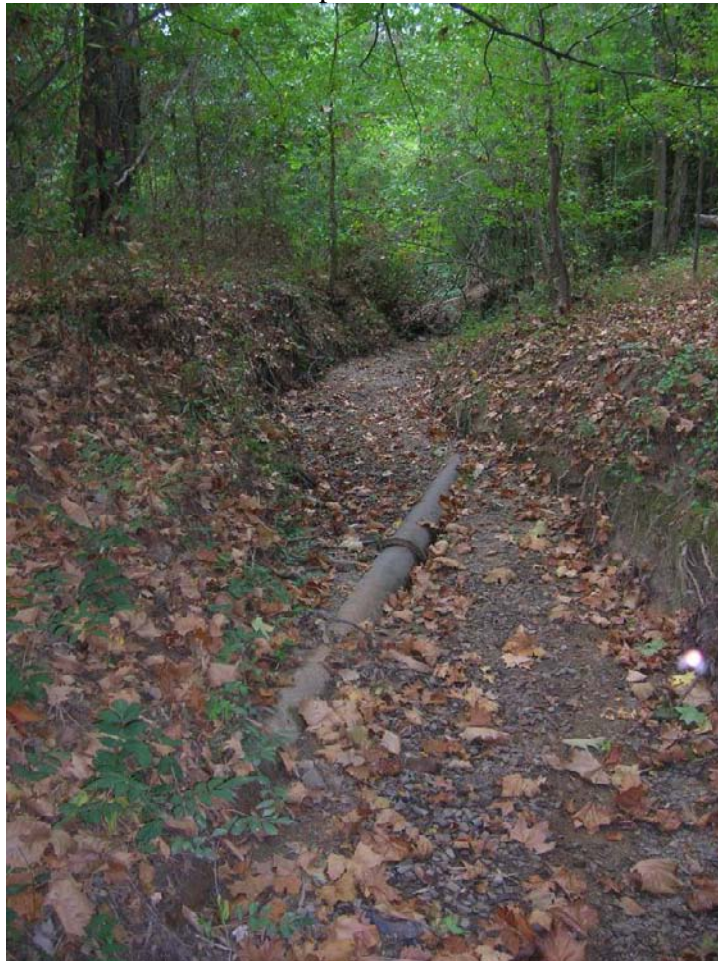
A utility line crosses the bed of the stream. Facing downstream.

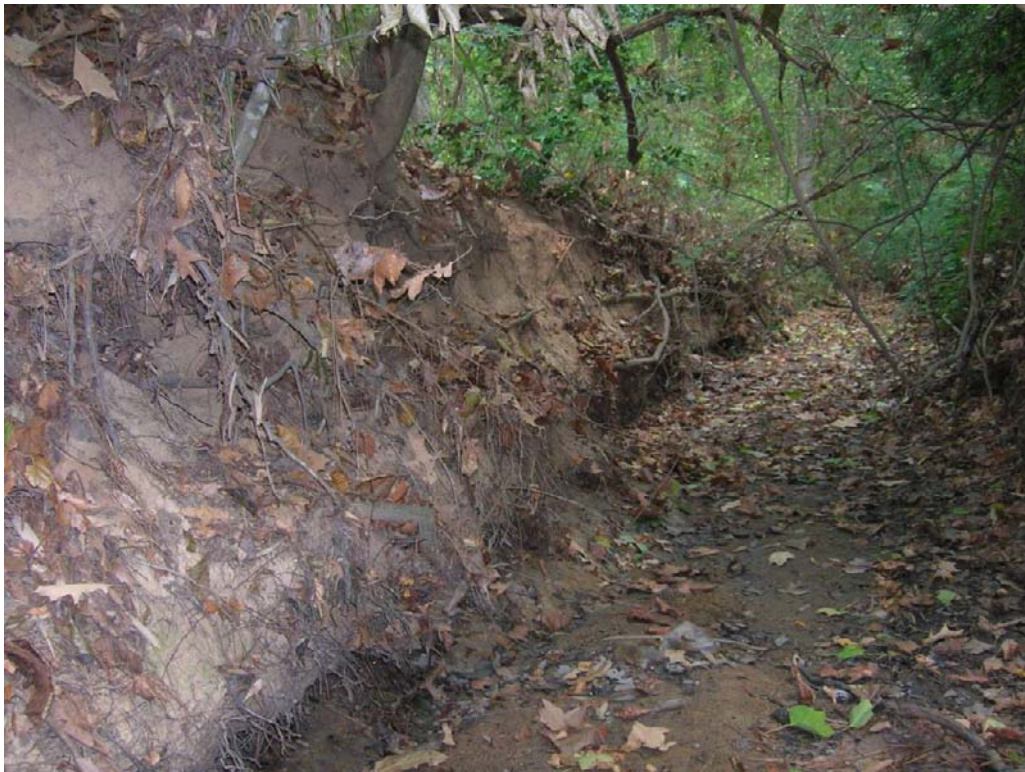
Eroding banks along the stream. Facing downstream.
