**SITE 28**

Geomorphic Analysis and Identification of  
Potential Sites for Stormwater BMPs  
Orange County, North Carolina

*Bolin Creek Watershed  
Geomorphic Analysis and Potential Site Identification for Stormwater BMPs and Retrofits*

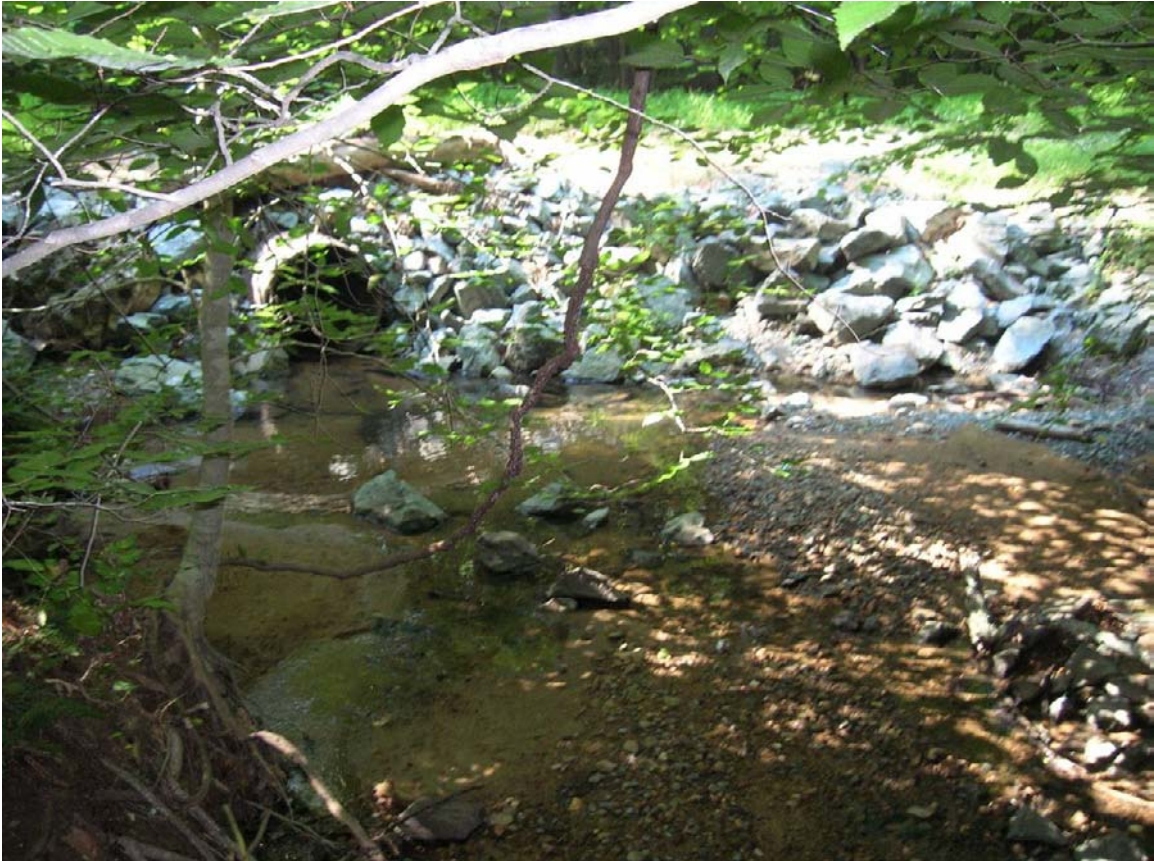
Index Sheet No.: 26  
Raw Data Name: BD 75

Site 28 is located just downstream of a utility crossing of Cole Springs Branch. The reach downstream of the crossing has suffered from the contraction and resulting incision from the utility crossing. Adding to the problem, and typical of this sub-watershed, just upstream of the crossing an ephemeral drain comes out of a residential area, down a steep valley, and carries high velocity flows that converge with Cole Springs Branch. The ephemeral drain is showing signs of incision and may become a head cut, creating a more significant sediment contribution in the future. The mass wasting banks that are downstream of the utility crossing are causing significant sediment contributions now.

This site was chosen as another site to use in this sub-watershed due to the blending of solutions that would be required to improve water quality. The ephemeral drain should be treated by the use of a stormwater wetland at the confluence with the floodplain of Cole Springs Branch. This wetland should be discharged via a level spreader, thereby reducing some of the destructive hydraulics that are impacting the immediate site. This would provide water quality treatment and quantity treatment for the runoff from the hill-top development. Immediately downstream of the wetland, the culvert at the utility crossing could be removed and the stream crossing can be accommodated by a stabilized

ford. This will allow flood plain access and reduce the negative effects of contraction that are created by the culvert.

Downstream of the culvert, the already damaged stream banks need stabilization. The combination of these BMP's indicates the typical situation that will be required to restore stream stability in this troubled watershed.
