SITE 16

Stabilize Erosion at Apartment Complex and Provide Water Quality Treatment.

Bolin Creek Watershed Geomorphic Analysis and Potential Site Identification for Stormwater BMPs and Retrofits

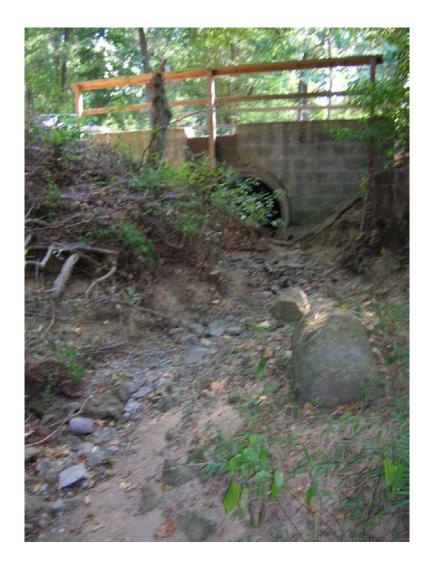
Site 16 consists of approximately 500 feet of an incised, actively eroding stream, and small tributary that converges with the stream after passing through a culvert under Estes Drive Extension. Both the Carrboro and Chapel Hill stream datasets list the flow type as "Unknown". However, based on the drainage area of 0.2 square miles and the position in the landscape, the stream appears to be perennial, though further verification is needed. The stream is surrounded on both sides by the landscaping and hardscapes of an apartment complex. A wooden footbridge passes over the stream near the midpoint of the problematic reach.

The chief problems at site 16 are active mass wasting banks, and considerable sediment export from the eroding stream banks. Using the BANCS model, it is estimated that approximately 200 tons of sediment are being exported from the site each year. Concomitant nutrient export has also been calculated and is listed in **Table 16.1**.

In Alternative 1, the banks would be sloped back, a bankfull bench would be established and both would be vegetated. Brush matting on the banks will provide the necessary change in boundary conditions of the banks to resist the erosive force of peak flows. On the small tributary leading into the main stream channel, a step-pool should be built to stop the active headcut where the two channels meet.

In Alternative 2, the treatments recommended in Alternative 1 would be implemented, with the added water quality treatment of a bioretention area. The bioretention area should be constructed inline with the tributary and receive the flow of its contributing drainage area.
