# SITE 2

# **Retrofit of Existing Stormwater Pond**

Index Sheet No.: 5 Raw Data Name: BD 100

# Bolin Creek Watershed Geomorphic Analysis and Potential Site Identification for Stormwater BMPs and Retrofits

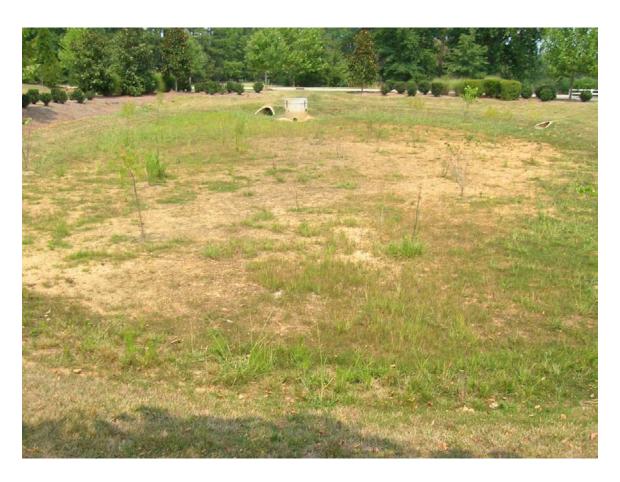
Site 2 is an existing stormwater basin was designed under an old ordinance whereby the basin discharges all rainfall events at a 10 year flow rate. The basin is composed of a flat, shallow depression with sparse plantings of hardwood saplings scattered throughout. The basin currently collects the runoff of Hogan Hills Rd and surrounding rooftops. The basin inlet is a reinforced concrete pipe and the outlet is a concrete vertical riser structure with a 6 inch diameter orifice which has an invert that is even with the basin's bottom elevation. This configuration creates a negative hydraulic effect, where a 1 year recurrence interval event is effectively discharged as a 10 year event. Also, with no permanent pool, soils that do not infiltrate, and no functional wetland system, this basin would not classify as any BMP that would be found in today's NC BMP manual. If the orifice were smaller, it would function to reduce the peak flow rates leaving the sites, and nothing more. Both the inlet and the outlet structures are located on the same side of the basin, further making the basin ineffective by not allowing sediment to settle and not obtaining enough nutrient treatment due to the flow path being only a few feet in length.

The existing basin of Site 2 is a prime candidate for a BMP retrofit in the form of a stormwater wetland to provide water quality treatment. To properly function as a wetland, this site should have a few permanent pools established and the soil amended so that plants will thrive. To accommodate the needed hydrology, the outlet structure should be modified to temporarily store approximately 6 inches of water depth and the outlet orifice would be sized to handle the excess, while reducing the runoff rate of the 10 year storm down to a 2 year storm. This can be accomplished by creating several

orifices in increasing size as the stage increases in the pond. To allow the proper resonance time, the flow length must be increased by adding a berm and forcing the flow coming from the inlet pipe to be routed to the furthest point of the pond away from the outlet. Other pools and low marsh benches could be built to create the appropriate diversity of habitat for various aquatic and semi-aquatic plants, which will provide treatment of stormwater for nutrients. The site is a desirable one for a stormwater BMP in that the amount of earthwork will be minimal.
