June 9, 2015

Subject: Physical Assessment, Former Chapel Hill Town Hall, 100 West Rosemary Street

RE: CHAPEL HILL OLD TOWN HALL - STRUCTURAL ASSESSMENT

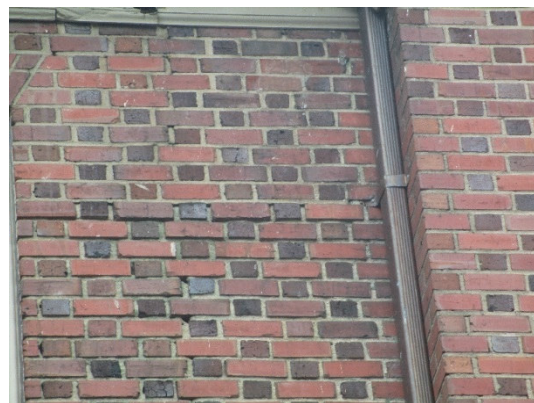
At some locations the mortar has deteriorated due to exposure to moisture. See photos below.

Deteriorated mortar below area in left photo.

We recommend that deteriorated mortar joints be repointed by an experience mason. The cause of the water leaking must be identified and corrected to prevent further damage. Other locations may also require repointing, such as at a steel lintel where the mortar had become loose due to minor rusting of the steel. At that location, the lintel should be cleaned and protected before repointing.

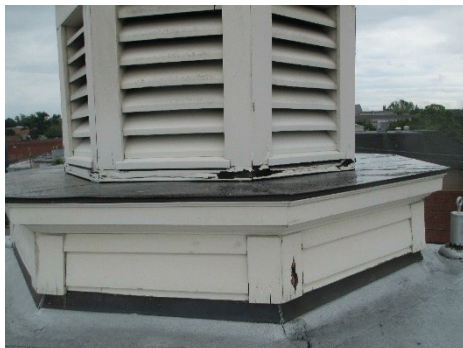
Currently, sections of the base flashing are sloped so that the rain water is trapped next to the cupola instead of flushing the water away. Serious deterioration of the wood fascia and moisture damage was noted. Our review would indicate that this should be repaired in the near future.

We also observed damage to the trim of the cupola caused by exposure to water. From within the cupola, the wood framing shows evidence of exposure to moisture, but we observed no significant structural damage. Once the moisture problems have been corrected, the trim can be replaced.

Water damage to trim of cupola.

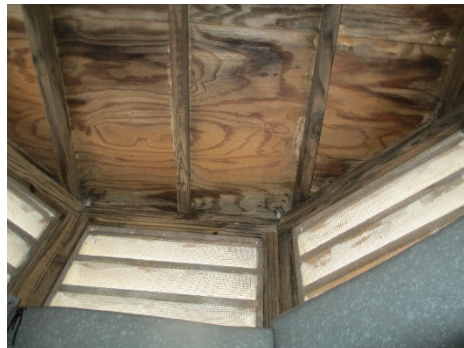
Evidence of moisture at interior of cupola.
Structural damage not yet significant.

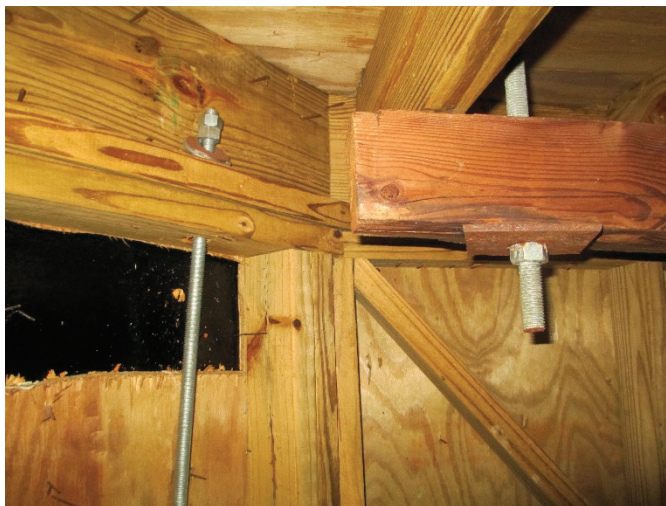
Below the lower portion of the cupola, some of the anchoring threaded rods were visibly loose. We recommend that these be tightened:

View of loose threaded rod inside the cupola.

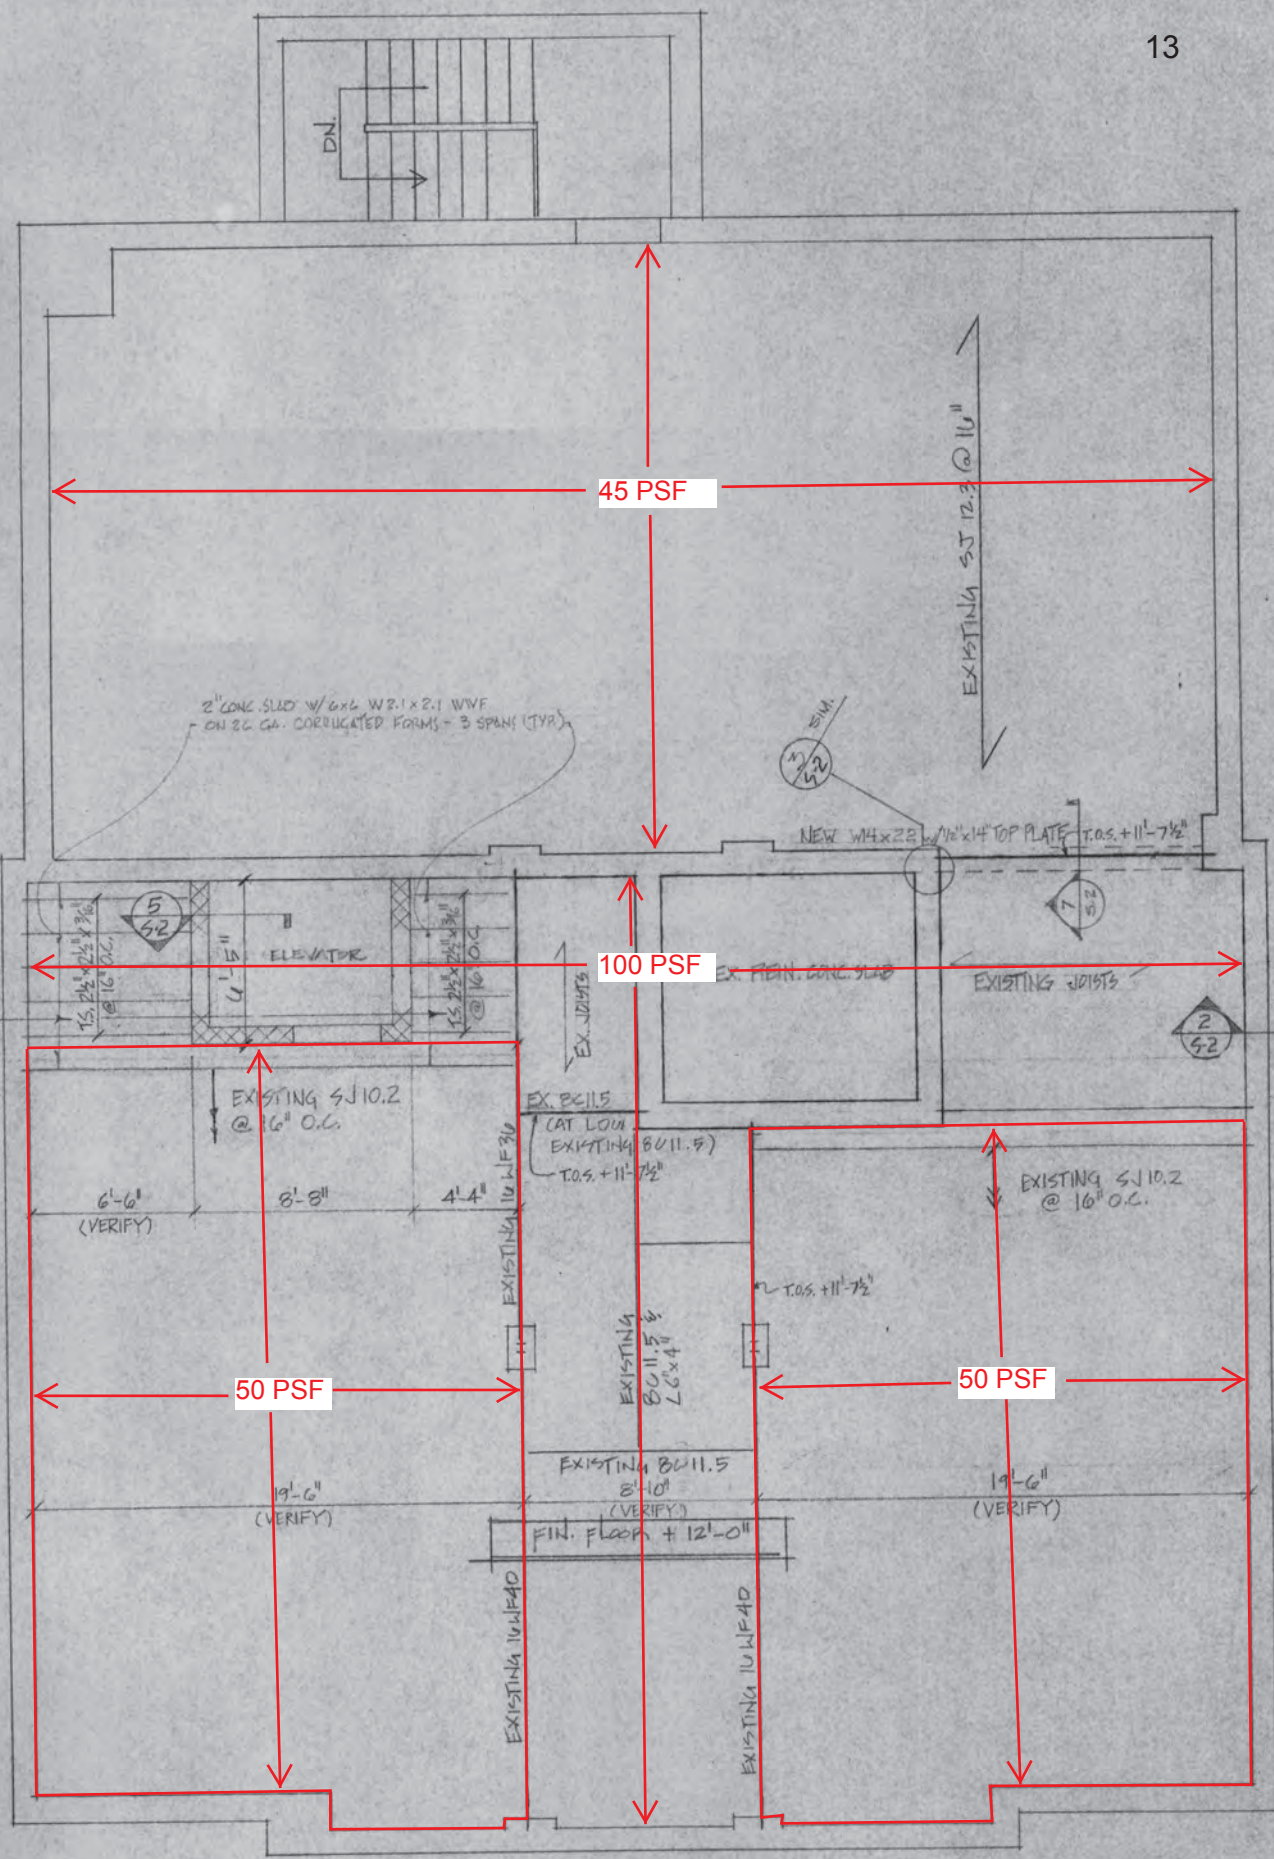
FIGURE 2

1. The rear and the southeast portions of the first floor that were built as part of the 1989 renovations can safely support 100 PSF live load. This confirms the design live load indicated on sheet S-2 of the 1989 structural drawings. The original framing in the southwest portion of the first floor can safely support a live load of 50 PSF.
2. The second floor framing, which consists of original framing except for the area adjacent to the elevator that was added in 1989, can safely support a live load of 45 PSF at the area to the rear of the building and a live load of 50 PSF at the southwest and southeast areas.

CURRENT LIVE LOAD CAPACITY
