# **MEMORANDUM**

From: Emma Radford, ISA Certified Arborist (SO-10804A)

Subject: South Creek Project - Summary of Findings Relating to Arborist Services

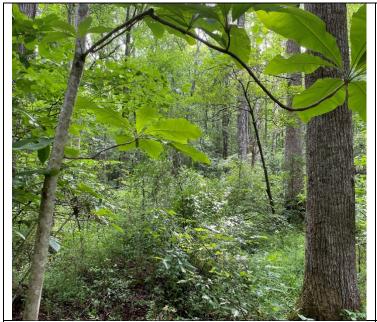
Photo 1 – Typical view of Area 1 located along the floodplain of Obey Creek within the northern portion of the Site. Understory species such as umbrella magnolia (*Magnolia tripetala*) were observed in Area 1.

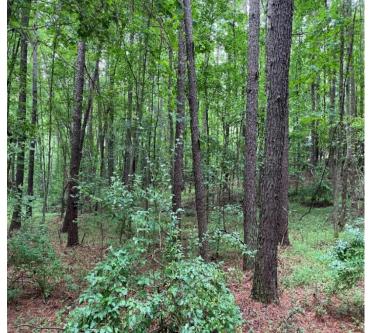
Photo 8 – Evidence of invasive growth throughout (*Eleagnus umbellata* and *Ligustrum sinense*) was observed within Area 2.

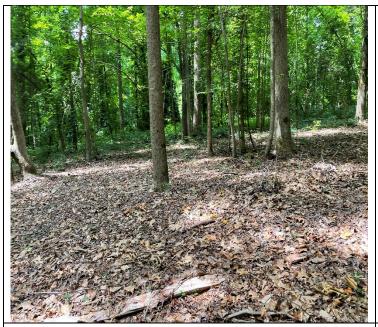
Photo 13 – Typical view of forest floor within Area 4. No herbaceous vegetation was observed in this area.

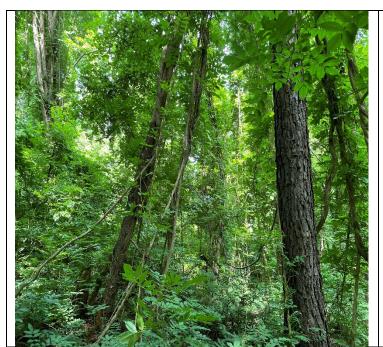
Two areas of concern located in the central portion of the Site were found to primarily consist of wisteria (*Wisteria floribunda*) and bamboo (*Phyllostachys aurea*). These are considered non-native, invasive species dominating portions of the landscape. The majority of native vegetation in these areas has been outcompeted to the point of severe stress or canopy death. Refer to EXHIBIT B for examples of these unhealthy areas.

Photo 33 – Typical view of overgrowth of Japanese wisteria (*Wisteria floribunda*), an invasive species, within the Site.

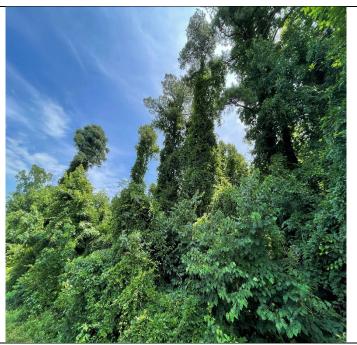
Photo 34 – Typical view of overgrowth of Japanese wisteria (Wisteria floribunda), an invasive species, facing east into the Site along US Highway 15-501 S.
