**BIOLOGICAL MONITORING OF  
CHAPEL HILL STREAMS, NORTH CAROLINA**

**April 2011**

**LENAT CONSULTING SERVICES  
3607 CORBIN STREET  
RALEIGH, NC 27612  
919-787-80897  
LENATBKS@MINDSPRING.COM**

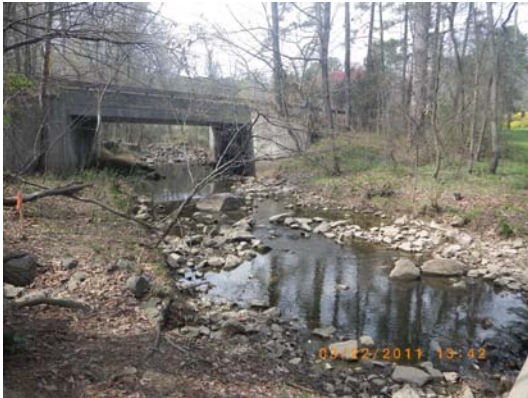
Bolin Creek Site 4 (Village Dr), March 2011.

Bolin Creek 4 (Village Drive). This portion of Bolin Creek is in a largely residential area; the catchment also drains most of Carrboro. The substrate was largely boulder and rubble, but some sand was being deposited in pools.

There were abundant growths of filamentous algae at this site, which may have interfered with the growth of macroinvertebrates. This algae also tended to homogenize all microhabitats.

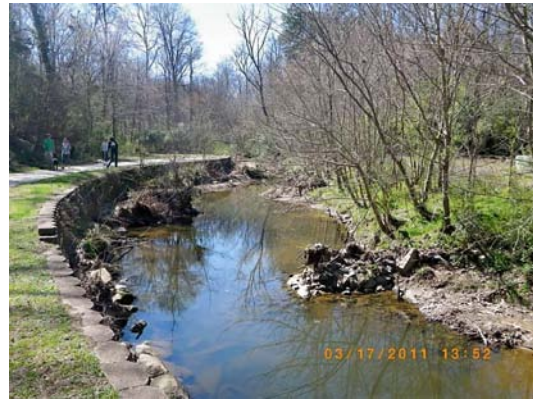
Bolin Creek Site 5 (Franklin) , March 2010.

Bolin Creek 5 (Franklin St). Bolin Creek has good rocky substrate near the bridge, but the stream bottom is mostly sand further upstream. A greenway path parallels Bolin Creek in this area.

This site drains a heavily developed catchment, including the downtown areas of both Carrboro and Chapel Hill.

Bolin Creek Site 5 (Franklin Street). This site received a Poor bioclassification in 2011, similar to DWQ collections in 1998 and 2008. This site is quite sandy upstream of the bridge area, but DWQ collections in 1986 demonstrate that habitat for this site is capable of supporting a Good or Good-Fair aquatic fauna. Urban runoff (toxics) is the most likely cause of problems in lower Bolin Creek. This is a common pattern for streams draining major cities throughout North Carolina. One intolerant species was abundant at this site (*Chimarra*), suggesting that some improvement is possible in years with a more normal flow regime.

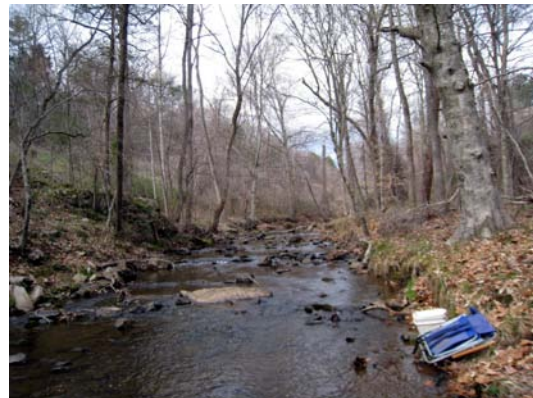
Morgan Cr Site 1 (NC 54), March 2011.

Morgan Creek 1 (NC 54). Morgan Creek has been used as a reference site for Carrboro surveys, although this stream is frequently affected by droughts. Prior surveys by the NC Division of Water Quality generally produced a Good or Excellent bioclassification for this site.

This catchment has a largely rural character, although the amount of residential land use has been increasing. Habitat quality, stream

Morgan Creek Site 1, NC 54. This site has been used as a reference site for studies in Carrboro, and there also have been many collections by the Division of Water Quality. These collections have shown the loss of many species due to problems caused by repeated summer droughts. However, the benthic macroinvertebrate fauna of upper Morgan Creek is dominated by intolerant species, and this site still maintains a Good rating.

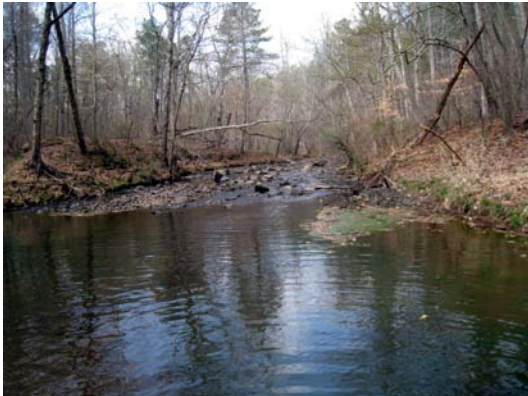
Morgan Creek Site 2 (Ashe), March 2011.

Morgan Creek 2 (Ashe St). This site is located near the Arboretum and it is downstream of University Lake. Although this part of Morgan Creek is located in a residential area, there is a forested buffer zone along most of the stream.

There was good rocky substrate in the riffles, but pools areas were being filled-in by sand deposition. There were very abundant growths of bright green filamentous algae at this site, often forming floating mats along the banks.

Morgan Creek at Ashe Place (near Botanical Garden). Prior DWQ sampling (1993, 1998) suggested this site should have a Good-Fair rating. Collections from March 2011 produced only a Fair bioclass, but the fauna had some common or abundant intolerant species, including *Isonychia*, *Chimarra*, and *Psephenus herricki*. Additionally, the mayflies *Maccaffertium modestum* and *Eurylophella verisimilis* were abundant in this portion of Morgan Creek. This pattern suggests that a Good-Fair rating is likely under more normal flow conditions.

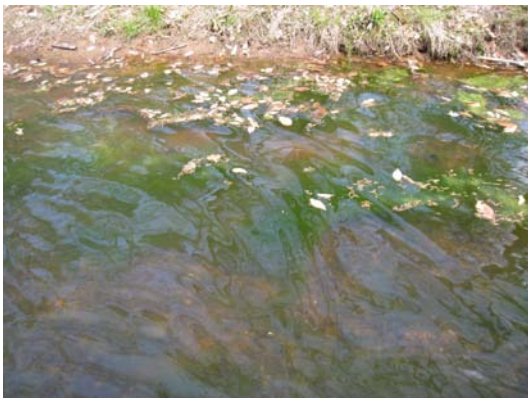
Algae at Morgan Creek Site 2 (Ashe), March 2011.

Morgan Creek was experiencing a bloom of bright green filamentous algae during the March 2011 collections. Floating mats of this algae were observed along most banks (especially in pool areas). Except in the areas of fastest current, the bottom was covered with heavy growths of this algae.

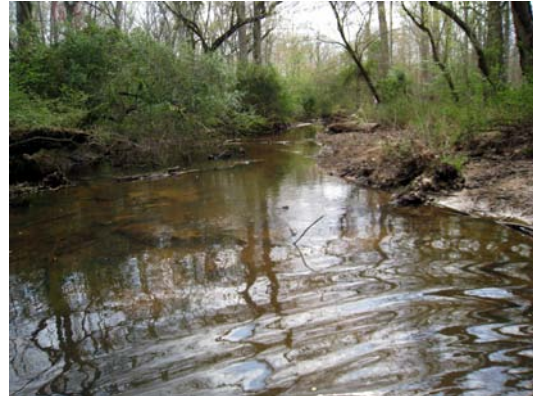
Little Creek, March 2011.

There were no rocky riffles, but snags and leaf-packs offered good habitat for macroinvertebrates.

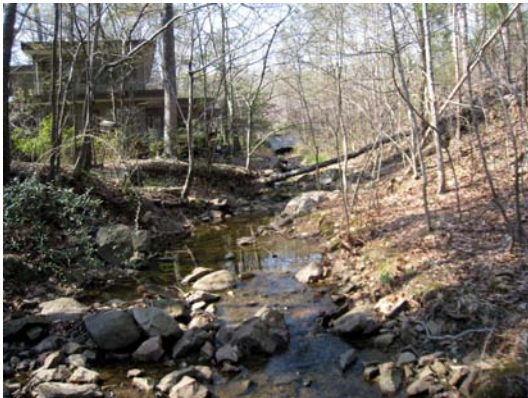
Cedar Fork, March 2011.

Cedar Fork. Cedar Fork is located in the northern section of Chapel Hill; it is one of the largest tributaries of Booker Creek (3 meters wide). The stream was sampled off Brookview Street, just above a small lake.

The surrounding land is an older residential area with large lots. Many of the houses, however, are placed very close to the stream. The substrate was rocky, but there were very abundant growths of filamentous algae in March.

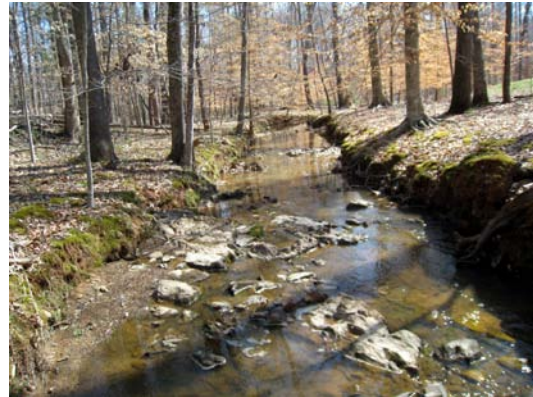
Old Field Creek, March 2011.

Old Field Creek. Old Field Creek was sampled north of town, near the Chapel Hill Operations Center. The surrounding area is largely forested, but there is some development (including a landfill) further upstream.

The stream is very rocky (often having extensive areas of bedrock), but there was a layer of silt and algae over most of the stream bottom. The composition of the fauna suggested that this stream is intermittent.

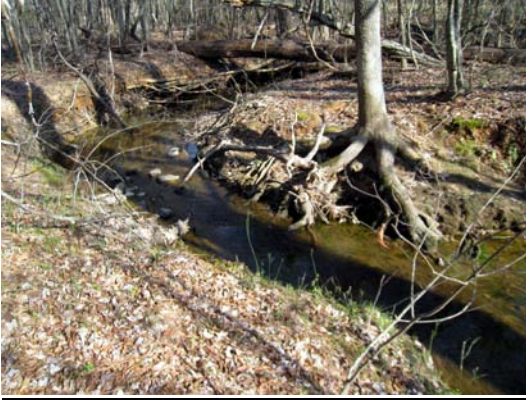
Booker Creek Site 1 (MLK) March 2011.

Booker Creek 1 (Above MLK Blvd). Booker Creek had a heavy layer of filamentous algae over all surfaces in March 2011. The surrounding area provided a forested buffer next to the stream, but it drains a largely residential area.

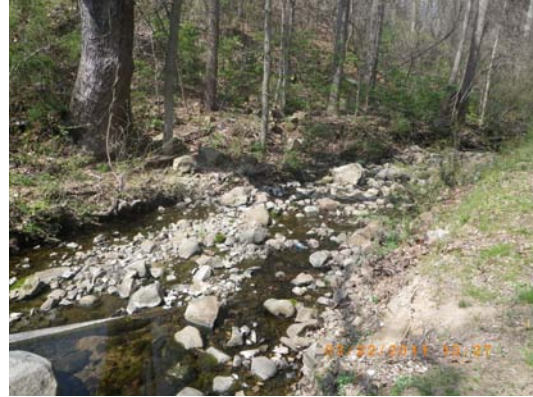
Tanyard Branch, March 2011

Tanyard Branch. Tanyard Branch is a small stream (2 meters wide) that was sampled near the end of Carver Street. There is a forested riparian zone, but the stream runs through a heavily developed residential area. The stream substrate was rocky, but 40-80% embedded with sand.

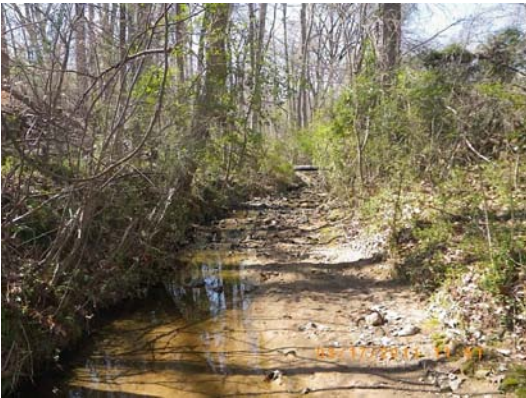
Mill Race Branch, March 2011.

Mill Race Branch. Mill Race Branch is located in a largely residential area; it was sampled off Bolinwood Drive just above its confluence with Bolin Creek. The substrate was largely gravel and sand, but with small rocky riffles areas.

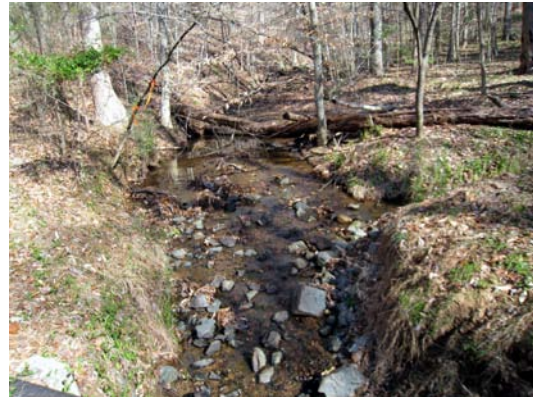
Cole Springs Branch, March 2011.

Cole Springs Branch. Cole Springs Branch was sampled near the end of Cedar Drive. This stream drains an older residential area with large lots; the area sampled was largely forest. This rocky stream had excellent habitat for aquatic fauna.

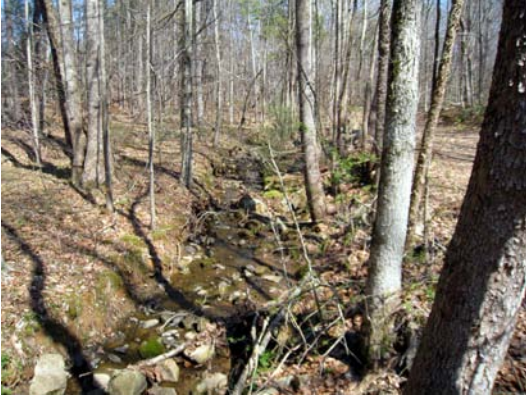
Jolly Branch, March 2011.

Jolly Branch near SR 1777 (just downstream of Bolin Creek 3). This site was accessed by walking about 100 meters downstream of SR 1777 (Homestead), crossing Bolin Creek, and going about 30 meters upstream on Jolly Branch. This small stream (1 meter wide) had good rocky habitat, but showed severe bank erosion in many places.

The surrounding area was largely forested, although there are residential areas further upstream. The aquatic life at Jolly Branch indicates that it may stop flowing (or go dry) during drought periods.

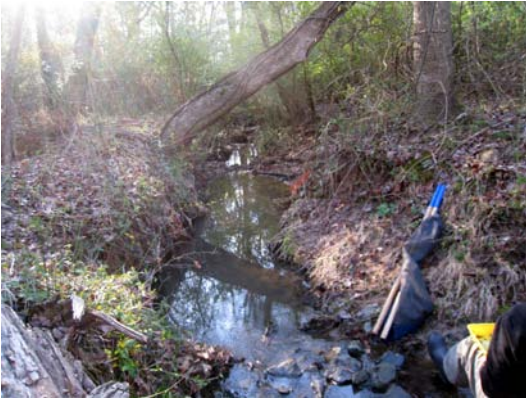
Library Branch, March 2011.

Library Branch. Library Branch was sampled downstream of Library Road. This very small stream (1 meter wide) had poor habitat due to the largely sand substrate. The abundance of the snail (*Elimia*), however, suggests that this stream does not dry up during drought periods.

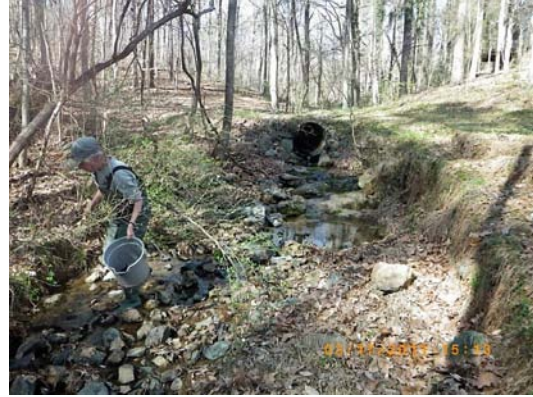
UT Bolin Creek, March 2011.

UT Bolin Creek. This very small stream (<1 meter wide) was sampled at the end of Severin Street. It is located in an older residential area with a forested buffer zone adjacent to the stream. The substrate was primarily boulder/rubble, with barely perceptible flow that may be largely subsurface. The fauna was very sparse, but dominated by intolerant species.

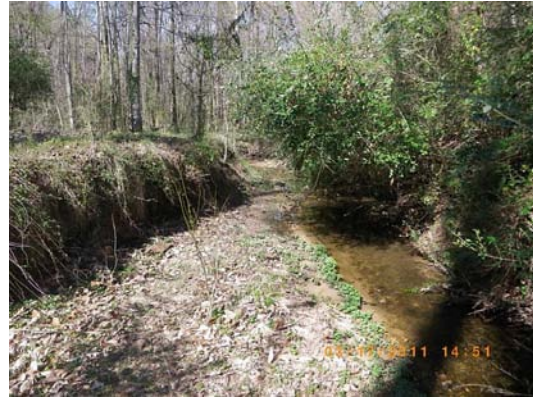
Battle Branch, March 2011.

Battle Branch. Battle Branch was sampled near Glendale Road. This stream is located in an older residential area, with forest and hiking paths next to the stream. The substrate is largely sand and gravel, with occasional rubble riffles. Battle Branch was entrenched with severely eroding banks.

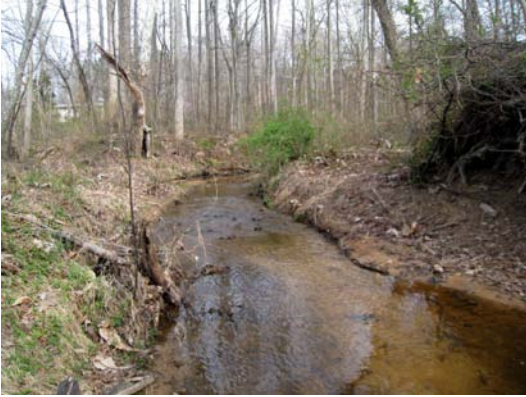
Wilson Creek, March 2011.

Wilson Creek. Wilson Creek was sampled at Arlen Park Drive, in a new residential area. The upstream area, however, is an older residential area (mostly forest) with large lot sizes.

Although this small stream was very sandy (95 % gravel, sand and silt), it supported a surprisingly diverse invertebrate community. Filamentous algae were very abundant at Wilson Creek.

-Wilson Creek and Fan Branch. These two streams appear to be affected by sedimentation, but the sand/gravel substrate may actually reflect local geology. Similar streams have been observed a little further south in the headwaters of Pokeberry Creek in Chatham County (Lenat, unpublished). Both sites were located in a high-density residential area, but most of the catchment is comprised of heavily forested older residential areas with large lot sizes. There is more bank erosion in the Fan Branch catchment. Wilson Creek and Fan Branch had the most diverse fauna in our survey on small Chapel Hill streams. Using small-stream criteria, a Good rating was given to Fan Branch and a Good-Fair rating to Wilson Creek.

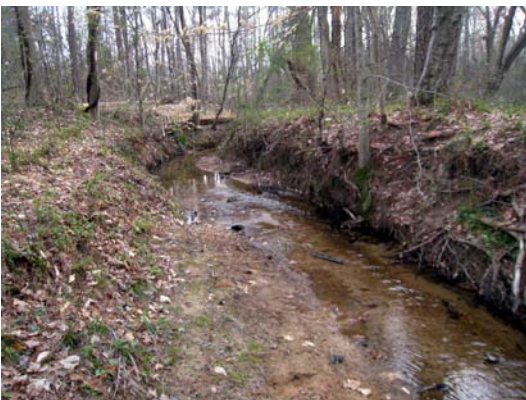
Fan Branch, March 2011.

Fan Branch. Fan Branch also was sampled in newer high-density residential development (at Parkview Crescent), but the upstream area is comprised of an older residential development with large lot sizes.

Like Wilson Creek, this is a very sandy stream (100% sand and gravel), but supports a surprisingly diverse invertebrate community. Both Wilson Creek and Fan Branch appears to be perennial streams based on the abundance of the snail *Elimia* and the presence of filter-feeding caddisflies.

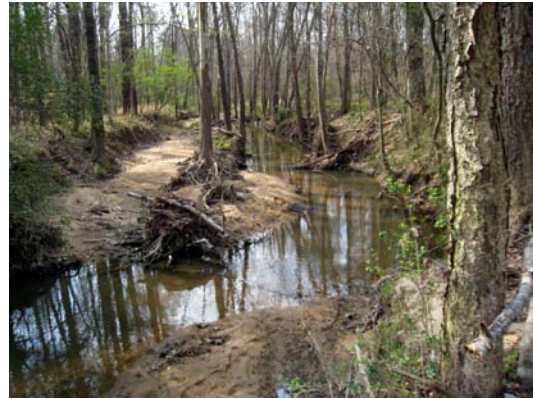
Booker Creek 2, March 2011.

Booker Creek 2 (Willow Drive). This segment of Willow drains a largely residential catchment. The stream appears

to have been channelized at some time, with a very entrenched channel. The substrate is entirely sand and clay, but was mostly covered by a layer of filamentous algae.

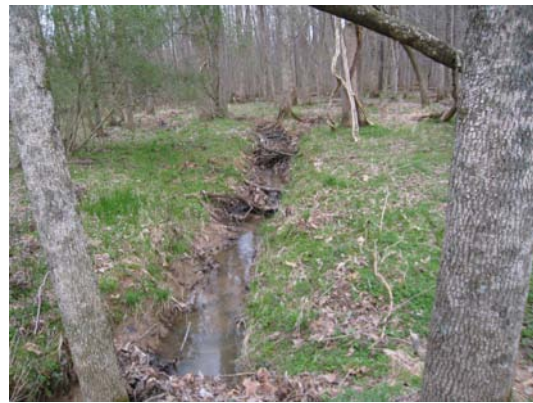
Dry Creek, March 2011.

Dry Creek. This very small stream (1 meter wide) was sampled upstream of Erwin Road. The substrate was mostly clay/silt, likely due to the Triassic Basin geology. Roots and logs were the most important habitat for the aquatic fauna.

The stream was entrenched near the road, but was more swamp-like further upstream. The riparian zone had many small seeps.
