**BOLIN CREEK WATERSHED RESTORATION
INITIATIVE
FINAL REPORT**

***Fiscal Year 2008 Section 319 Nonpoint Source Water Quality Improvement Grant
of \$369,792 in Federal Funding***

NC-DENR Project Contract # 1666

Town of Chapel Hill, NC, Sponsor

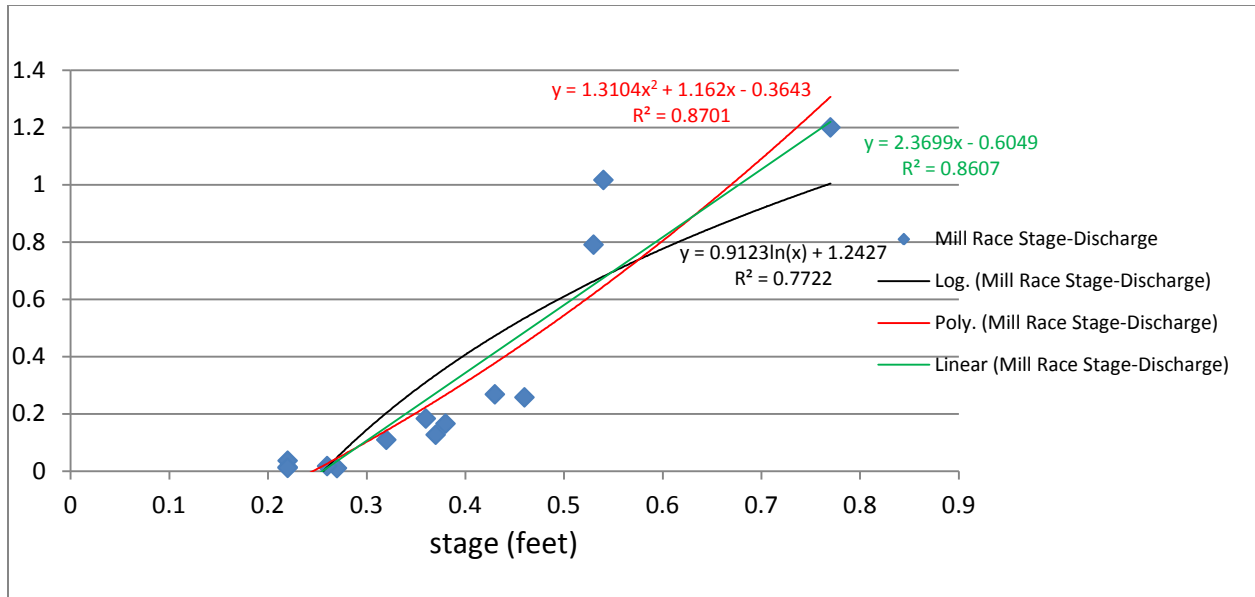
Figure 5: Mill Race Tributary Stage-Discharge

As noted in the Methods and Execution Chapter, we had difficulty setting up rating curves for both sites. In particular, when regression equations were applied, the lower ends resulted in negative discharges, which is not what we observed. We believe these were the result of calibration problems. Figures 5 and 6 show the stage-discharge rating curves for the two sites, with 3 different regression equations shown. Each equation had similar problems with generating negative discharges at low flows. We will be consulting with NCSU more extensively to try to diagnose what went wrong with our data collection.

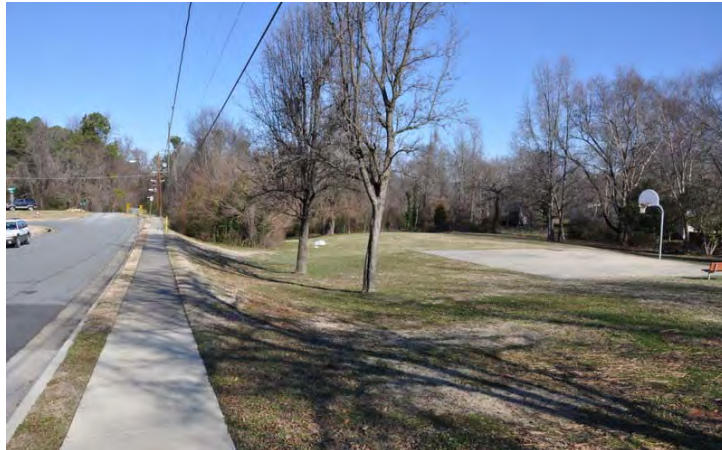
Proposed Bioretention Site

The proposed bioretention area is located in the grassy area between the basketball court and the sidewalk along Broad Street. See photograph below.

The two trees in the above photograph will have to be removed. Stormwater will be intercepted from the existing 15-inch storm sewer along Broad Street. The approximate drainage area to the storm sewer at this location is 1.2-acres (80% impervious, 20% open grassed area). There is not sufficient space in the proposed bioretention area to treat the entire first flush volume from the drainage area due to existing constraints (e.g., basketball pad and sidewalk). Therefore, an adjustable weir shall be installed in the diversion structure such that the initial portion of runoff (typically the dirtiest portion) will be diverted to the bioretention area and excess runoff can pass over the weir and remain in the existing storm sewer that discharges to the creek.

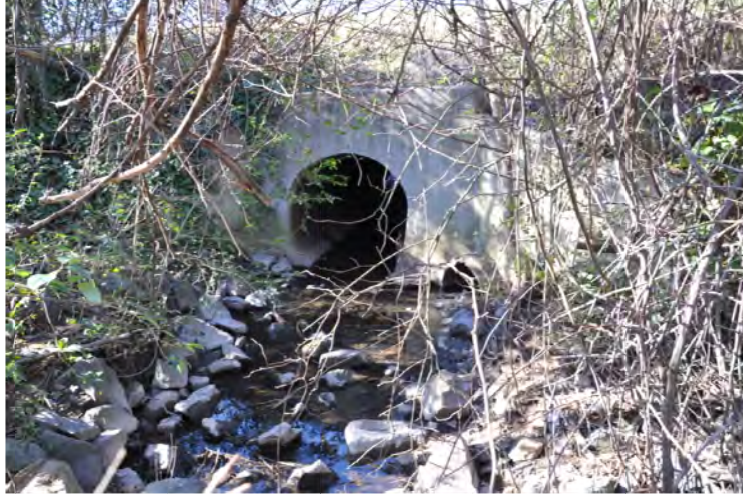
Storm Sewer Outfall

- Boulder plunge pool at storm sewer outfall to dissipate energy and reduce erosion downstream
- Invasive plant removal
- Native riparian planting
- Create boulder step pools to improve pool habitat
- Create a bankfull bench and reduce bank slope to stabilize the streambanks

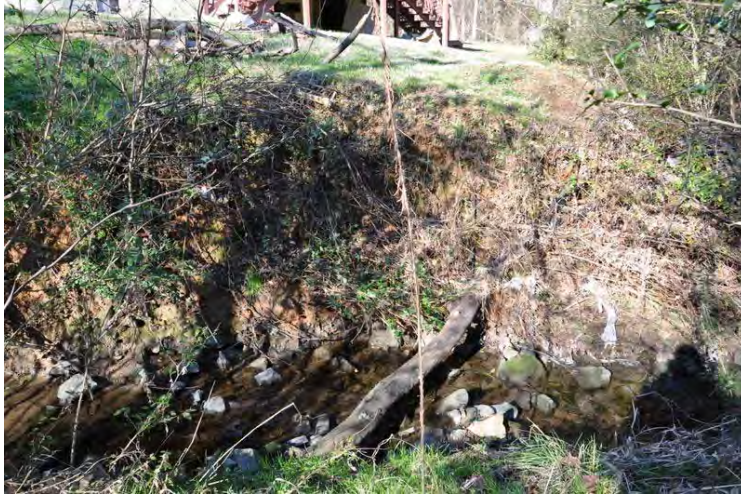
Area 3 Eroding Streambank

Option 2: Relocate the stream away from the eroding bank. Create a new and stable bankfull channel in the floodplain adjacent to the existing channel. Stabilize the area with coir matting and native riparian vegetation. Fill the abandoned channel with material generated onsite. See attached Figure 4.

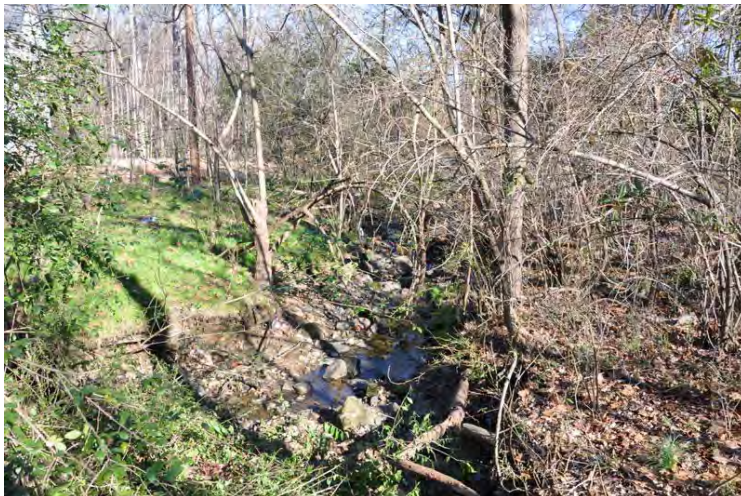
Area 4 View Facing Downstream

Area 4 is located on the property owned by the Safavis (PIN 9778987139) and extends to the confluence with the unnamed tributary. The stream is fairly stable in this area. Only invasive vegetation management and native riparian planting are proposed for this area. See attached Figure 4.

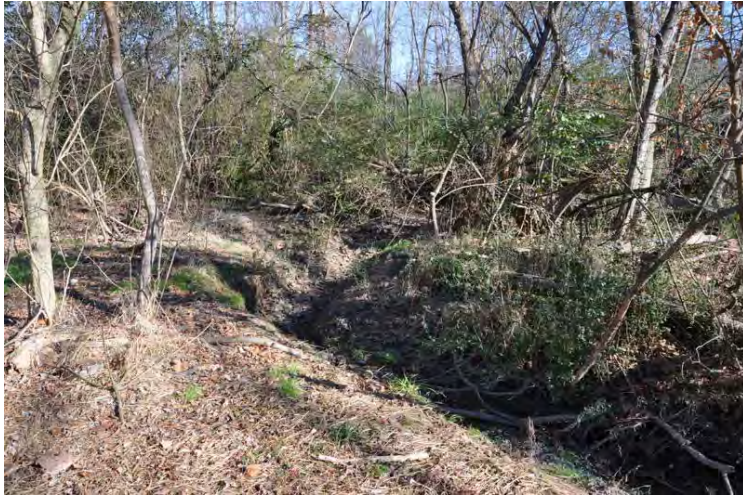
Area 5 View Facing Downstream

Nothing is proposed for the existing rip rap sewer crossing as OWASA requires this area to remain open and passable for their service vehicles.

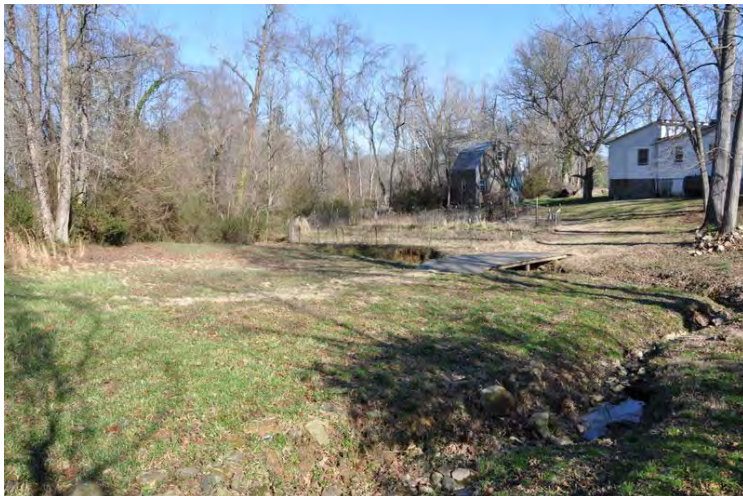
Area 6 View Facing Downstream

Option 1: Leave the stream where it is, reduce the bank slope, and stabilize the area with coir matting and native riparian vegetation. The property owner will lose a portion of their garden to reduce the bank slope and for riparian plants.

Option 2: Relocate the stream away from the eroding bank. Create a new and stable bankfull channel in the floodplain adjacent to the existing channel. Stabilize the area with coir matting and native riparian vegetation. Fill the abandoned channel with material generated onsite. This option will require relocating the existing footbridge. See attached Figure 6.

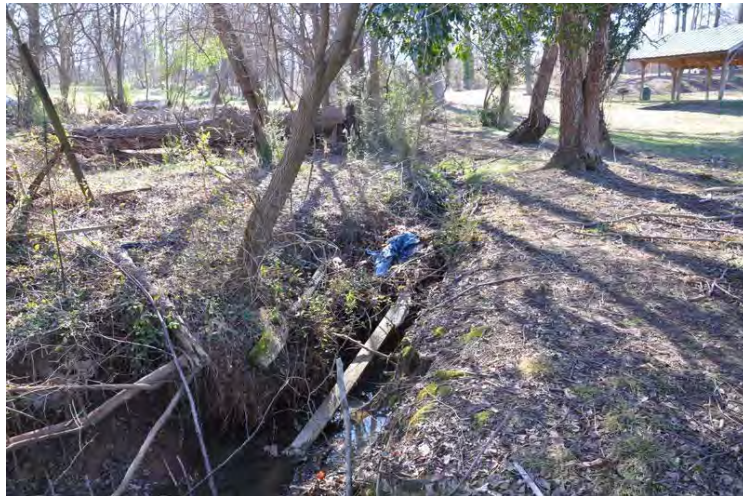
Area 7 View of Head Cut Facing Upstream

- Add some fill below the head cut to bring up the downstream portion of the channel and create a stable slope. Create boulder step pool system to stabilize the channel in the head cut area.
- Create a bankful bench where the channel is incised
- Invasive plant removal
- Native riparian planting

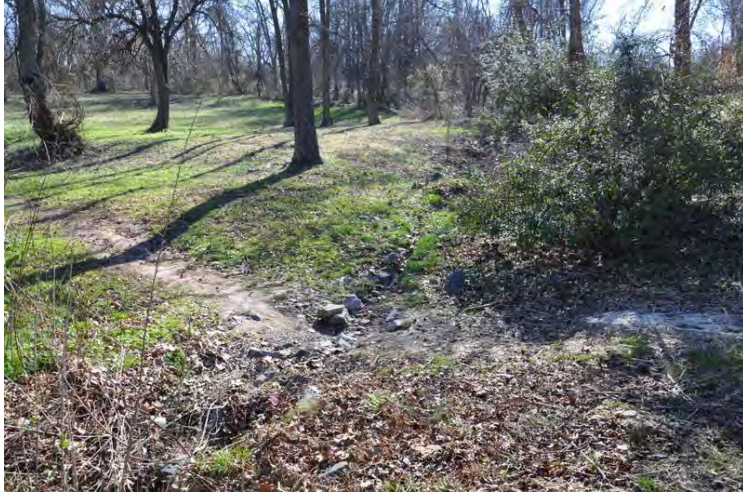
Area 7 Trail Crossing

Additionally, a footpath leading to the stream in this area will be hardened with a combination of gravel and filter fabric to reduce trail erosion and sedimentation downstream. A small footbridge is proposed where the path crosses the stream.

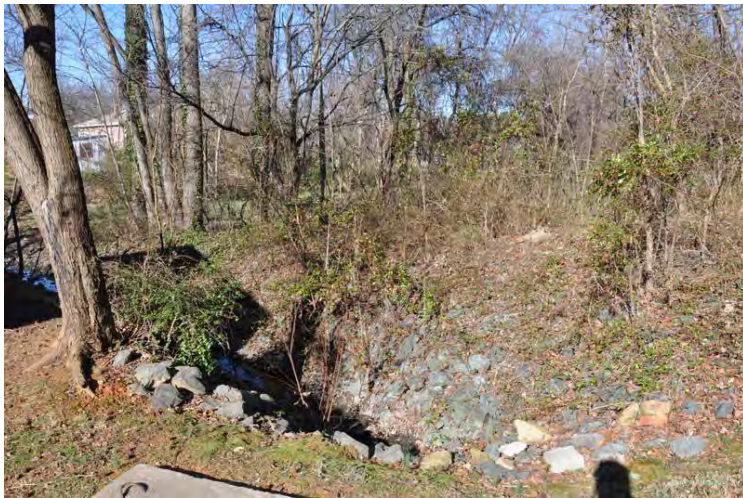
Area 8 View from 30-inch Culvert Outfall

The proposed enhancement for this area is to relocate the existing stream to a rock lined energy dissipation basin. The basin would be planted with a native juncus for stabilization and stormwater treatment. The purpose of the basin is to slow down stormwater flow, dissipate energy, and remove sediment to prevent degradation of the downstream restored sections. The new alignment would also avoid the two sewer crossings. Additionally, a swale will be designed to transport runoff to the basin from an existing 15-inch stormwater pipe outfall at the turn on Starlite Drive. See attached Figure 8.

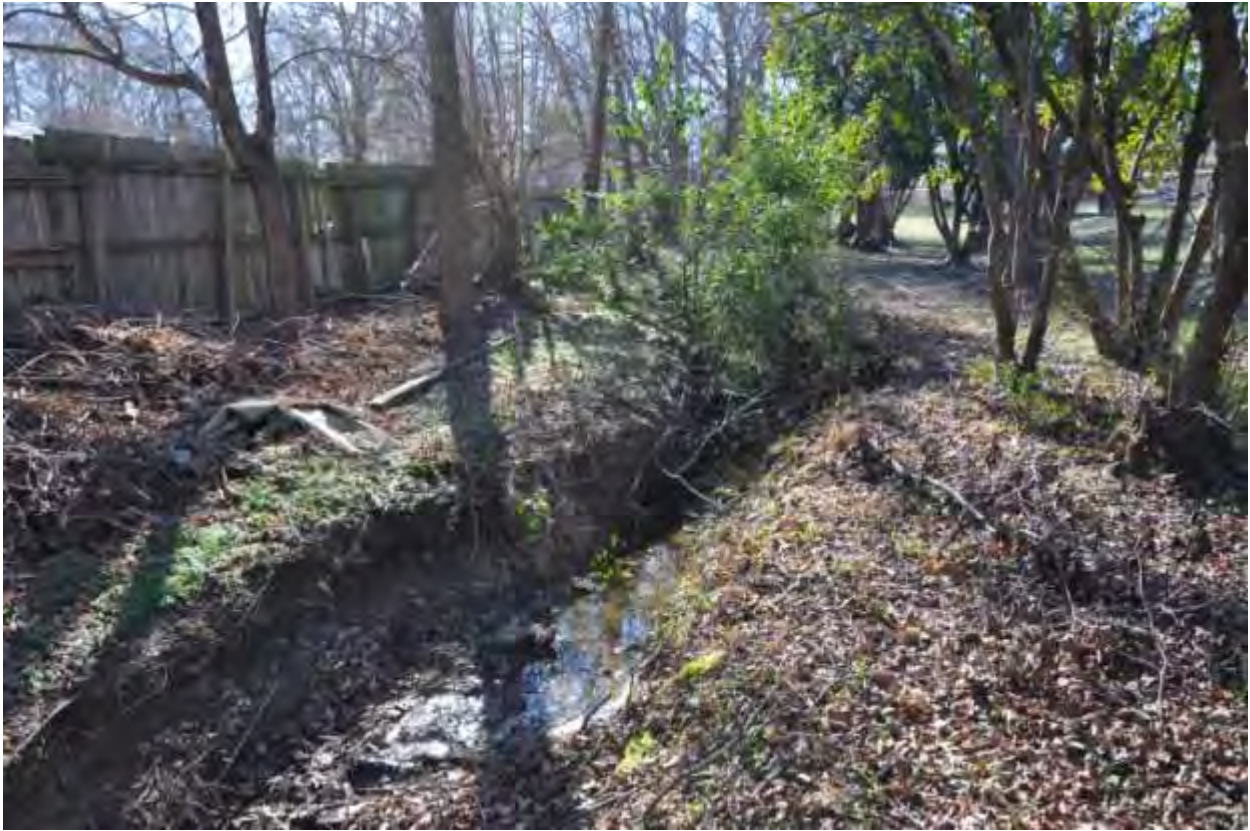
Erosion on the east side of the park, before construction

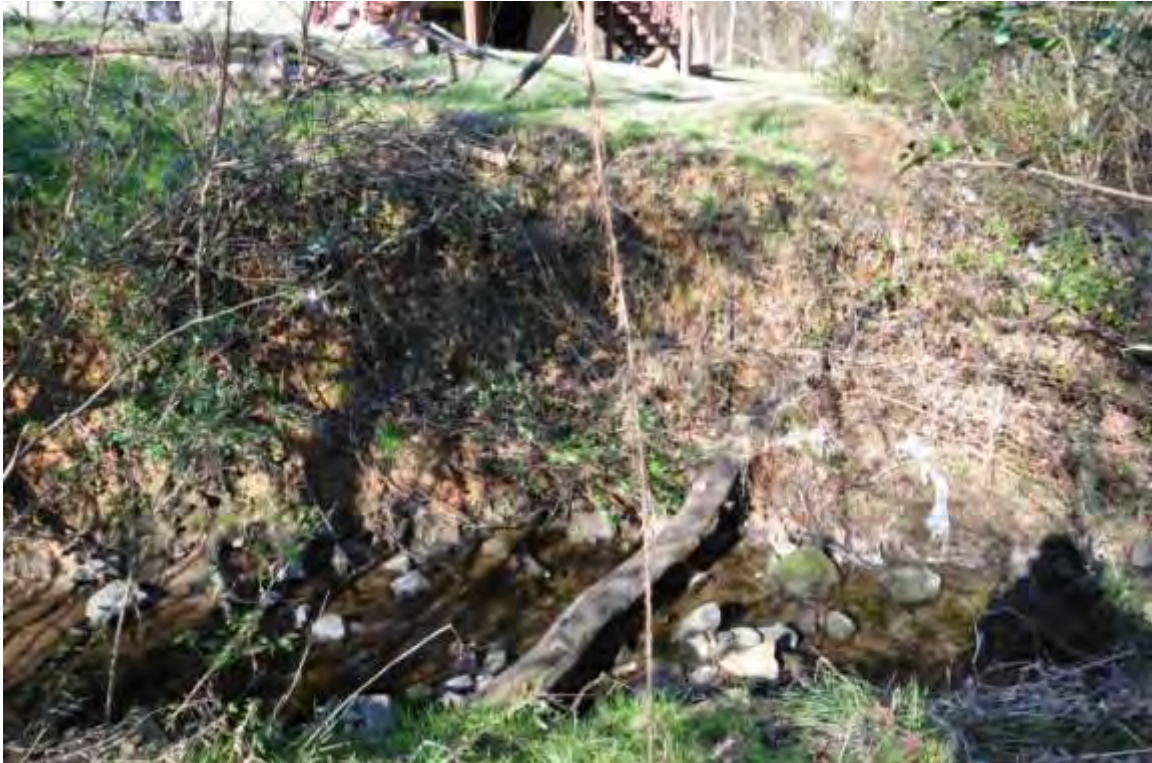
Erosion on private property to the north – pre-construction

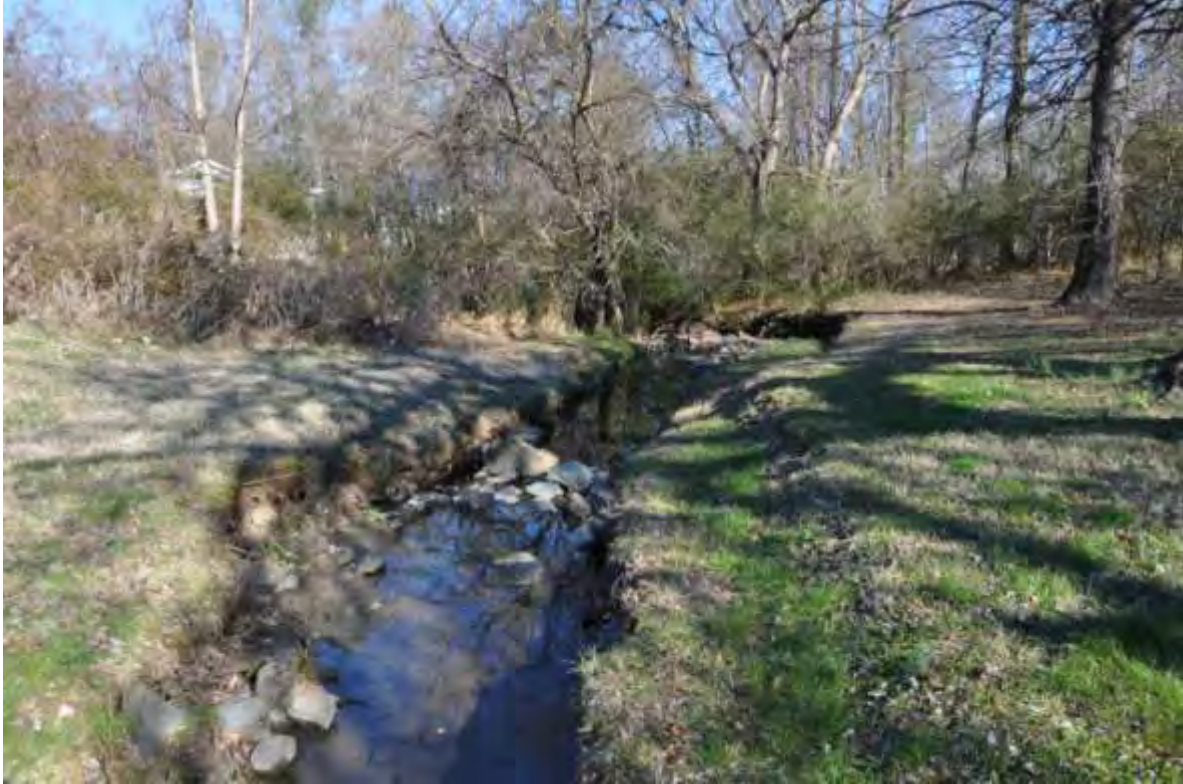
Erosion on the west channel in Baldwin Park – pre-construction

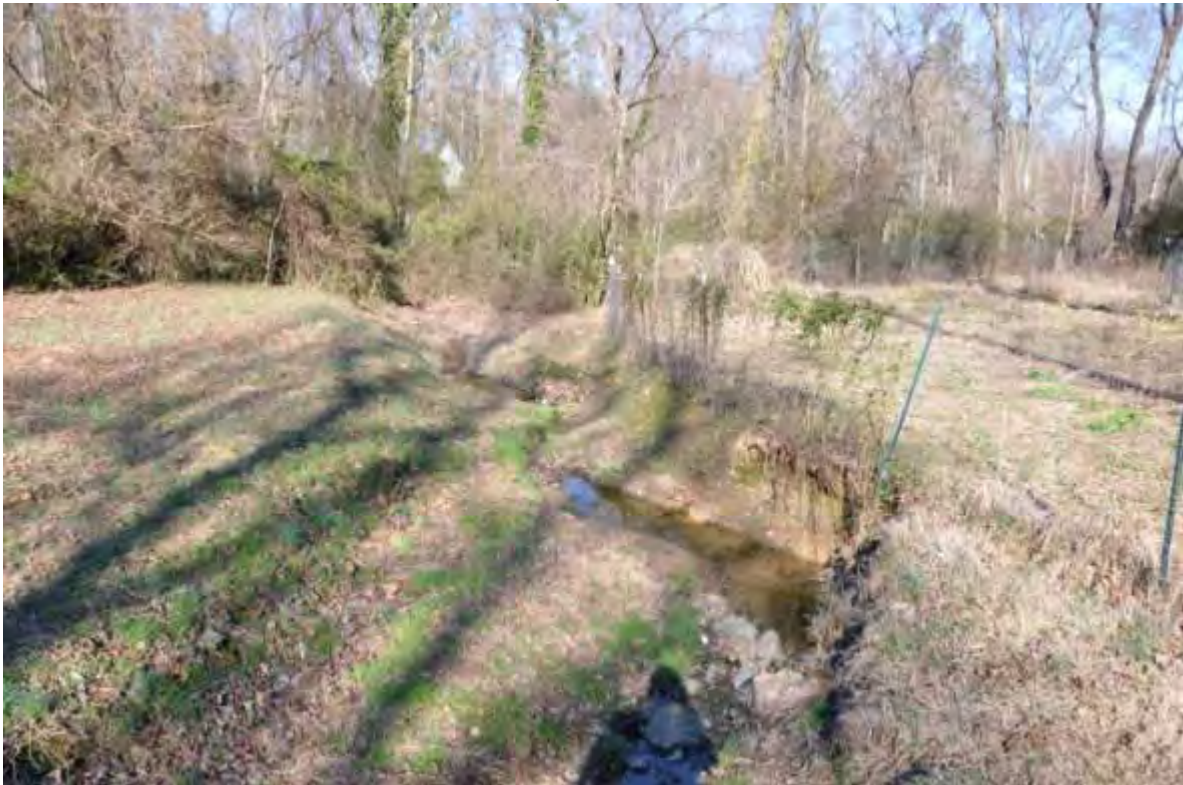
Erosion on the east channel – pre-construction

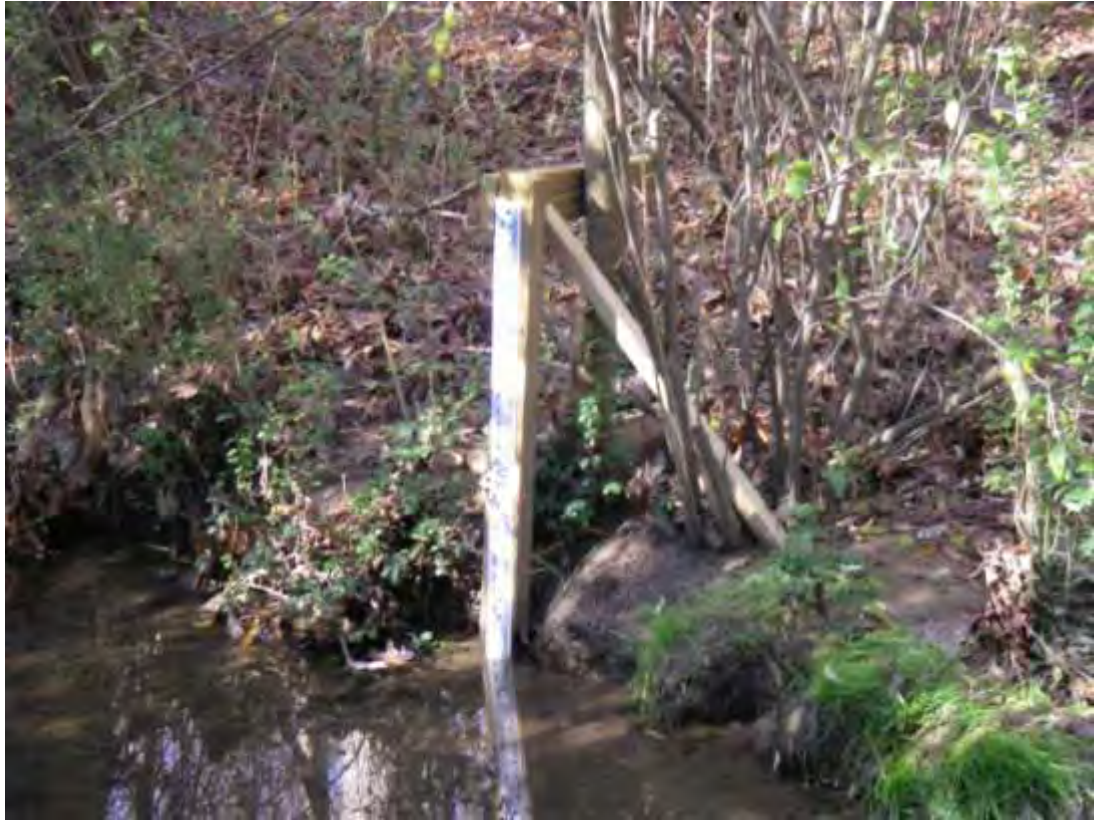
The stream gage below the project area

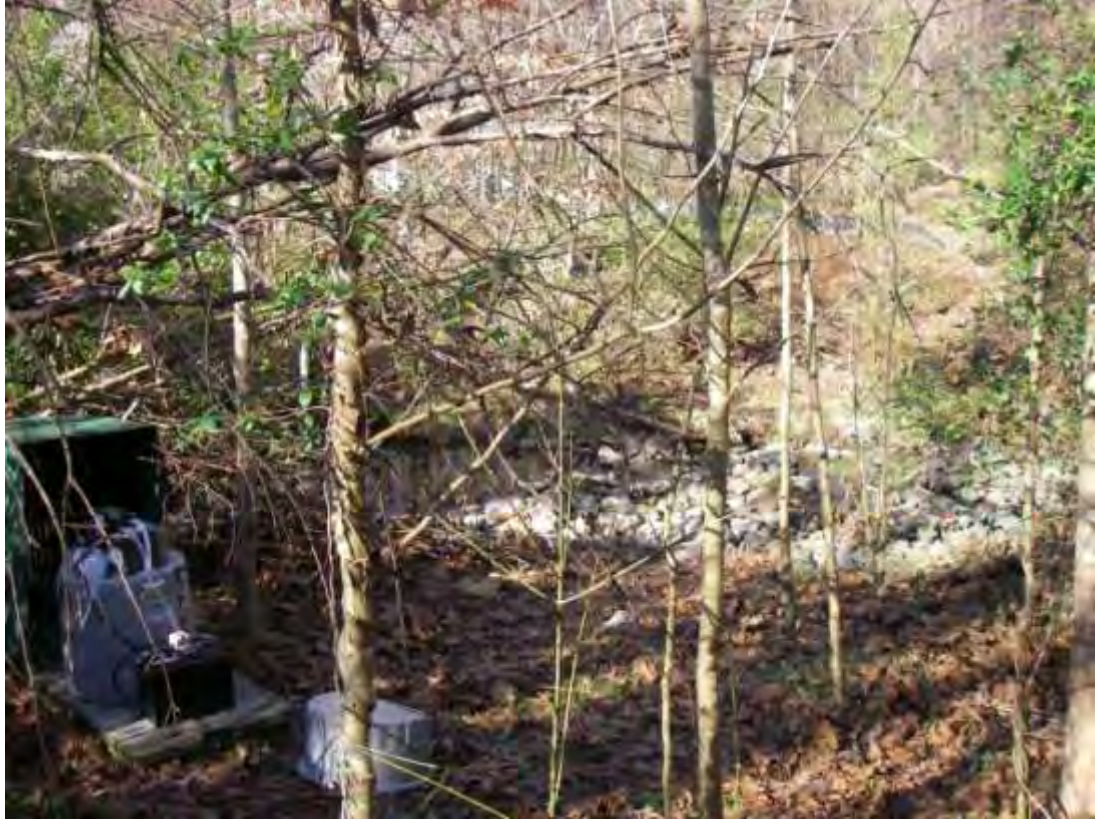
The autosampler below the project area

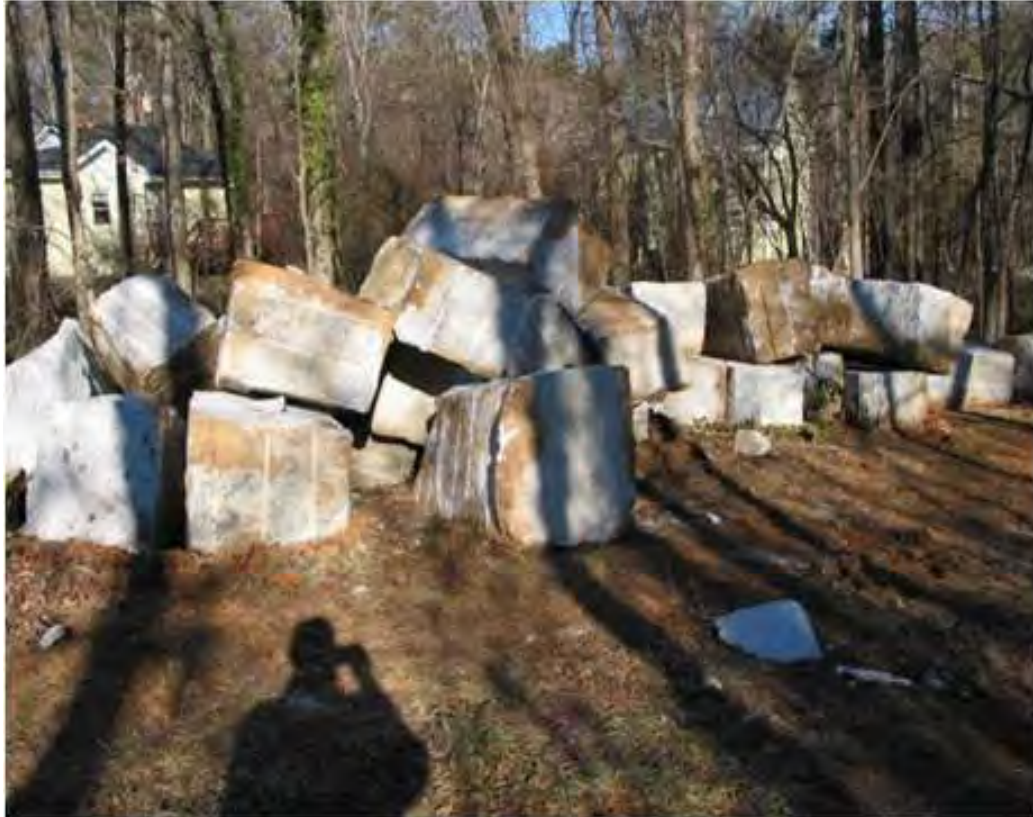
The giant(8'x4'x4') rocks used to create the step-pools

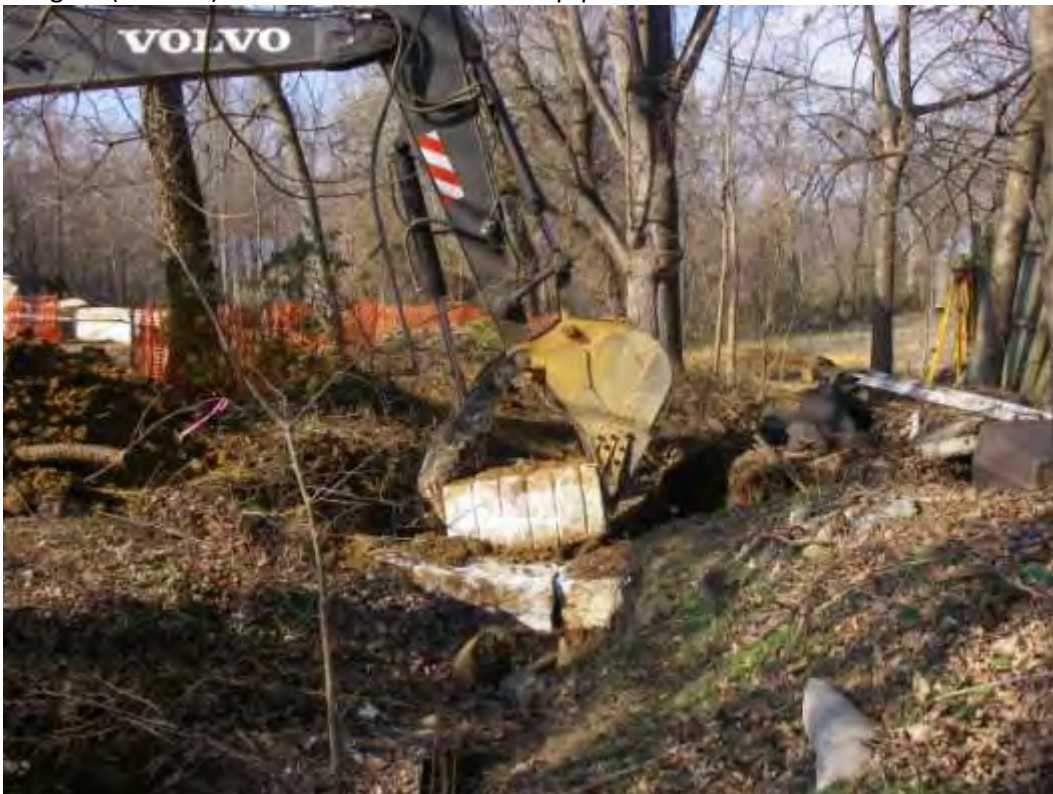
Placement of the giant rocks perpendicular to the channel to create the step-pools

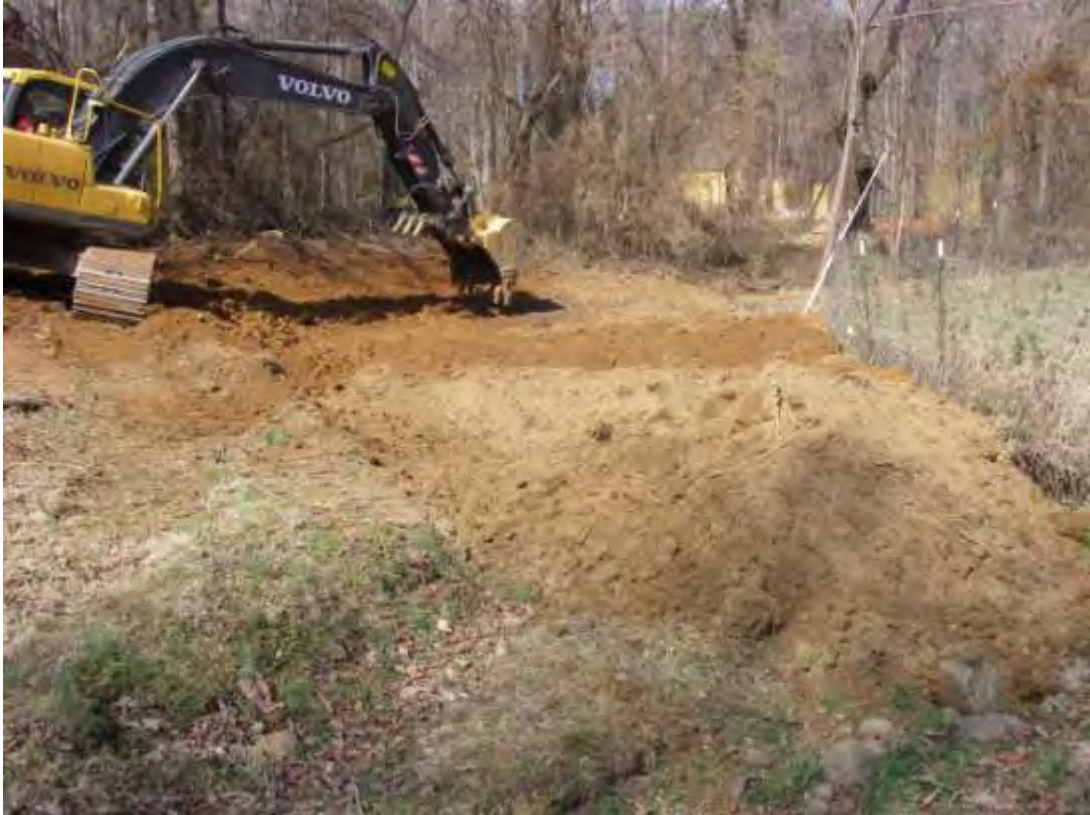
Creating the new channel on the east side

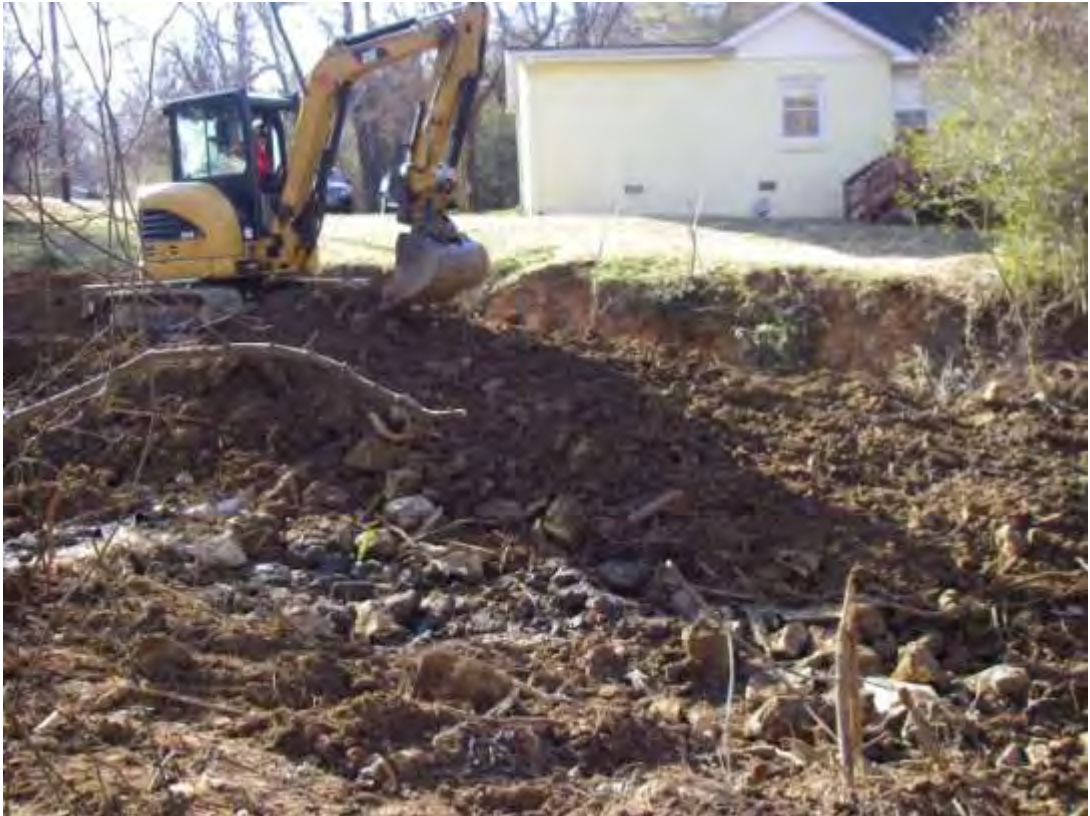
Creating the new channel on the west side

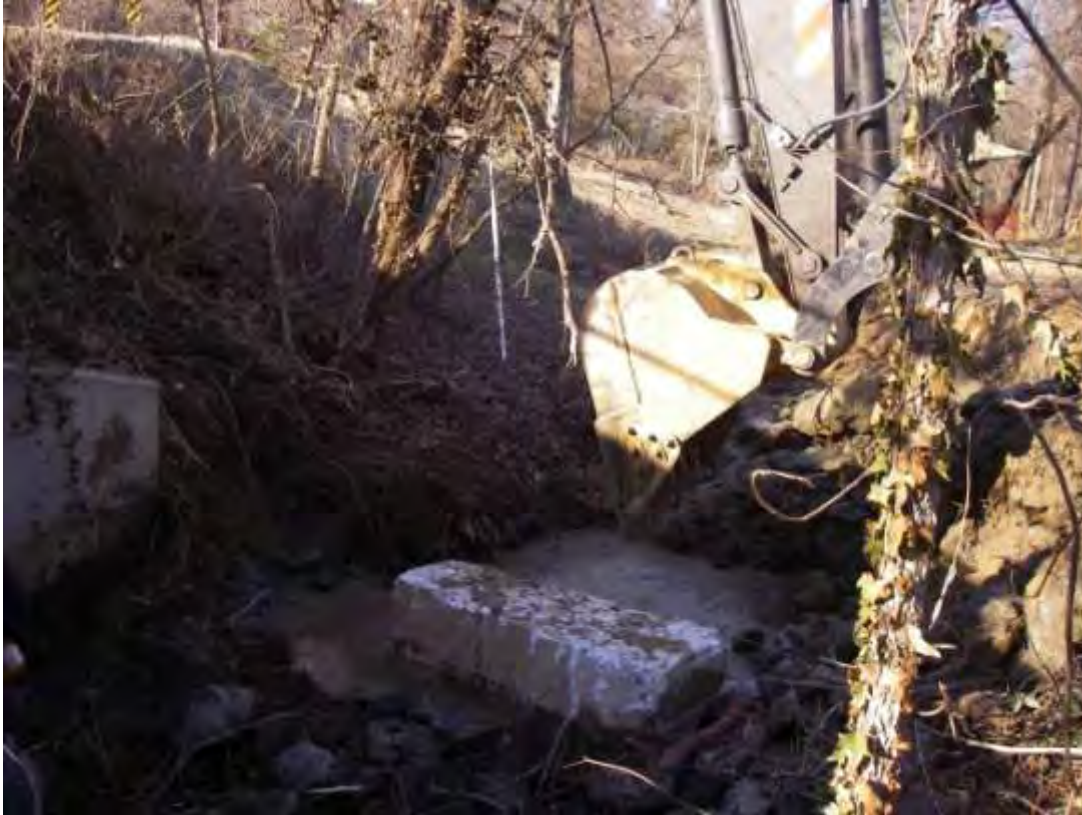
Installing more giant rocks to create step-pools

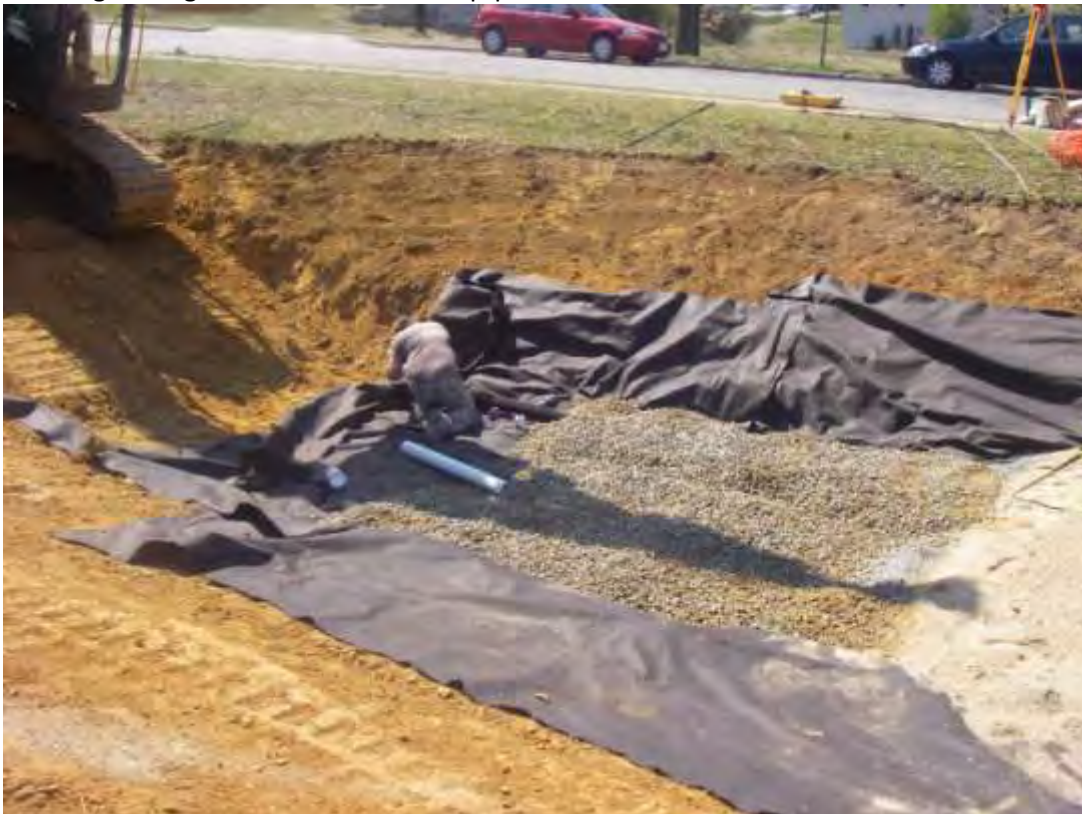
Laying the filter fabric and hooking up the pipes in the bioretention

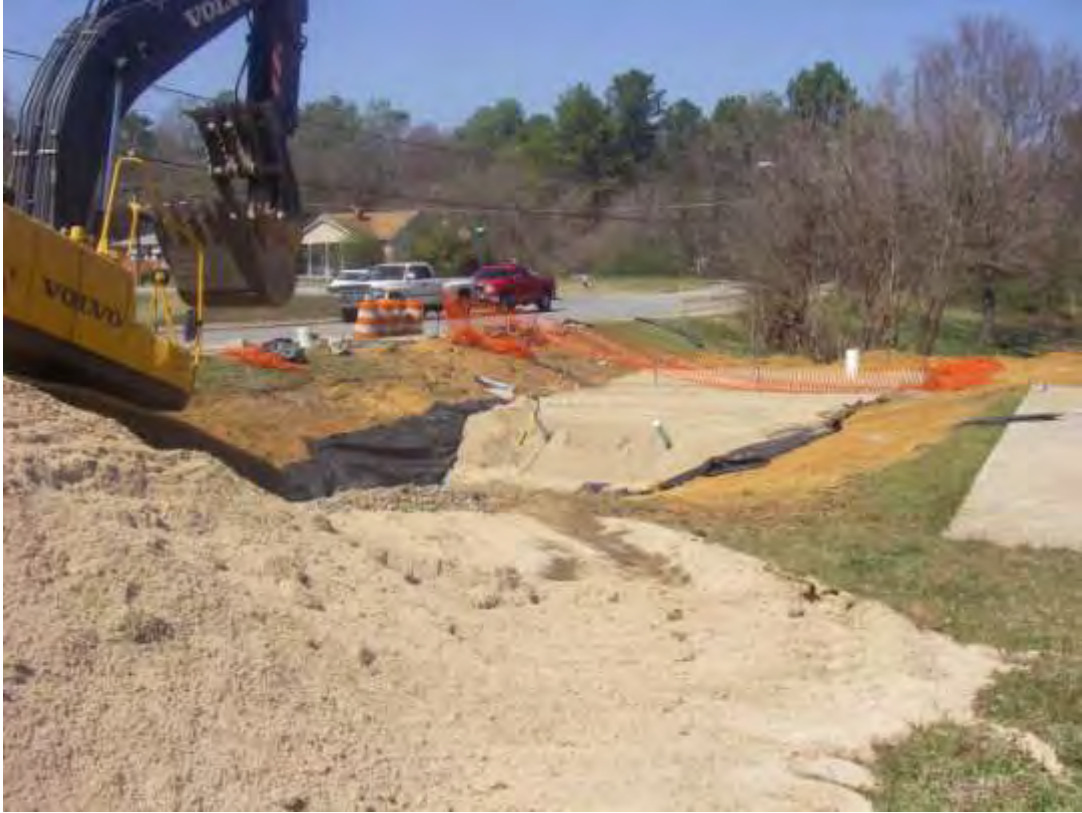
Installing the bioretention basin

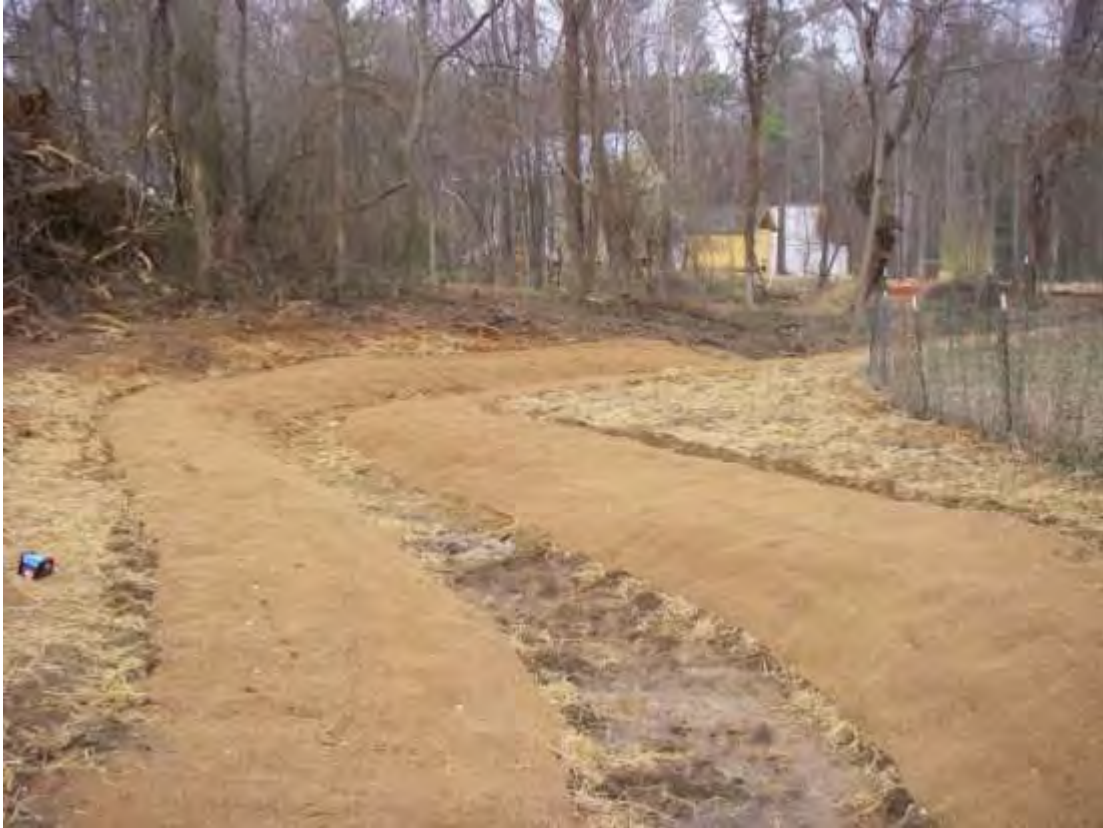
Construction of the eastern channel is complete

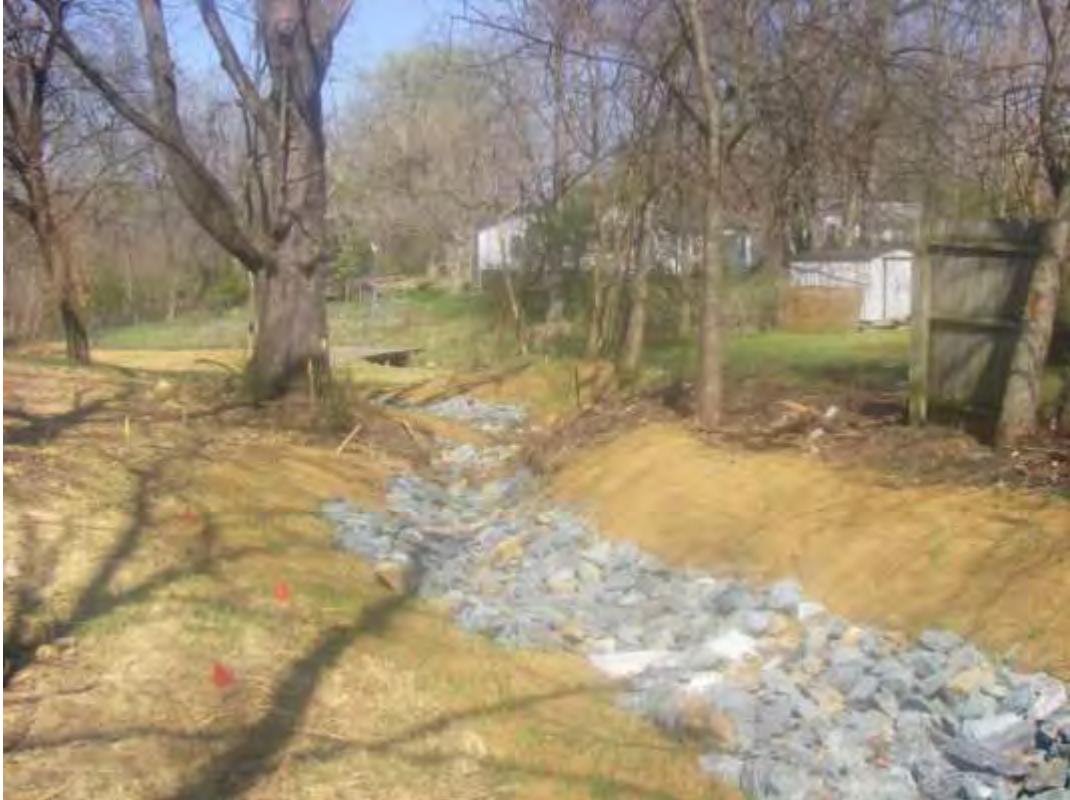
Upper part of the eastern channel with higher gradient

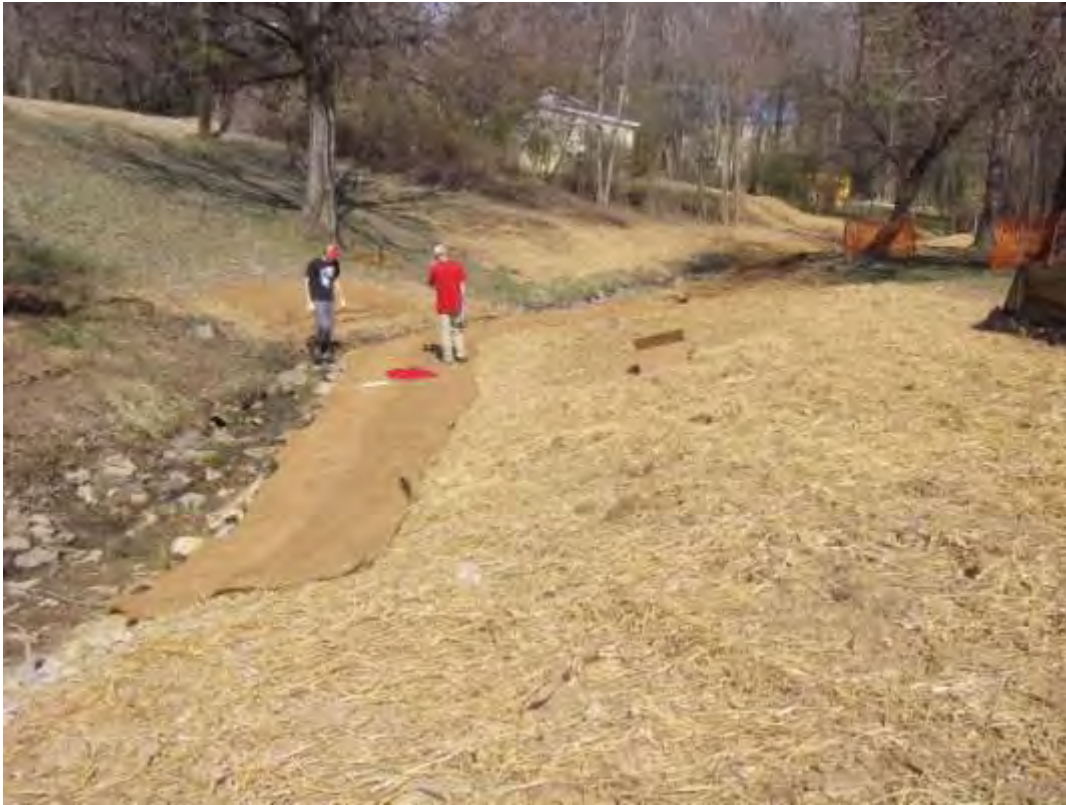
Laying coir matting on the western channel after construction

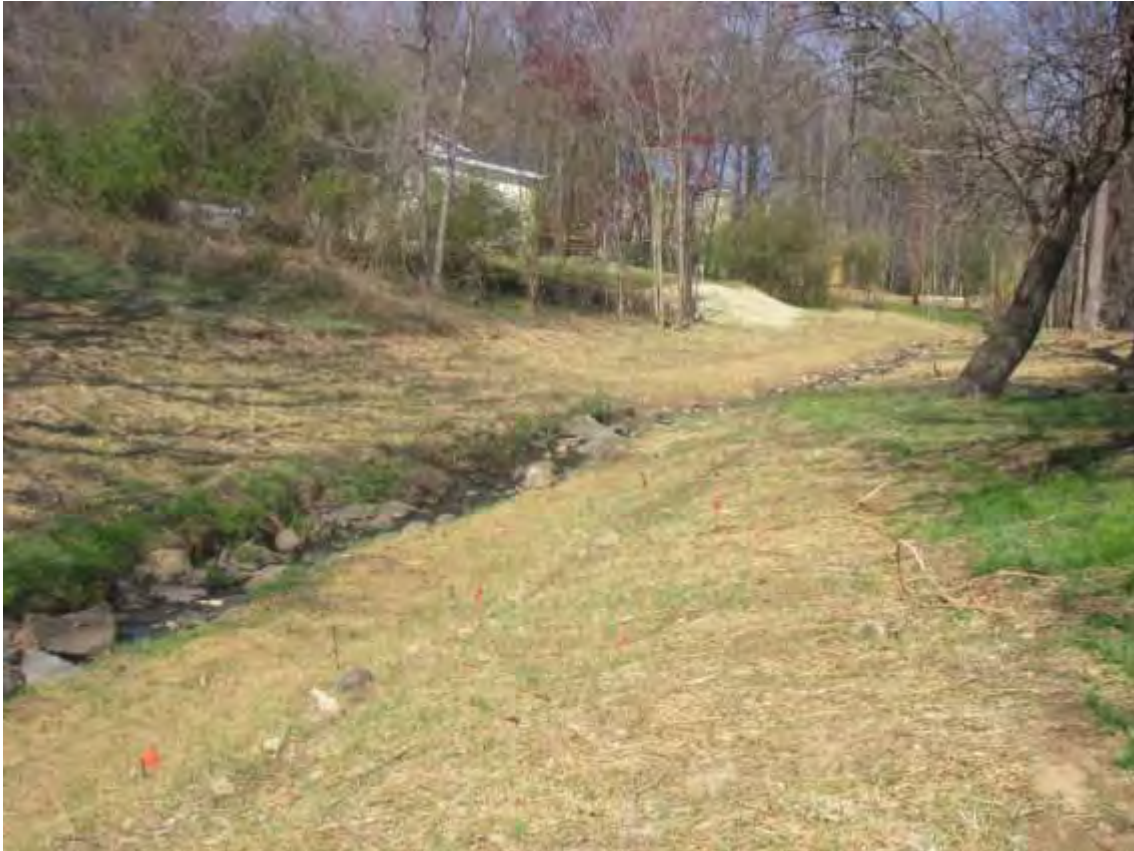
The western channel after grass has started to grow

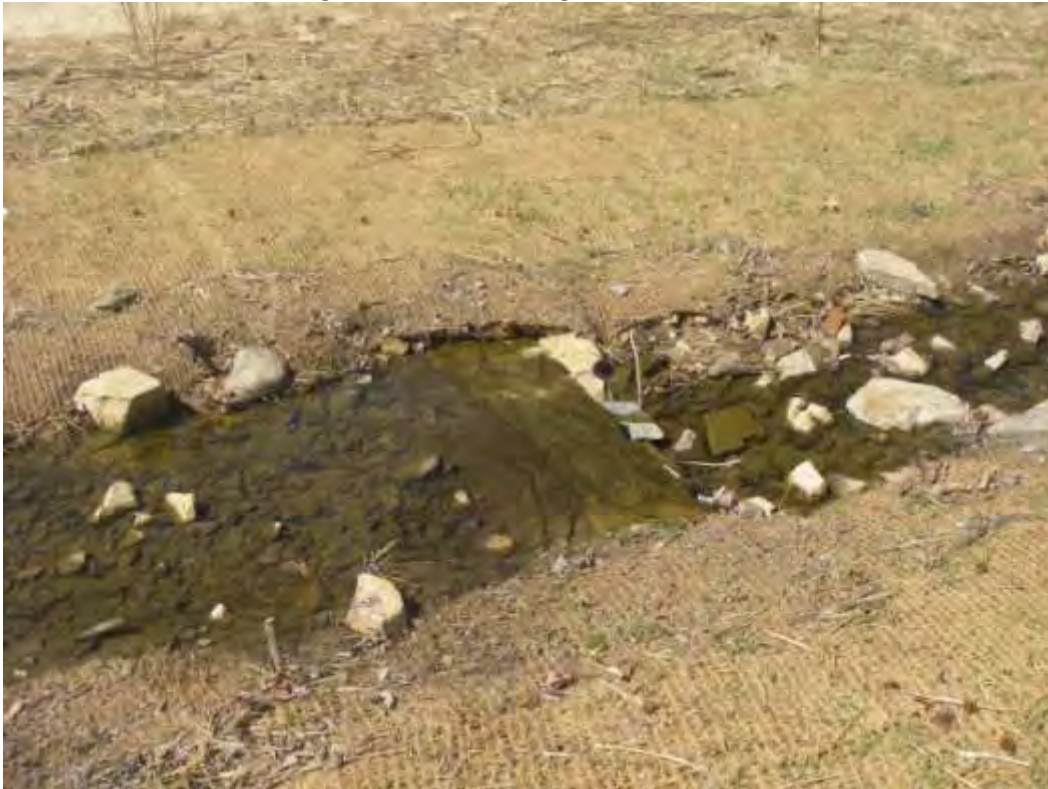
Close-up of a step-pool – there is a giant rock under there, but you can see only about 3 feet

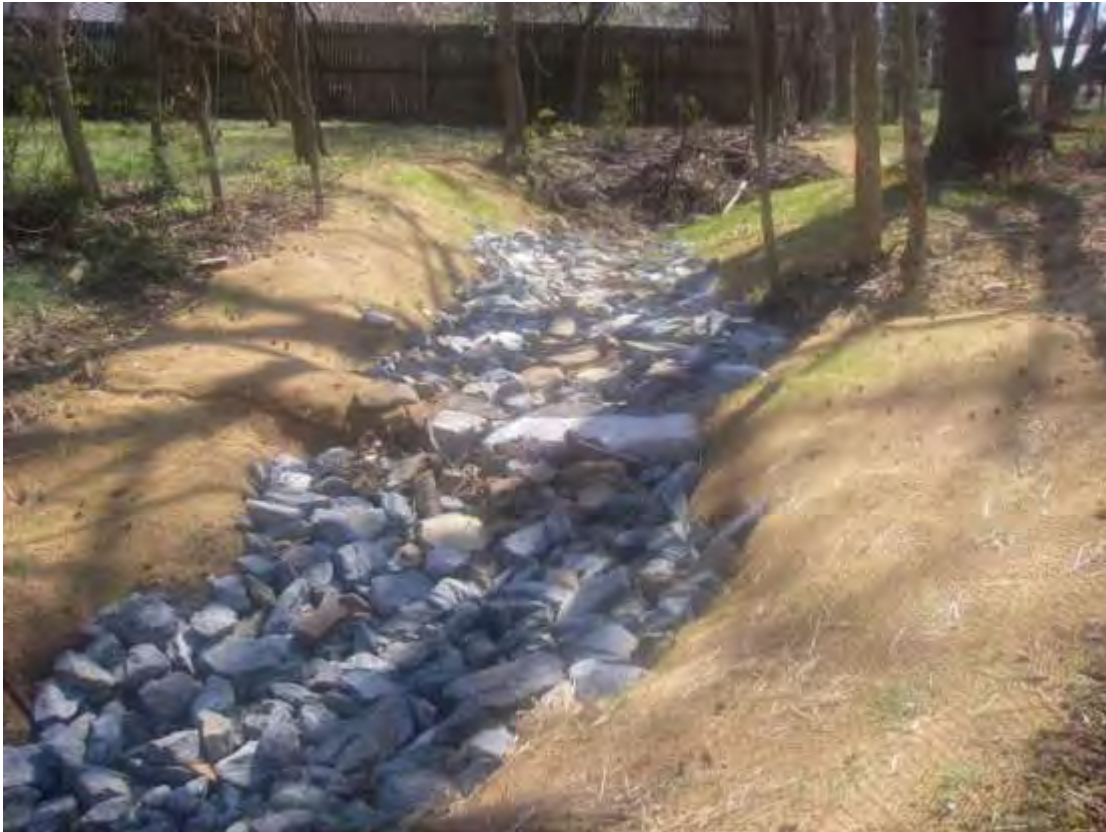
Step-pool close-up on the eastern side
