**BOLIN CREEK WATERSHED RESTORATION
INITIATIVE
FINAL REPORT**

***Fiscal Year 2008 Section 319 Nonpoint Source Water Quality Improvement Grant
of \$369,792 in Federal Funding***

NC-DENR Project Contract # 1666

Town of Chapel Hill, NC, Sponsor

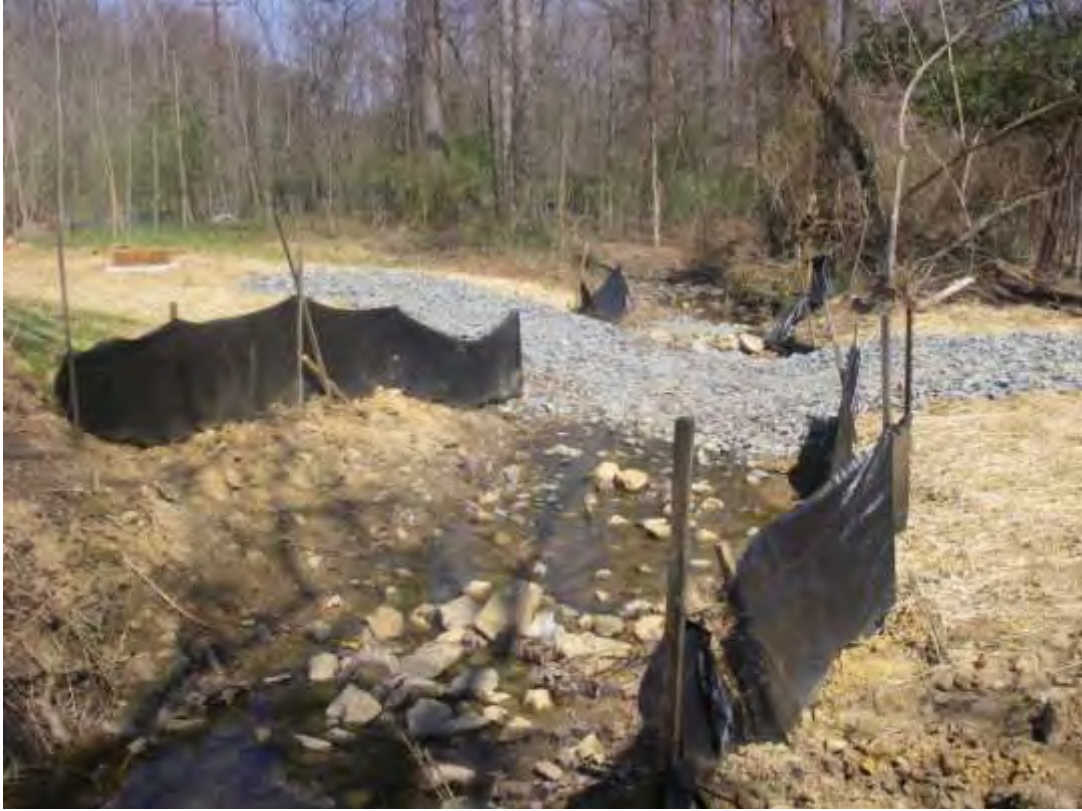
The OWASA crossing done incorrectly

The OWASA crossing redone – this time correctly

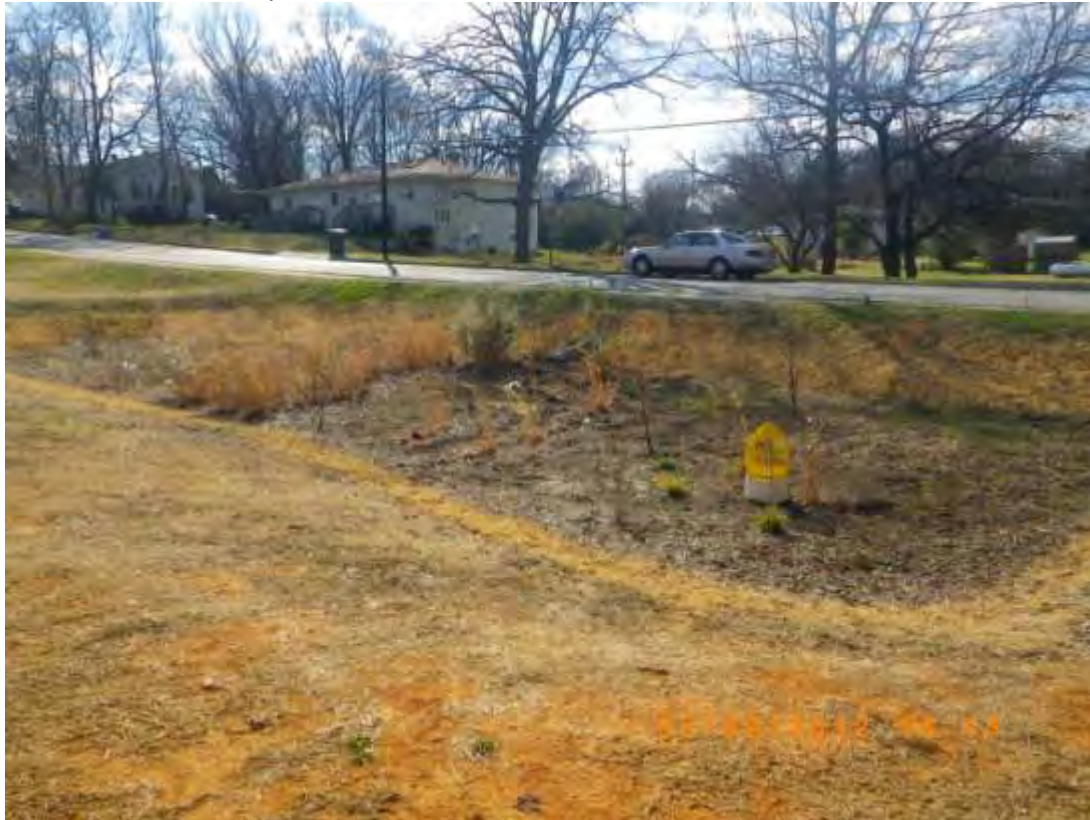
Most of the plants in the bioretention basin have survived the winter and grazing by deer

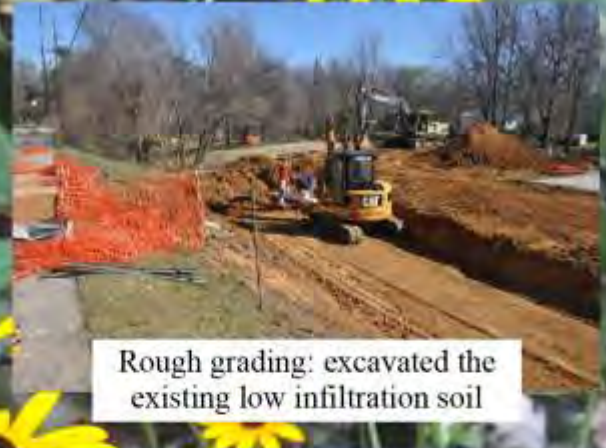
Rough grading: excavated the existing low infiltration soil

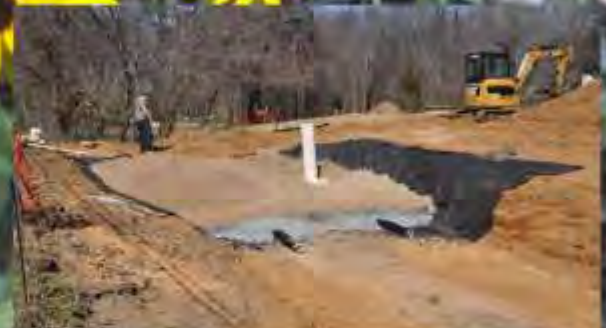
During construction: lined with geotextile fabric, added a gravel layer with underdrains, and several feet of high infiltration soil

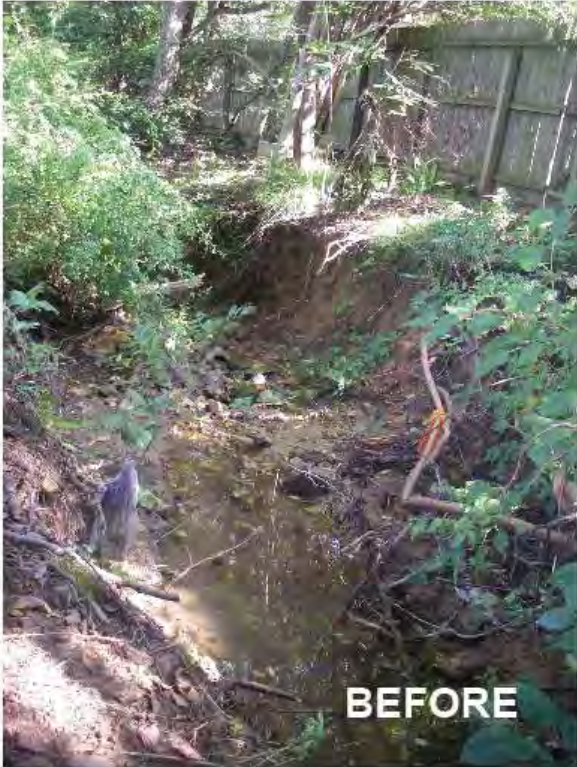
Before the project, **EROSION** created large cuts in the streambed and bank, destroying property and sending tons of sediment into Bolin Creek. Sediment harms stream habitat, carries pollutants, clogs gills of aquatic life and can increase water temperatures.

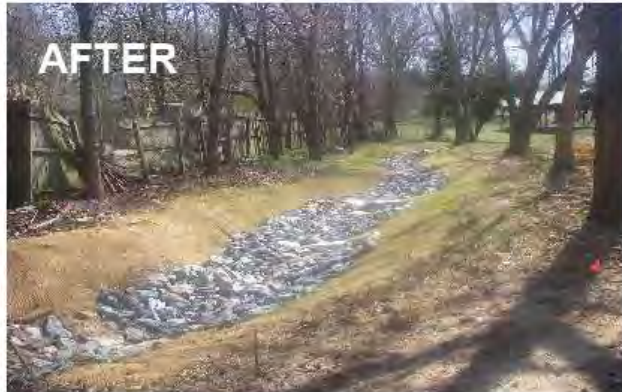
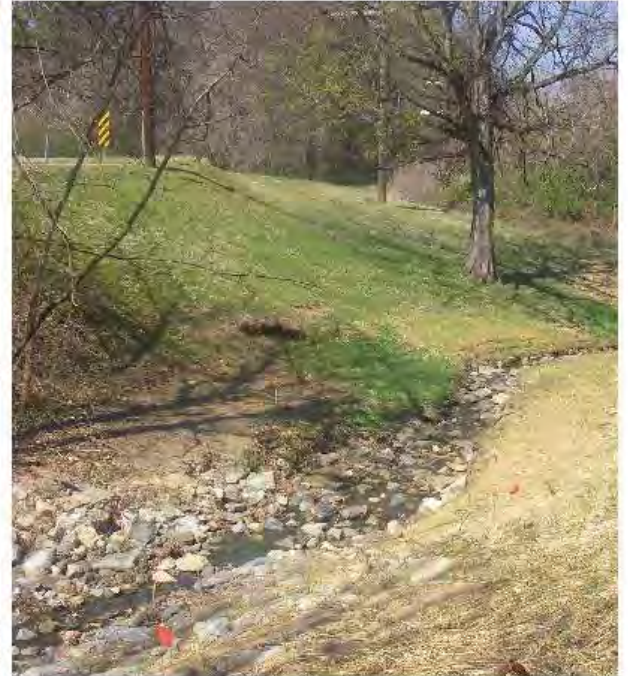
A series of in-stream "step-pools" were constructed with large granite blocks to reduce erosion on the banks and to improve in-stream habitat by providing riffles and pools to support a diversity of aquatic life.

BANK RESHAPING angles the banks back to reduce the energy of water during high flows, and prevents further erosion of the banks. After reshaping, stream banks were covered with natural fiber matting to prevent erosion, then planted with native trees and bushes.
