SITE 30

Retrofit of Existing Sediment Basin and Stabilization of Hillside erosion.

Geomorphic Analysis and Identification of Potential Sites for Stormwater BMPs
Orange County, North Carolina

*Bolin Creek Watershed
Geomorphic Analysis and Potential Site Identification for Stormwater BMPs and Retrofits*

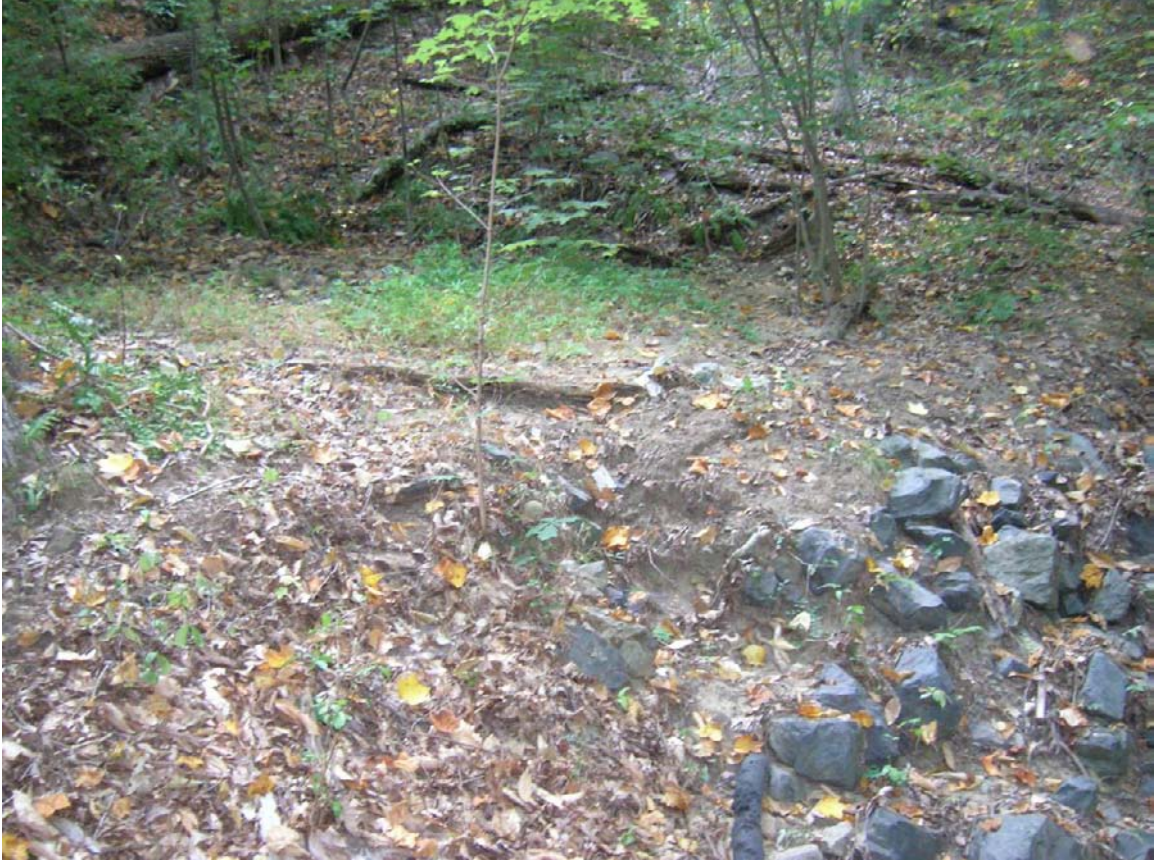
Site 30 consists of an existing sediment basin on a steep hillside, just below a residential development constructed on top of the hillside. The basin has filled in since the construction of the residential area, and is no longer storing the runoff produced from the street, rooftops and driveways. In addition, there is no evidence that the basin was ever intended for water quality treatment. Runoff flows over the rip-rap berm of the basin, into an apparently ephemeral drainage and then into a perennial stream at the bottom of the hill.

A concrete pipe outlet is located uphill of the existing basin, but has no stormwater control structure immediately below it. Because of this, the steep slope below the outlet has begun to erode. In the span of a month, between two visits to the site, the hillside below the outlet visibly increased in erosion. Evidence of the increased peak flows being produced by the drainage area can also be seen in the perennial stream located downhill from the site. Significant bank erosion is apparent where the ephemeral drainage joins with the stream, which is otherwise stable throughout most of its course.
