## **SITE 24**

### **Construction of Bioretention Cells for Pollutant Removal at Apartment Complex**

Geomorphic Analysis and Identification of Potential Sites for Stormwater BMPs  
Orange County, North Carolina

*Bolin Creek Watershed  
Geomorphic Analysis and Potential Site Identification for Stormwater BMPs and Retrofits*

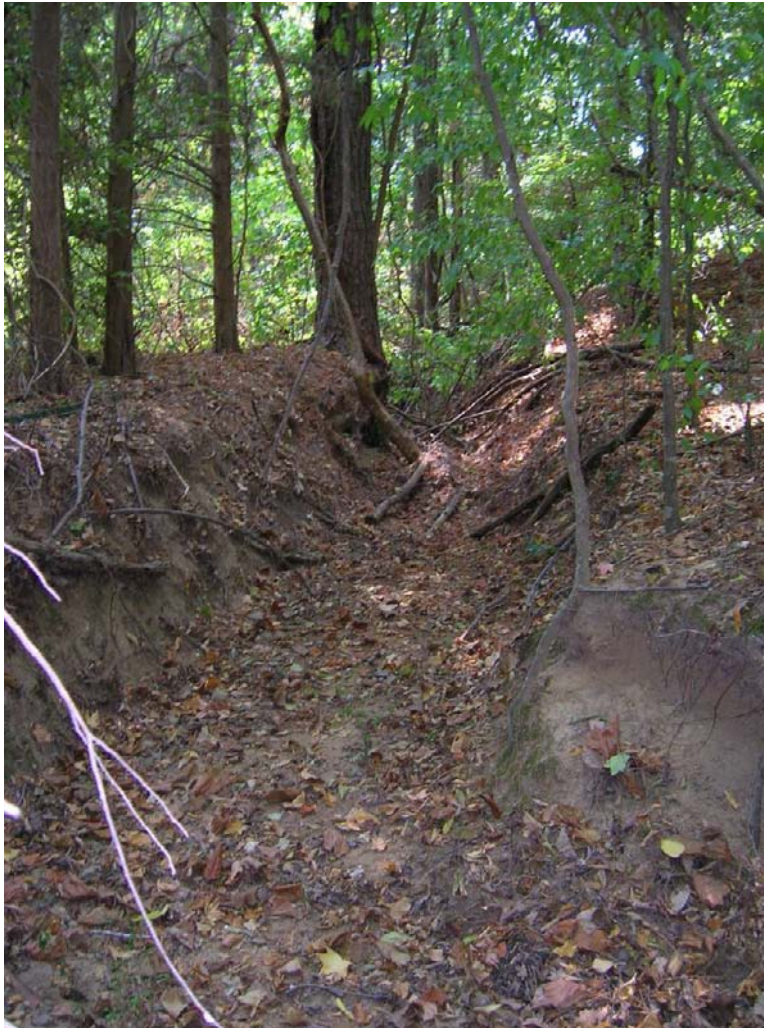
Site24 consists of 140 feet of an incised, actively eroding stream (low bank height approximately 4 feet). A very prominent headcut (approximately 3’ vertical in 1’ horizontal) marks the top of this site (upstream). The head cut is active and undercut, demonstrating a high degree of mobility. A BEHI rating of “extreme” was found for the entire length of the channel. Likely causes of this incision are the increase in peak flows of the contributing drainage area due to development, headcut effects caused by the past construction of the greenway downstream, and possible stream modification during the construction of the adjacent apartment complex. The stream flows into Bolin Creek only 70 feet downstream of the site, after passing under the Bolin Creek Greenway.

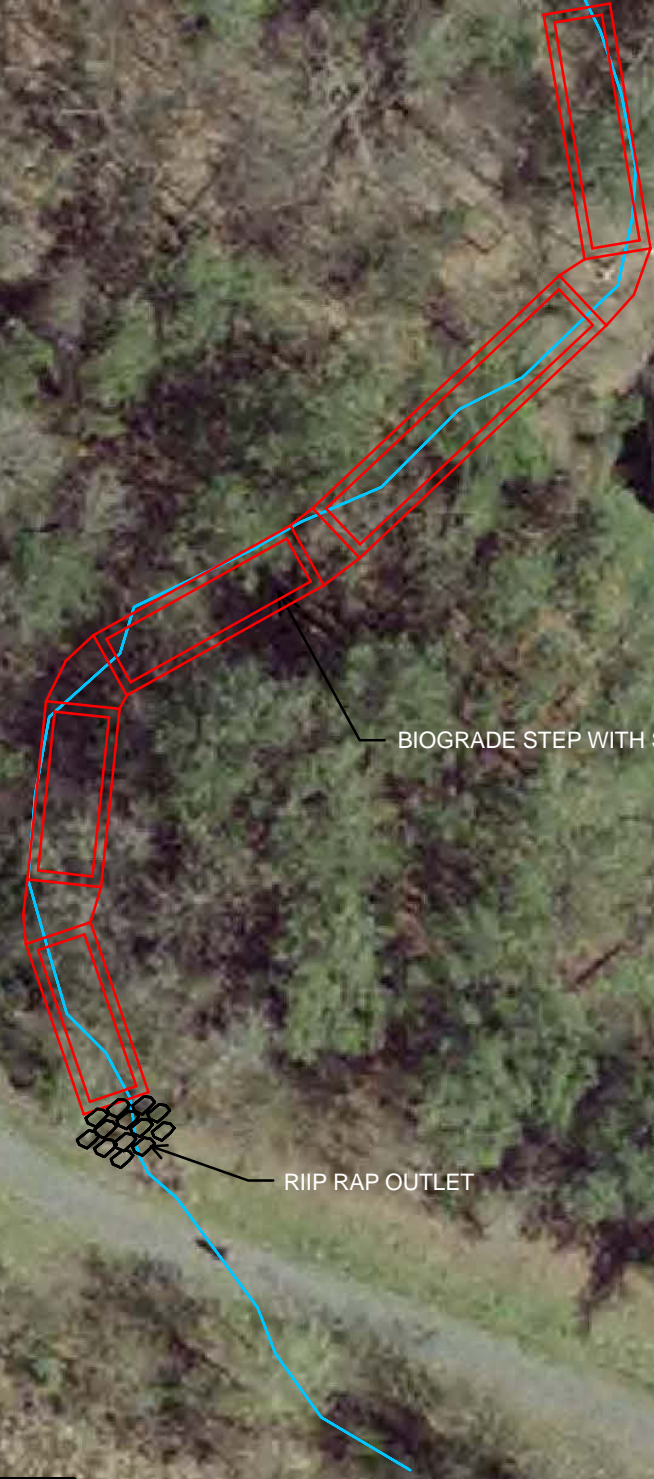
**AERIAL PHOTO VIEW**

BIOGRADE STEP WITH STORAGE

RIIP RAP OUTLET

stream flows directly into Bolin Creek after only a short distance, without any intervening storage or detention. However, space is limited within the site, which is composed of young pines and hardwoods, and a relatively narrow valley (man made). Thus, the preferred solution is the construction of a “bio-grade step”, which is a series of small bio-retention cells filled with a filter media, such as a mixture of sand fines and organic matter (see Appendix A-Details). Ideally, this media will have a filtration rate of 1.0 to 2.0 inches per hour, to optimize pollution removal (Schueler, et. al., 2007). Each cell is connected to the other through a seepage or drain layer, thus allowing stormwater to filter through each cell and augment baseflow to the receiving channel. The combination of the underground storage volume that results from each cell can create a significant reduction in runoff volume to receiving waters and attenuates the peak flow rates. The individual cells must drain over time to regain the available storage volume for the next rain event. Below the bio-grade step, an energy dissipation, stilling/ boulder basin(see Appendix A-Details), should be built to dissipate any overflow before reaching the greenway and Bolin Creek.
