SITE 14

Index Sheet No.: 16 Raw Data Name: None

Bolin Creek Watershed Geomorphic Analysis and Potential Site Identification for Stormwater BMPs and Retrofits

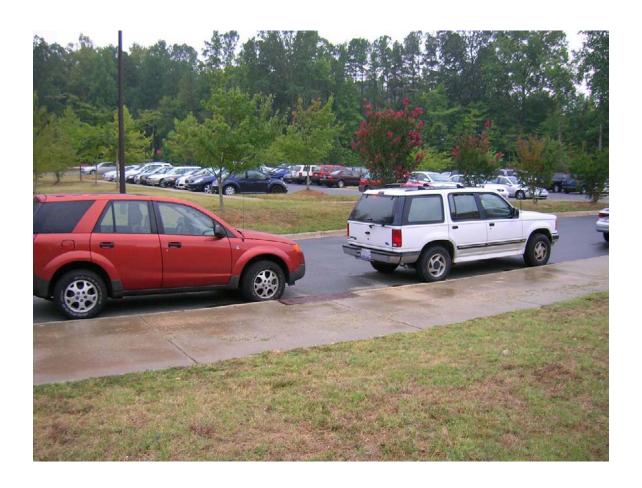
Site 14 is situated at the outlet pipe that discharges the storm flow of one of the parking lots of Smith Middle School. Currently, no water quality treatment is provided for the parking lot runoff before it reaches the receiving stream, Jolly Branch. This direct discharge to the stream has caused channel incision and does not provide water quality or quantity treatment of any form. Channel instability will continue due to this direct discharge of stormwater into the receiving channel, Jolly Branch.

The outlet pipe at Site 14 provides a good location to intercept the runoff produced by the parking lot and provide treatment for pollutants. Because of the small drainage area and limited space available for construction, a bio-retention area with underground storage is the preffered stormwater BMP here. The underground storage will serve to reduce the peak flows of the runoff from the impervious area and can be designed with a drain layer to augment baseflow to Jolly Branch while regaining needed storage volume for the next rain event. For this particular bio-retention area, the concept of providing a drain for the underground storage is an important one. Without intentional release of the stored rainfall, the BMP would loose some of its benefits during frequent rainfall events. It is suggested that this project be designed with a drain layer or under-drain that will drain the stored volume of rainfall within 3-5 days.
