Bolin Creek Watershed Geomorphic Analysis and Potential Site Identification for Stormwater BMPs and Retrofits

SITE 12

Index Sheet No.: 16 Raw Data Name: IJ 24

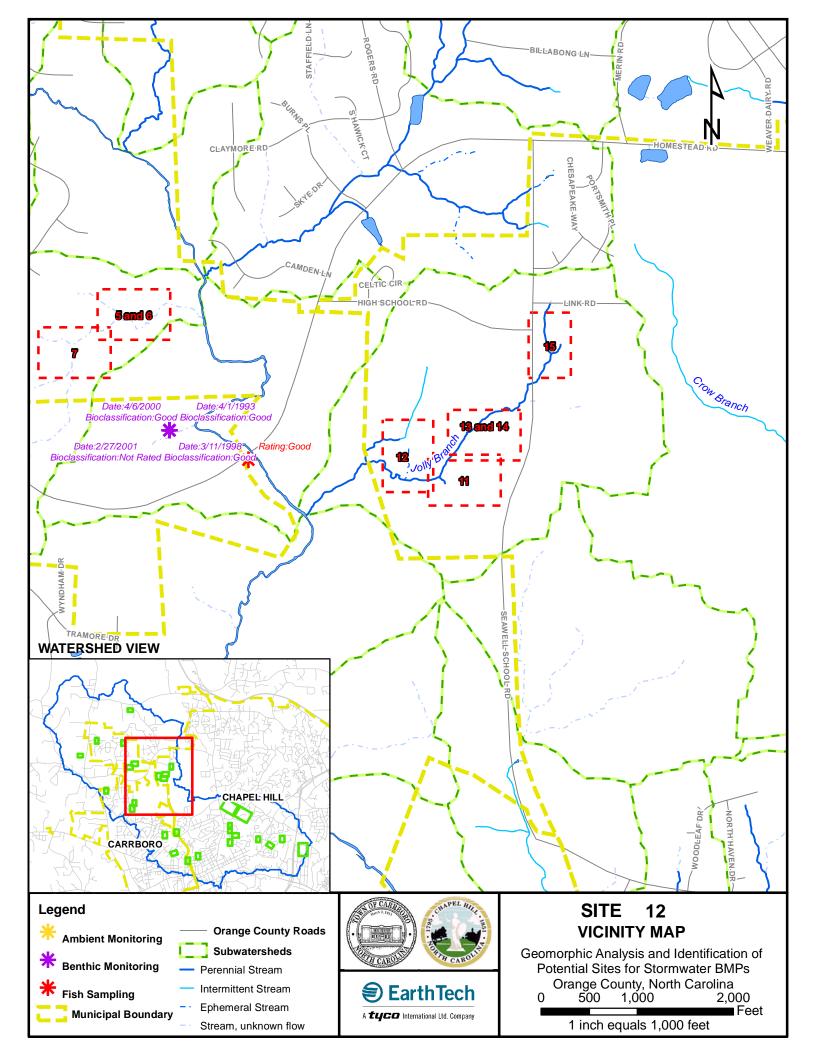
Site 12 consists of a corrugated metal pipe outlet and ditch draining part of the football stadium facility at Chapel Hill High School. The football field is likely fertilized on a regular basis. The ditch discharges the stormwater from this field into Jolly Branch, a perennial stream, without any water quality treatment. Several spots of geomorphic instability, in the form of eroding banks and scour lines in the floodplain, were noted in Jolly Branch where these stormwater inputs reach a confluence.
