SITE 7

Bolin Creek Watershed Geomorphic Analysis and Potential Site Identification for Stormwater BMPs and Retrofits

Project Description

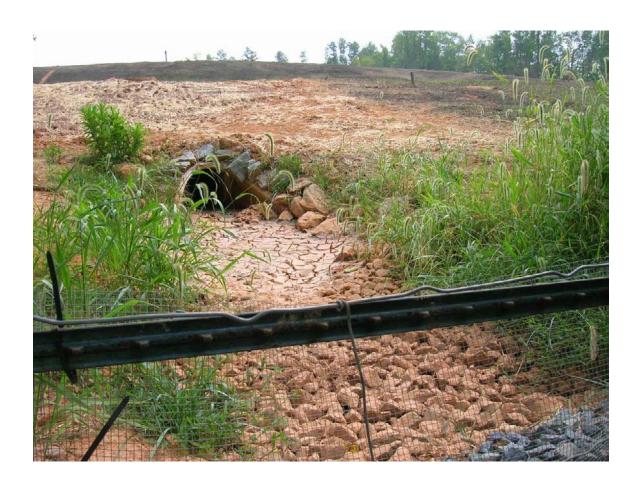
Index Sheet No.: 11 Raw Data Name: None

The stormwater system coming from several acres of the Winmore subdivision is discharged at a location that is very near an un-named perennial stream. The pipe system outlet had a small pre-formed scour type sediment basin and the plans call for a rip-rap apron at the completion of construction. During the site visit, Earth Tech observed the effects of concentrated flow on the perennial stream and the flood plain. Rill erosion has begun and a head cut up from the stream to the outlet will likely be the end result of the erosive forces of the concentrated flows. Also, from a water quality point of view, the approximately 10' of distance between the BMP and the stream channel is not a sufficient filter strip. This BMP will very likely cause significant degradation to the water quality of the receiving waters due to the anticipated sediment inputs from future channel instability and direct inputs of nutrients.

The terrain of this site limits the options for retrofitting the existing BMP. A linear bioretention area is proposed a solution to dissipative energy, reduce velocities by distributing flow over a significantly larger area, and utilizing a much larger area of biological treatment of nutrients by using the bioretention are itself and increased area of filter strip that results. This project would be a hybrid of a bioretention area with storage and a level spreader.
