Merin Road Community

Special Use Permit Planned Development

Response to Ms. Alena Callimanis concerns addressed to the
Stormwater Advisory Board

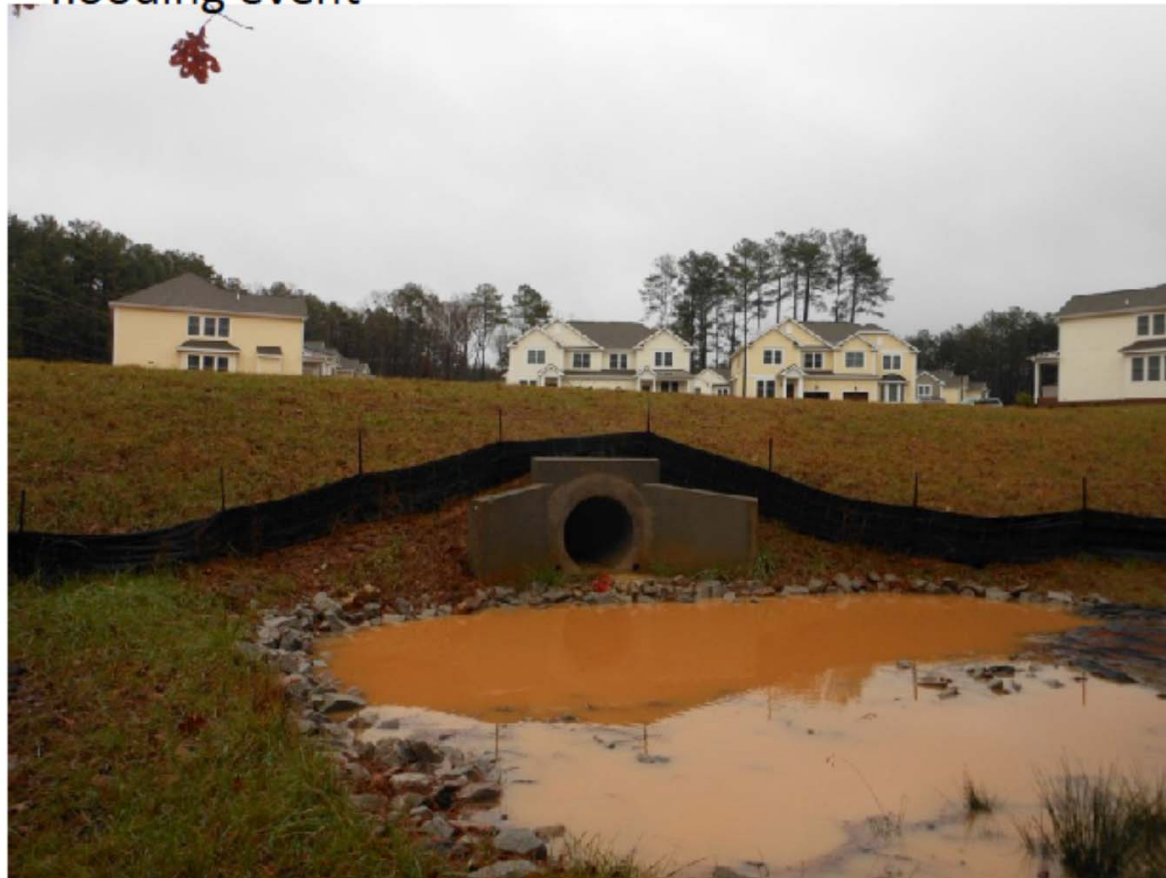
Burch Kove nearing completion - December 30, 2015
flooding event

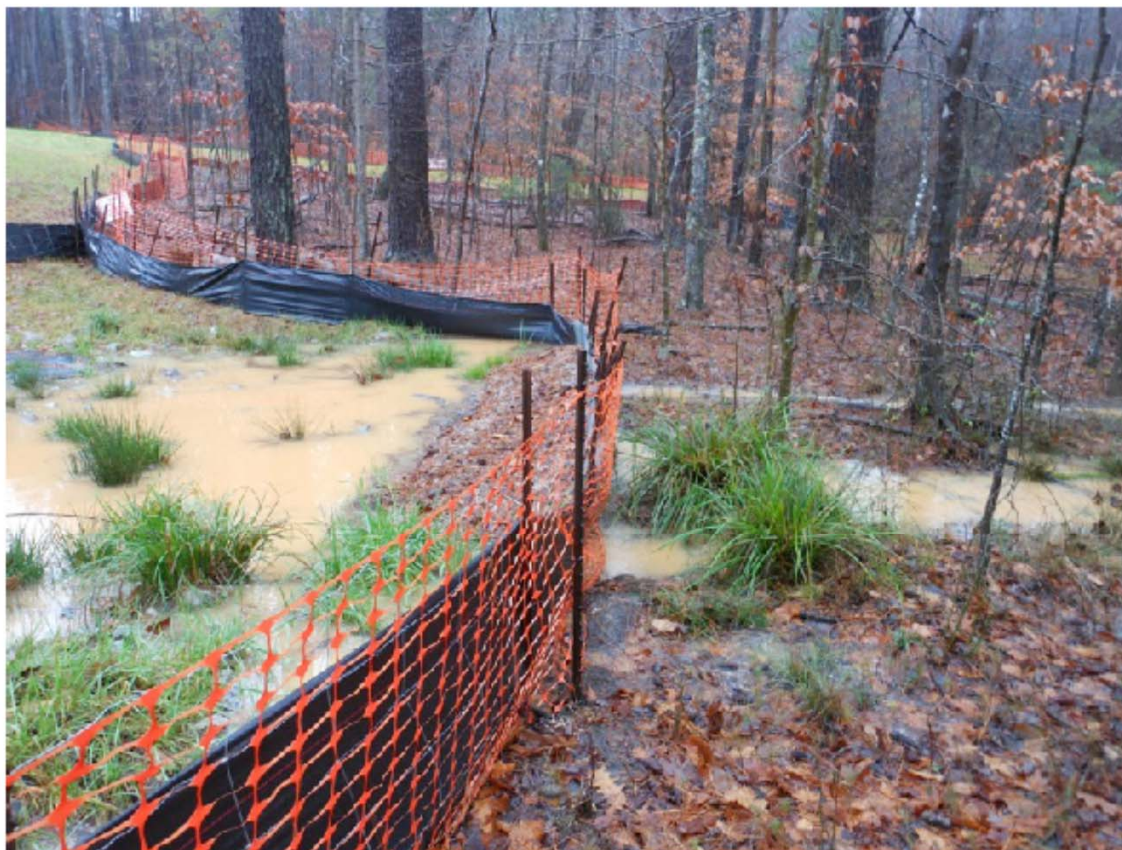
Burch Kove runoff December 30, 2015

- The picture shown in Slide #2 above is looking upstream at the principal spillway pipe for the pond. According to Ms. Callimanis this picture was taken during the storm event on December 30, 2015. The flow leaving the basin is minimal. The silt fence is in good working order. The dam is not being over topped.
- The picture shown in Slide #3 above is looking along a section of silt fence installed along the perimeter of the project. The water leaving the silt fence is passing through a silt fence outlet that are typically installed at low points and include 57 stone to filter the runoff. The stormwater leaving the fence above the outlet doesn't appear to have an outlet. Weekly walks would help to identify required adjustments to resolve areas like these.

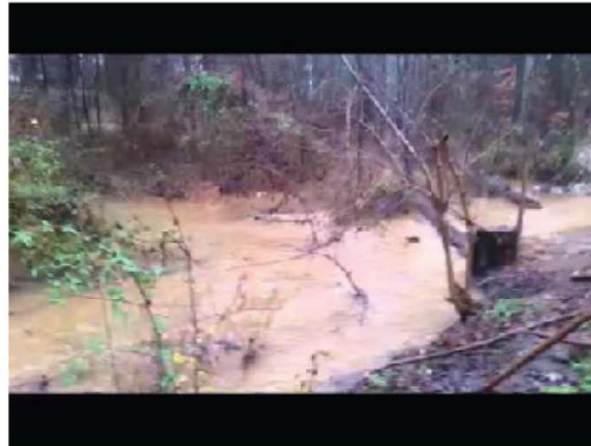
Stormwater video immediately behind
1804 Homestead Road on Dec. 30, 2015
at the culvert at Rogers Road
downstream from Merin Road project
Note: Resident at 1804 Homestead said
water was at top of the culvert

- In the video attached to Slide #5 above states the culvert at Rogers Road was surcharged. There is no evidence in the video that proves the claim that the culvert in Rogers road is backing up or being blocked.
- The home at 1804 Homestead Road was recently purchased in September of 2015 and the buyers were fully aware of their proximity of the creek.

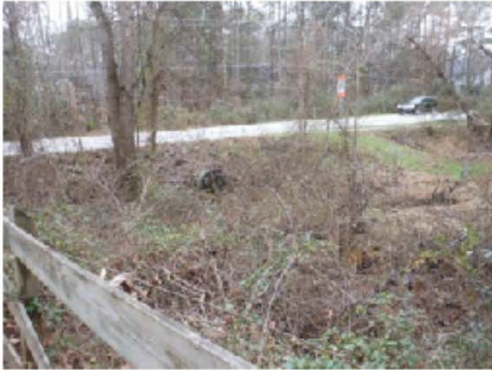
Rogers Road culvert at Homestead Road with no floodwaters on Feb. 5, 2016

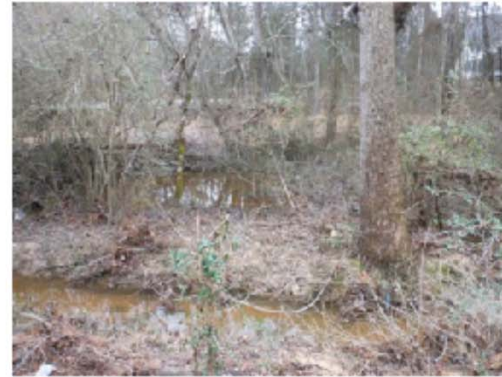
Culvert under Rogers Road

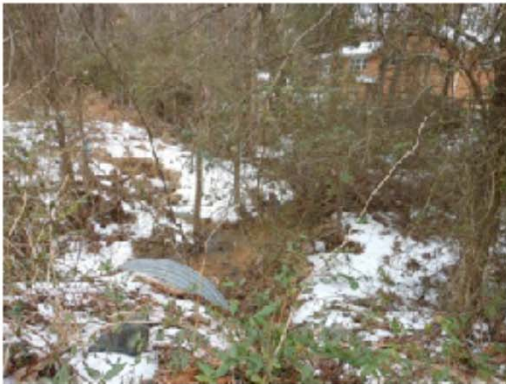
View back towards flooding video
location behind 1804 Homestead

View from Rogers Road culvert to
house at 1804 Homestead
(Jan. 26, 2015)

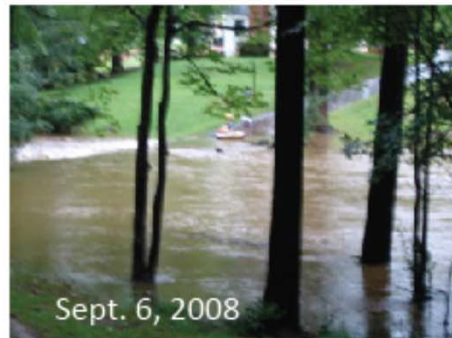
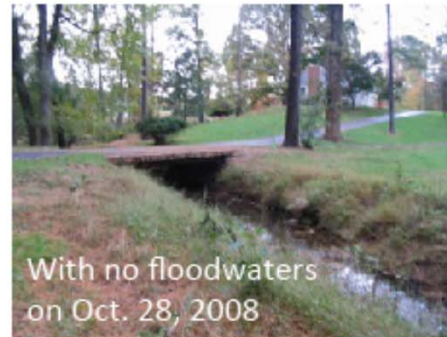
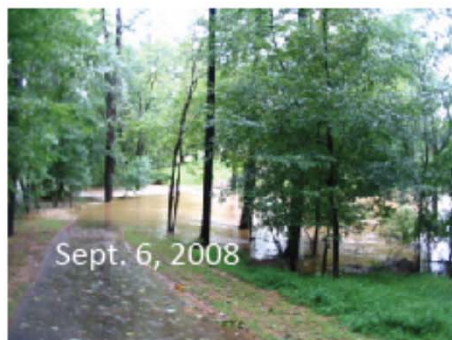
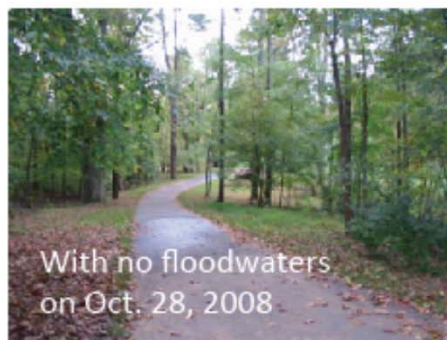
Winmore flooding Sept. 6, 2008 at the initial walking bridge over Bolin Creek that was replaced by developer (shown on the next slide). **Note** the shallow and narrow creek at that original bridge and lack of erosion of the banks of Bolin Creek

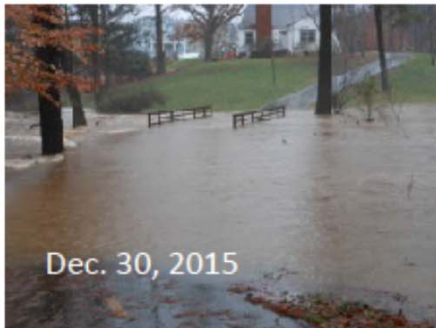
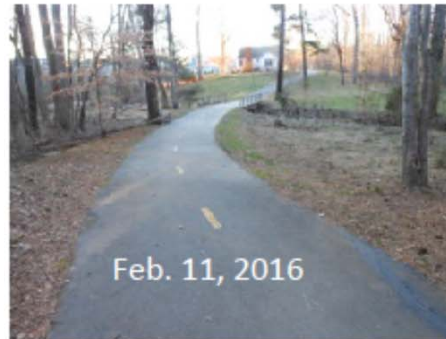
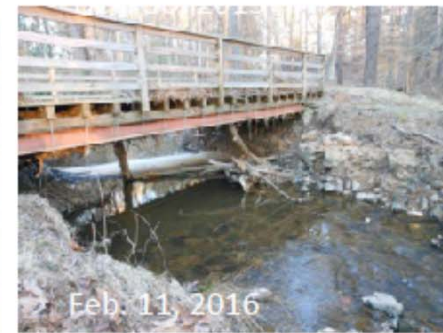
Dec. 30, 2015 flooding at replacement walking bridge at same location as pictures on prior page. (**Note** Feb. 11, 2016 pictures show the erosion to the Bolin Creek banks from increased and more frequent stormwater runoff)

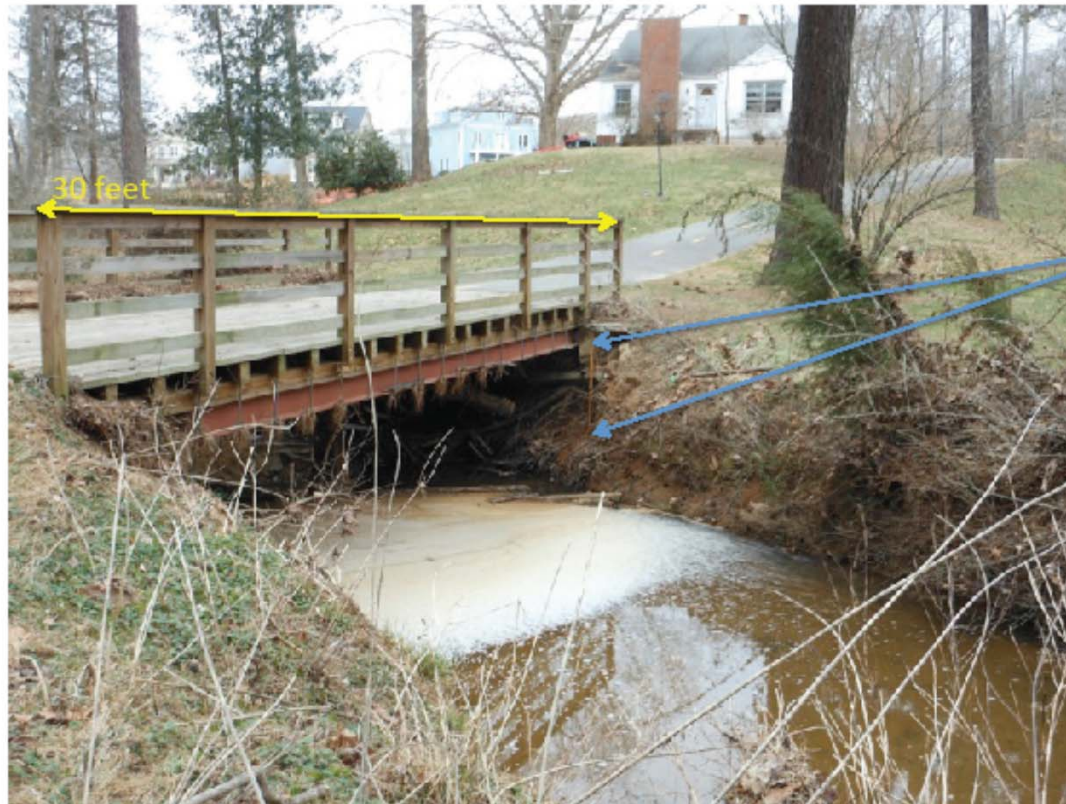
Winmore walking bridge over Bolin Creek Feb. 12, 2016 – **Note** significant undercutting of the bridge support. Bridge is 30 feet long and 6 to 7 feet to bottom of creek

Yard stick is between the arrow points, with top even with bottom of red girder

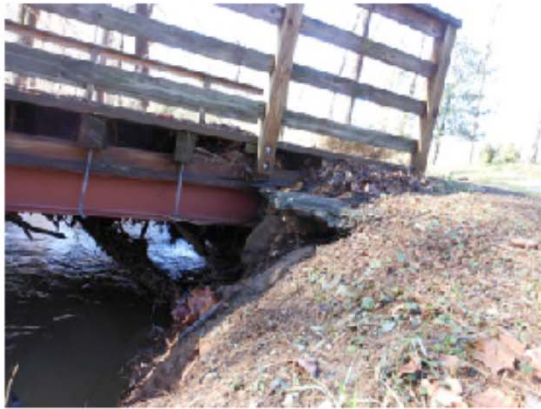
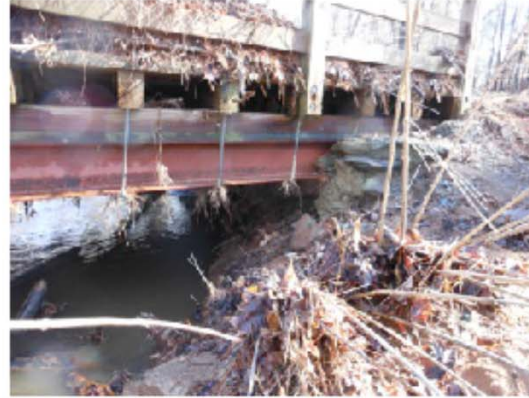
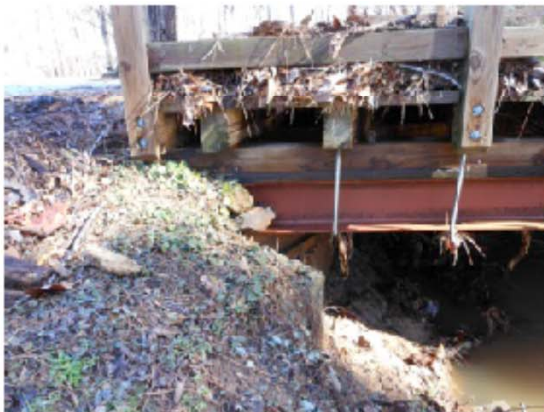
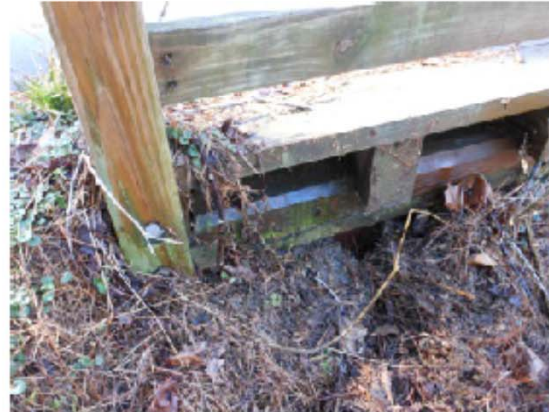
Four corners of the Winmore Pedestrian bridge showing potential support compromise – **Note:** Carrboro should not take ownership of this bridge until it is fixed or ideally replaced by a longer bridge by the developer

- The Winmore pedestrian bridge was constructed long before large scale development in the area yet we have accounts of it flooding 50 years ago. Recently with the development of Winmore the bridge was redesigned to handle large scale construction equipment capable of supporting over 70,000 lbs. With the Winmore construction completed its intended use is a pedestrian bridge owned and maintained by the Winmore Homeowners Association.

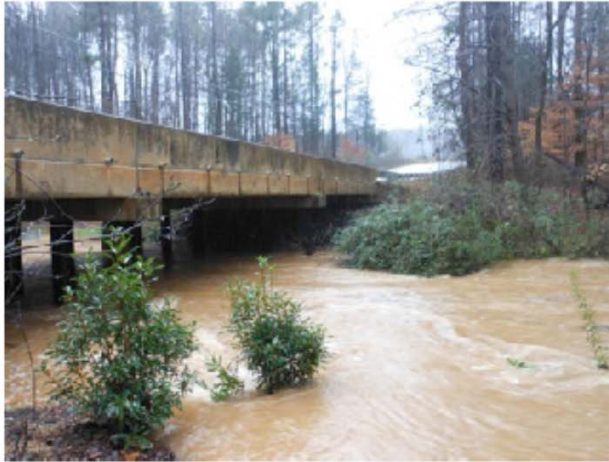
North Side

Homestead Road bridge Dec. 30, 2015 Flooding

youtube videos of flooding at these locations. **Note:** Carrboro is planning to put a greenway along Bolin Creek, under this bridge.

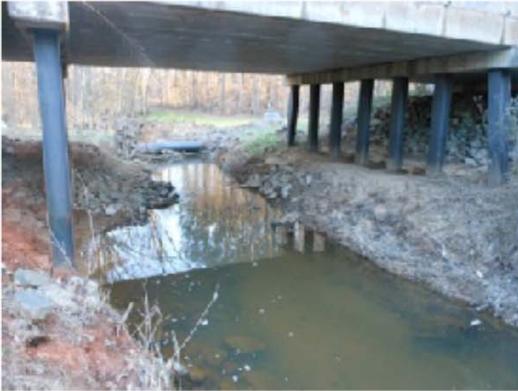
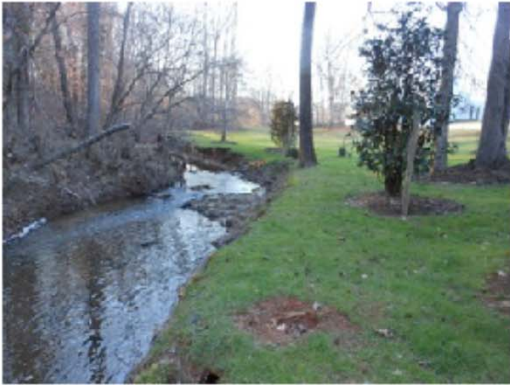
North Side

February 11, 2016 post flooding pictures at Homestead Road bridge

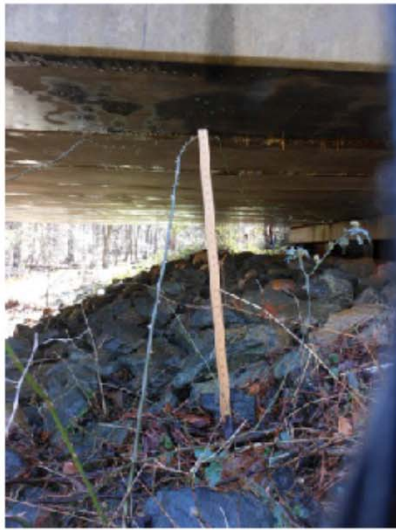
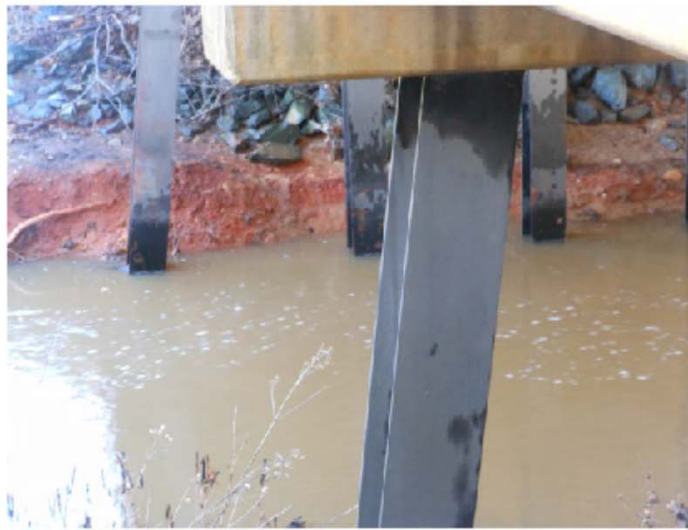
Homestead Bridge additional views on Feb. 16, 2016

Water in Dec. 30 video was within 39 inches of bottom of bridge (at time video was taken.)

Urgent note: Erosion and water on east side of Homestead Bridge extends behind the steel bridge supports

- Response: Bridges that handle vehicular traffic have standard design requirements that require solid foundation supports, which are typically keyed into bedrock, and are designed to account for seasonal flooding and scouring.

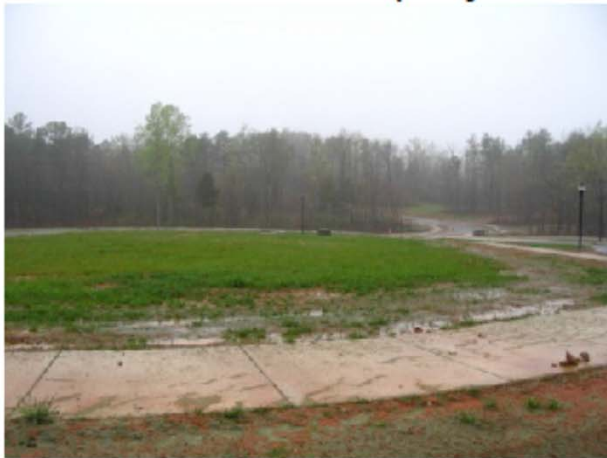
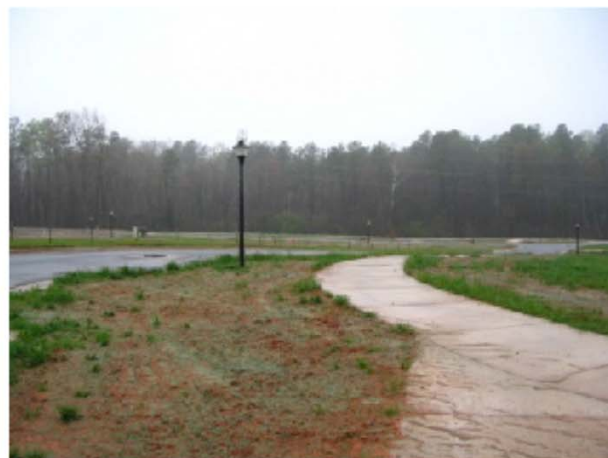
While impervious surface significantly contributes to stormwater runoff, clear cutting also reduces the amount of rainfall absorption of non-impervious surfaces. **Note:** See Winmore pre-construction photos below. The developer for Winmore is the applicant for the Merin Road project.

- The photo referenced above is a picture of Philip Square, a public open green, and will not be used for future single family home construction. Since this is a green area for recreational use it was graded with minimal slope. The green area was graded and cleared with the infrastructure.
- Since this is a green area the developer was required to clear it.
- Looking beyond the green area one can see tree stands that have not been cleared and were saved for future single family lots.
