Lower Booker Creek Subwatershed Study

Town of Chapel Hill Stormwater Advisory Board

April 26, 2016

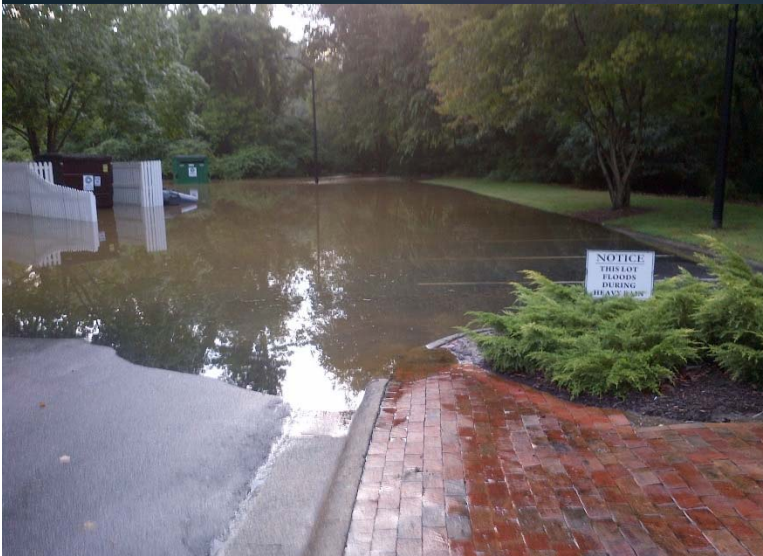
Floodplain

- Validation Storms
 - June 2013
 - December 2015
- Floodprone structures
 - Single family – 52
 - High density res – 12
 - Office – 7
 - Commercial - 16

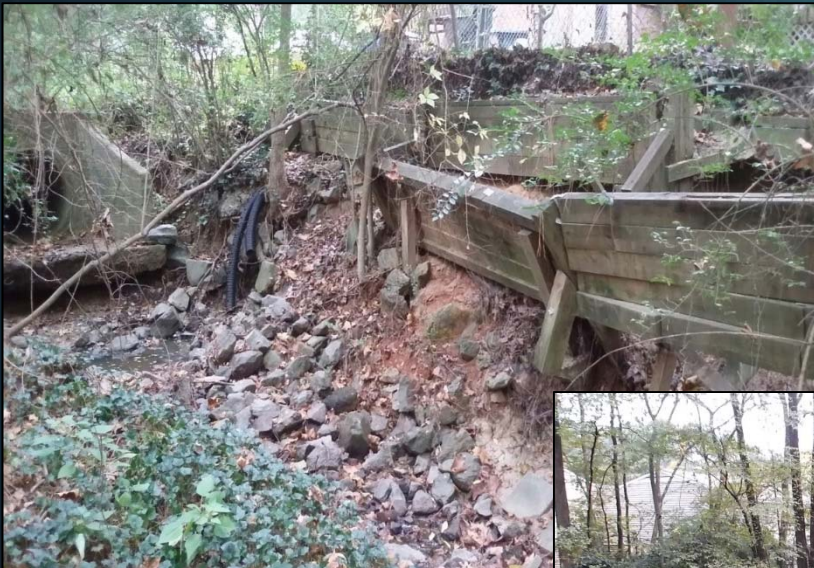
Sedgefield Drive outfall and bank stabilization

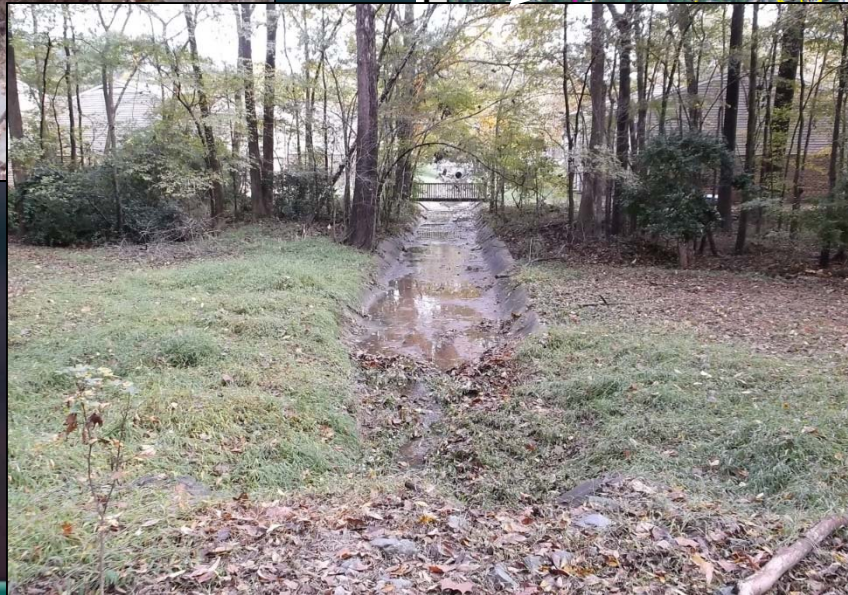
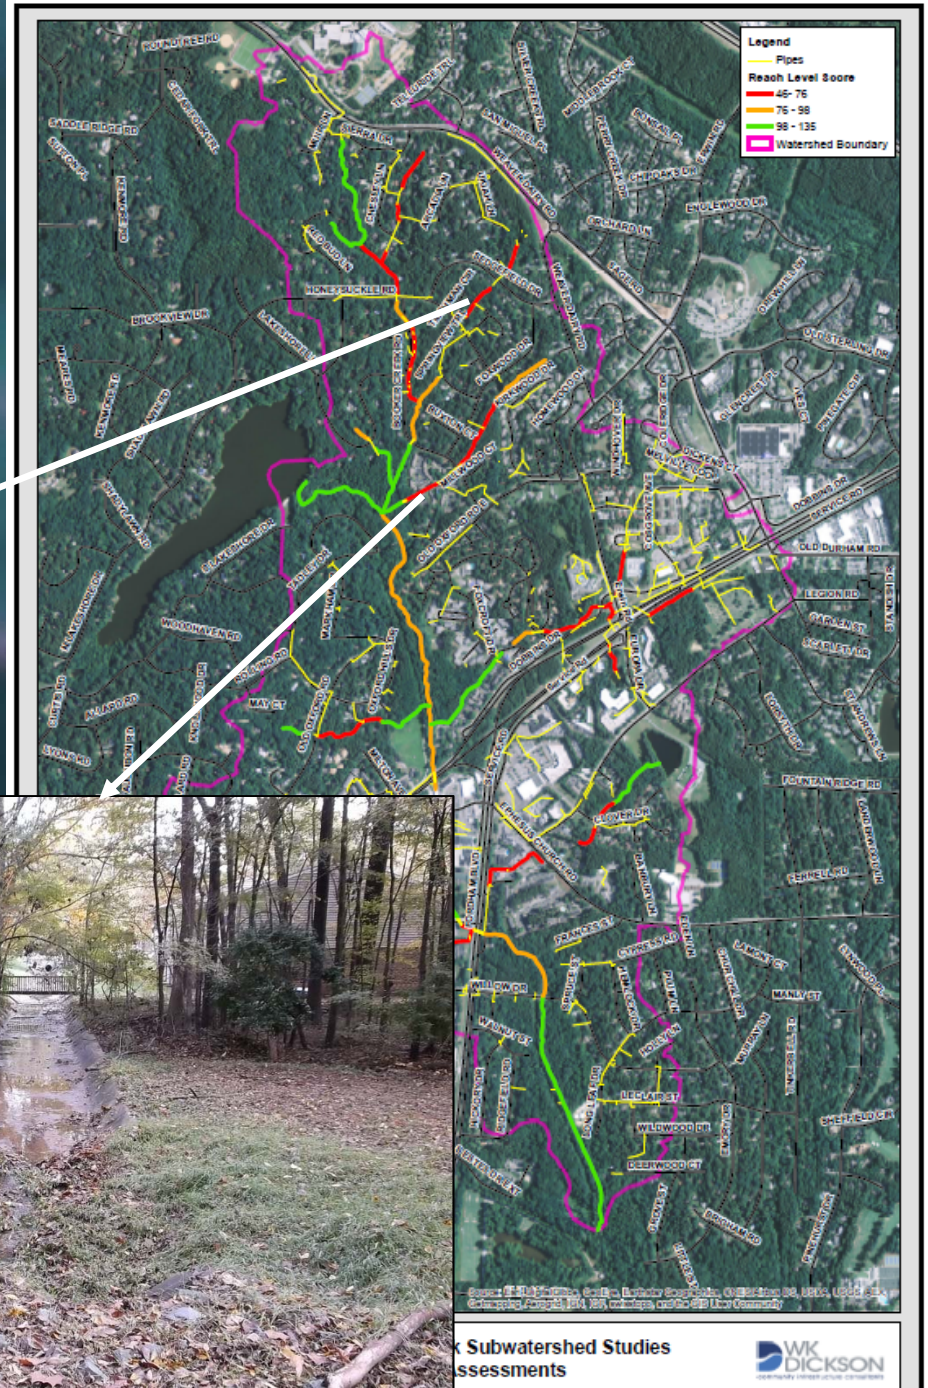
Booker Creek Townhouse Apts Stream Restoration or RSC

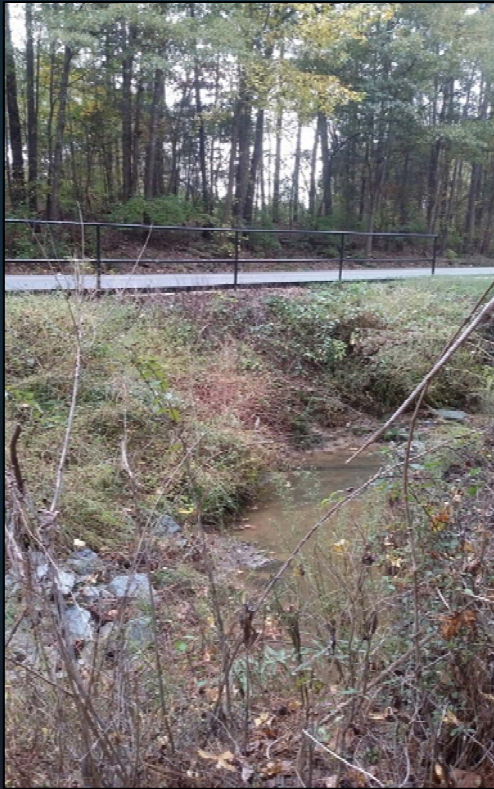
Dobbins Drive bank stabilization

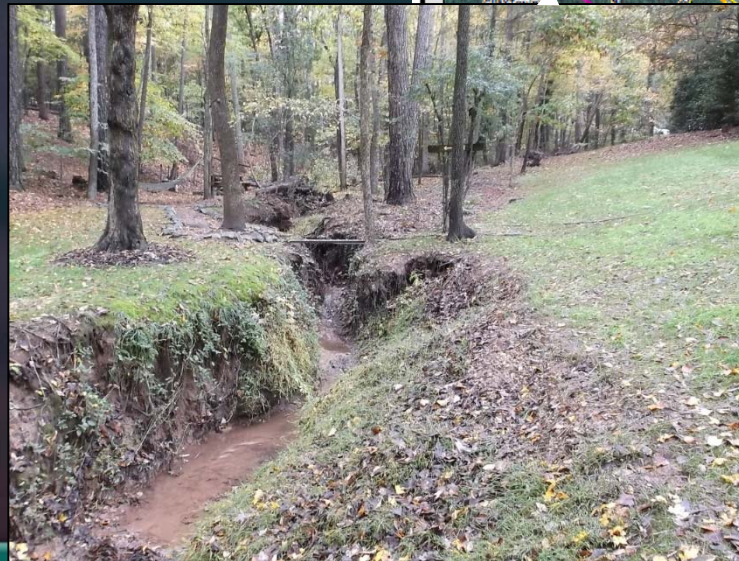
Oxford Hill Rd stream stabilization and buffer enhancement
