carmel church road

3D exterior views

A2.01

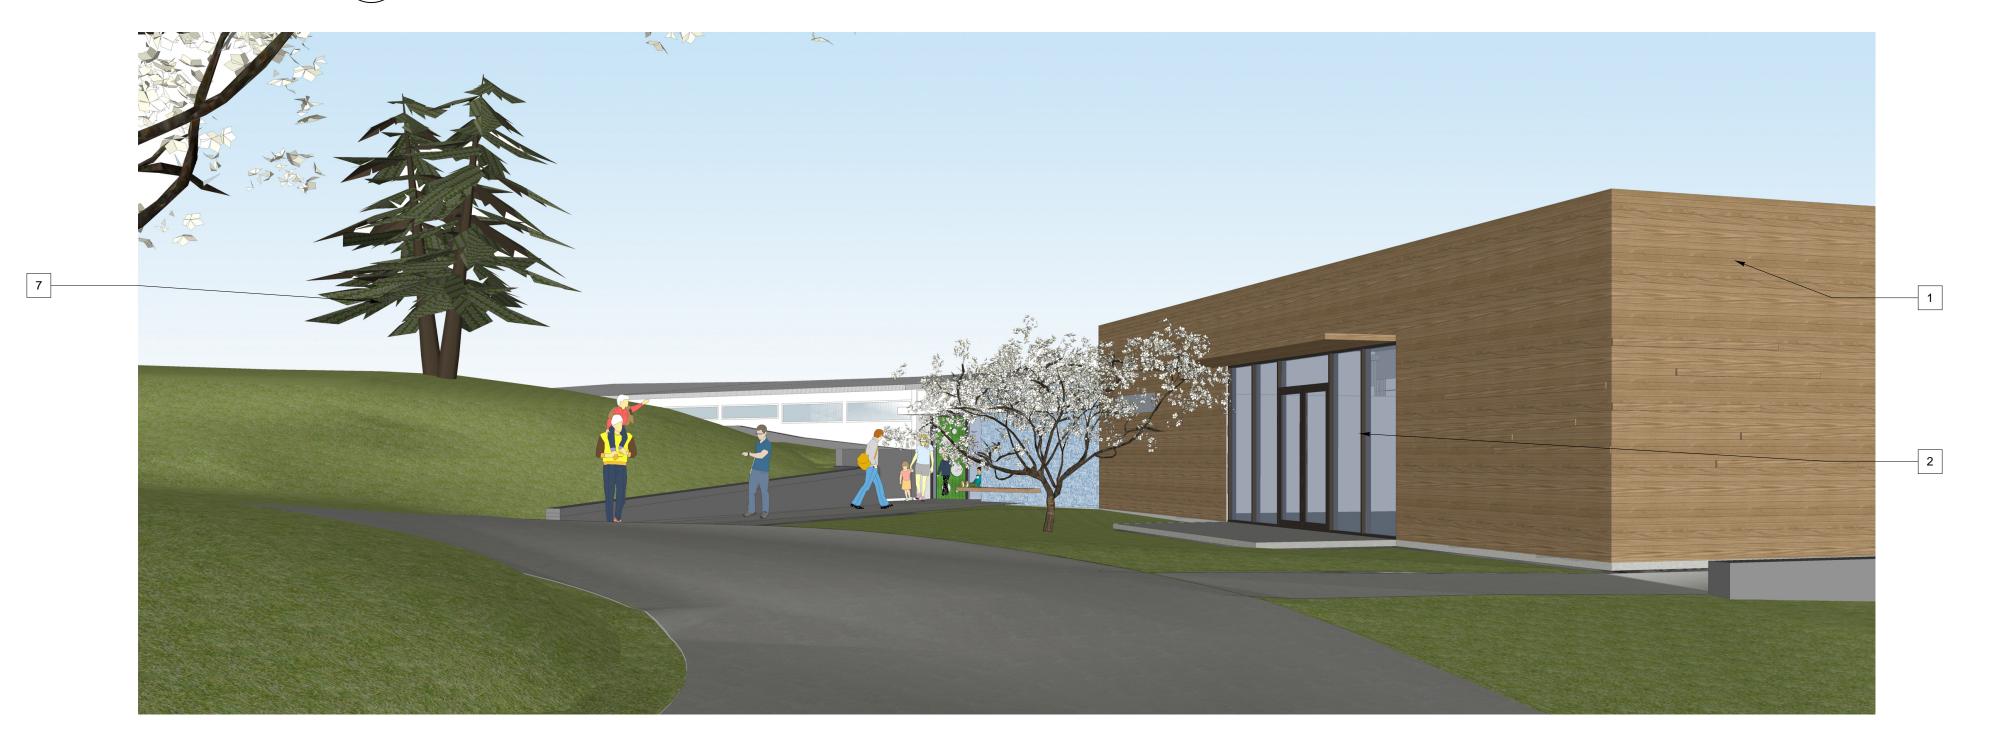
elevation key notes

2 aluminum storefront windows and doors

4 hvac equipment mounted on roof

5 vinyl windows, various sizes

8 galvalume standing seam roof

9 white TPO roof

11 parking lot

10 mosaic tile wall finish

12 circular driveway, drop off

3 concrete retaining wall, painted or stained

7 existing double 20" hemlock on hilltop to remain

1 wood siding installed as rain scren; cypress or similar; parapet wall is 15'-6" above finished floor and average grade around building

6 fiber cement siding, various types including 4" lap, 4" shiplap, monolithic panels with aluminum reveal trim

approach to building, looking north
