BIOLOGICAL MONITORING OF CHAPEL HILL STREAMS, NORTH CAROLINA

April – July 2017

Prepared for the Town of Chapel Hill by:

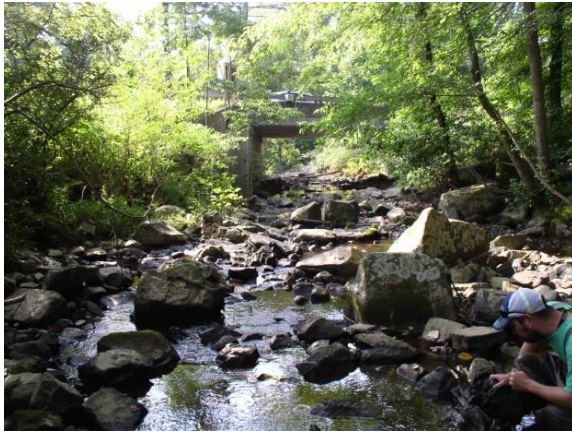
Figure 3. Bolin Creek Site 4, July 2017.

Bolin Creek 4 (Village Drive). This site was moved slightly downstream into Chapel Hill (Village Drive) in 2011 so data from this site could be used by both Towns of Carrboro and Chapel Hill.

This portion of Bolin Creek is similar to the site on Estes Drive, having good rocky substrate. Attached filamentous algae was very abundant at the Village Drive site in March 2011, but was not a problem in 2012-2017. Specific conductance for this site in July 2017 (128 $\mu\text{S}/\text{cm}$) was similar to 2016 (139 $\mu\text{S}/\text{cm}$).

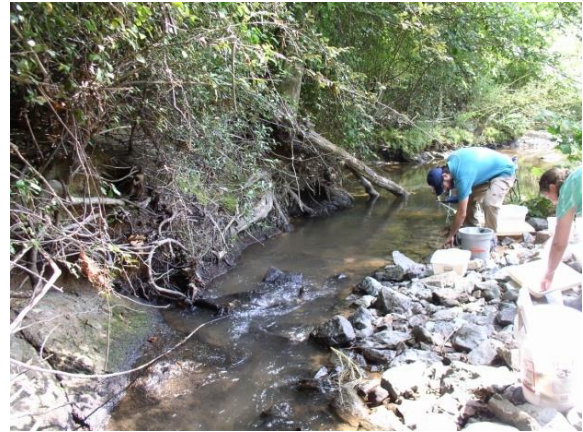
Figure 4. Bolin Creek Site 5, July 2017.

Bolin Creek 5 (Franklin St). Bolin Creek has good rocky substrate near the Franklin Street bridge, but the stream bottom is mostly sand further upstream.

A greenway path parallels Bolin Creek in this area. This site drains a heavily developed catchment, including the downtown areas of both Carrboro and Chapel Hill. Specific conductance was much higher at Site 5 than at Site 4 (Village Drive) in July 2017: 128 vs. 204 $\mu\text{S}/\text{cm}$, possibly due to the entry of Tanyard Branch between the two sites. Lower water levels in 2017 compared to 2016 likely led to a reduction in microhabitats and a reduction in Total Taxa in 2017.

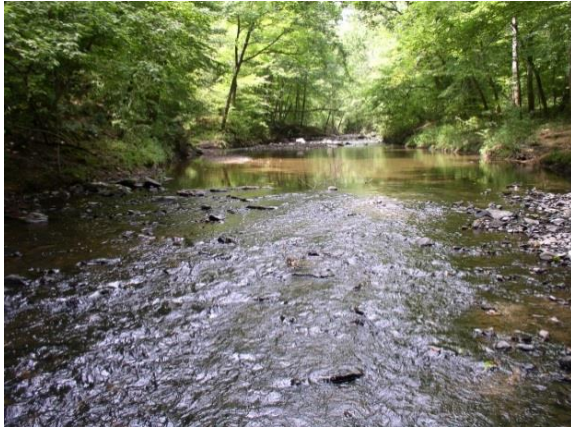
Figure 5. Morgan Creek Site 2 (Ashe Place), July 2017.

Morgan Creek 2 (Ashe Place). This site is located near the NC Botanical Garden and is downstream of University Lake. Although this part of Morgan Creek is located in a residential area, there is a forested buffer zone along most of the stream.

There was good rocky substrate in the riffles, but pools areas were being filled in by sand deposition. Flows were very low in 2016, only being visible in the riffles, but were better in 2017.

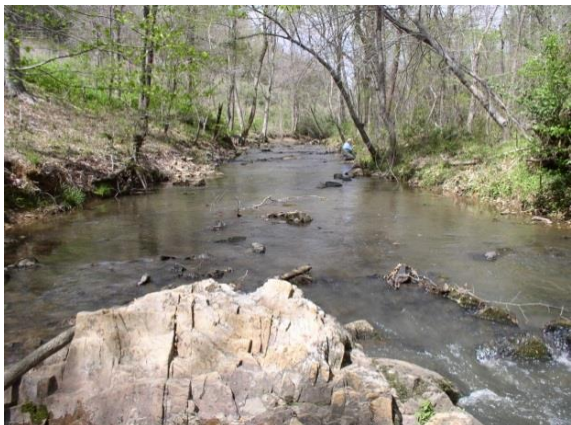
Figure 6. Morgan Creek Site 1 (NC 54), April 2017.

Morgan Creek 1 (NC 54). Morgan Creek has been used as a reference site for Carrboro surveys, although this stream is frequently affected by droughts. This catchment has a largely rural character. Habitat quality, stream width, and substrate composition are similar to Bolin Creek.

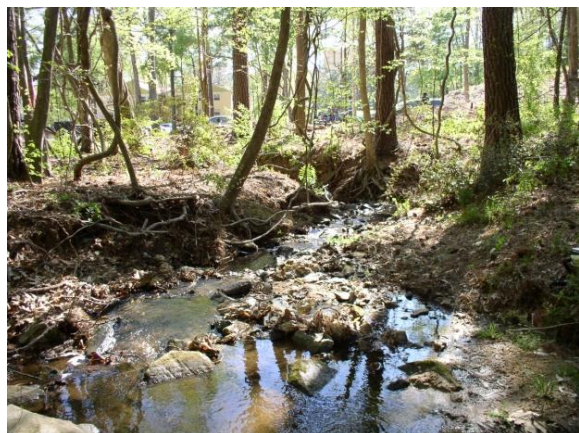
Figure 7. Pritchard Branch, April 2017.

Pritchard Branch. Pritchard Branch is a tributary of Morgan Creek in the southwest portion of Chapel Hill. Although this is a naturally rocky stream, there have been large inputs of sand. Pritchard Branch drains the southern part of downtown Chapel Hill.

The stream appears both entrenched and widened by erosion. The invertebrate fauna was sparse in 2017. Conductivity values were moderately elevated in 2017 (262 $\mu\text{S}/\text{cm}$) at the time of the invertebrate collections.

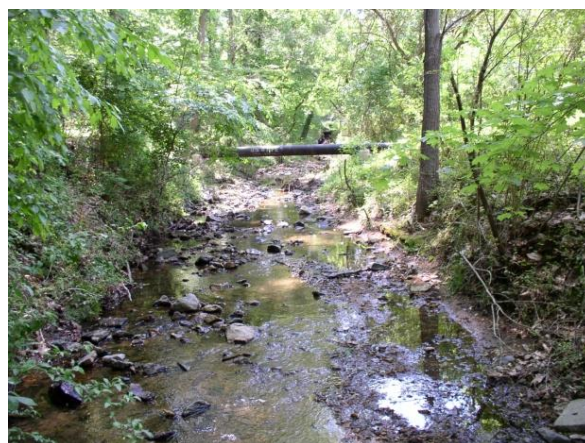
Figure 8. Mill Race Branch, April 2017.

Mill Race Branch. Mill Race Branch is located in a largely residential area, and receives stormwater from downtown Chapel Hill. A portion of this stream is also piped through a parking lot upstream. Mill Race Branch was sampled off Bolinwood Drive, just above its confluence with Bolin Creek. The substrate is largely gravel and sand, but with small rocky riffles areas.

In 2017, there was little periphyton growth on rocks, and the fauna was very sparse. Conductivity values were moderately elevated (274 $\mu\text{S}/\text{cm}$) in 2017.

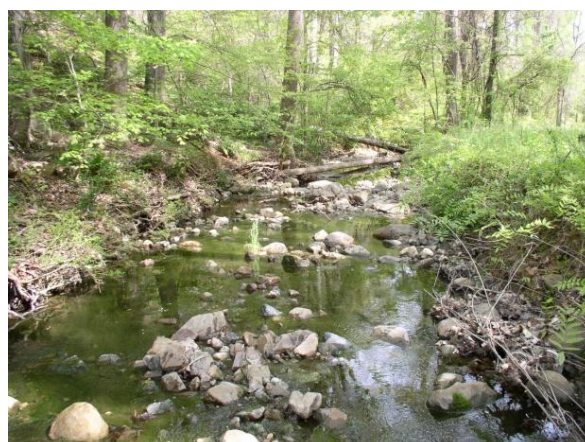
Figure 9. Tanyard Branch, April 2017.

Tanyard Branch. Tanyard Branch is a small stream (2 meters wide) that was sampled near the end of Carver Street, accessed via Umstead Park.

There is a forested riparian zone, but the stream runs through a heavily developed residential area and receives substantial stormwater from W. Franklin Street (downtown Chapel Hill). The stream substrate was rocky, but 40-80% was embedded with sand and was covered by a thick mat of filamentous algae. Conductivity values were highly elevated (364 $\mu\text{S}/\text{cm}$) at the time of the invertebrate collections.

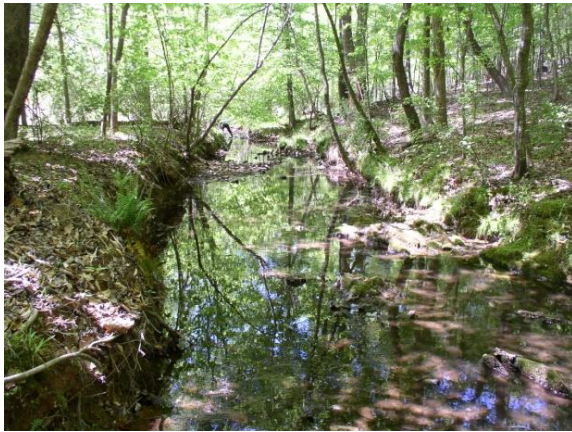
Figure 10. Old Field Creek, April 2017.

Old Field Creek. Old Field Creek was sampled north of town, near the Chapel Hill Town Operations and Transit Center. The surrounding area is largely forested, but there is some development (including a landfill) further upstream.

The stream is very rocky (often having extensive areas of bedrock), with good root and leafpack habitat. The composition of the fauna suggested that this stream is sometimes intermittent, although there was still a small amount of flow when it was sampled in 2017. It was unclear why there were chicken feathers in the stream during the 2017 site visit. Conductivity was moderately elevated (271 $\mu\text{S}/\text{cm}$) at the time of the invertebrate collections in 2017.

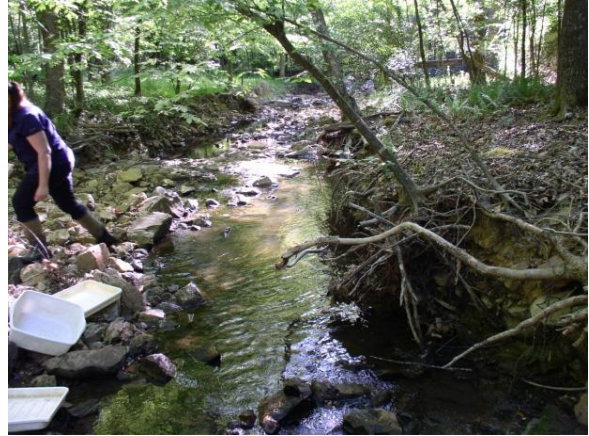
Figure 11. Cedar Fork at Brookview Drive, April 2017.

Cedar Fork 1, Brookview Drive. Cedar Fork is located in the northern section of Chapel Hill; it is one of the largest tributaries of Booker Creek (4 meters wide). The stream was sampled off Brookview Drive, just above a small lake (Eastwood Lake).

The surrounding land is an older residential area with large lots. Many of the houses, however, are placed very close to the stream. The substrate was rocky and there was severe bank erosion at bends. Conductivity was measured at 182 $\mu\text{S}/\text{cm}$ in 2017.

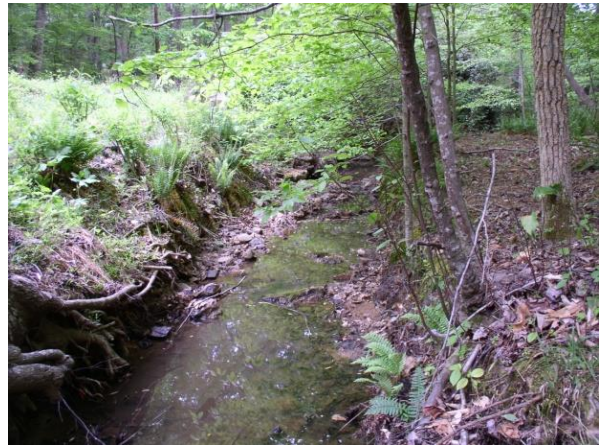
Figure 12. UT Cedar Fork, South of Brookview Drive, April 2017.

Unnamed Tributary (UT) 1 to Cedar Fork, South of Brookview Drive. This small (1 meter wide), shallow stream parallels Brookview Drive and is one of two tributaries that enter Cedar Fork between sites 1 and 2. The other tributary was not sampled because it was smaller and had even less flow.

The substrate was rocky and supported a large number of crayfish and larval salamanders. The conductivity (167 $\mu\text{S}/\text{cm}$) was less than the mainstem of Cedar Fork.

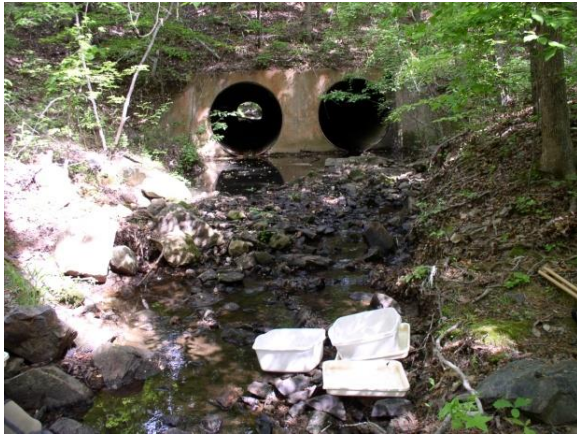
Figure 13. Cedar Fork 2, below Kenmore Drive, April 2017.

This segment of Cedar Fork had good habitat, with 65% boulder rubble substrate. There was a good buffer zone downstream of Kenmore Drive, but there was more development in the upstream area. The conductivity (205 $\mu\text{S}/\text{cm}$) and the fauna did not indicate good water quality.

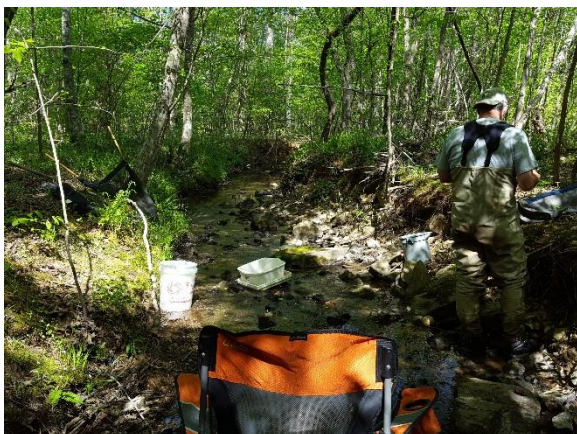
Figure 14. Booker Creek Site 1 (above MLK), April 2017.

This site is located above MLK Jr. Boulevard, downstream from Homestead Park, and is accessed via Northern Park Drive (Aquatics Drive). Booker Creek has a forested buffer next to the stream, but it drains a largely residential area. The substrate is rocky, but flows are low enough that this stream may have intermittent flow in some years.

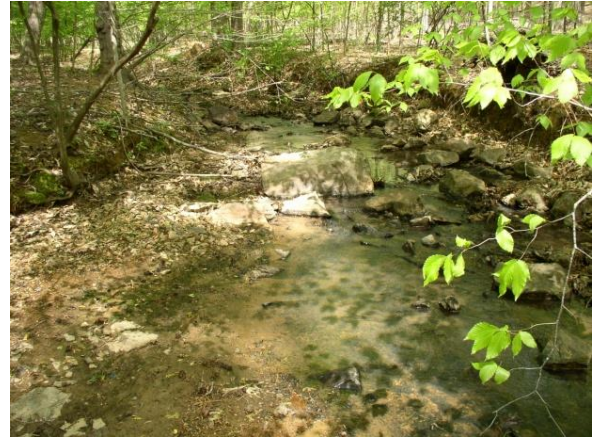
Figure 15. Booker Creek, above Piney Mountain Road, April 2017.

Booker Creek, above Piney Mountain Rd. This site is located above Piney Mountain Road. This is a rocky site with good habitat, very similar to Bolin Creek upstream in Carrboro.

Historic data from NCDWR collections have been evaluated as either Fair or Not Rated, with EPT taxa richness of 8-10 in spring collections. Conductivity here was moderate (220 $\mu\text{S}/\text{cm}$).

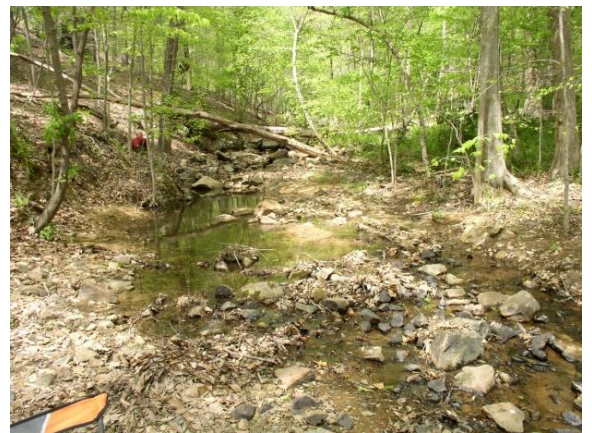
Figure 16. Cole Springs Branch, April 2017.

Cole Springs Branch was sampled near the end of Cedar Drive. This stream drains an older residential area with large lots and a good buffer zone; the area sampled was largely forested. This rocky stream had excellent habitat for aquatic fauna. The stream was mostly boulder and rubble with sand and gravel embedding some riffles. Given the relatively undisturbed watershed, conductivity was high (271 $\mu\text{S}/\text{cm}$) in 2017.

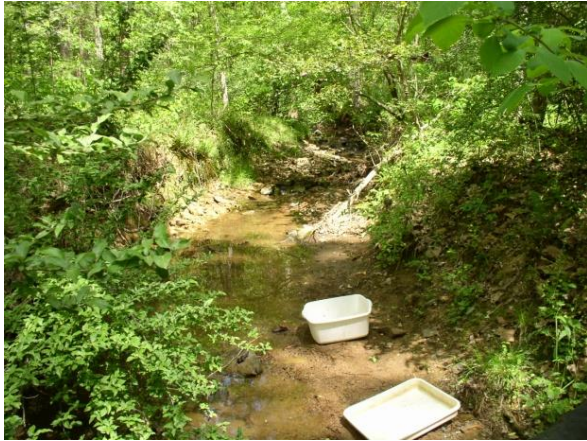
Figure 17. Jolly Branch, April 2017.

good rocky habitat, but showed severe bank erosion in many places.

The surrounding area was largely forested, although there are residential areas further upstream, as well as Chapel Hill High School and Smith Middle School. The aquatic life at Jolly Branch indicates that it may stop flowing (or go dry) during drought periods.

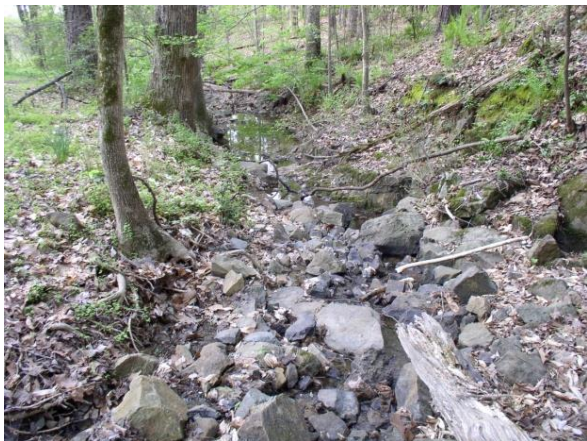
Figure 18. UT Bolin Creek near Severin Street, April 2017.

UT Bolin Creek near Severin Street. This very small stream (1-2 meters wide) was sampled at the end of Severin St, which was downstream of the usual sampling location. It is located in an older residential area with a forested buffer zone adjacent to the stream. The substrate was primarily boulder/rubble, with barely perceptible flow that may be largely subsurface. The fauna was limited, but contained several intolerant species.

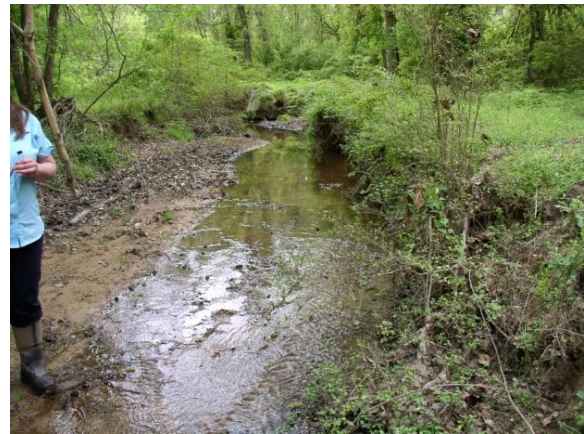
Figure 19. Battle Branch, April 2017.

Battle Branch. Battle Branch was sampled near Glendale Drive and the Weaver Road Greenway section of the Battle Branch Trail. This stream is located in an older residential area, with forest and hiking paths next to the stream. The substrate is largely sand and gravel, with occasional rubble riffles. Battle Branch was entrenched with severely eroding banks.

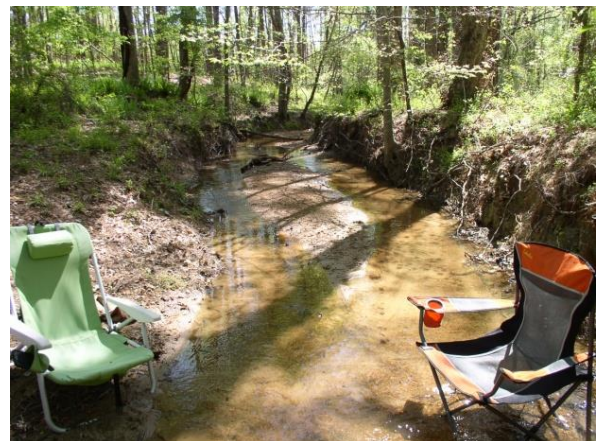
Figure 20. Fan Branch, April 2017.

Fan Branch below Parkview Drive. This site is located downstream from Parkview Crescent Drive. The stream channel for Fan Branch was entrenched and substrate composition was 95% sand and gravel. However, there was good bank and leaf pack habitat. The sampling site is within the Southern Village development, but there is a good buffer zone adjacent to the stream.

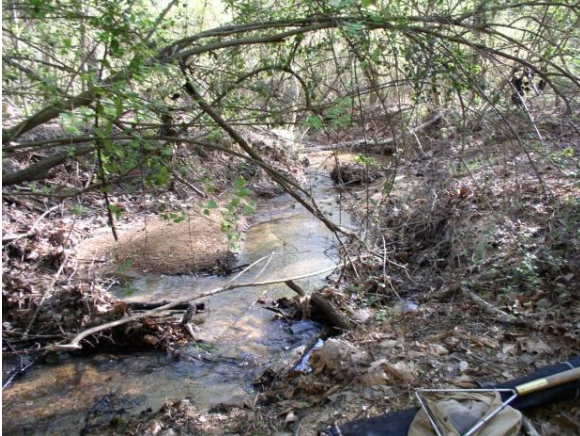
Figure 21. Wilson Creek 1 (above Wave Road), April 2017.

Wilson Creek 1, above Wave Road. This site is located upstream from Wave Road. Although it is intended as a control site, upper Wilson Creek is still a very sandy stream with gravel riffles. At the sampling site, there are many open areas adjacent to the stream. Despite the sand, the conductivity was low (126 $\mu\text{S}/\text{cm}$) and the invertebrate community was intolerant.

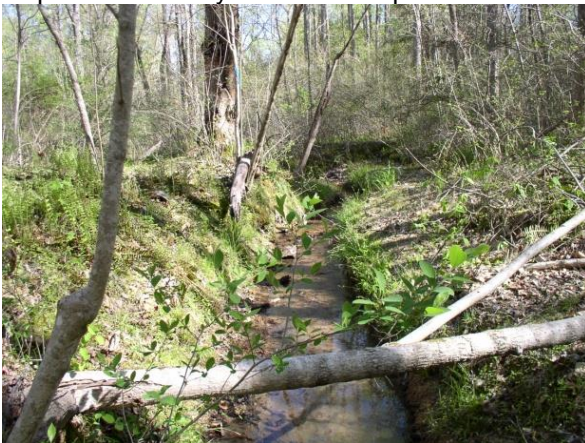
Figure 22. UT Wilson Creek within the Obey Creek development, April 2017.

UT Wilson Creek (Obey Creek Development). UT Wilson Creek was sampled for the first time in July 2016. The sample was collected at the mouth of a small (130 acres), undeveloped, catchment upstream from Wilson Creek 1A, which will be preserved as part of the Obey Creek development.

Although this stream was very small and very sandy (90% gravel, sand and silt), it supported a surprisingly diverse invertebrate community in 2017 and had the lowest conductivity of all sites sampled (111 $\mu\text{S}/\text{cm}$).

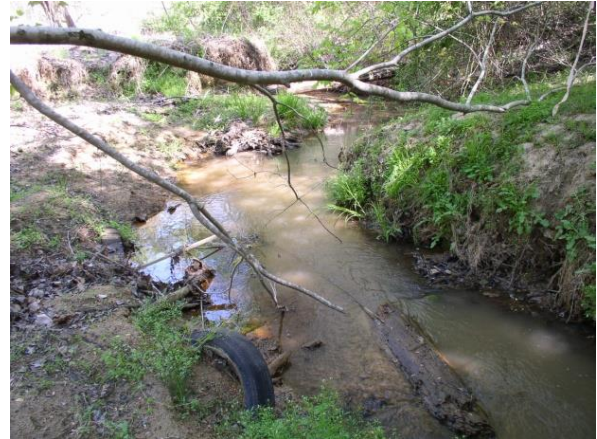
Figure 23. Wilson Creek within the Obey Creek Development, April 2017.

Wilson Creek 1A (Obey Creek Development). This site is located behind Strata Solar, within the Obey Creek Development site. This stream was sampled for the first time in 2016. It is a sandy stream with bank erosion, but prior samples upstream and downstream have indicated good water quality. This section of stream appears to carry a heavy sediment load, as evidenced by the half-buried tire.

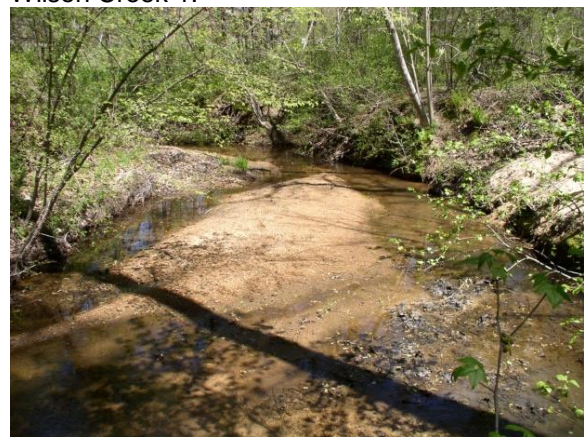
Figure 24. Wilson Creek 2 above Arlen Park Drive, April 2017.

Wilson Creek 2, above Arlen Park Drive. Wilson Creek was sampled above Arlen Park Drive, in a residential area of the Southern Village development. The upstream area is an older residential area (mostly forest) with large lot sizes. The stream continues its sandy character; however, there is also adequate habitat for invertebrates. This part of Wilson Creek probably has more permanent flow than Wilson Creek 1.

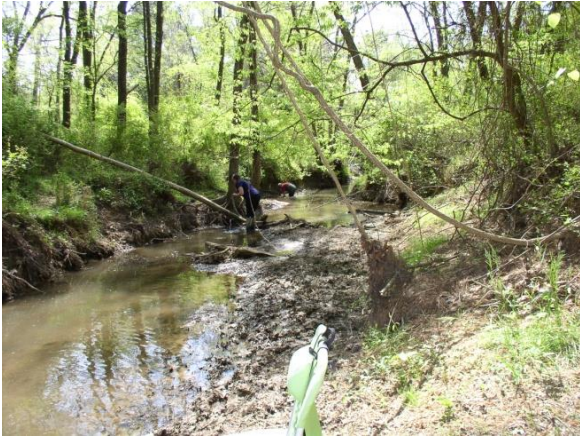
Figure 25. Booker Creek above Tadley Greenway, April 2017.

This site is located just below the confluence of Booker Creek and Cedar Fork and Eastwood Lake. The substrate was primarily sand, silt and clay. While there was very little flow when the stream was sampled, the banks were severely eroded.

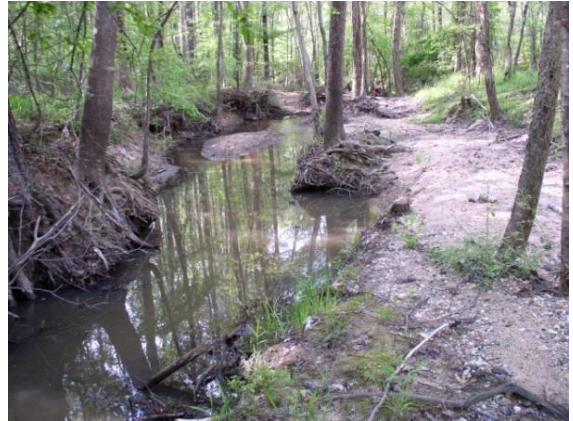
Figure 26. Booker Creek below Willow Drive, April 2017.

This segment of Booker Creek drains a largely residential catchment. The stream appears to have been channelized at some time, with a very entrenched channel. The substrate is entirely sand and clay. In 2017, there was a heavy growth of filamentous algae and small patches of a petroleum sheen on the water.
