ACCESSIBILITY AUDIT

CHAPEL HILL TOD PLANNING & UDO VISIONING STUDY

December 2022

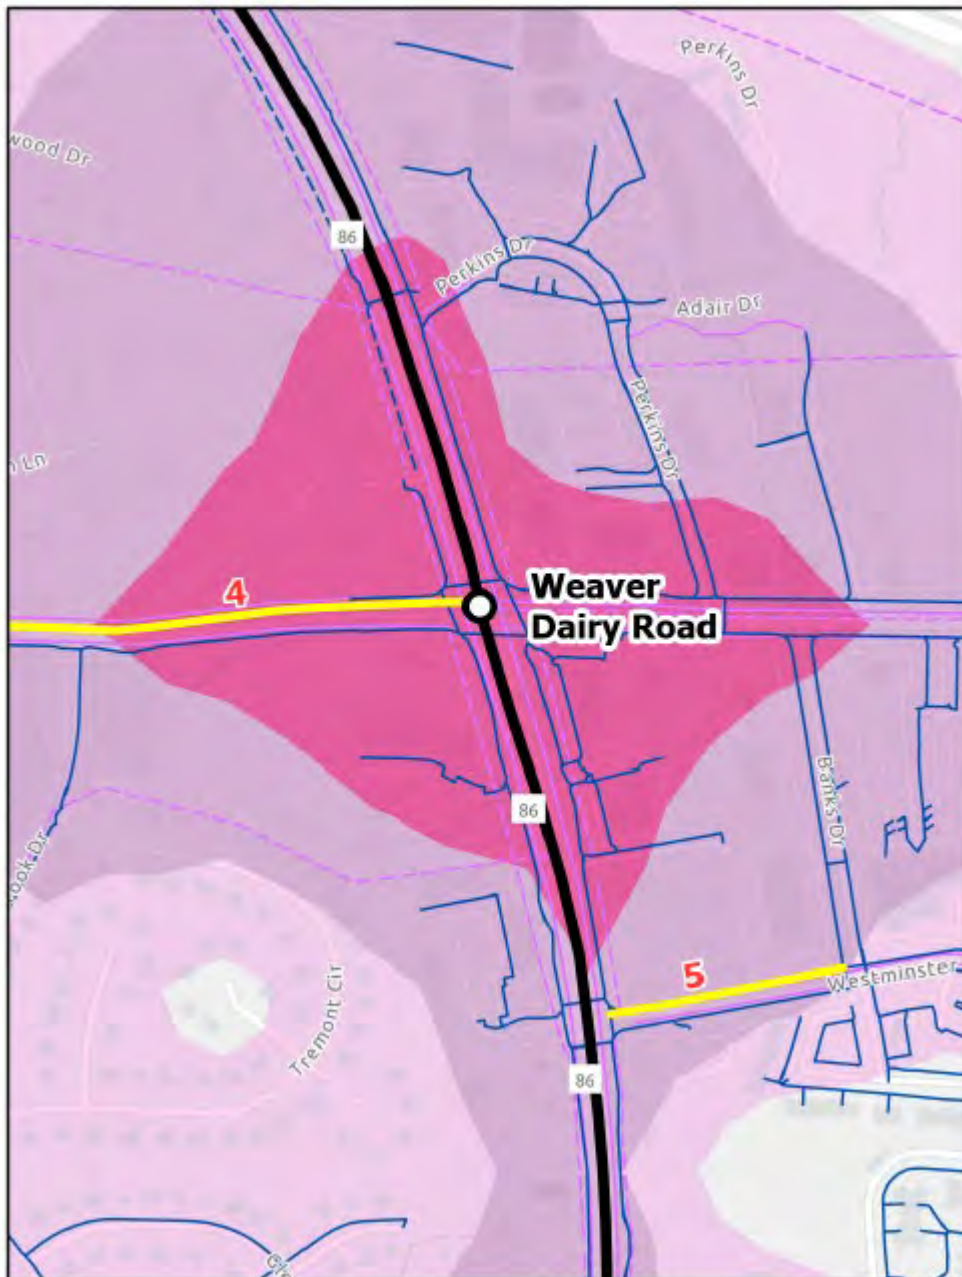
Network Gaps - Weaver Dairy Road

No.	Station	Description	Recommendations/Transit Equity Recommendations
4	Weaver Dairy Road	Sidewalk ends north side.	2,110 LF Sidewalk Extension, dependent upon development and construction of Butterfield Court connection.
5	Weaver Dairy Road	Sidewalk is not compliant along the north side of Westminister Drive.	380 LF Sidewalk Reconstruction

- Sidewalk gap (4): Extend sidewalk on the north side of Weaver Dairy Road 2,110 linear feet to connect with a future Butterfield Court. This recommendation is dependent upon that roadway connection being completed.
- Sidewalk upgrade (5): Reconstruct 380 linear feet of sidewalk on the north side of Westminster Drive.

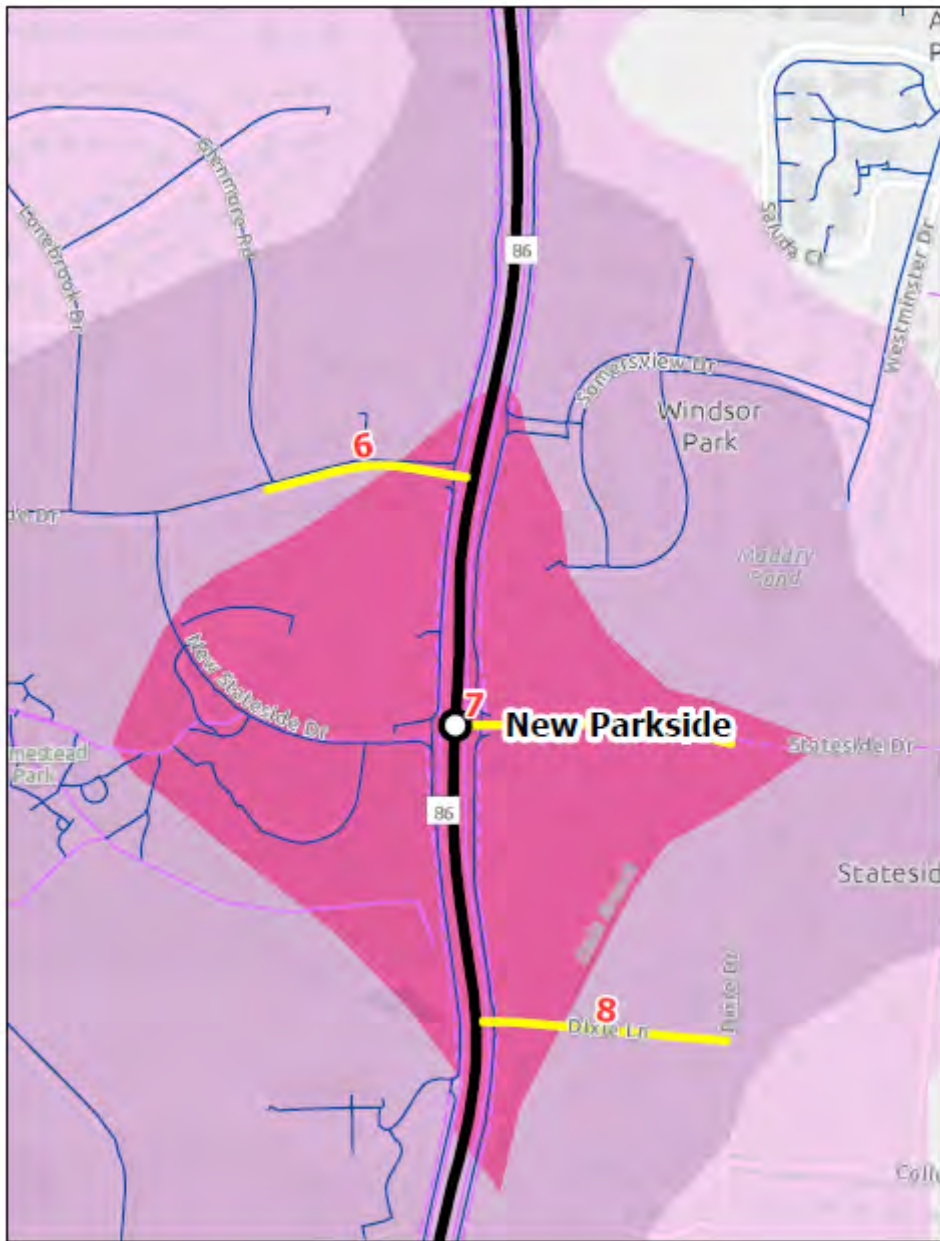
Network Gaps - New Parkside

- Sidewalk gap (6): On New Parkside Drive no sidewalk is present along the south side to connect with existing sidewalk and ADA-compliant curb ramp crossing at New Stateside Drive. The sidewalk is not accessible along the north side today due to a missing curb ramp at New Stateside Drive. In addition to the sidewalk, no crossing of Martin Luther King Jr. Boulevard exists at New Parkside Drive.
- Sidewalk gap (7): On Stateside Drive no sidewalk exists today. In addition to the sidewalk, no crossing of Martin Luther King Jr. Boulevard exists at Stateside Drive.
- Sidewalk gap (8): On Dixie Lane no sidewalk exists today. In addition to the sidewalk, no crossing of Martin Luther King Jr. Boulevard exists at Dixie Lane.

No.	Station	Description	Recommendations/Transit Equity Recommendations
6	New Parkside	No sidewalk south side of New Parkside Drive	750 LF sidewalk extension
7	New Parkside	No sidewalk either side of Stateside Drive	Minimum 700 LF sidewalk extension
8	New Parkside	No sidewalk either side of Dixie Lane	660 LF sidewalk extension

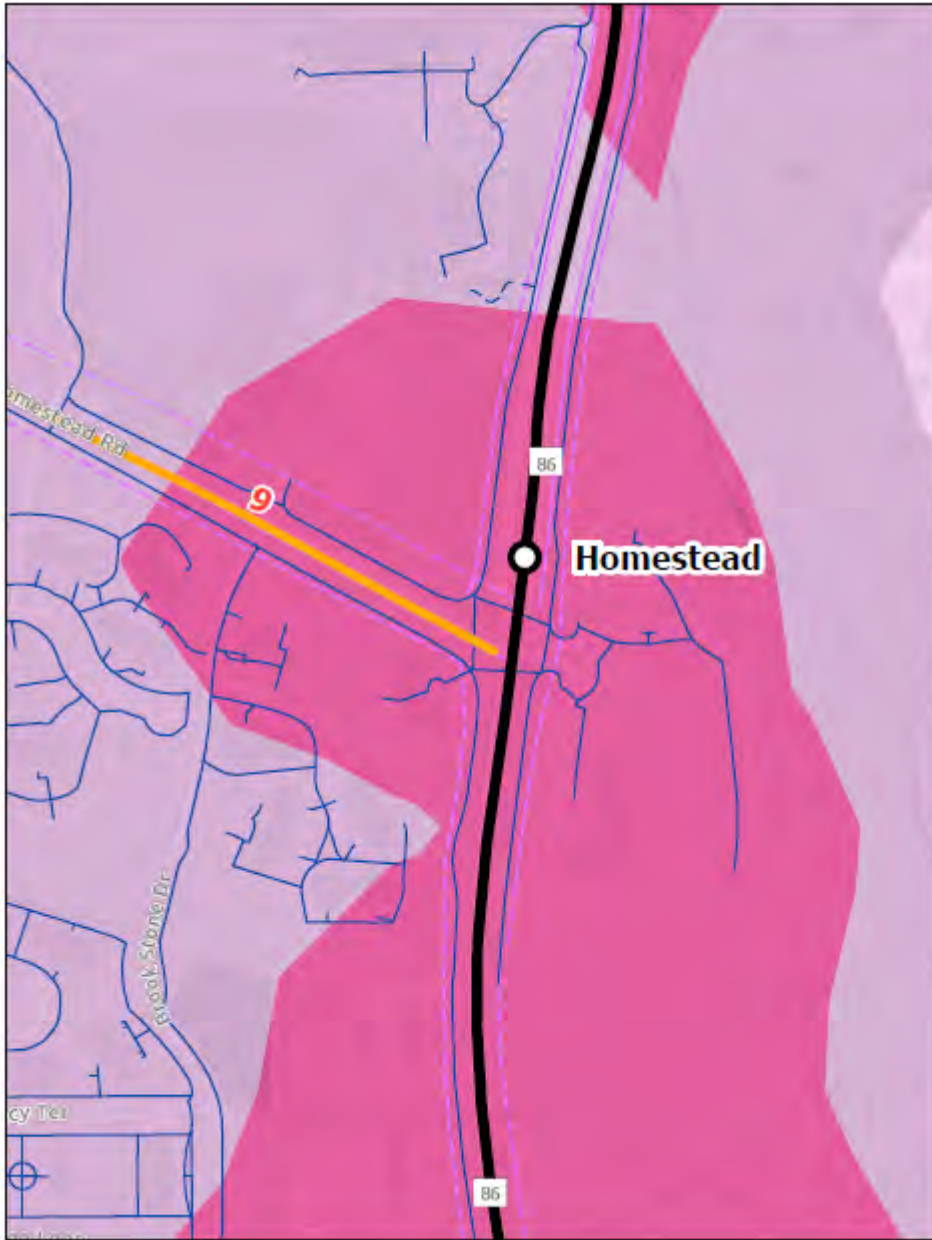
Network Gaps - Homestead

No.	Station	Description	Recommendations/Transit Equity Recommendations
9	Homestead	No dedicated bike facilities along Homestead from MLK to trail entrance	2,500 LF sharrow or bikeable road conversion

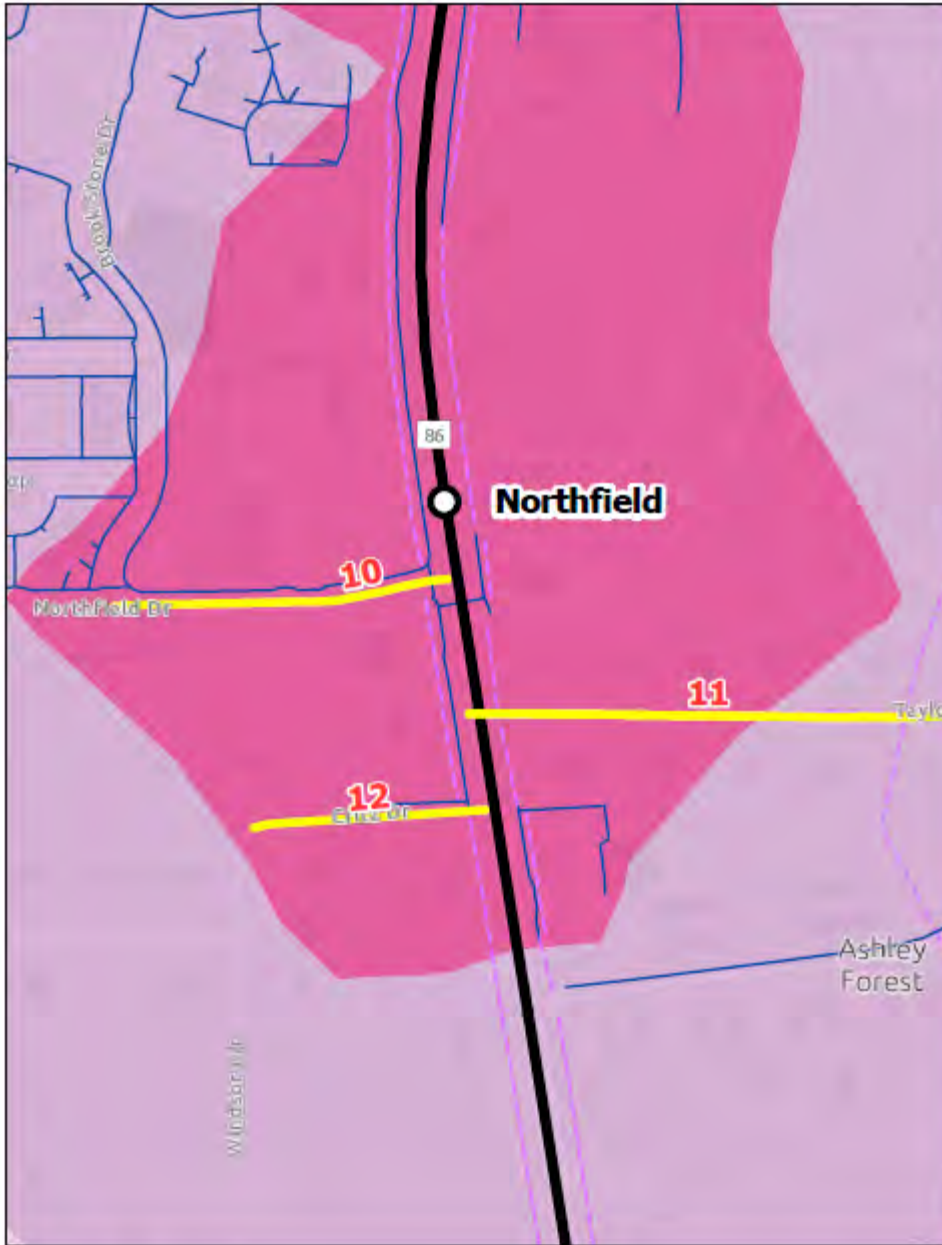
Network Gaps - Northfield

No.	Station	Description	Recommendations/Transit Equity Recommendations
10	Northfield	No sidewalk south side of Northfield Drive.	Min 500 LF Sidewalk Extension - If development occurs on south side of Northfield Drive
11	Northfield	No sidewalk either side of Taylor Street	1,350 LF Sidewalk Extension
12	Northfield	No sidewalk either side of Critz Dr. and crossing gap of MLK	Min 400 LF Sidewalk Extension and Crossing of MLK

- Sidewalk gap (10): Extend sidewalk on the south side of Northfield Drive a minimum of 500 linear feet though this recommendation is dependent upon future development of the area.

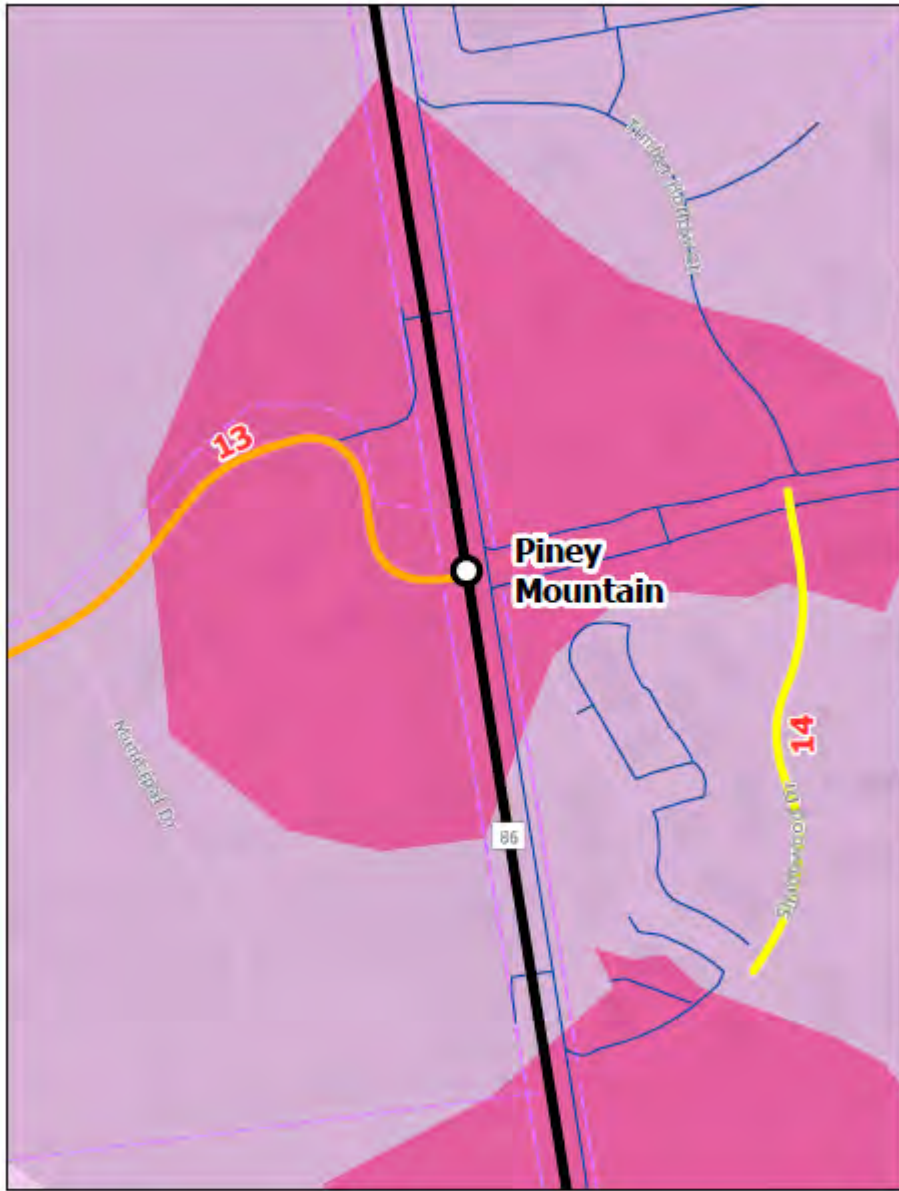
Network Gaps - Piney Mountain

No.	Station	Description	Recommendations/Transit Equity Recommendations
13	Piney Mountain	No dedicated bike facility or sidewalk along Municipal Drive connecting MLK to nearby greenway.	Min 1,500 LF sharrow or bikeable road conversion and sidewalk
14	Piney Mountain	No sidewalk down south side of Shadowood Dr.	Min 350 LF Sidewalk Extension

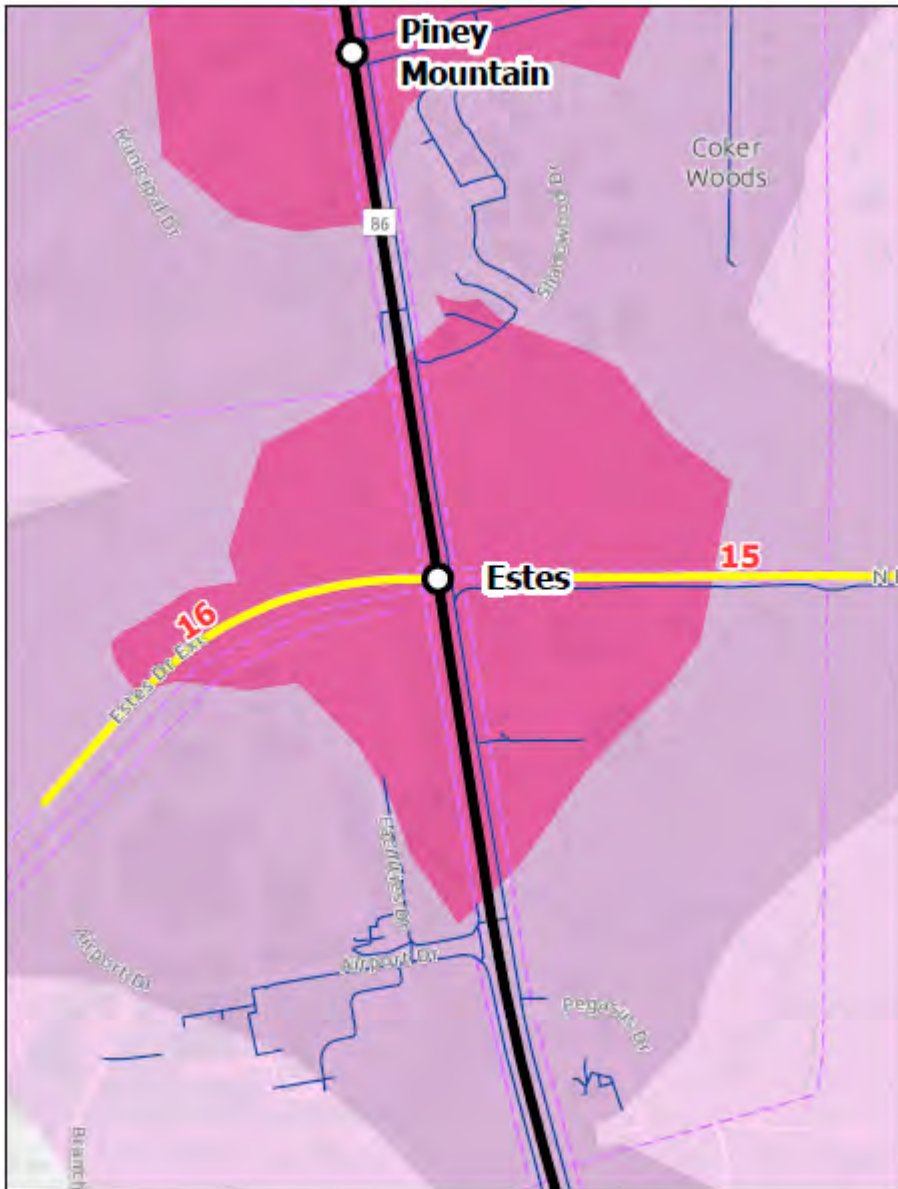
Network Gaps - Estes

No.	Station	Description	Recommendations/Transit Equity Recommendations
15	Estes	3-4 foot, not compliant, asphalt walkway along east side of Estes Drive.	Min 1,500 LF Sidewalk Widening to Compliance
16	Estes	No sidewalk along west leg of Estes.	Min 700 LF Sidewalk Extension

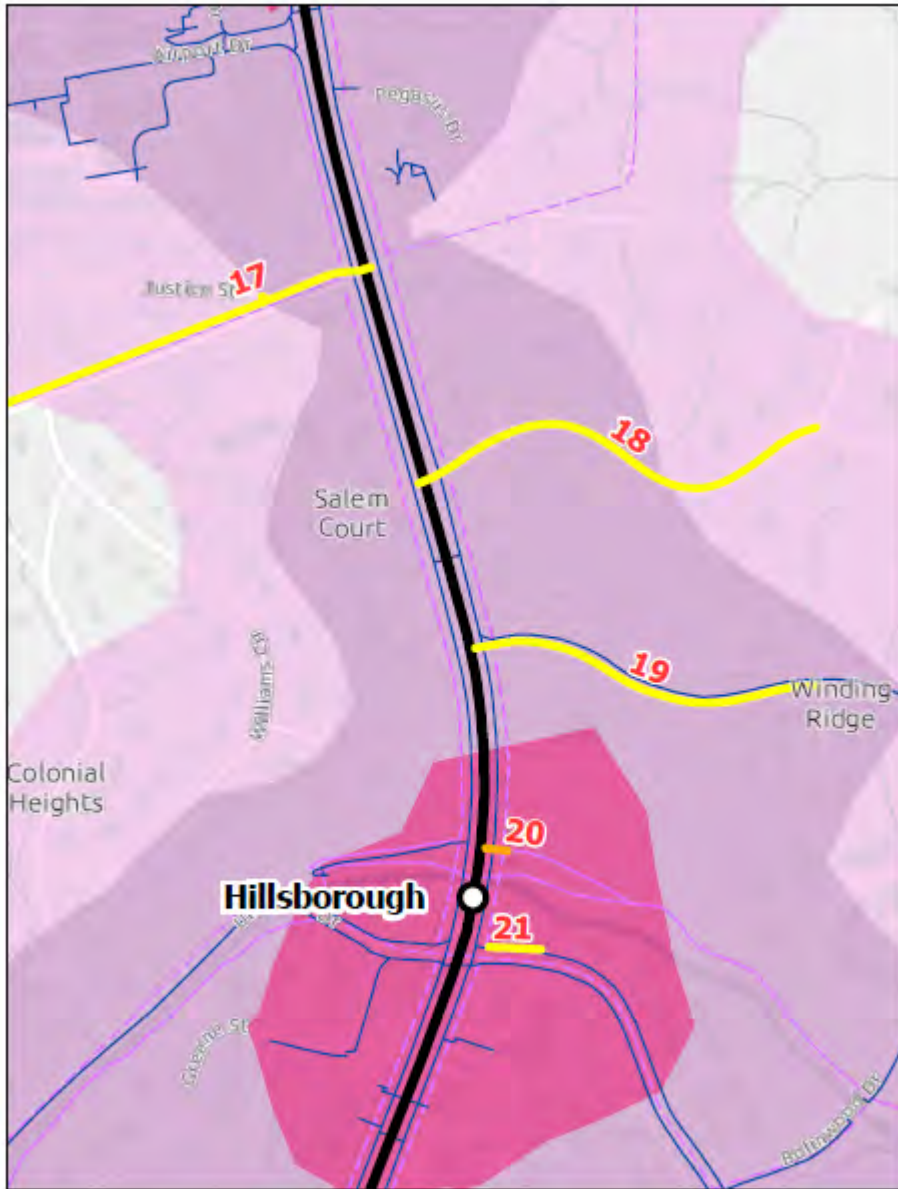
Network Gaps - Hillsborough

Two sidewalk gaps were identified along Barclay Road and Mt. Bolus Road, two sidewalk gaps and/or areas of non-ADA compliance along Bolinwood Drive and Hillsborough Street, and a missing access point to the Bolin Creek Greenway.

No.	Station	Description	Recommendations/Transit Equity Recommendations
17	Hillsborough	No sidewalk down Barclay St, No crossing over MLK.	3,500 LF Sidewalk Extension down Barclay St and Crossing of MLK
18	Hillsborough	No sidewalk down Mt Bolus Rd	Min 1,200 LF Sidewalk Extension
19	Hillsborough	Noncompliance, narrow sidewalk along Bolinwood Drive.	Min 1,500 LF Sidewalk Widening to Compliance
20	Hillsborough	No curb cut or dedicated access from MLK bike shoulder to greenway entrance, limited greenway access	Installation of accessible curb cut and integration with MLK on-road bike, add stairwell west side, and widen west sidewalk access to greenway
21	Hillsborough	Sidewalk on Hillsborough Street ends at gas station with ADA issues along the property.	Min 900 LF Sidewalk Extension + 100 LF Sidewalk Widening to Compliance

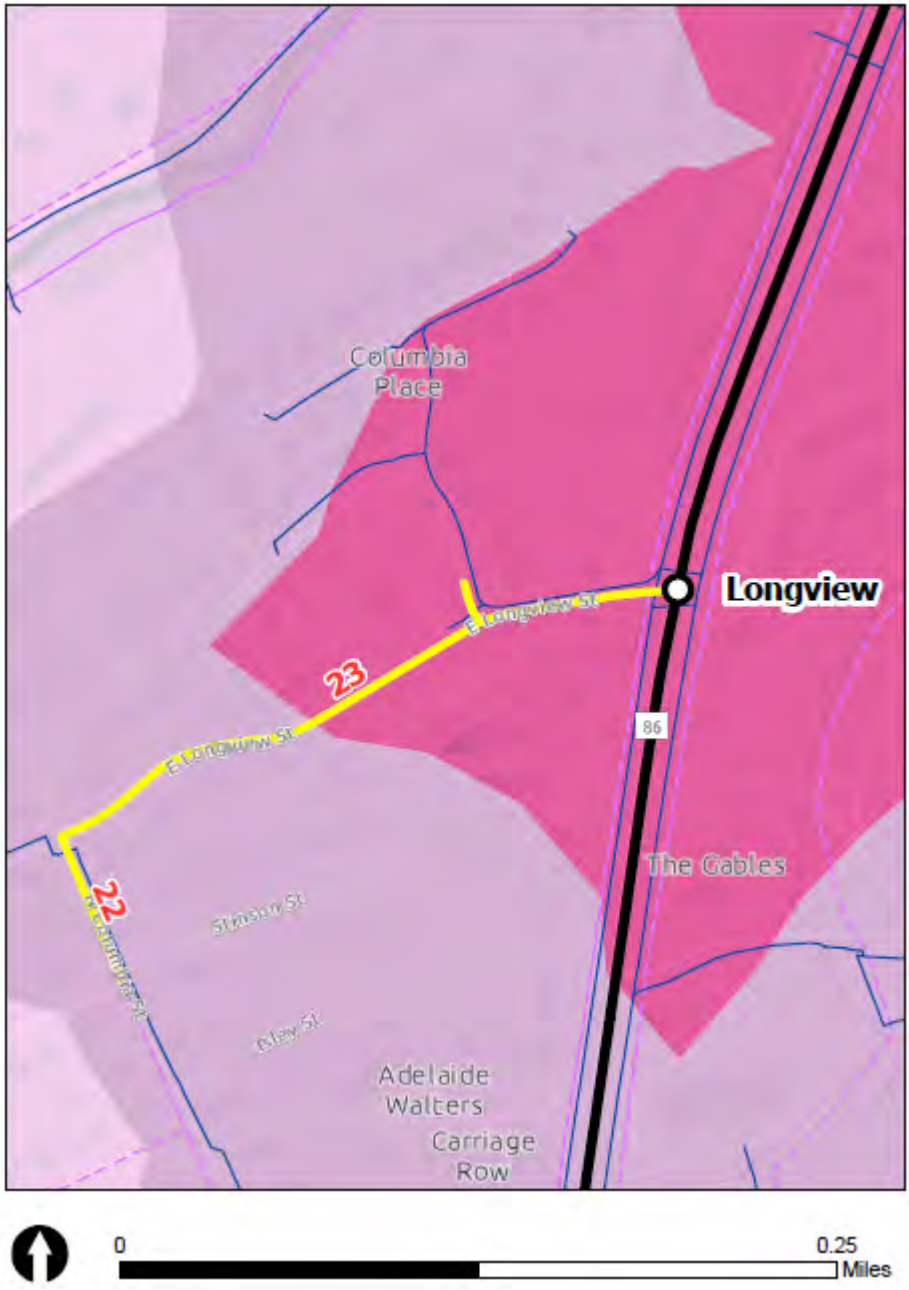
Network Gaps - Longview

No.	Station	Description	Recommendations/Transit Equity Recommendations
22	Longview	Sidewalk inconsistent along North Columbia Street.	Sidewalk Extension or Dedicated Pedestrian Crossing where Sidewalks Change Sides
23	Longview	No sidewalk, goat path on south side of west leg of East Longview Street.	350 LF Sidewalk Extension

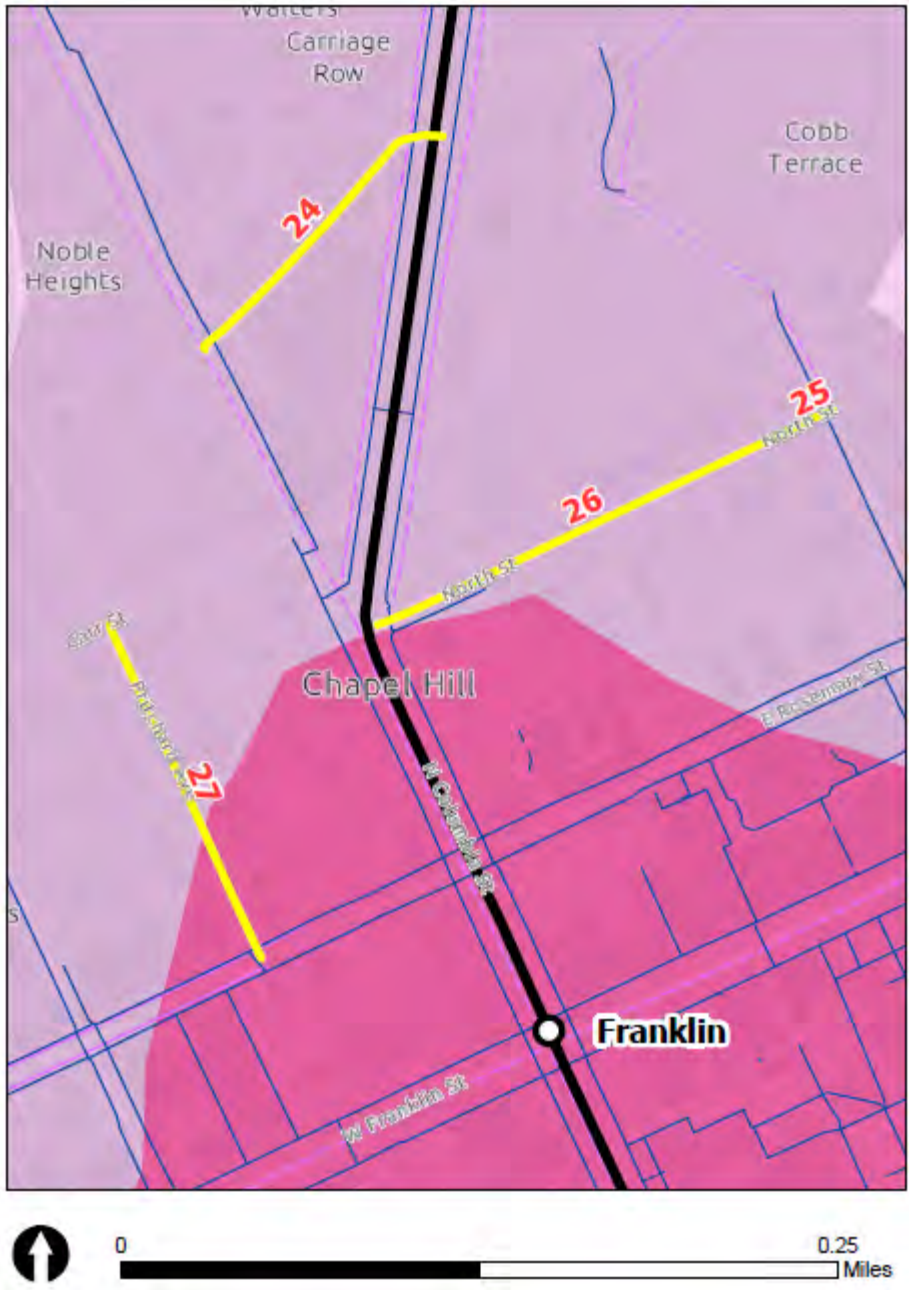
Network Gaps - Franklin

No.	Station	Description	Recommendations/Transit Equity Recommendations
24	Franklin	Sidewalk ends around corner from MLK Blvd. and Stephens Street, sidewalk only 30 LF on one side of Stephens.	Min 500 LF Sidewalk Extension
25	Franklin	Curb ramps blocked and inaccessible at corner of North Street and Henderson Street.	Reconstruct to Compliance
26	Franklin	No sidewalk either side of North Street.	Min 900 LF Sidewalk Extension on north Side of North Street
27	Franklin	No sidewalk either side of Pritchard Ave.	Min 650 LF Sidewalk Extension on east side of Pritchard Avenue

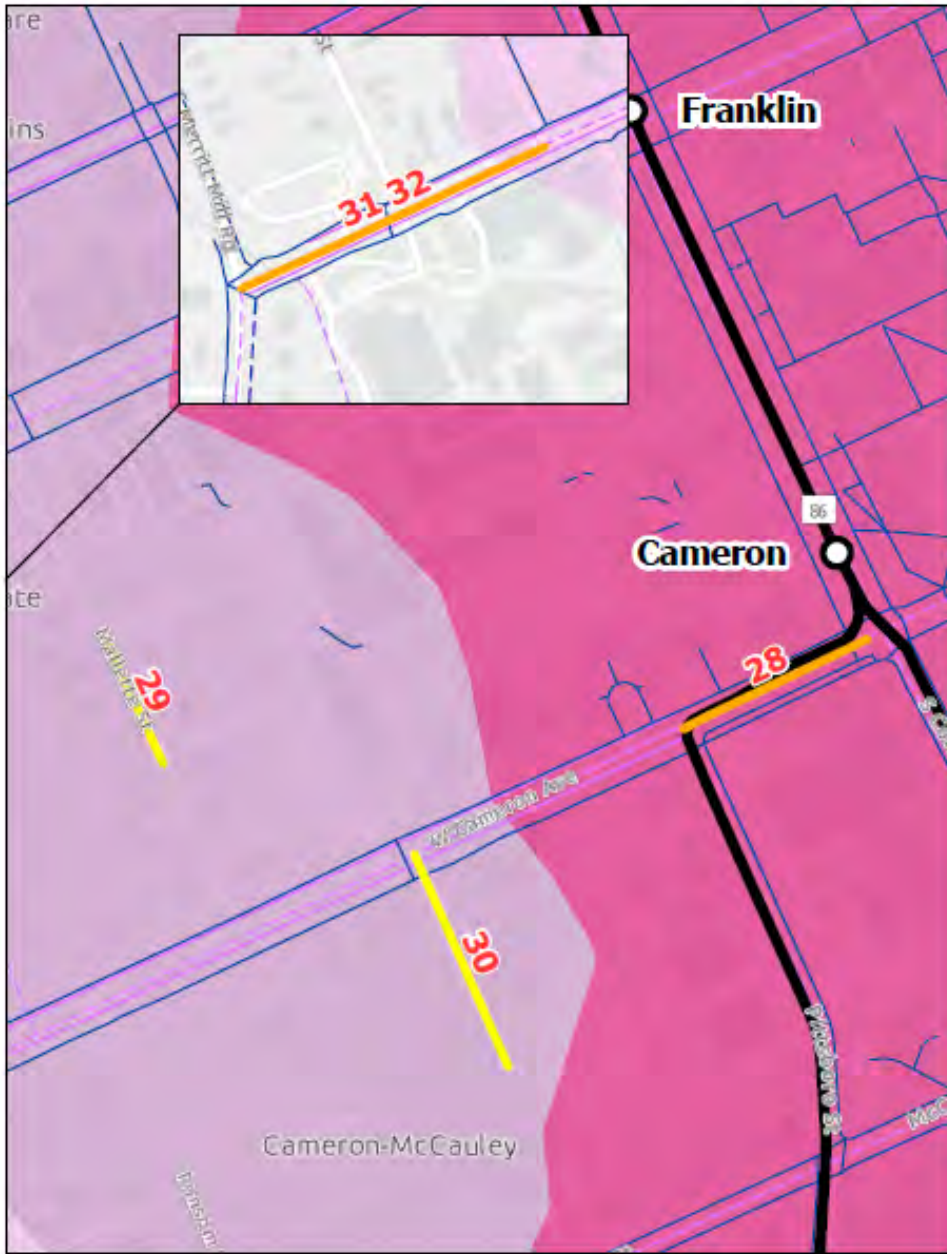
Network Gaps - Cameron

There are seven gaps and deficiencies identified in the Cameron Station area that include impacts to the sidewalk network and bike lanes.

- Sidewalk deficiency (28a): The sidewalk on the north side of Cameron Avenue is made of brick and has several missing or uneven individual bricks. The sidewalk is also elevated above street level, posing challenges to grades at crossing locations.

- Sidewalk deficiency (28b): The sidewalk on the south side of Cameron Avenue is made of brick and is elevated above street grade. There are three large specimen trees with trunks growing immediately adjacent to the sidewalk that are causing issues with root flare and brick displacement.

- Sidewalk deficiency (29): The sidewalk along Mallette Street between Dawson Alley and West Franklin Street is narrow and obstructed by utility poles. The walk surface is brick.

- Sidewalk gap (30): The sidewalk along Wilson Street is inconsistent and is in poor condition where it does exist. There are no pedestrian curb ramps present.

No.	Station	Description	Recommendations/Transit Equity Recommendations
28a	Cameron	Missing bricks, steep slope along West Cameron Ave.	Redesign sidewalk or provide accessible alternate route on north end of Cameron
28b	Cameron	Sidewalk on West Cameron not compliant though tree important.	Redesign sidewalk or provide accessible alternate route on north end of Cameron
28c	Cameron	Bike lane/shoulder gap on West Cameron Avenue, ends abruptly across Pittsboro.	380 LF Bikeable Road Conversion
29	Cameron	Noncompliant, narrow and inaccessible sidewalk along Mallette Street.	Min 250 Sidewalk Redesign to Compliance
30	Cameron	Inconsistent sidewalk along Wilson Street, goat path present.	400 LF Sidewalk Extension
31	Cameron	No perpendicular crossing for bikes over RR crossing at Cameron & Merritt Hill Road.	Re-align bike lane to approach RR crossing at perpendicular angle
32	Cameron	No dedicated bike facility on eastbound side of Cameron, clearly well used.	2,000 LF bike lane or Bikeable Road Conversion along south side of West Cameron Ave.

- Sidewalk deficiency (28a): Redesign the sidewalk along the north side of West Cameron Avenue using concrete to provide an accessible walkway.
- Sidewalk deficiency (28b): Redesign the sidewalk along the south side of West Cameron Avenue using concrete to provide an accessible walkway. This may impact specimen trees which are causing the surface of the sidewalk to break.
- Bike lane gap (28c): Install 380 linear feet of Bikeable Road Conversion along West Cameron Avenue between Pittsboro Street and campus.
- Sidewalk deficiency (29): Install 250 linear feet of new sidewalk on the east side of Mallette Street that is wide enough for pedestrian access around the utility poles.
- Sidewalk gap (30): Install 400 linear feet of sidewalk to replace the inconsistent existing sidewalk to create continuous pedestrian access.

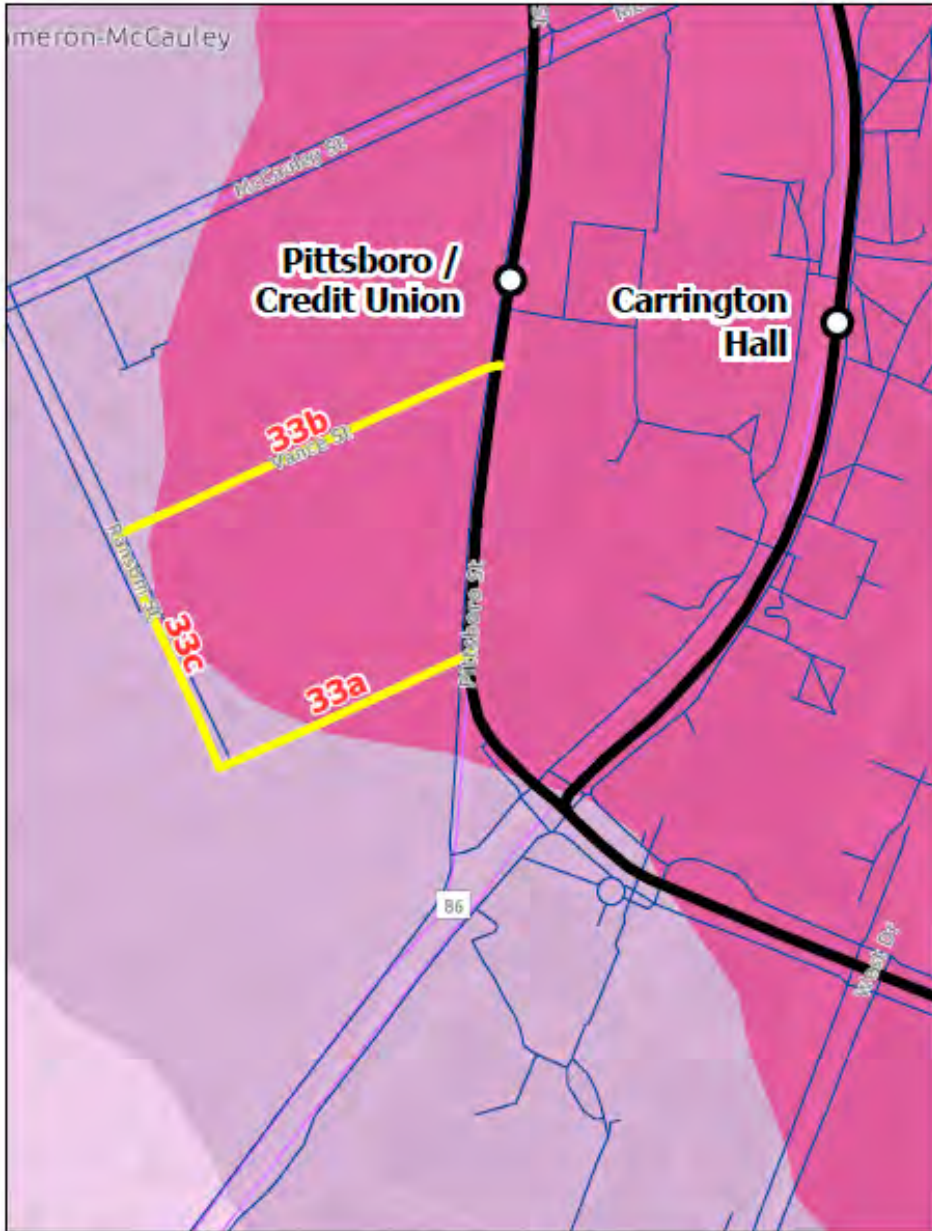
Network Gaps - Pittsboro / Credit Union

- Sidewalk gap (33a): Gaps in the existing sidewalk along West University Drive between Pittsboro Street and Briar Bridge Lane.
- Sidewalk gap (33b): No sidewalk exists along the south side of Vance Street, though a well-worn goat path exists in this location, extending to Ransom Street.
- Sidewalk gap (33c): A well-worn goat path exists along the east side of Ransom Street.

No.	Station	Description	Recommendations/Transit Equity Recommendations
33a	Pittsboro/ Credit Union	Sidewalk gaps along University	450 LF Sidewalk Extension
33b	Pittsboro/ Credit Union	Sidewalk gaps, well-worn goat path present along Vance	700 LF Sidewalk Extension on Vance Street
33c	Pittsboro/ Credit Union	Sidewalk gaps, well-worn goat path present along Ransom	430 LF Sidewalk Extension on Ransom Street

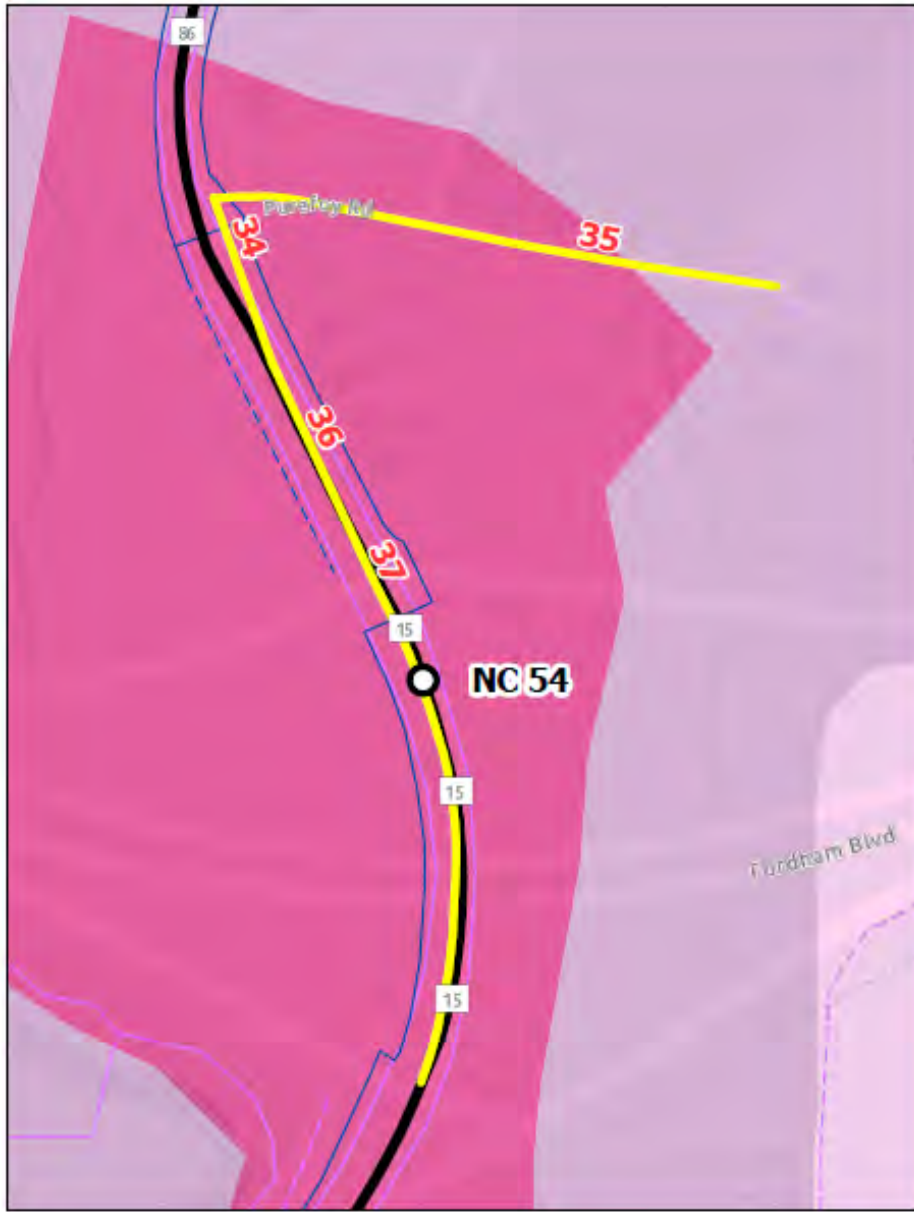
Network Gaps - NC 54

There are four gaps and deficiencies identified in the NC 54 Station Area that impact pedestrian and bicycle movement. These include:

- Sidewalk gap (34): There is no sidewalk present on the west side of South Columbia Street between Purefoy Road and the NC 54 intersection, though a goat path is present indicating a desirable location for pedestrian use.
- Sidewalk gap (35): There is no sidewalk on either side of Purefoy Road east of South Columbia Street.
- Sidewalk Deficiency (36): The sidewalk on the east side of South Columbia Street between Purefoy Road and NC 54 is less than four-feet wide and is non-compliant.
- Sidewalk gap (37): There is no sidewalk on the east side of South Columbia Street at the NC 54 offramp extending south to Mt Carmel Road.

- Sidewalk gap (34): Extend the sidewalk 500 linear feet on the west side of South Columbia Street between Purefoy Road and the NC 54 intersection.
- Sidewalk gap (35): Extend at least 650 linear feet of sidewalk on both sides of Purefoy Road east of South Columbia Street.
- Sidewalk Deficiency (36): Reconstruct 500 linear feet of sidewalk on the east side of South Columbia Street between Purefoy Road and NC 54 to six feet wide.
- Sidewalk gap (37): This issue will be resolved with a new compliant sidewalk on the west side. Once completed, install signage and barriers to keep pedestrians from walking on the east side.

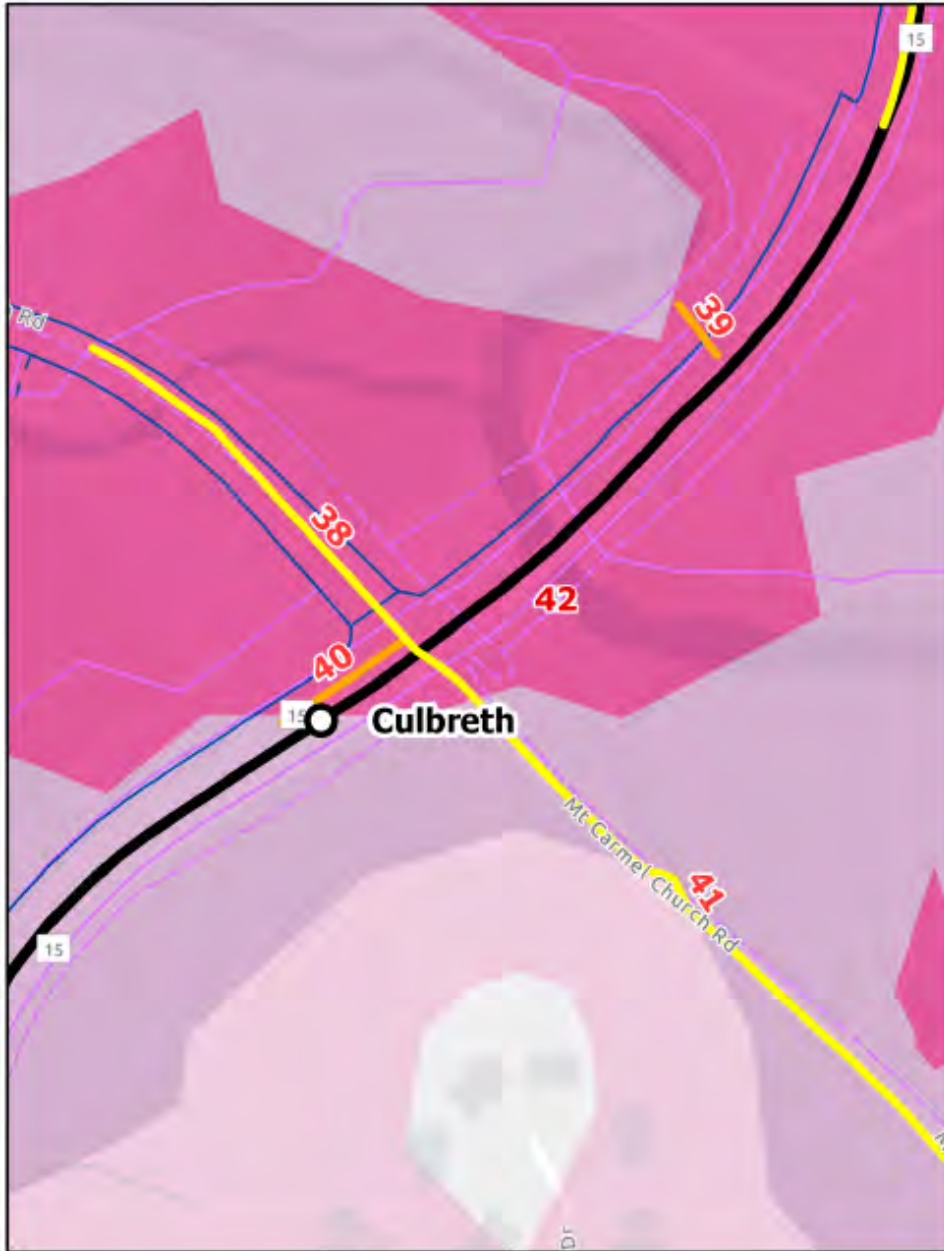
Network Gaps - Culbreth

There are five deficiencies and gaps in the sidewalk and sidepath network in the Culbreth Station area. These include:

- Sidewalk Deficiency (38): There is a non-compliant sidewalk that is less than four feet wide on Culbreth Road between the middle school entrance and Culbreth Park Drive.
- Sidepath Deficiency (39): There is no curb cut from the bike lane on South Columbia Street to access the Morgan Creek Trail at the trail access on the north side of Culbreth Road.
- Sidepath Deficiency (40): There is no access to the Morgan Creek Trail access path from South Columbia Street on the south side of Culbreth Road. Cyclists must cut into Culbreth Road to access the sidepath.
- Sidewalk gap (41): There is no sidewalk on either side of Mt. Carmel Church Road on the east side of South Columbia Street.
- Sidepath gap (42): There is no sidepath connection on the east side of the Morgan Creek Bridge on South Columbia Street.

- Sidewalk Deficiency (38): Widen 400 linear feet of sidewalk on Culbreth Road between the middle school entrance and Culbreth Park Drive.
- Sidepath Deficiency (39): Install an accessible curb cut from the bike lane on South Columbia Street to access the Morgan Creek Trail at the trail access on the north side of Culbreth Road.
- Sidepath Deficiency (40): Install an accessible access to the Morgan Creek Trail from South Columbia Street on the south side of Culbreth Road.
- Sidewalk gap (41): Construct 650 linear feet of sidewalk on one or both sides of Mt. Carmel Church Road on the east side of South Columbia Street.
- Sidepath gap (42): Widen bridge to accommodate pedestrians or facilitate all pedestrian activity on the west side of the bridge.

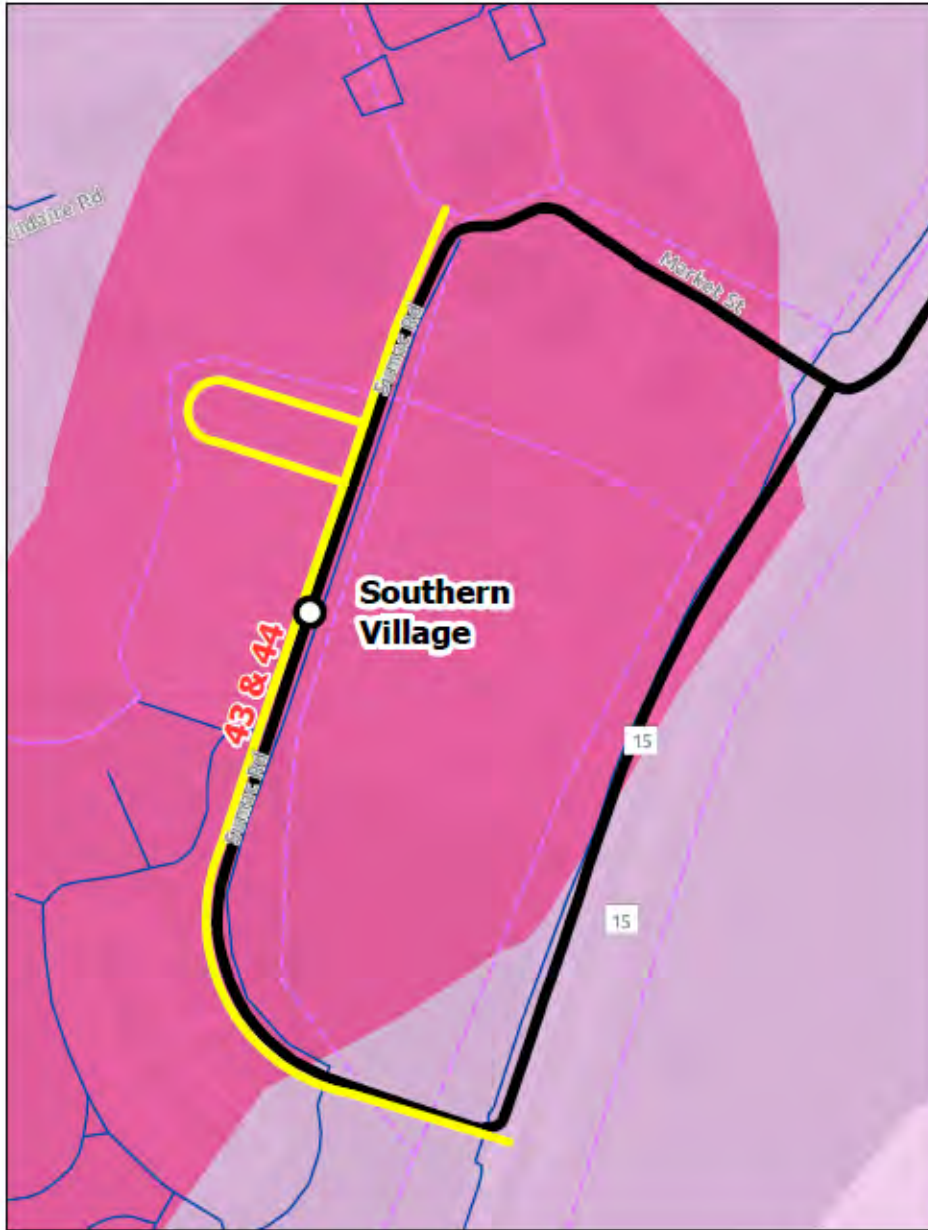
Network Gaps - Southern Village

Two sidewalk gaps and deficiencies were identified at the Southern Village Station area. These include:

- Sidewalk deficiency (43): There is a noncompliant sidewalk connection across Sumac Road on the north side of the bus station terminal that forces pedestrians and wheeled users to utilize the roadway instead of the sidewalk.
- Sidewalk gap (44): There is no sidewalk on the west side of Sumac Road south of the bus terminal.

No.	Station	Description	Recommendations/Transit Equity Recommendations
43	Southern Village	Non-compliant sidewalk connection off Sumac Road.	Redesign to Compliance
44	Southern Village	Key sidewalk gap along all west side of Sumac Road and lack of curb ramps.	1,000 LF Sidewalk Extension

- Sidewalk deficiency (43): Reconstruct the sidewalk pedestrian ramps at the Sumac Road pedestrian crossing on the north side of the bus station terminal.

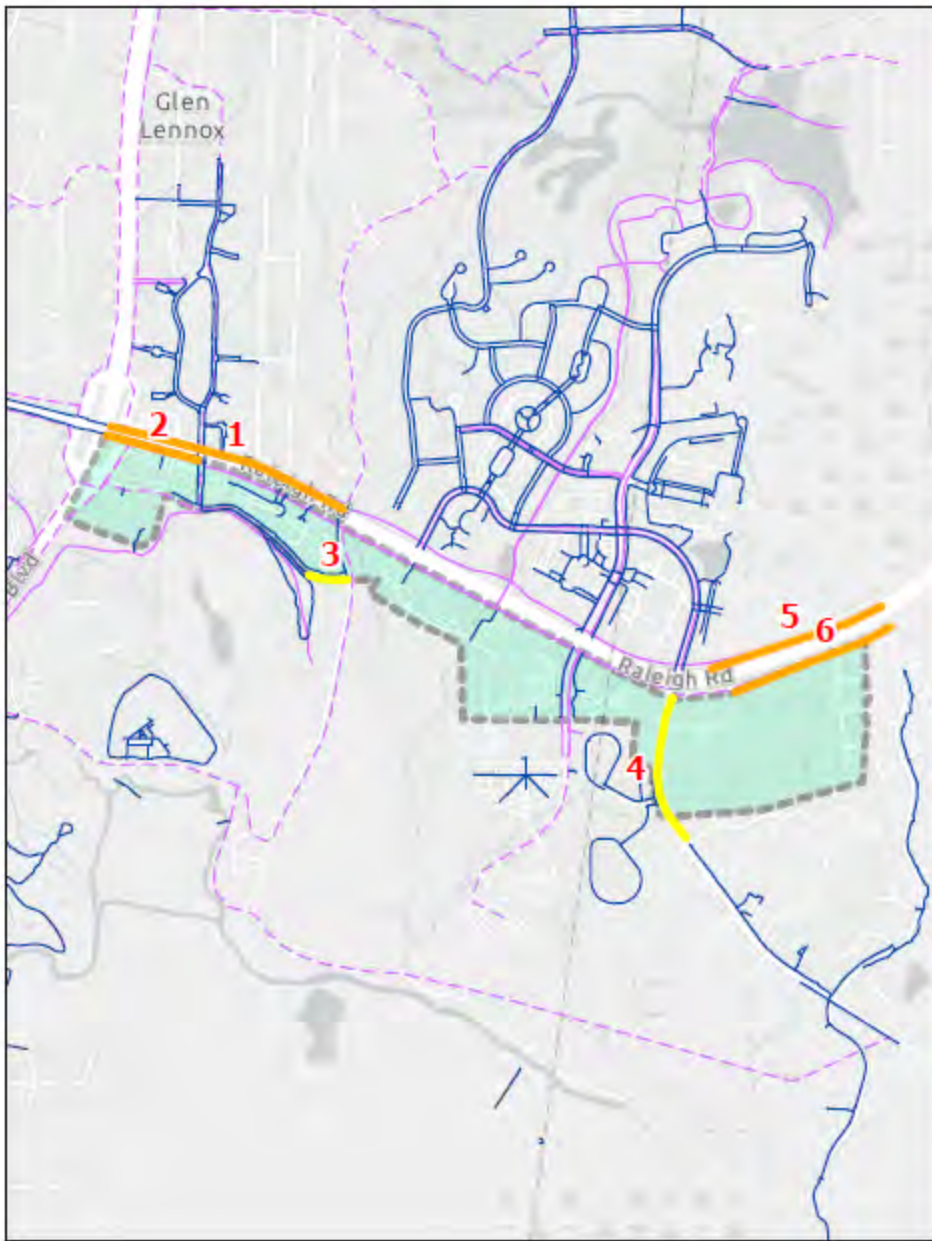
Network Gaps - Focus Area NC-54

No.	Description	Recommendations/Transit Equity Recommendations
1	No sidepath along north side of NC 54/Raleigh Road from Barbee Chapel Road west to Fordham Blvd.	2,553 LF sidepath extension
2	No sidepath along south side of NC 54/Raleigh Road from Hamilton Road west to Fordham Blvd.	970 LF sidepath extension
3	No sidewalk connection to Finley Golf Course Road on the south side of Prestwick Road.	396 LF sidewalk extension
4	No sidewalk on the east side of Barbee Chapel Road north of Spring Meadow Drive.	1,546 LF sidewalk extension
5	Existing sidepath along north side of NC 54/Raleigh Road ends just east of E. Barbee Chapel Road.	1,860 LF sidepath extension to Downing Creek Parkway
6	Existing sidepath along south side of NC 54/Raleigh Road ends 640 LF east of E. Barbee Chapel Road.	1,740 LF sidepath extension to Downing Creek Parkway

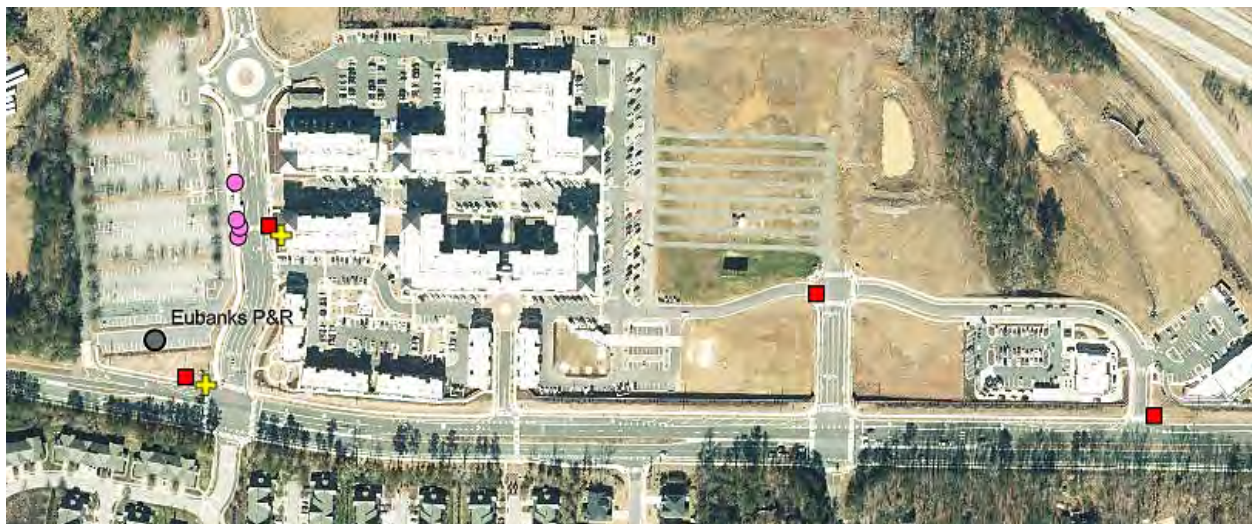
- The station has facilities including trash receptacle, bench seating, a portable toilet and shelter.
- Walking and biking gap between Myrica Street and Millhouse Road.
- On-street bicycle facilities along Eubanks Road are not low stress or accessible to those of all ages and abilities.
- Sidewalk gap along the north side of Eubanks Road from Village Center Drive to MLK Jr. Blvd.
- Sidewalk gap between the Carraway Village and Northwood Drive.
- Eubanks Road crossing at Myrica Street is wider than potentially needed with painted curb extension that could be permanent.
- Northbound to westbound bicycle connectivity from MLK Jr. Blvd to Eubanks Road does not exist.

- Affordable housing is planned north of Carraway Village.
- Expansion of the I-40 interchange is planned which could alter access at the Eubanks intersection.
- Desire for secure bike parking at the station.
- Enhanced wayfinding for people biking to know how to access the station, particularly from MLK Jr. Blvd.
- Sidepath along one side of Eubanks Road (perhaps the north side makes the most sense).
- Potential future rail to trial opportunity to the west.
- Desire for pedestrian refuge islands at major intersection crossings.
- Potential to change RRFBs to HAWKs along this corridor per the Town.
