ACCESSIBILITY AUDIT

CHAPEL HILL TOD PLANNING & UDO VISIONING STUDY

December 2022

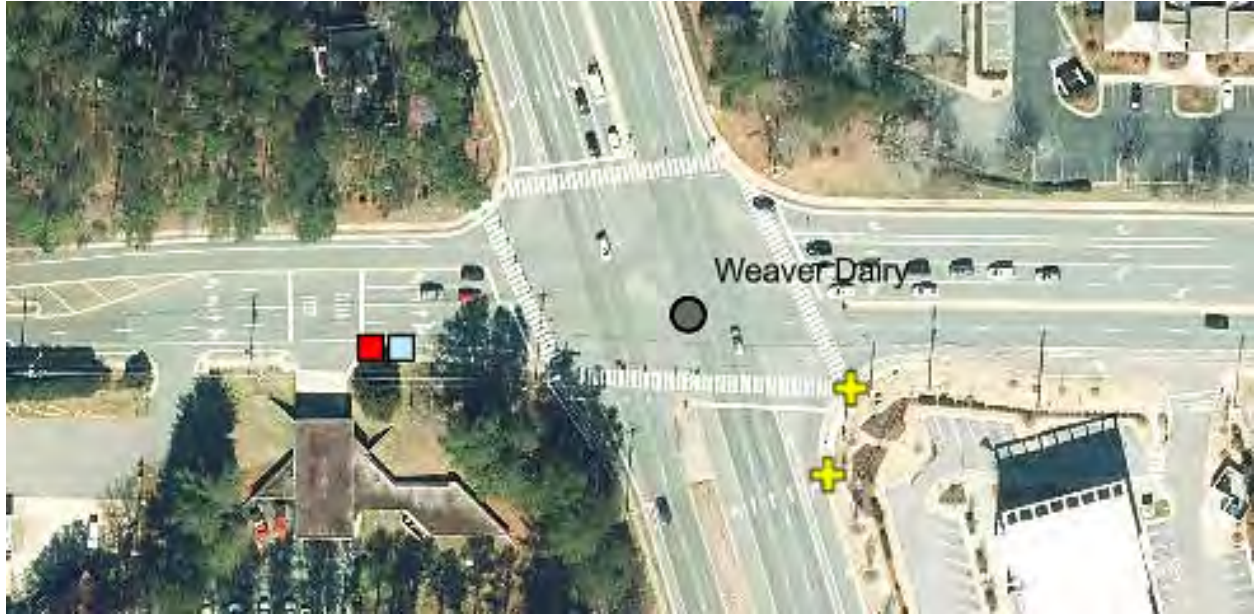
- Crossing of MLK Jr. Blvd at Weaver Dairy Road is very long with no refuge.
- Wide curb radii promote high-turn speeds.
- Long wait time to receive walk signal.
- Non-ADA compliant sidewalk along Westminster Drive.

- No bike detection at the signal.
- Dangerous perception due to the size of the intersection for people walking and bicycling.
- Bike lanes are too narrow along both corridors.

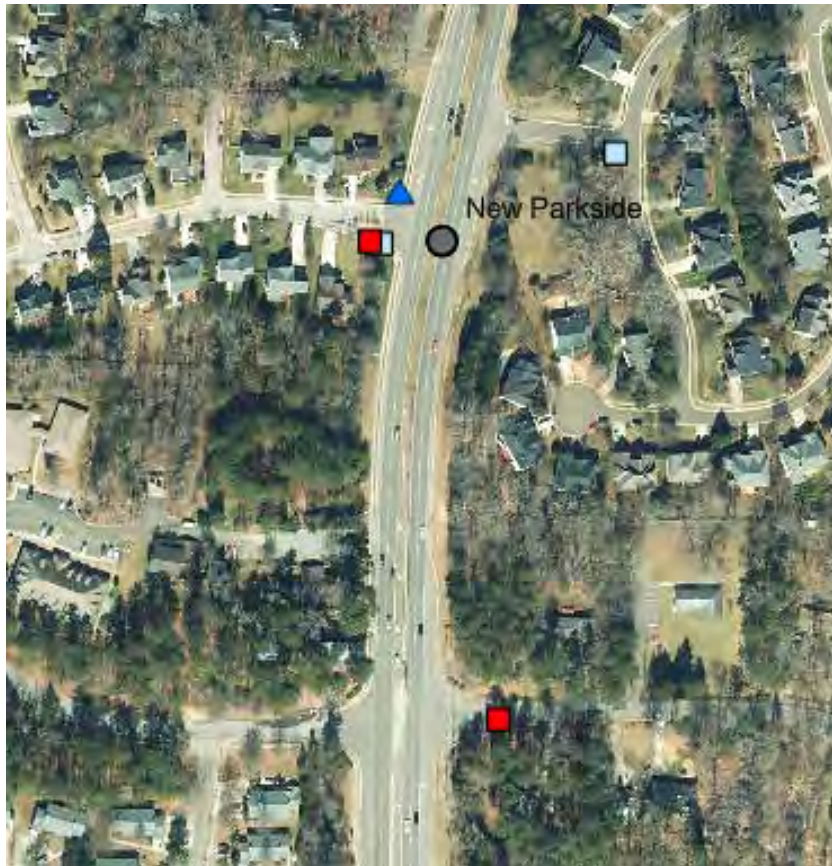
- Wide crossing of New Parkside Drive along MLK Jr. Blvd with non-directional ramps that direct users into MLK.
- Sidewalk gap along the south side of New Parkside Drive between MLK Jr. Blvd and New Statewide Drive.
- No crossing of MLK Jr. Blvd exists here to provide E/W connectivity across the corridor.
- Sidewalk gaps along Stateside Drive.

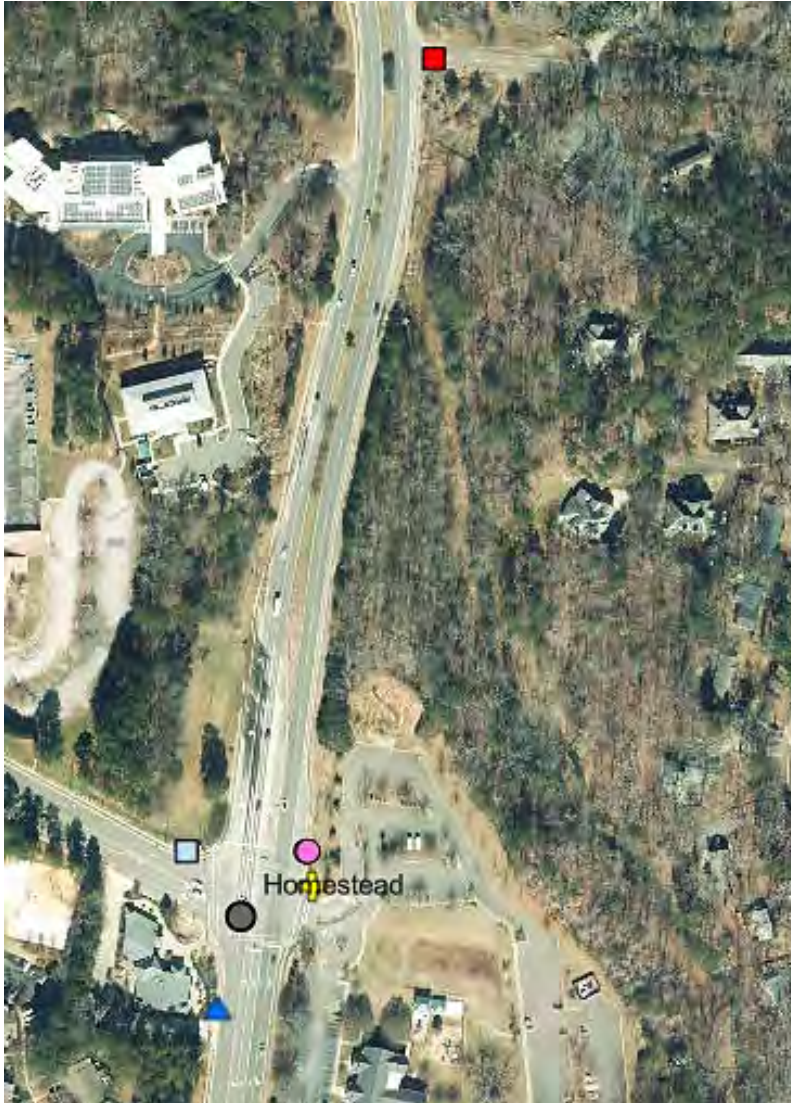
- Sidewalk gap along Dixie Lane.
- Non-ADA accessible crossing of business driveway southwest of the intersection.
- Bike rack present at northbound bus stop.
- Non-ADA compliant curb ramps at the intersection. All ped phase with long crossing.

- Supportive services and housing for the homeless present northwest of the station which is important to consider.
- Important station serving multifamily and student housing.
- Heavily used stop currently.

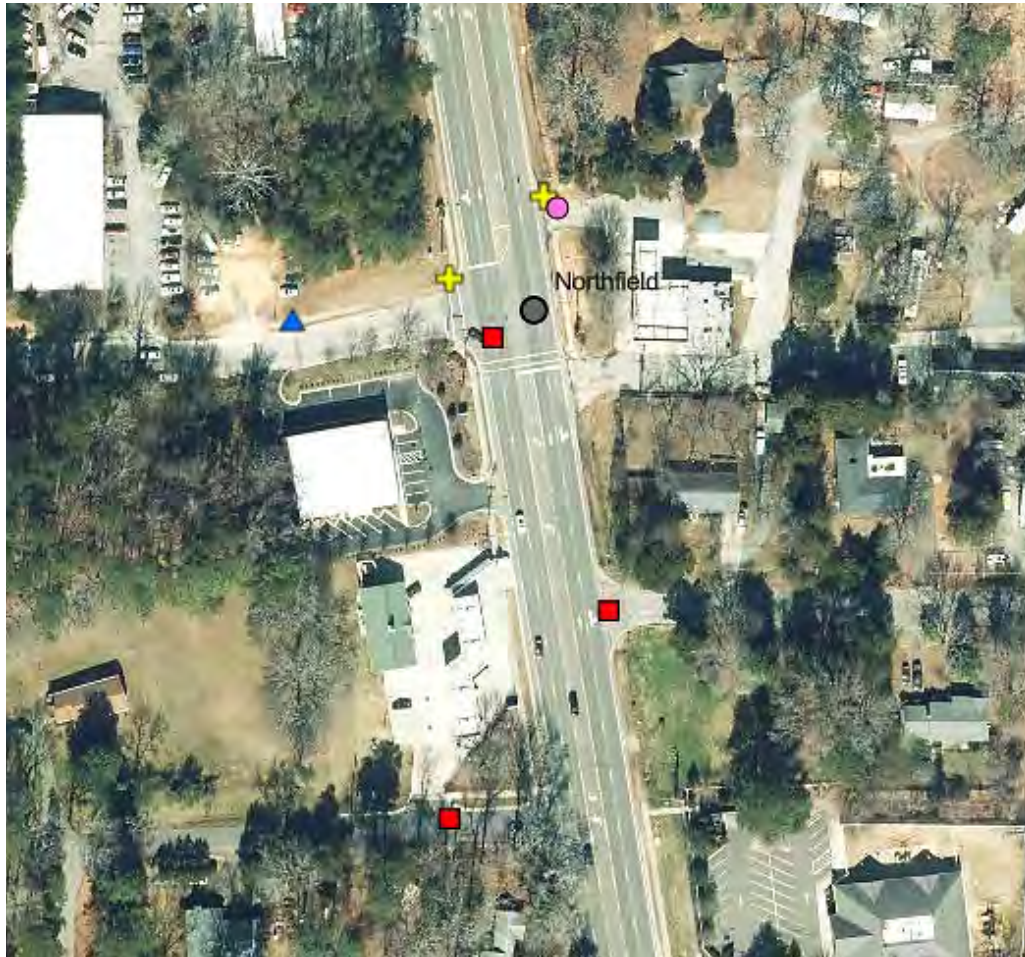
- Non-compliant driveway crossing along the northside of Northfield Drive.
- No sidewalk along Taylor Street, Ashley Forest Road, and Critz Drive.
- Lack of crossings at all legs of MLK Jr. Blvd intersection.

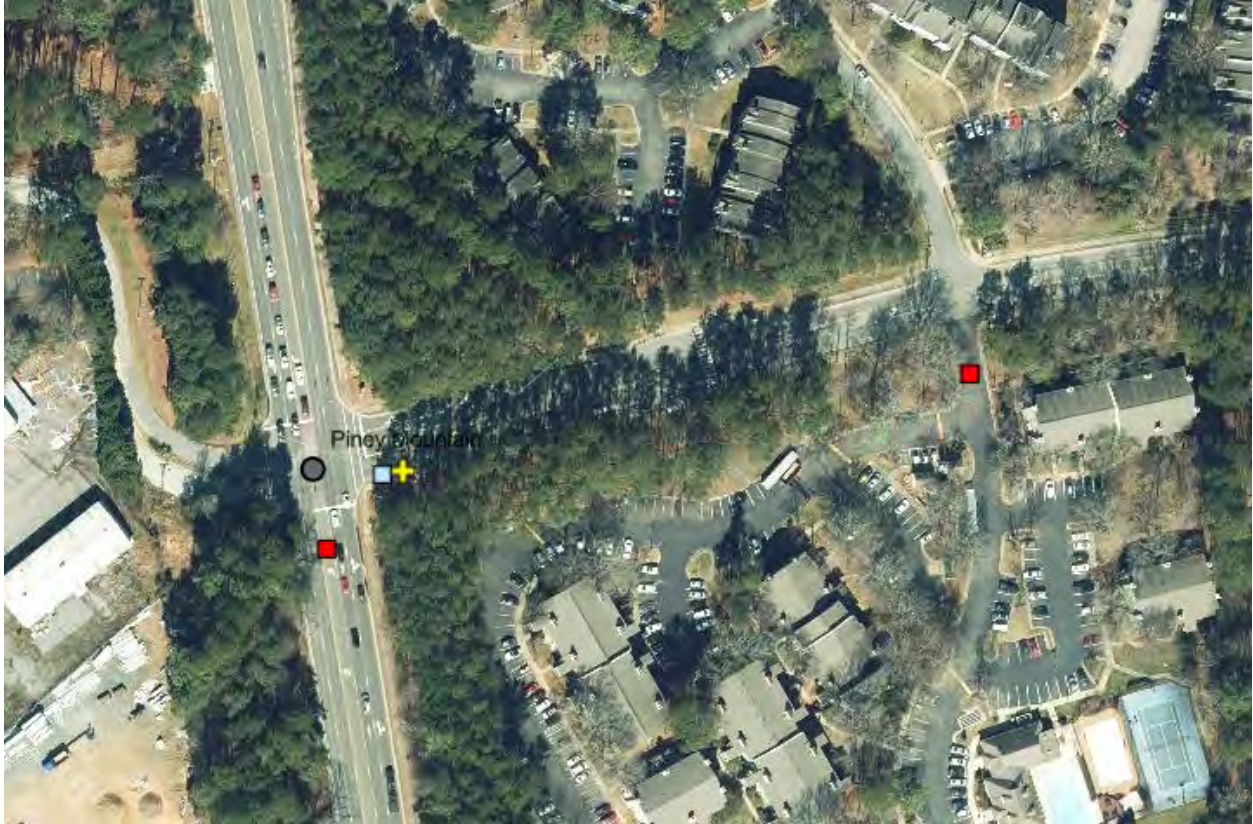
- No sidewalk along Shadowwood Drive.
- Lack of crossings at all legs of MLK Jr. Blvd intersection.

- Near the proposed UNC North Campus and airport development.

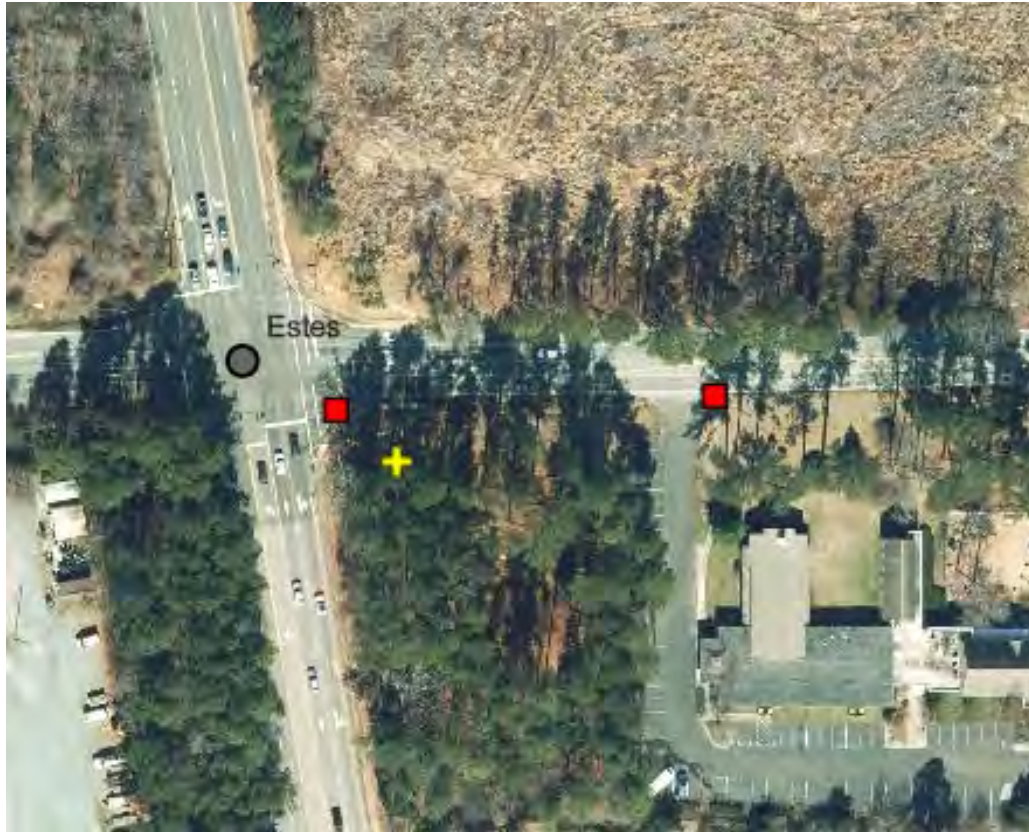
- Lack of crossings at all legs of MLK Jr. Blvd intersection.
- No sidewalk east or west of MLK Jr. Blvd along Estes Drive.

- Estes Drive is a key E/W bicycle connection between Carbarro and destinations in east Chapel Hill.
- Future bike facilities planned along Estes are key.
- Major mixed-use development under construction in NE corner of intersection.
- Near misses between vehicles and bicyclists along Estes Drive have been seen.

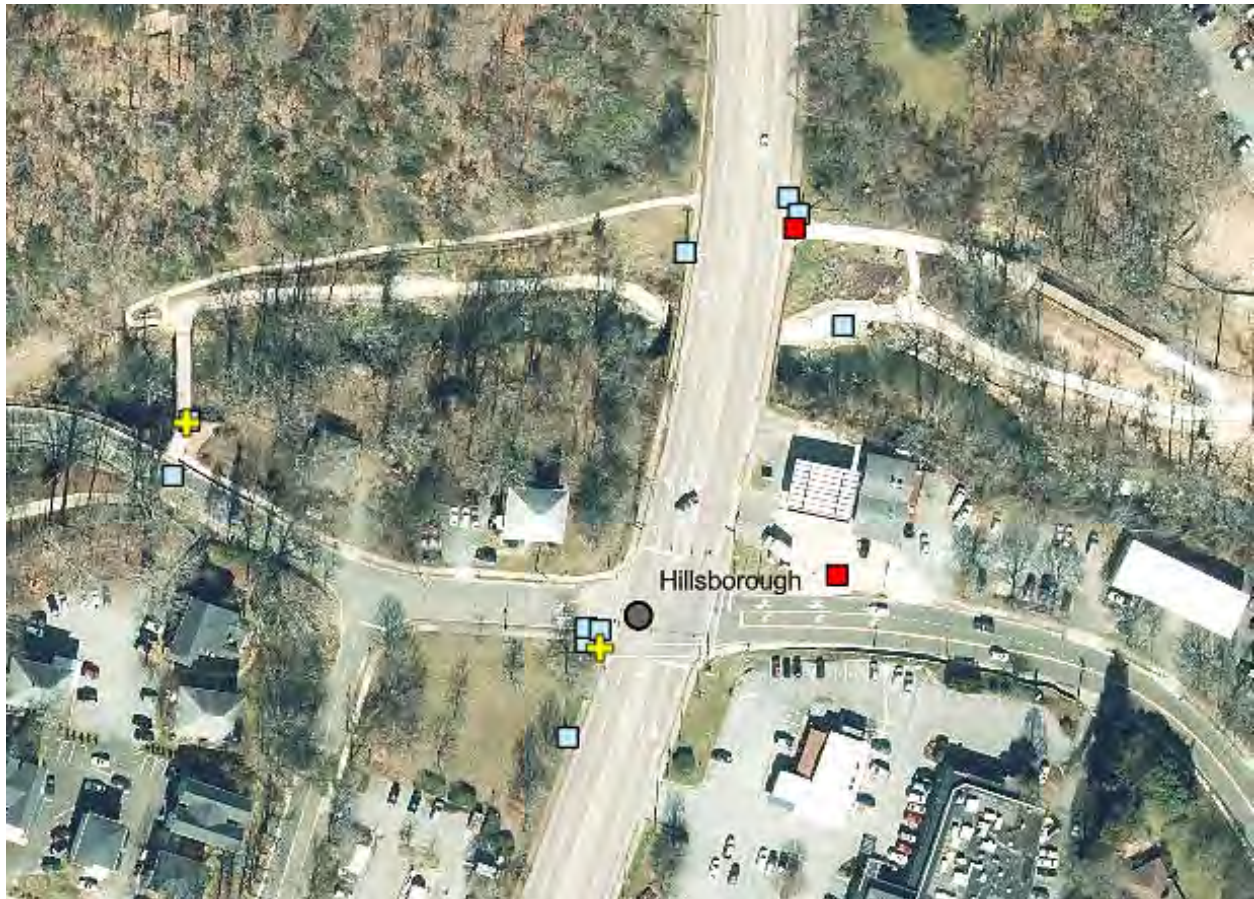
- No sidewalk along Barclay Street or Mt. Bolus Road.
- Non-ADA compliant sidewalk along Bolinwood Drive.
- Missing pedestrian connection between Bolin Creek Greenway and west side of MLK Jr. Blvd. A staircase exists on the east side.
- Non-ADA compliant driveway crossings of the gas station along Hillsborough Street.

- Key connection between future BRT and a highly used Greenway.
- Hillsborough Street sidewalk and grade is very difficult for ADA-compliance. Stairs exist in some sections due to the topography.
- Police headquarters is slated for redevelopment.
- Close calls seen at the intersection.
- Lack of crossings at all legs of MLK Jr. Blvd intersection.

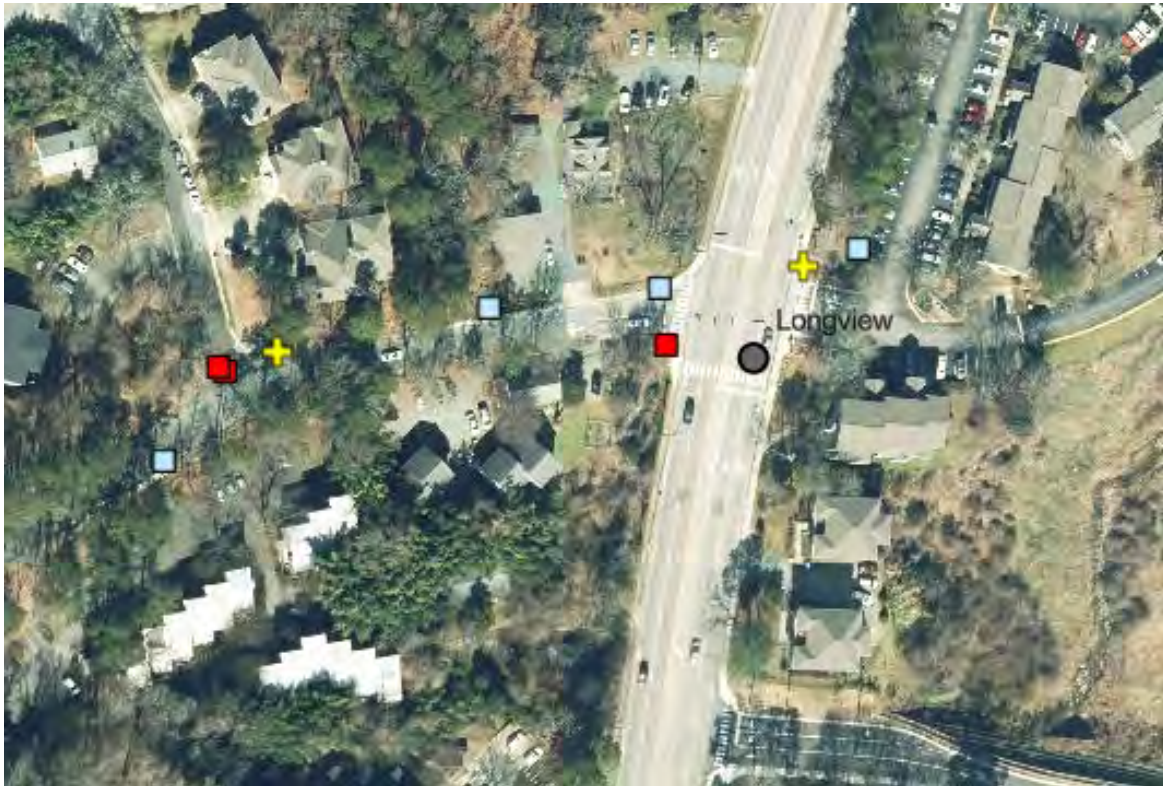
- Lack of crossings at all legs of MLK Jr. Blvd intersection.
- Sidewalk gaps along Longview Street, though the grade is very steep and topographically challenging.

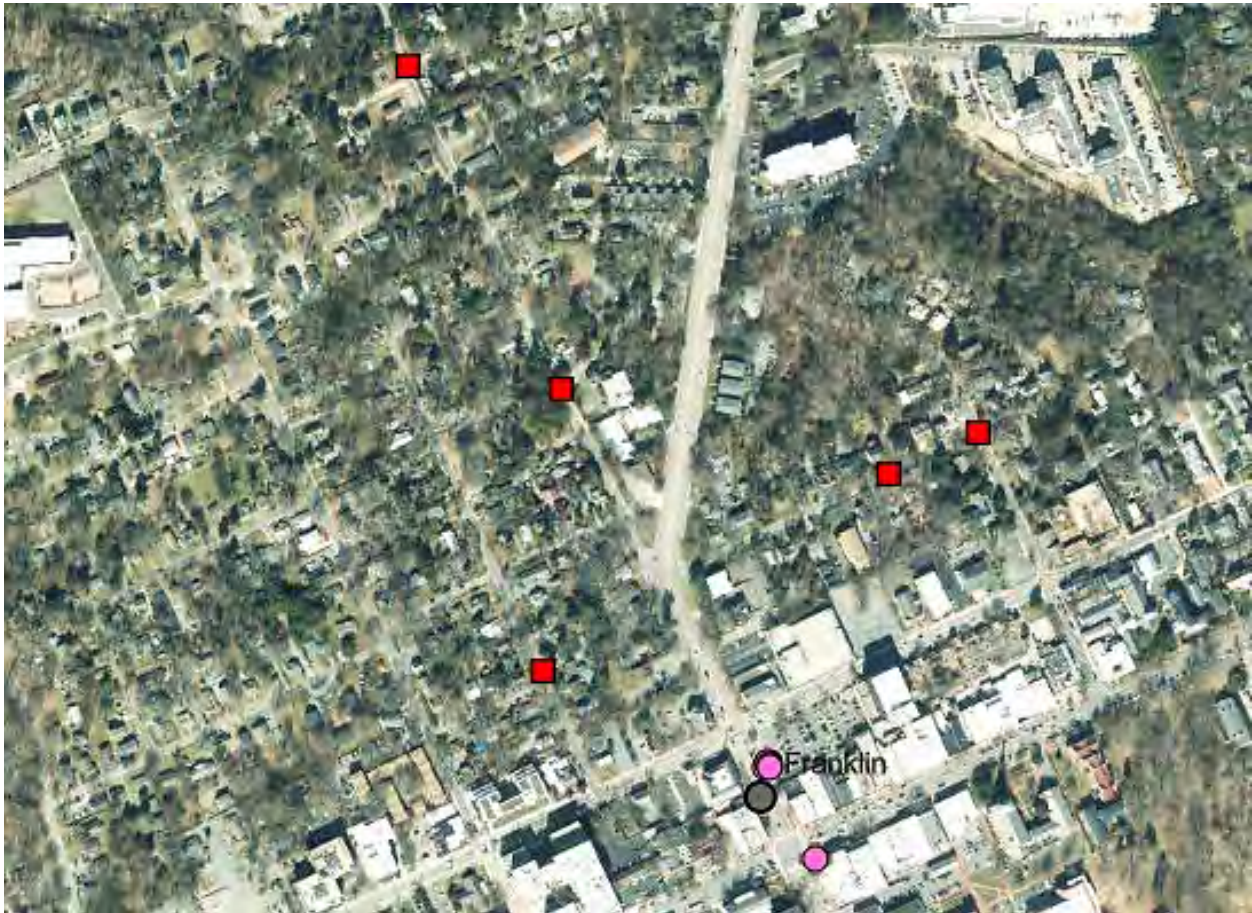
- Sidewalk gaps along Columbia Street, North Street, and most of the local streets west of MLK Jr. Blvd and north of Rosemary Street.
- The station has facilities including trash receptacle, bench seating, and shelter.

- This is one of the most important stations along the line.
- Explore opportunities for placemaking, public art, etc. here.
- The Rosemary Street intersection can be a busy location to cross.
- Gap in on-street bicycle infrastructure along Rosemary and east of Columbia Street. Was planned but the new development may have scuttled that.
- The Columbia/Franklin intersection is very busy with all modes and needs to be reviewed for additional safety improvements.

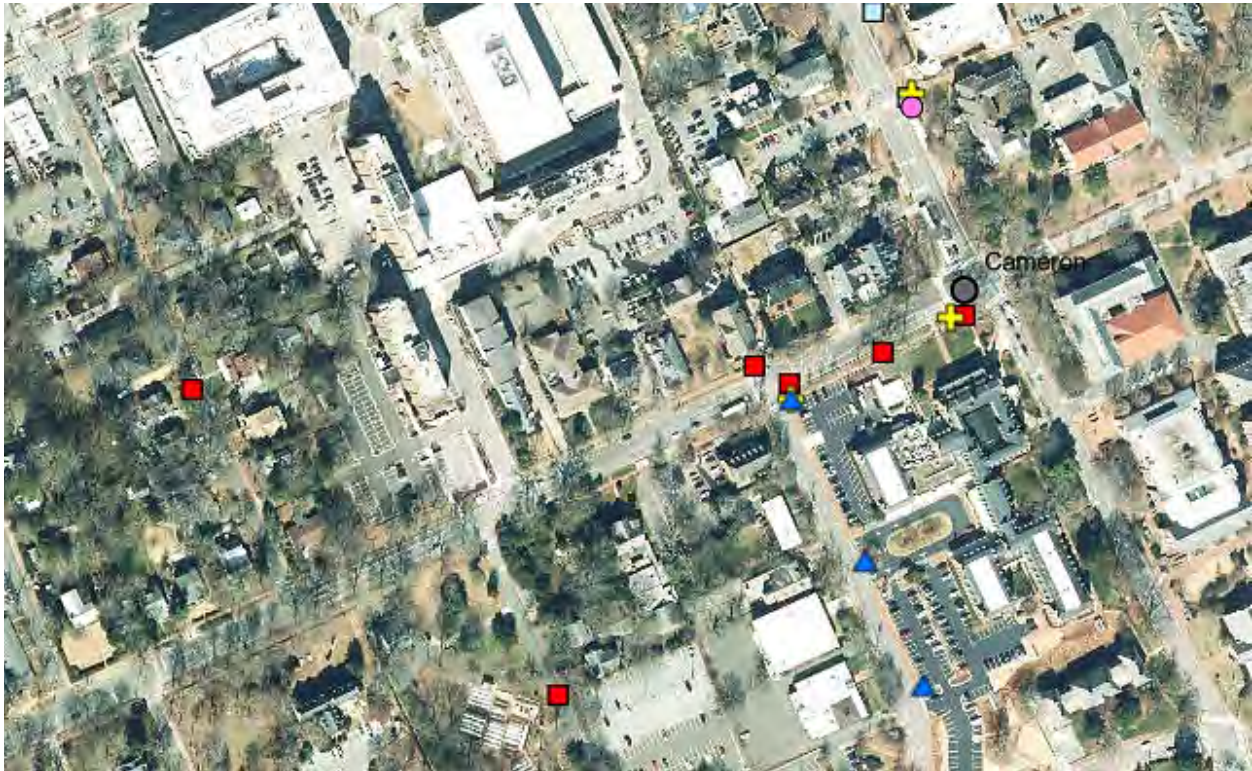
- Non-ADA compliant sidewalk along Mallette Street and south side of Cameron Avenue.
- All ped phase at Columbia/Cameron, though no signage/signals or roadway markings exist denoting this.

- Idea to remove eastbound traffic along Cameron Avenue to provide on-street bicycle facilities and better organize the Columbia/Cameron intersection.
- Cameron is a key bike connector.

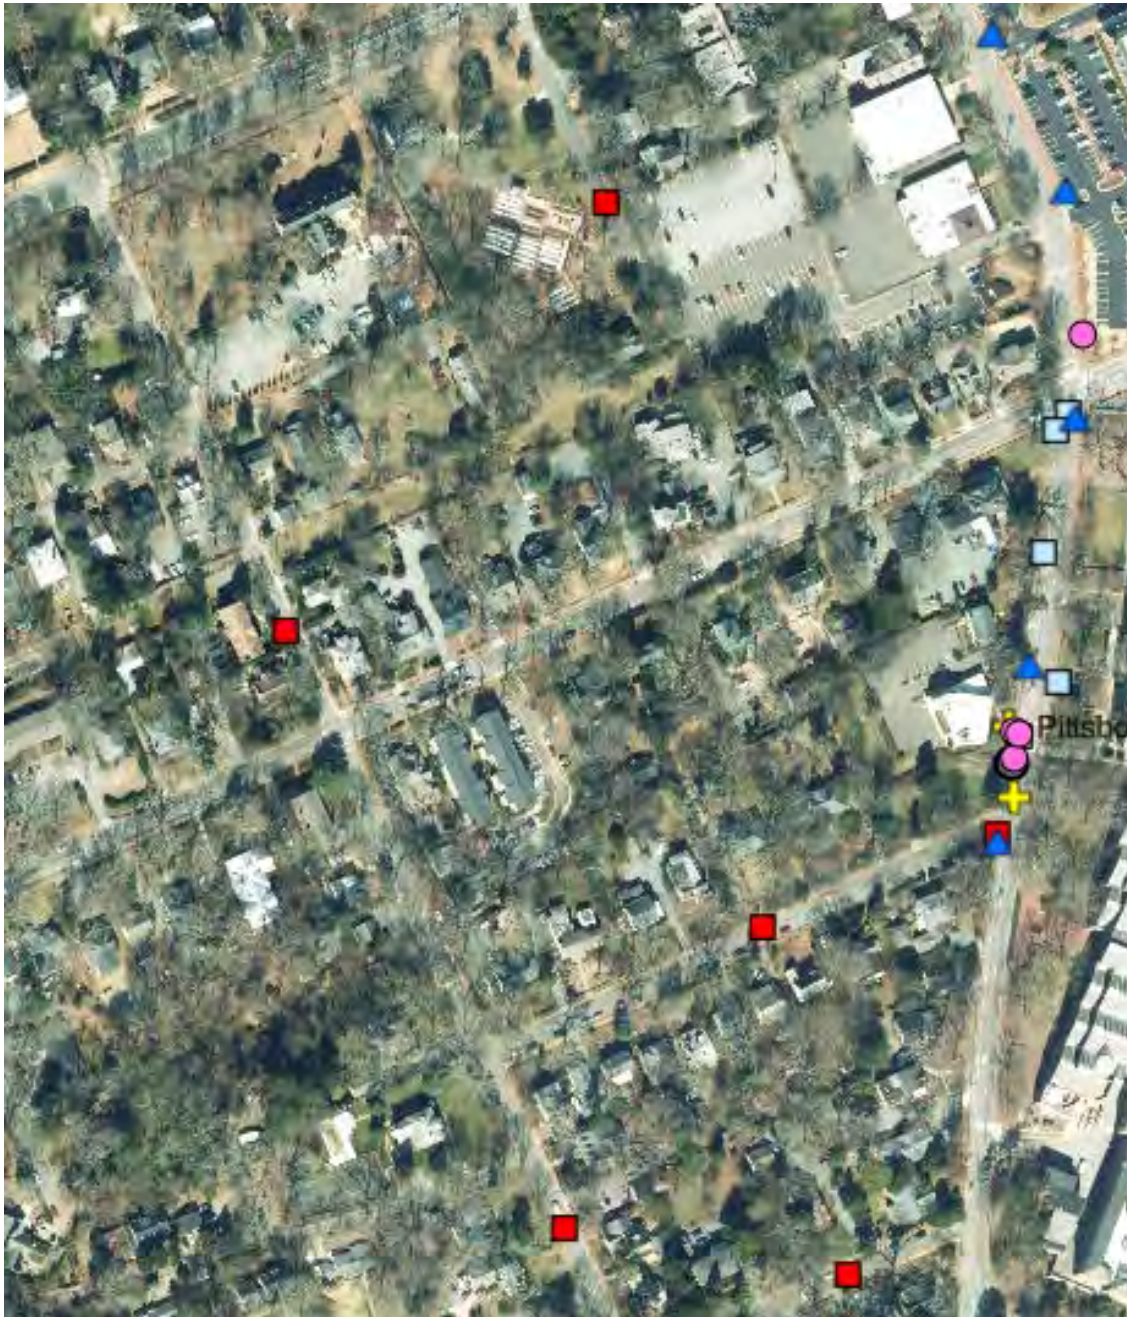
- Sidewalk gaps present along several local streets west of the station.

- Speed a concern here.
- Potential to remove one travel lane due volumes to provide on-street bicycle infrastructure.

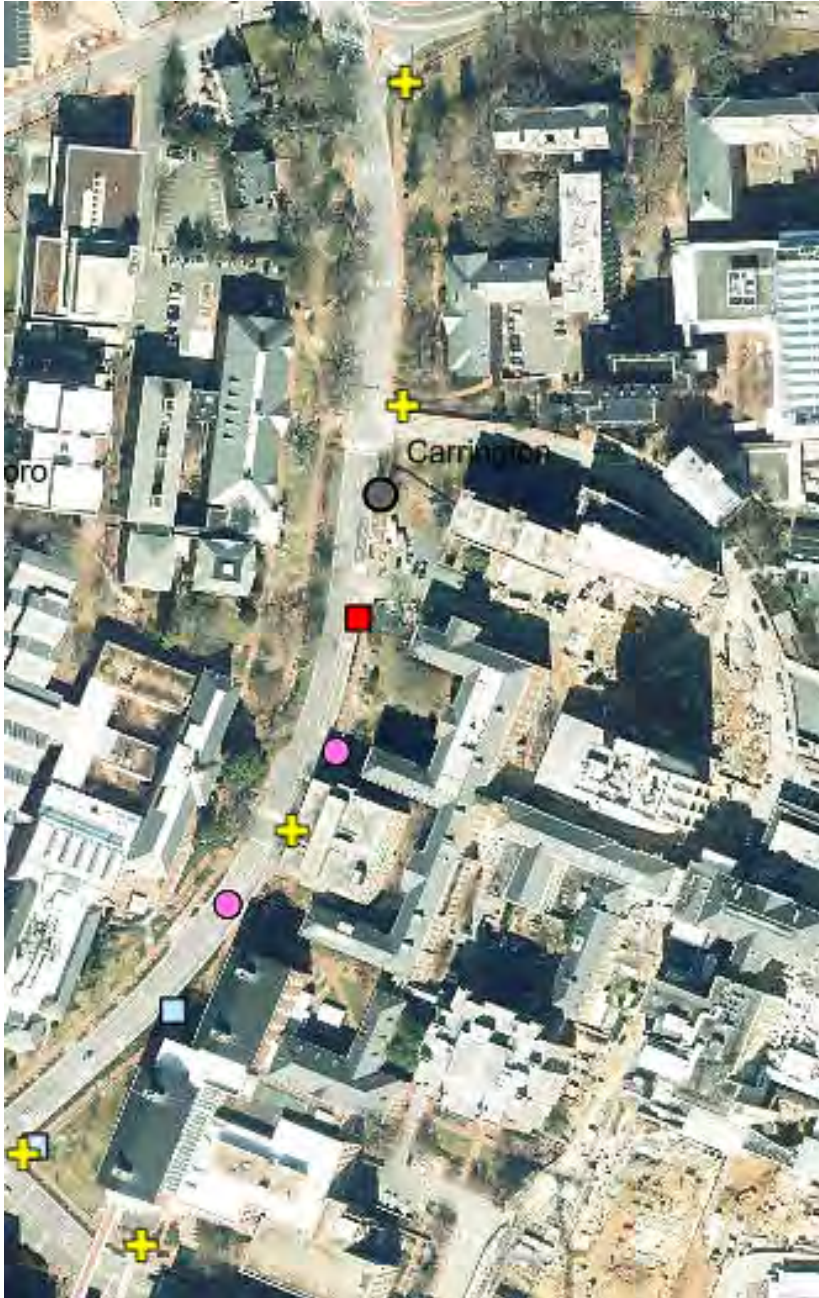
- Bike racks present at several locations.

- Desire for secure bike parking.
- Could protected bicycle infrastructure be provided here? A wide boulevard is present.

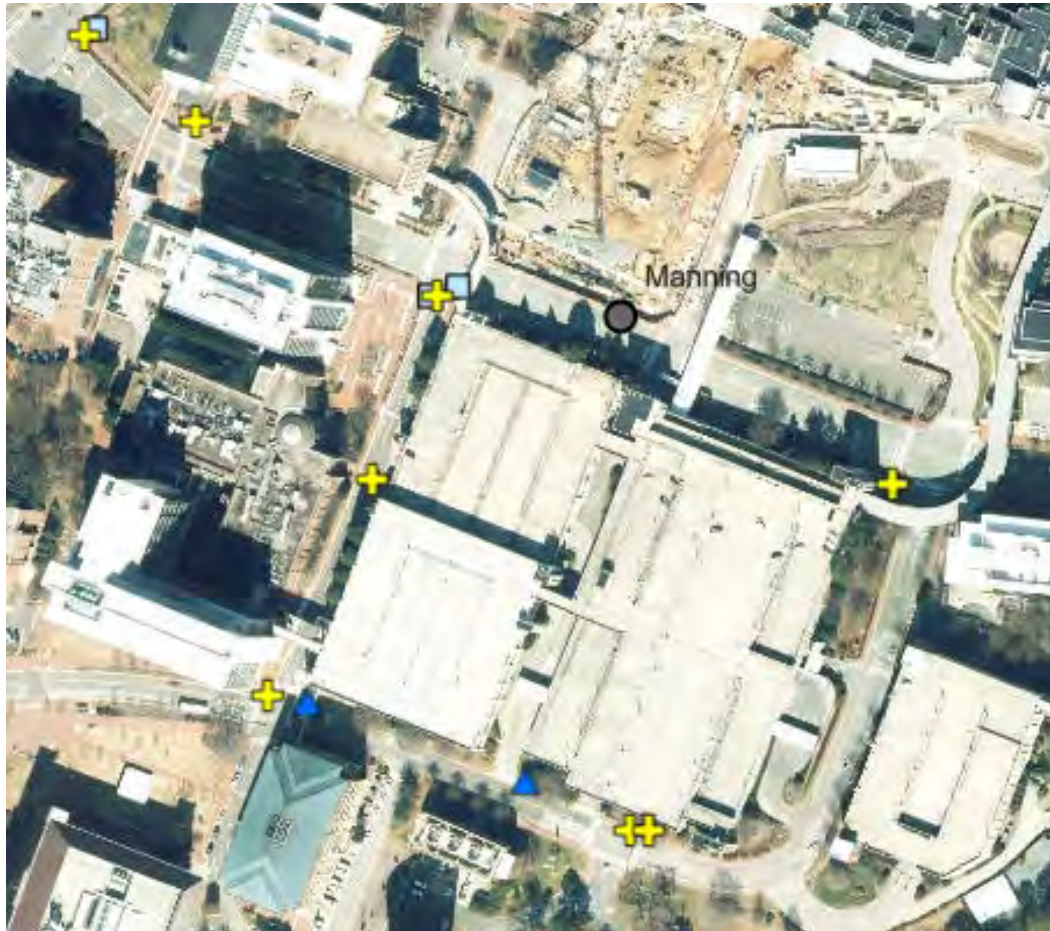
- Complete sidewalk network, several intersection crossings though all are ADA-compliant.

- Future UNC development to the south may require another station and new alignment.

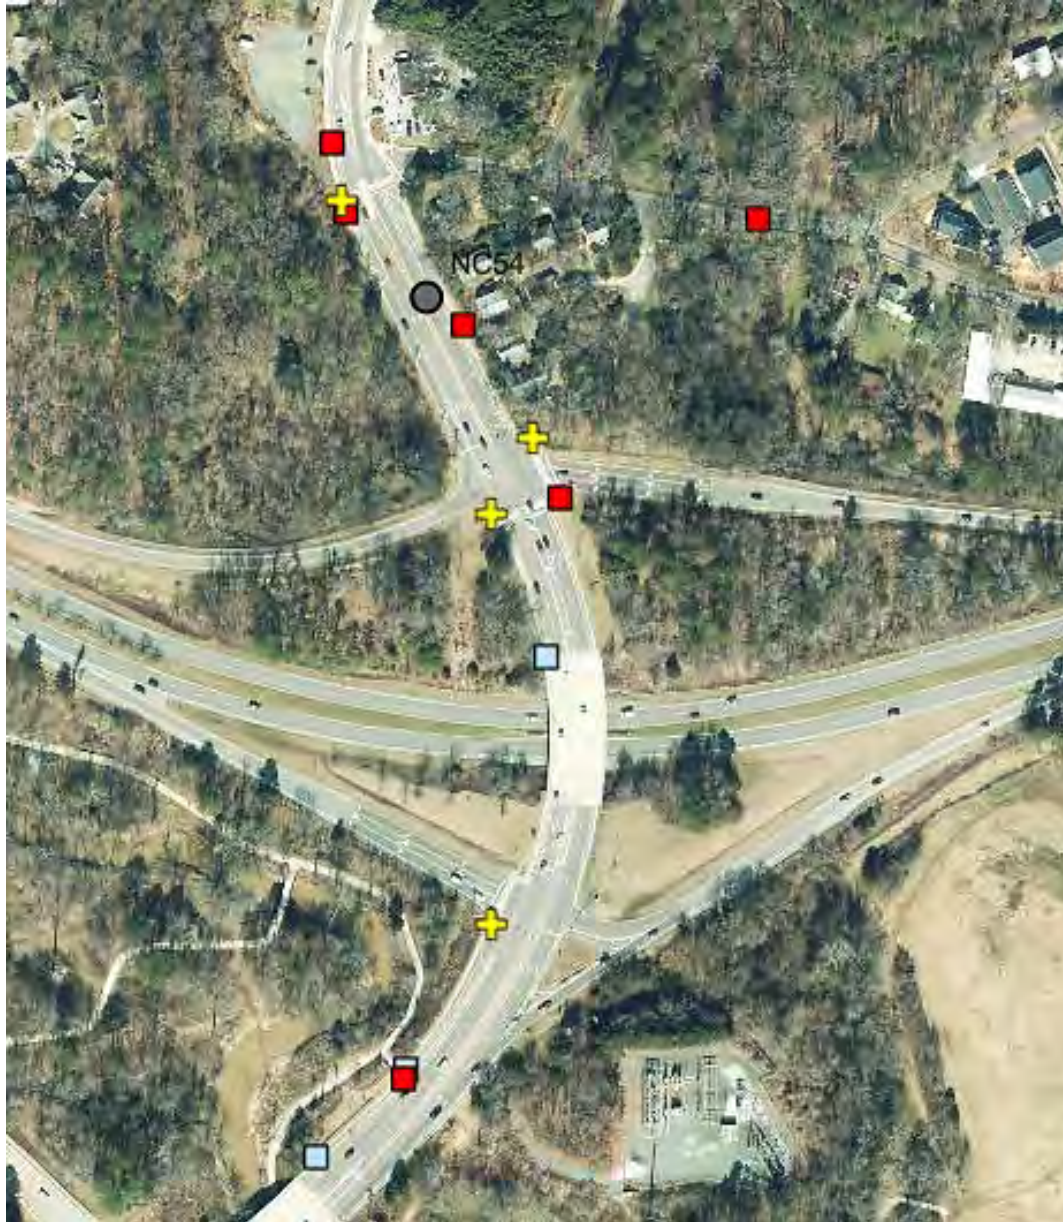
- Sidewalk gaps to the east of Columbia Street, key is Purefoy Road.
- Non-ADA compliant sidewalk at the overpass.

- Desire for the station to not be within the overpass.

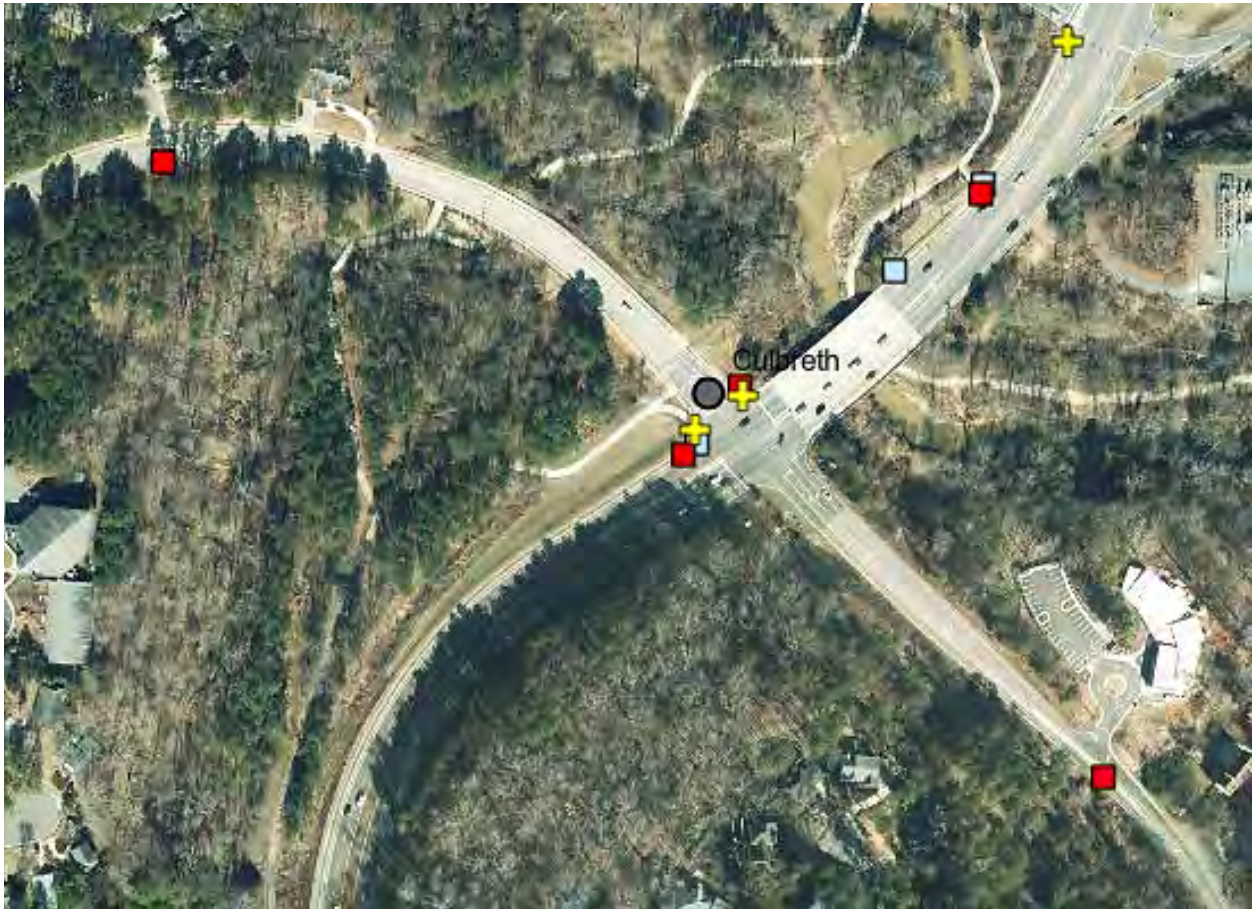
- Sidewalk gaps along Culbreth Road and Mt. Carmel Church Road.
- No marked crossing of TH 15/501 at the intersection.
- Gap in the Greenway network here.

- Better Greenway connections desired.
