PUBLIC WORKS DEPARTMENT STORMWATER MANAGEMENT DIVISION

RE: Stream Determination for 135, 146, 138 & 134 Stancell Drive, 120 & 122 Little John Road, 5109, 5119, 5111 & 5103 Barbee Chapel Road, Chapel Hill, Durham County, NC

STREAM DETERMINATION SITE VISIT RESULTS

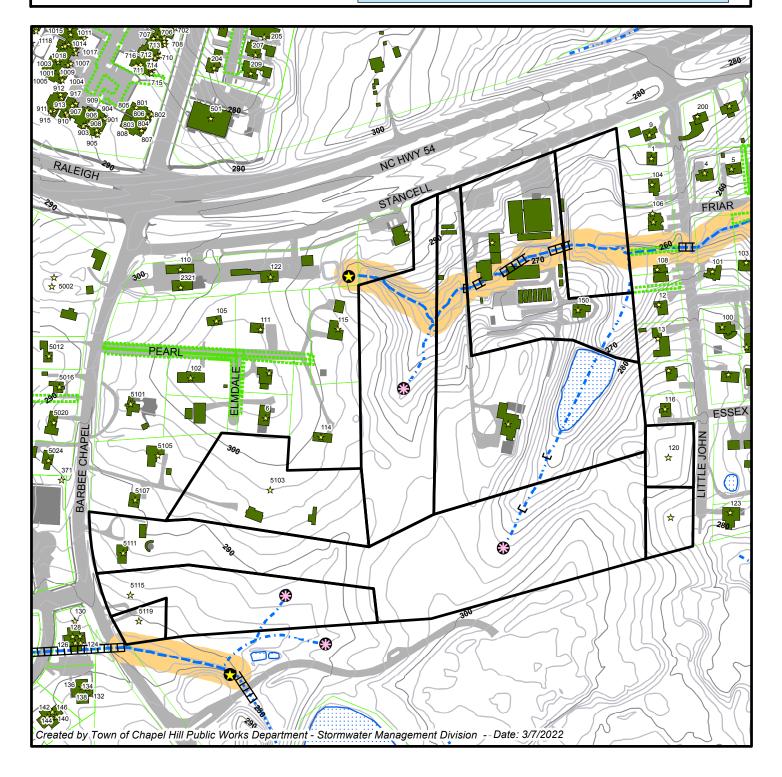
Stream Determination Area Map Address: 135, 146, 138 & 134 Stancell Drive, 120 & 122 Little John **Unclassified Stream** Non-perennial Waterbody Road, 5109, 5119, 5111 & 5103 Barbee Chapel Road, **Ephemeral Stream** Subject Property Chapel Hill, Durham County, NC Intermittent Stream Ephemeral Breakpoint Parcel ID: 9798-04-93-2025, 9798-04-92-0839, 9798-04-82-9499, □□ Culverts 9798-04-82-6522, 9798-04-92-4361, 9798-04-82-6093, Intermittent Breakpoint 2-foot Contours (Durham) 9798-04-71-8728, 9798-04-81-1816 & 9798-04-82-2139 Perennial Breakpoint 10-foot Contours (Durham) 150 600 Feet Buildings 1 inch = 300 feet **Durham Parcels OWASA Easements** Stream locations are approximate and must be verified by survey. Buffers are measured from top of bank. RCD buffers are not shown but may apply. Addresses Wetlands are present but not shown. Please contact the Town of Chapel Hill Approximate Jordan Buffer Planning Department to verify all applicable buffers.

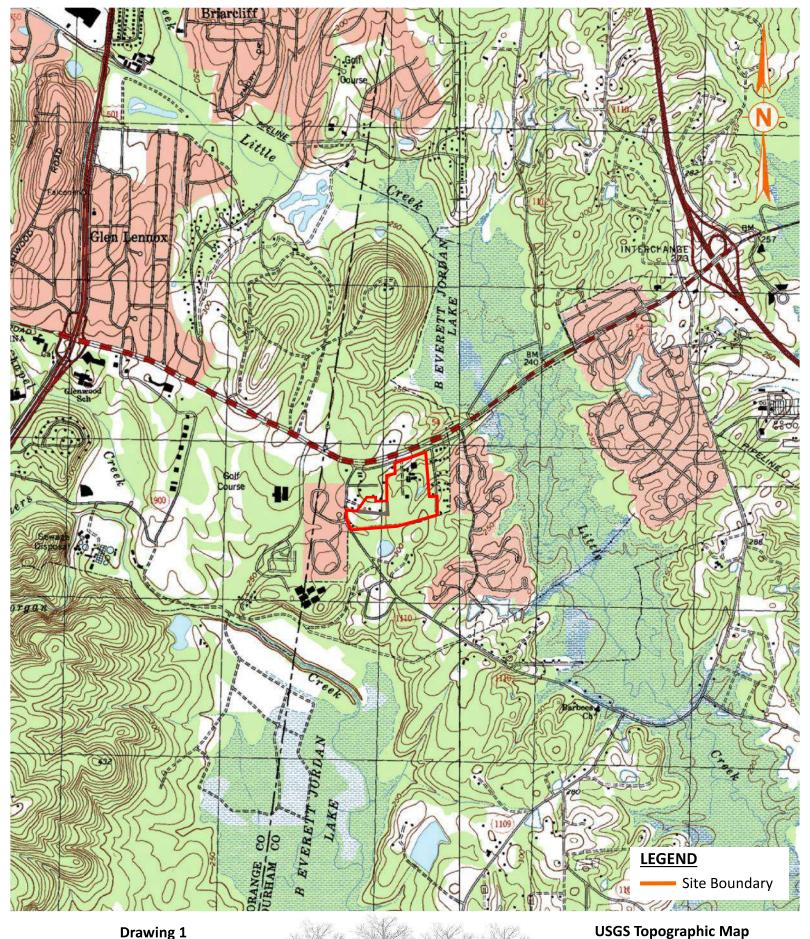
Drawing 1

USGS Topographic Map Chapel Hill and Southwest Durham, NC Quadrangles Scale: 1" = 2,000'

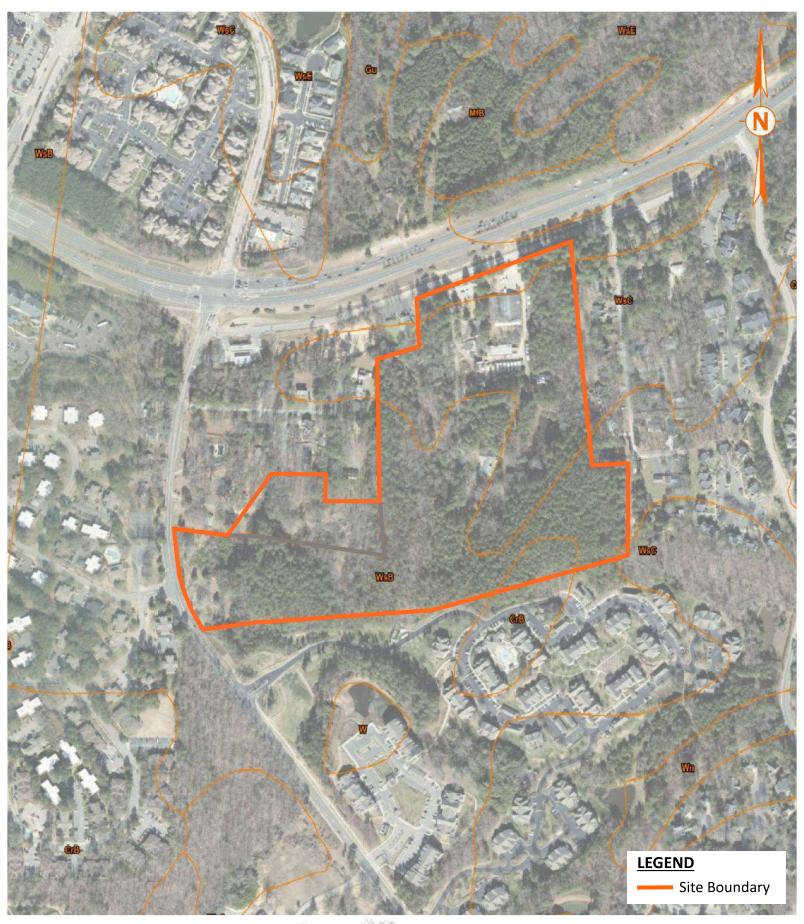
Drawing 2 USDA Web Soil Survey of Durham County, NC Scale: 1" = 400'

Web Soil Map

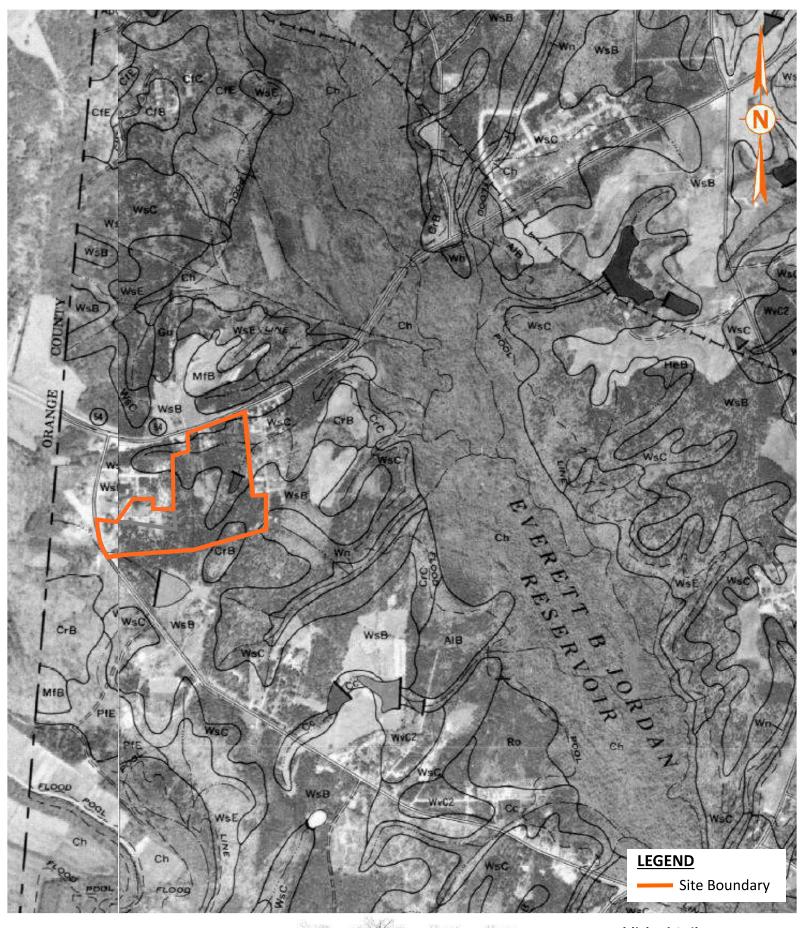
Drawing 2A USDA Soil Survey of Durham County, NC Published 1976, Sheets 34 and 37 Not to Scale

Published Soil Map Hillmont Properties Approximate 35-Acre Tract Chapel Hill, Durham County, NC Pilot Project 5516
