# Field Visit Guidance

**Observe and record what you see for physical elements and behaviors that may affect pedestrian and bicycle safety along NC 54.**

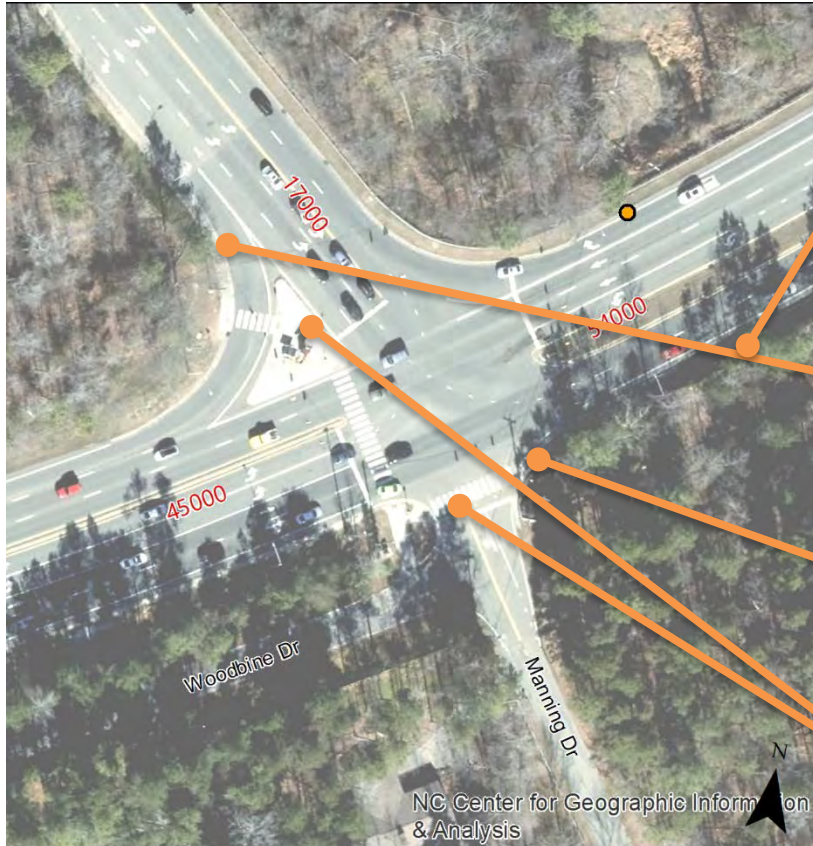
# Manning Dr @ NC 54

- No sidewalk present (south side). Steep slope along Manning Dr. Drainage below guardrail. Very unsafe crossing in any direction.
- Overhead tree canopy on north west corner. Free flow RT lane? If so, move pedestrian crossing nearer to beginning of radius to improve pedestrian conspicuity.
- Could add yield line at pedestrian crossing on right turn slip lane for emphasis. Bike loop signage is faded. Consider moving pedestrian crossing to north to improve visibility for south bound traffic.
- No pedestrian signal head-on south east corner. Long green phase on NC 54. No Sidewalk to the south on Manning Dr. No advance yield line on Manning Drive headed west to NC 54.
- Mysterious curb cuts on Manning Drive north of intersection. Bike markings are faded at Manning Drive north. Overhanging trees may limit visibility of pedestrians on north west side of intersection

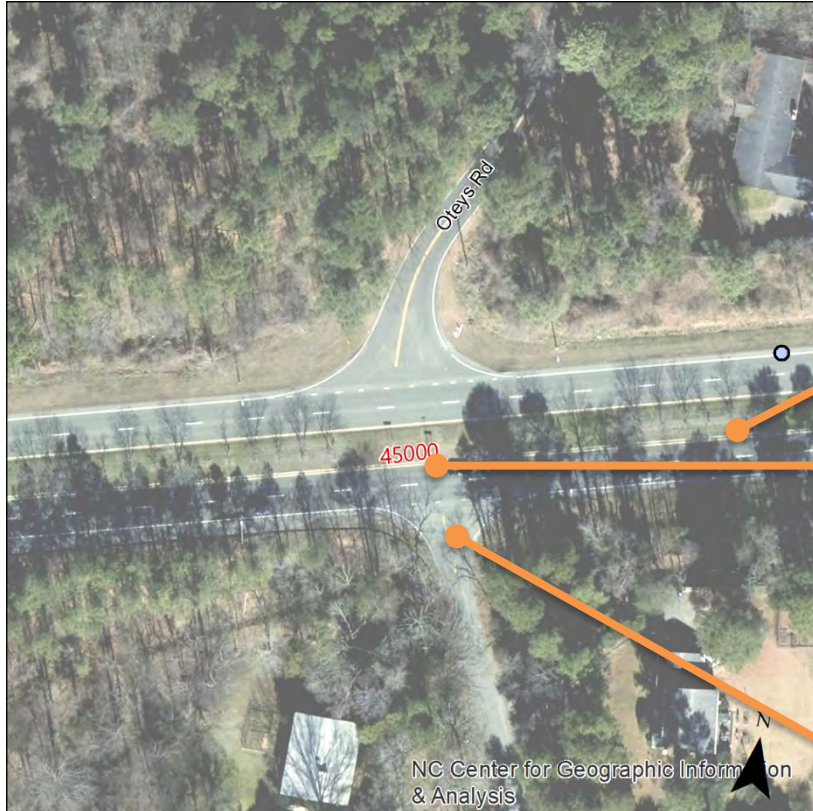
# Oteys Rd @ NC 54

- Very steep slope. No visual cues to NC 54 traffic to expect bike ped crossings. No bike ped facilities and network on either side of road.
- Recommend Zig Zag crossing in median to reduce conflict with high speed right turns.
- Crest limits sight distance for east bound traffic (west of intersection). Street lighting in place.
- HAWK signal at intersection? Future Morgan Creek greenway area. Signal impacts gaps (from east)
- Broad median. High curb. Higher travel speed. Street lighting at four comers. Low density walkable neighborhoods. Paved shoulder on NC 54 east ends well before Ottey's Rd.
- Long crossing time. Speed. No pedestrian facilities
- Rise heading east make visibility to cross. No pedestrian lighting.

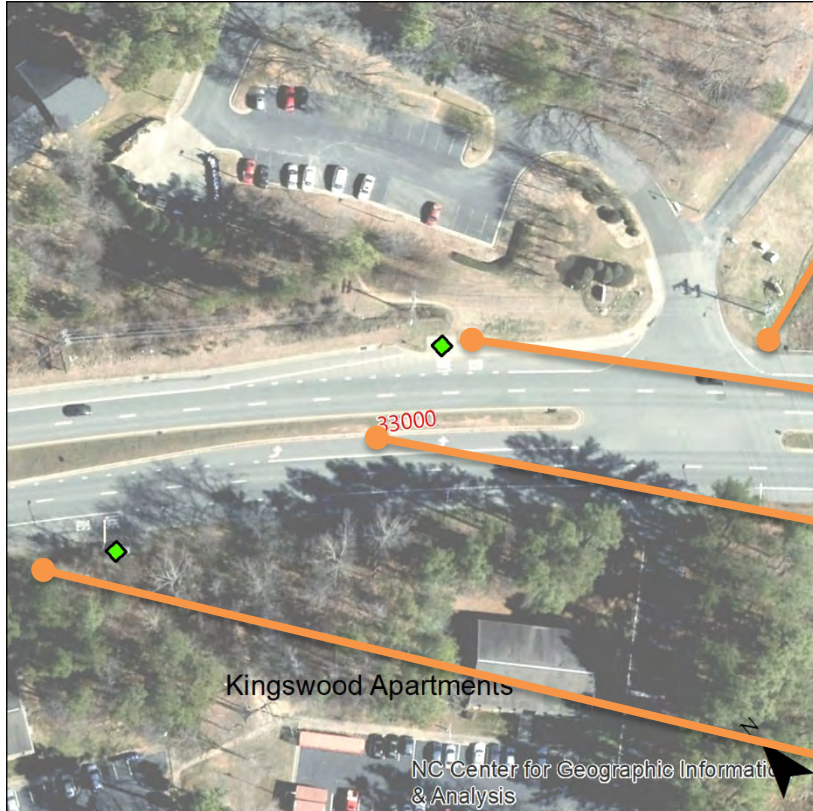
# Kingswood Apts @ NC 54

- Consider near side bus stops, (see notes), consider left over for pedestrian refuge. Restripe existing bus lane as right turn acceleration lane
- Consider zig zag concept, moving bus stops [signalized?].
- Talked to people who said dangerous at dark.
- No bus shelter on north side of NC 54. Three pedestrians crossed during visit. Pedestrians using median to stage crossing.
- Need sidewalk with ramps connectivity for bus stops. Rocky goat path in the median, south side connecting to bus stop.
- Consider left over.
- How necessary are bus pullouts?
- 1/4 mile to Morgan Creek Trail parking lot; Poor sight distance
