ENVIRONMENTAL UPDATE

CHAPEL HILL POLICE DEPARTMENT PROPERTY

David Goldman, P.G.
Kimley-Horn and Associates, Inc.

Steve Hart, P.G.
Hart & Hickman, PC

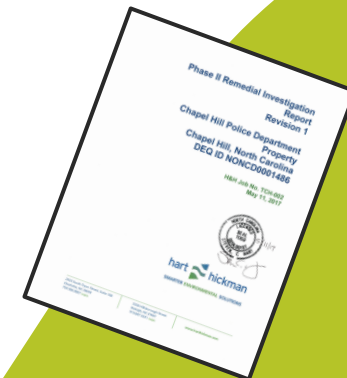
Site Conditions

- Additional assessment completed by Hart & Hickman in early 2017 indicated the following:
 - Soil
 - Contaminants of Concern are metals, primarily arsenic, manganese, and selenium
 - CCP exposed at certain locations on the property
 - NC DEQ preliminary risk analysis indicates soil along Bolin trail not significant risk to users and construction workers (May 2016)
 - Groundwater
 - Contaminants of Concern are metals, primarily manganese and strontium
 - There are no groundwater users
 - Sediment and Surface Water
 - No significant impacts to Bolin Creek

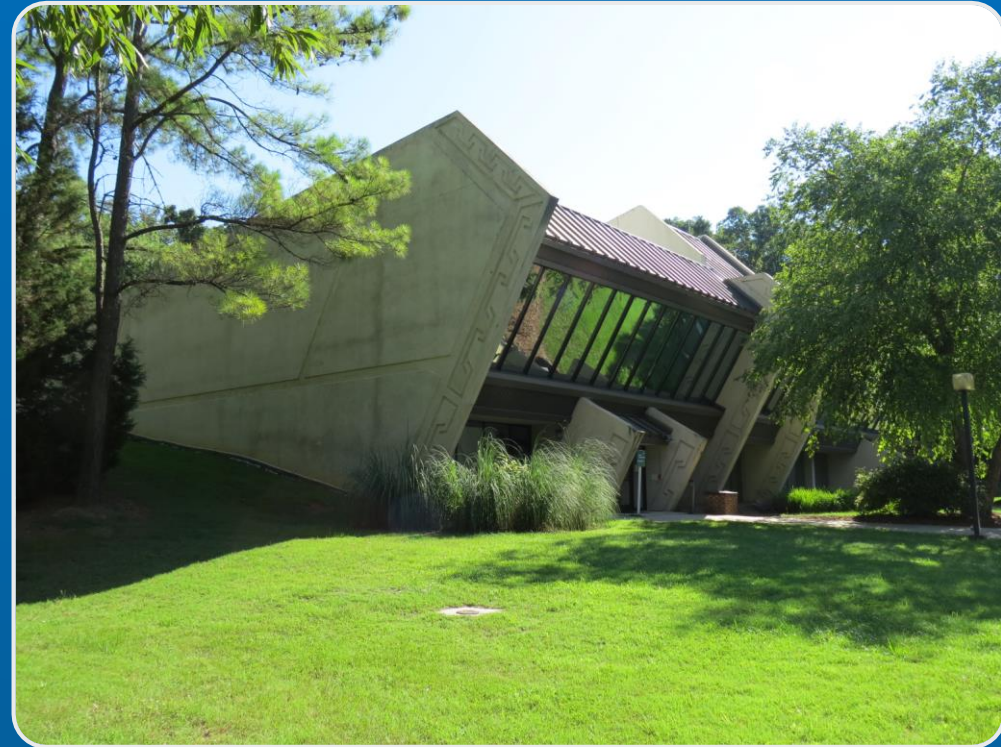
Scenario Assumptions (June 2018)

- High level analysis with preliminary market information
- Land acquisition cost
- Remediation cost
- Construction costs
- Prevailing market lease rates
- Ground floor residential (may be allowed)
- Standard parking ratios
- Trail will be subdivided from the larger tract

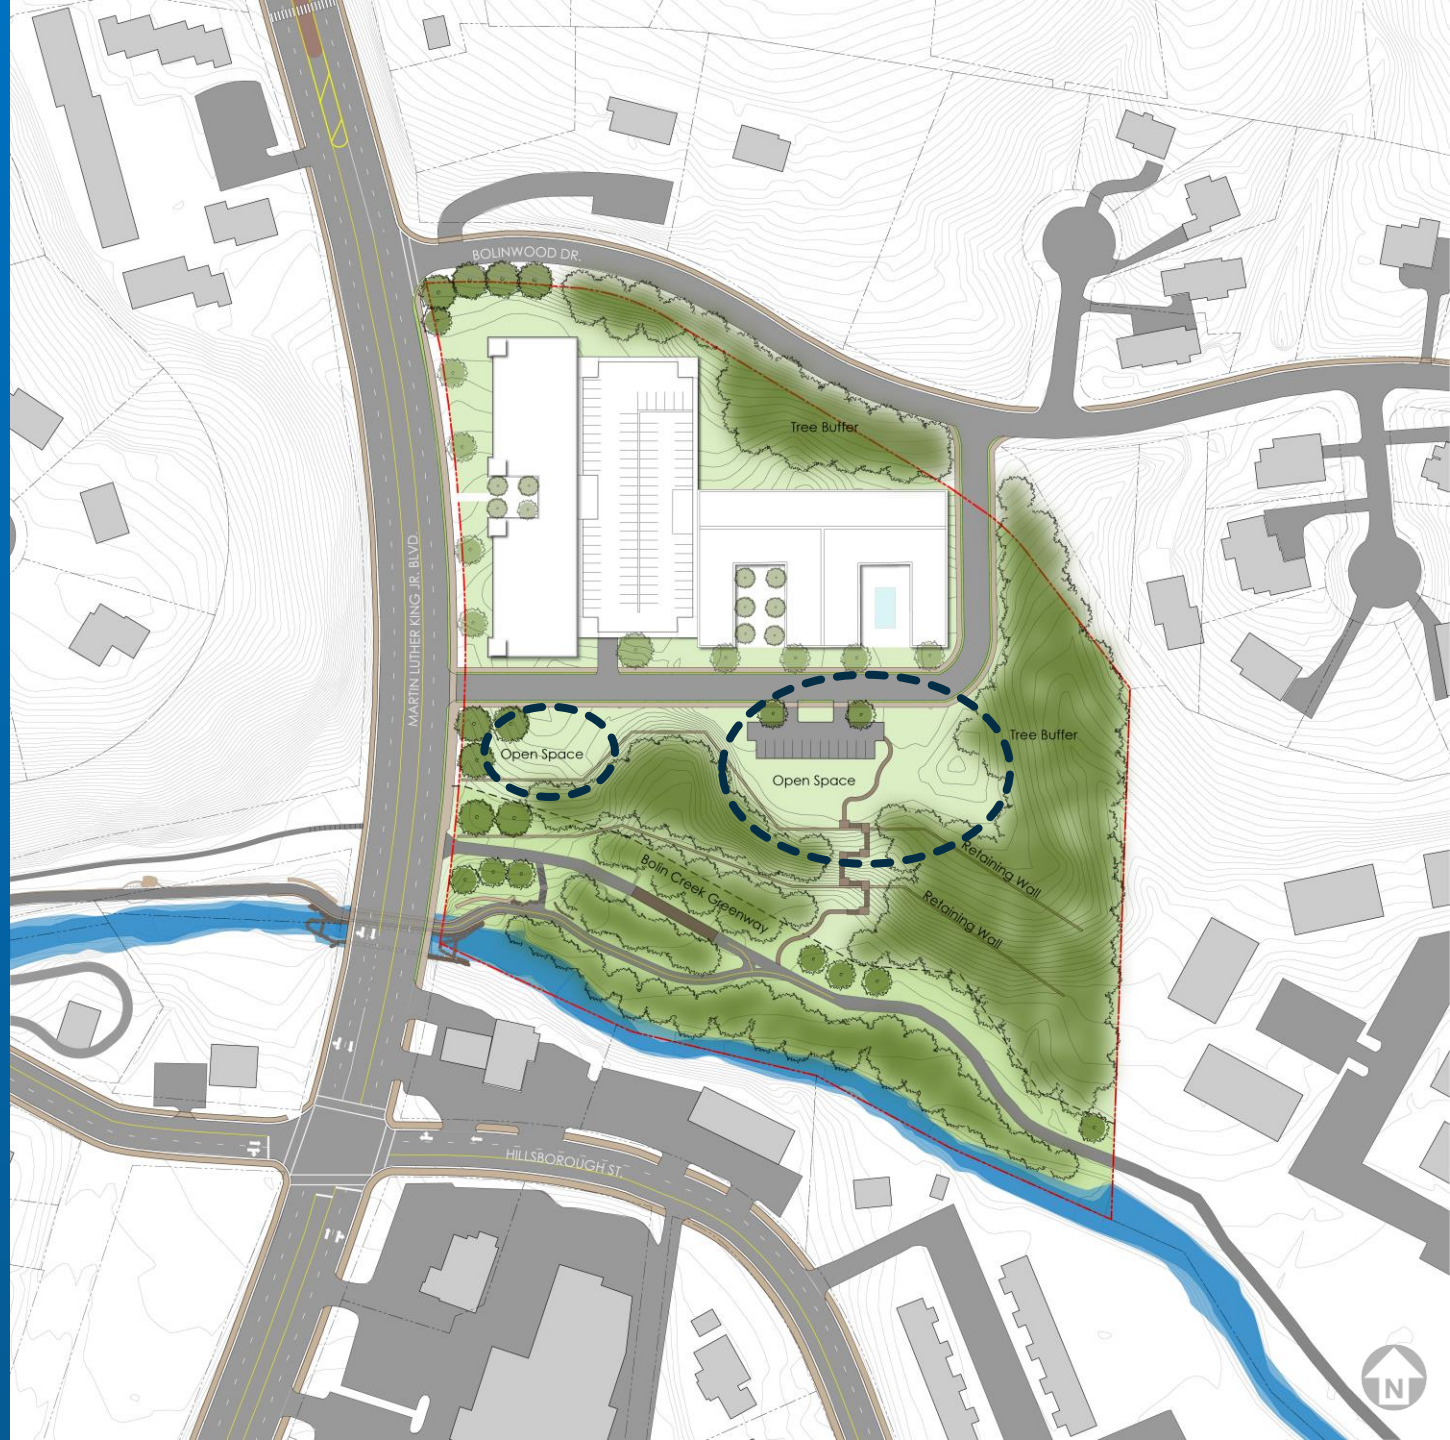
Revised Scenario (August 2018)

- Greenspace / Open Space
- Pedestrian Connectivity
- Access to BRT
- Trail Access and Parking
- Tree Preservation / Tree Buffer

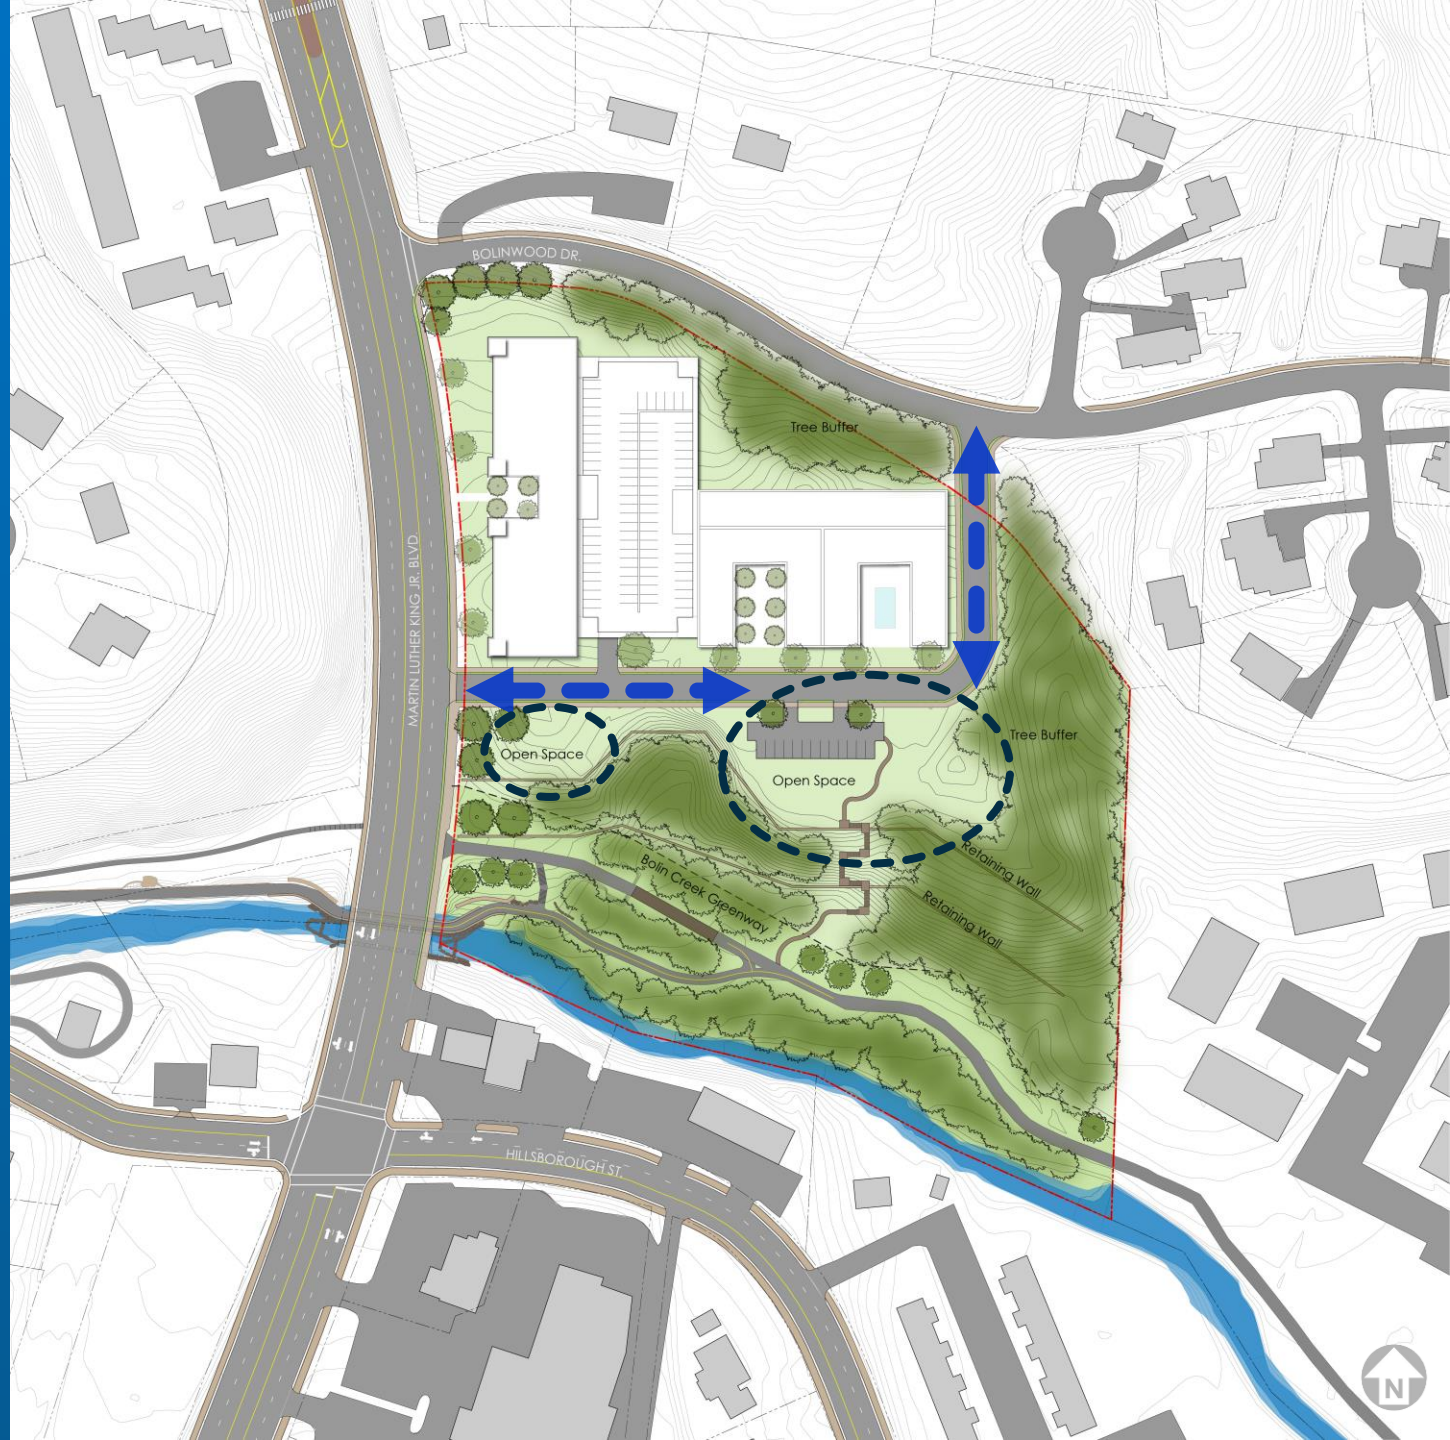
Revised Scenario (August 2018)

- Greenspace / Open Space
- Pedestrian Connectivity
- Access to BRT
- Trail Access and Parking
- Tree Preservation / Tree Buffer

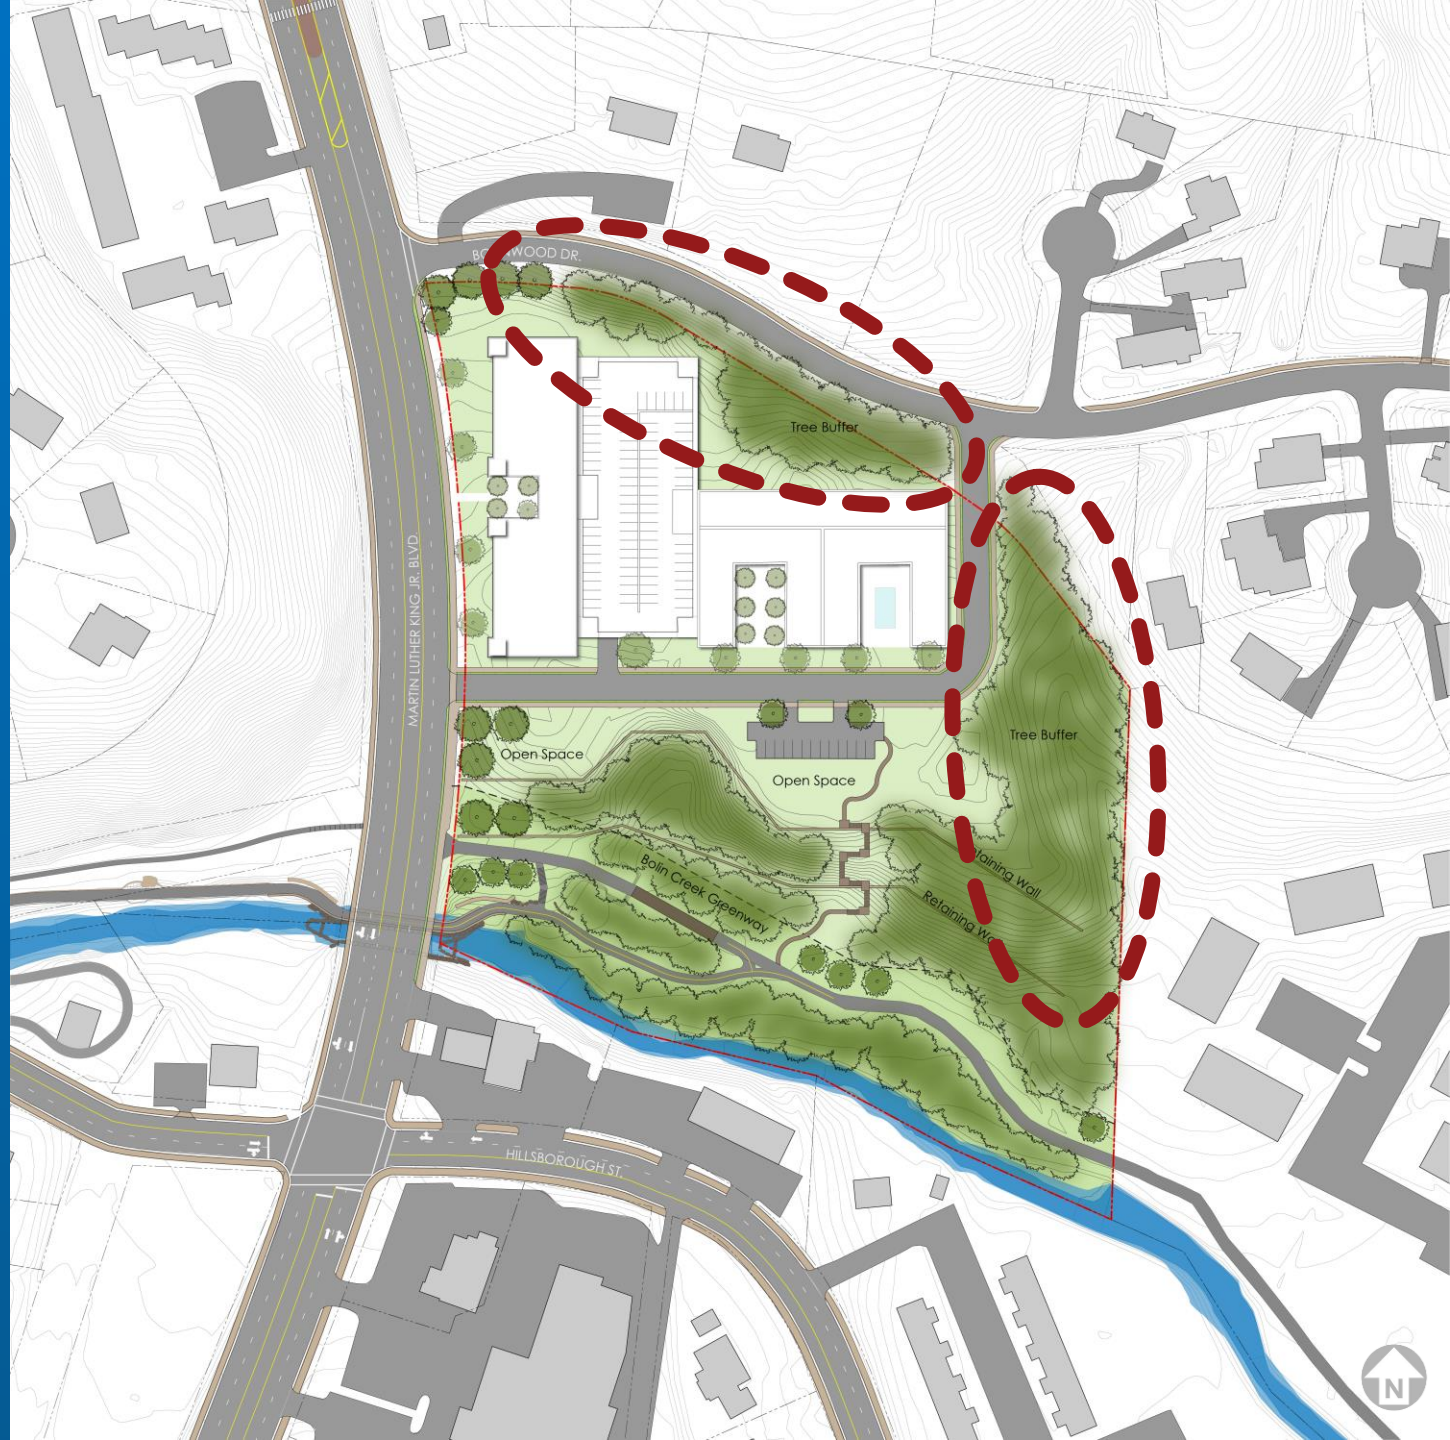
Revised Scenario (August 2018)

- Greenspace / Open Space
- Pedestrian Connectivity
- Access to BRT
- Trail Access and Parking
- **Tree Preservation / Tree Buffer**

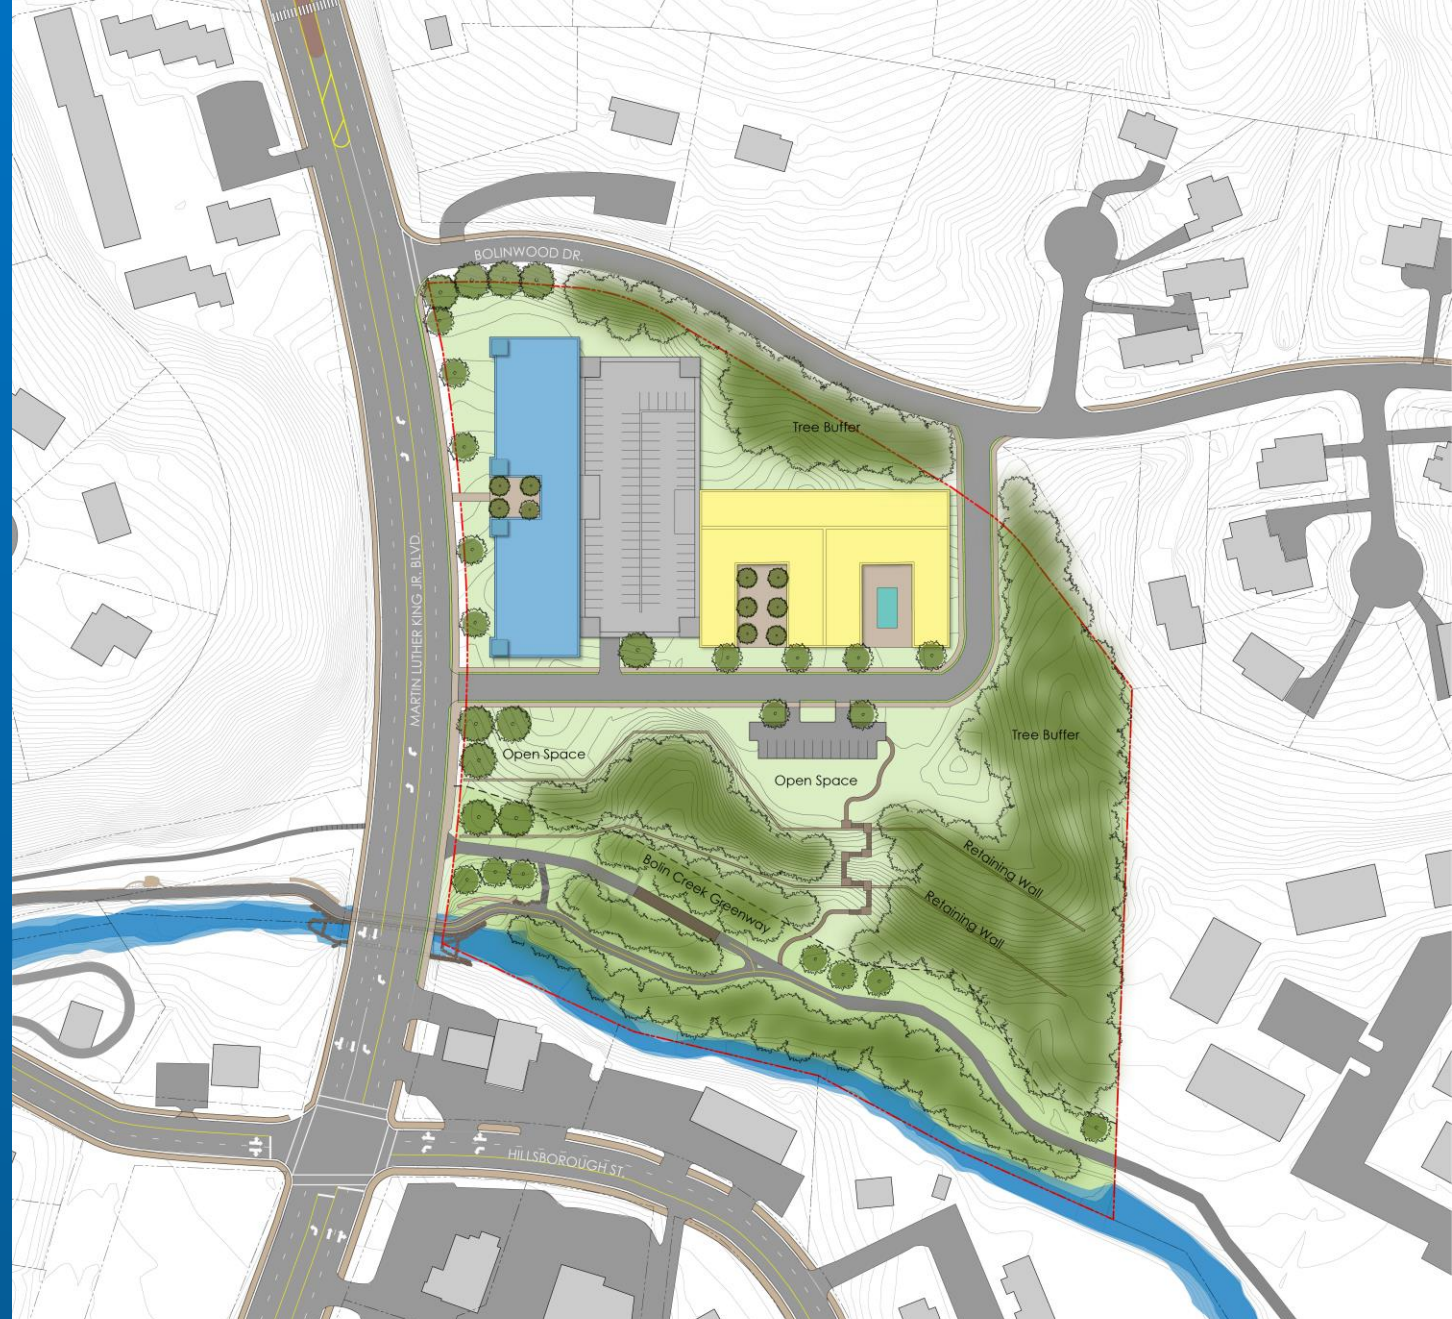
Revised Scenario

- 98,000 sq. ft. office
 - Increased density on MLK Jr Blvd.
 - 6 story
- 6,000 sq. ft. retail
- 560 space parking structure
 - 6 story
- 6 story residential
- Reduction in height may impact financial viability
- Access to Bolinwood Dr.
 - Fire Code
 - NCDOT requirements

Residential

Office + Retail (small)

Parking Deck
