### Discuss Budget Proposal for Interim Measures to Begin Addressing Coal Ash Clean-up and Monitoring.

# Staff Report

# Bolin Creek Trail Risk Assessment

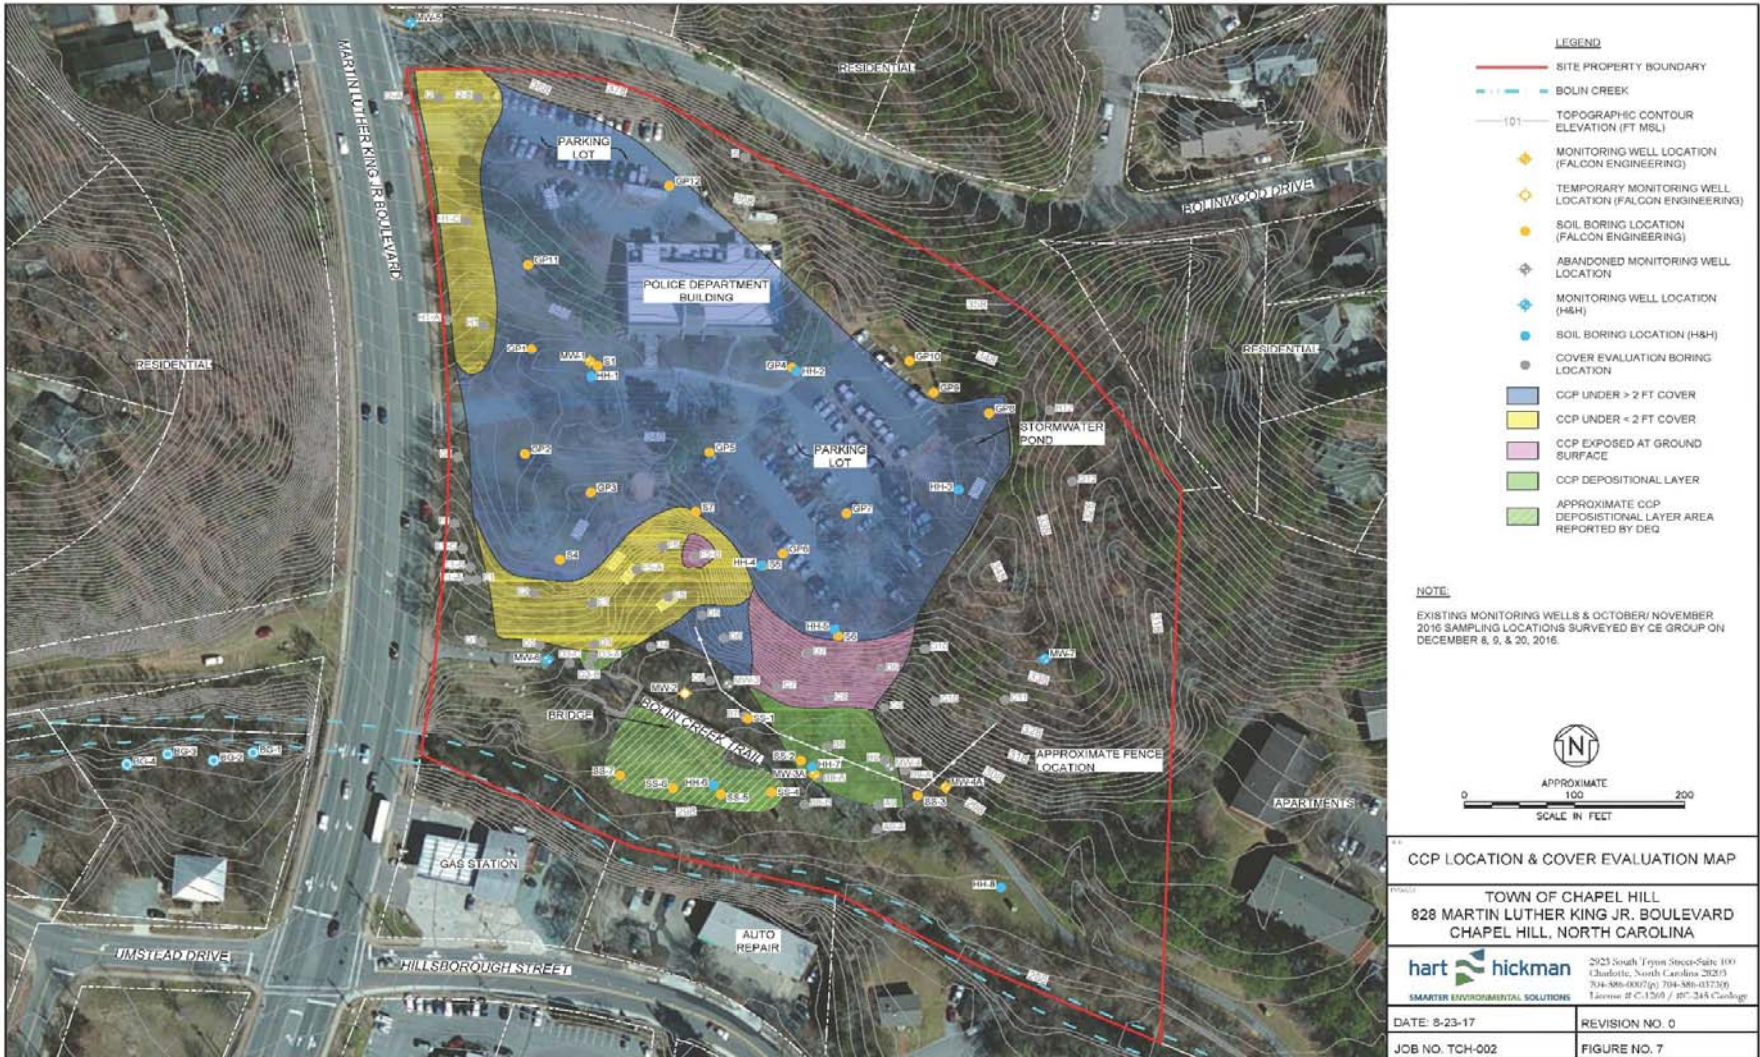
Coal Combustion Products (CCPs) Location and Cover Evaluation Map

Remove deposits of contaminated soil in the areas next to the trail and the creek (see green areas on map below). This work includes the removal of approximately 6-12" of contaminated soil to a facility that is permitted to receive these materials. Clean soil would then be brought in to replace the amount that was removed.

Add matting, clean soil and grow new vegetation on the areas of the embankment where CCPs are currently exposed (see the pink areas on the map below). The goal of this measure is to reduce the likelihood of CCP erosion and further contamination of the soils next to the trail and the creek.

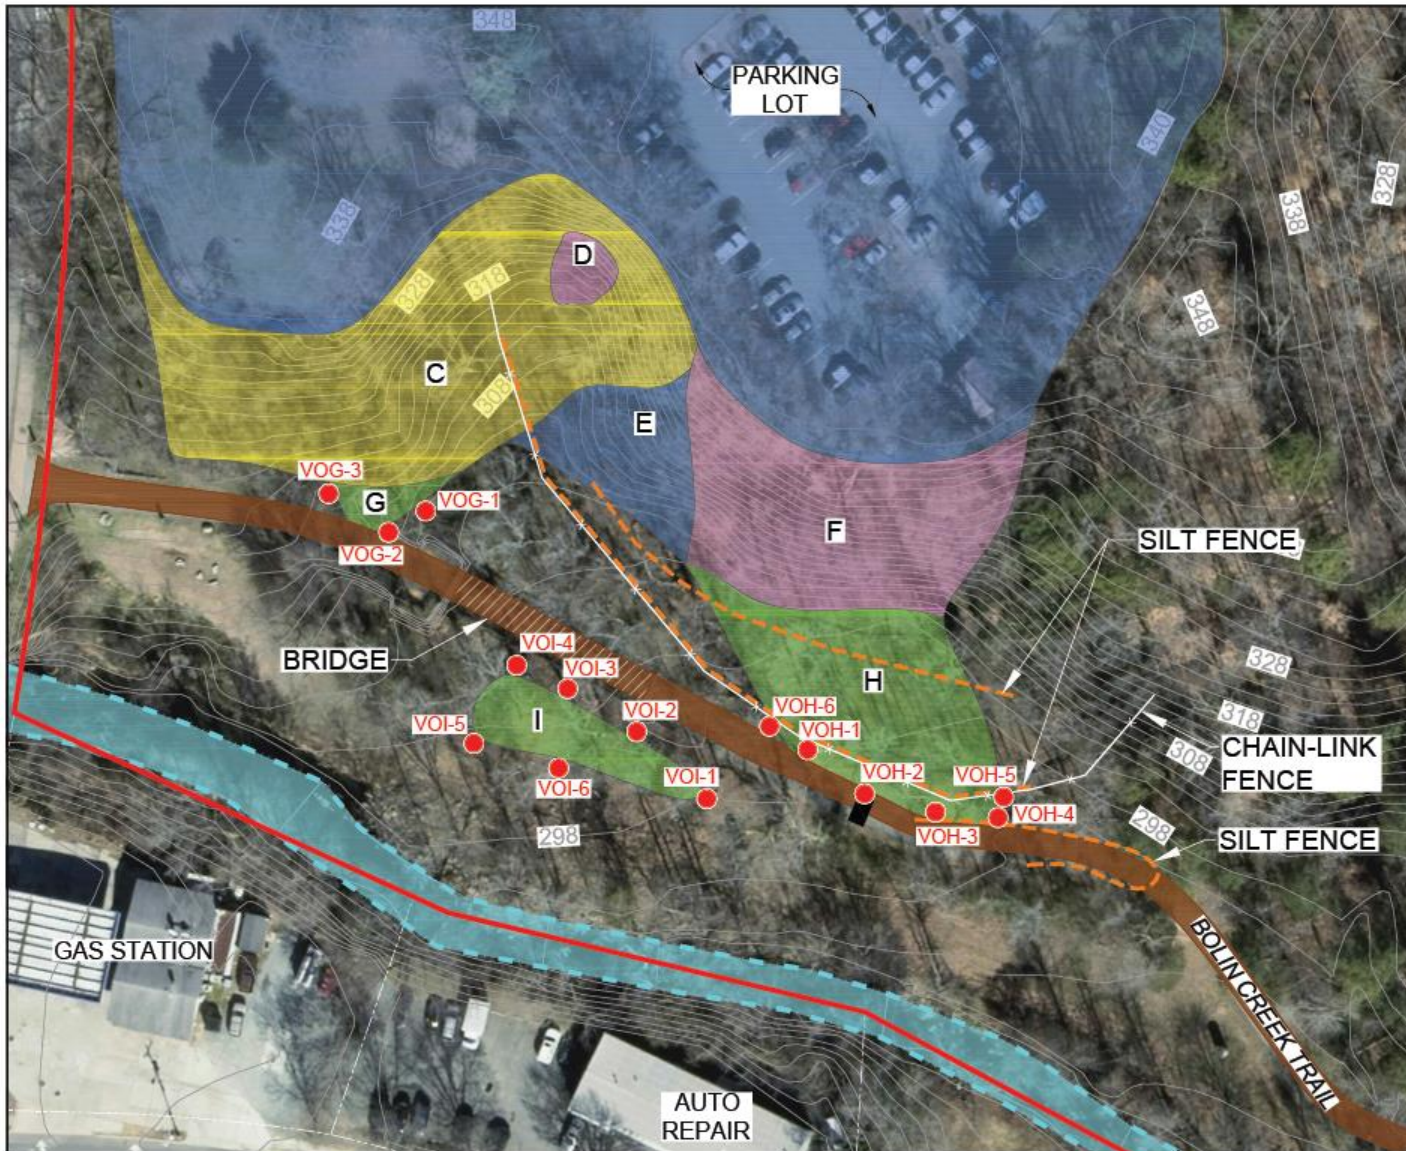
**SITE MAP - EXISTING CONDITIONS**

DATE: 5-10-19	REVISION NO. 0
JOB NO. TCH-003	FIGURE NO. 1

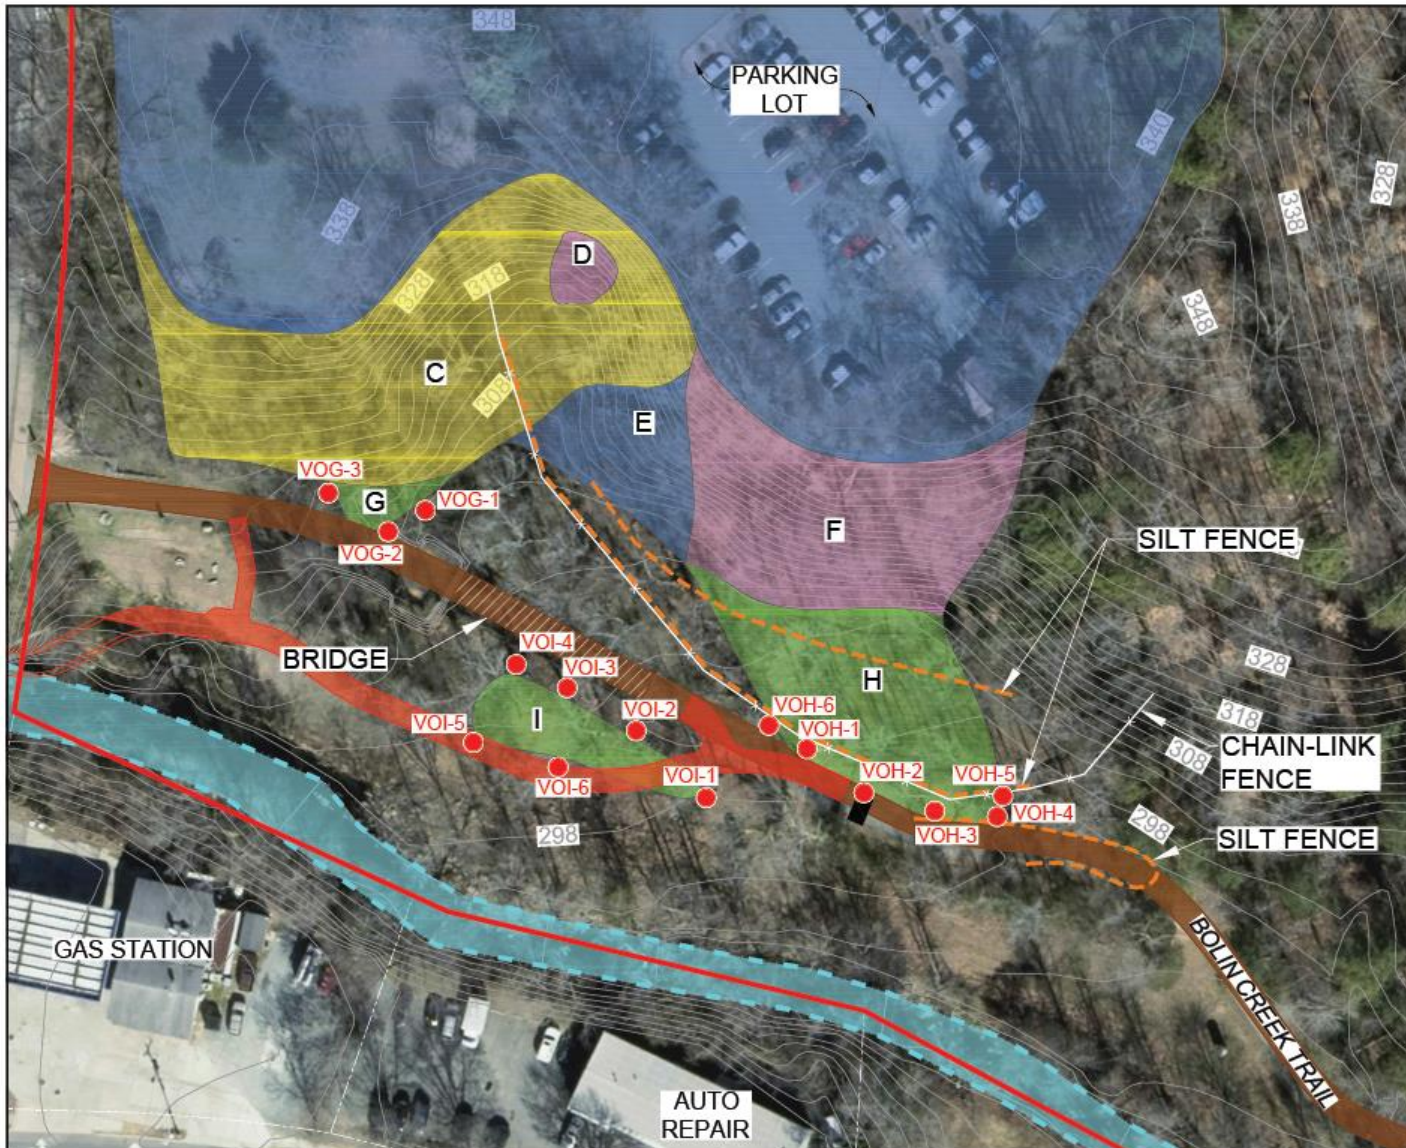
<b>SITE MAP - PROPOSED TRAIL LOCATION</b>	
TOWN OF CHAPEL HILL 828 MARTIN LUTHER KING JR. BOULEVARD CHAPEL HILL, NORTH CAROLINA

<span style="font-size: small;">2525 South Tryon Street, Suite 100 Chapel Hill, North Carolina 27515 704-586-0007 (p) 704-586-0373 (f) License # C-1269 / #C-245 Geology</span>	
DATE: 5-10-19	REVISION NO. 0
JOB NO. TCH-003	FIGURE NO. 2

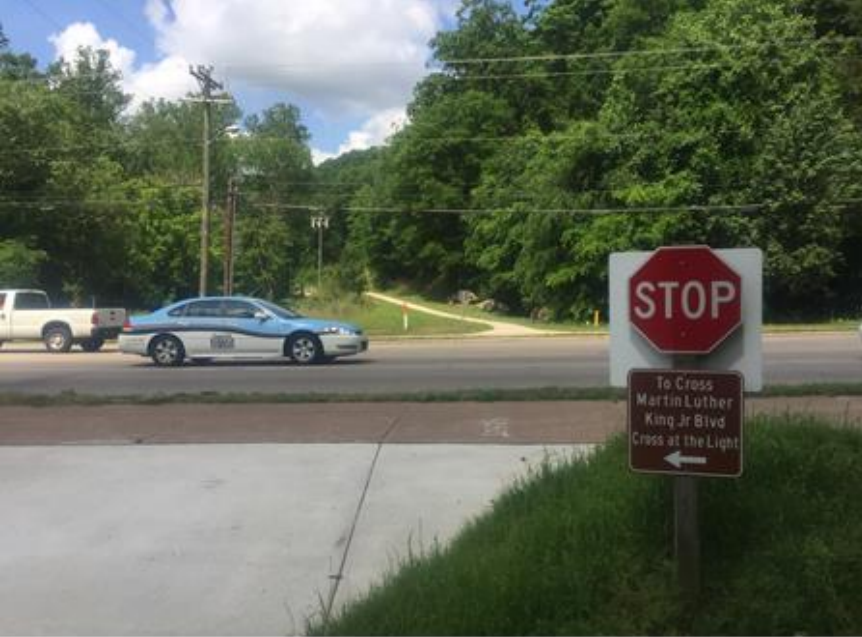
# Completing the Greenway Project and Opening the Bridge Underpass

- Manage Risk to Construction Workers with Proper Training
- There is Currently Risk To Trail Users By Crossing Martin Luther King, Jr. Blvd.

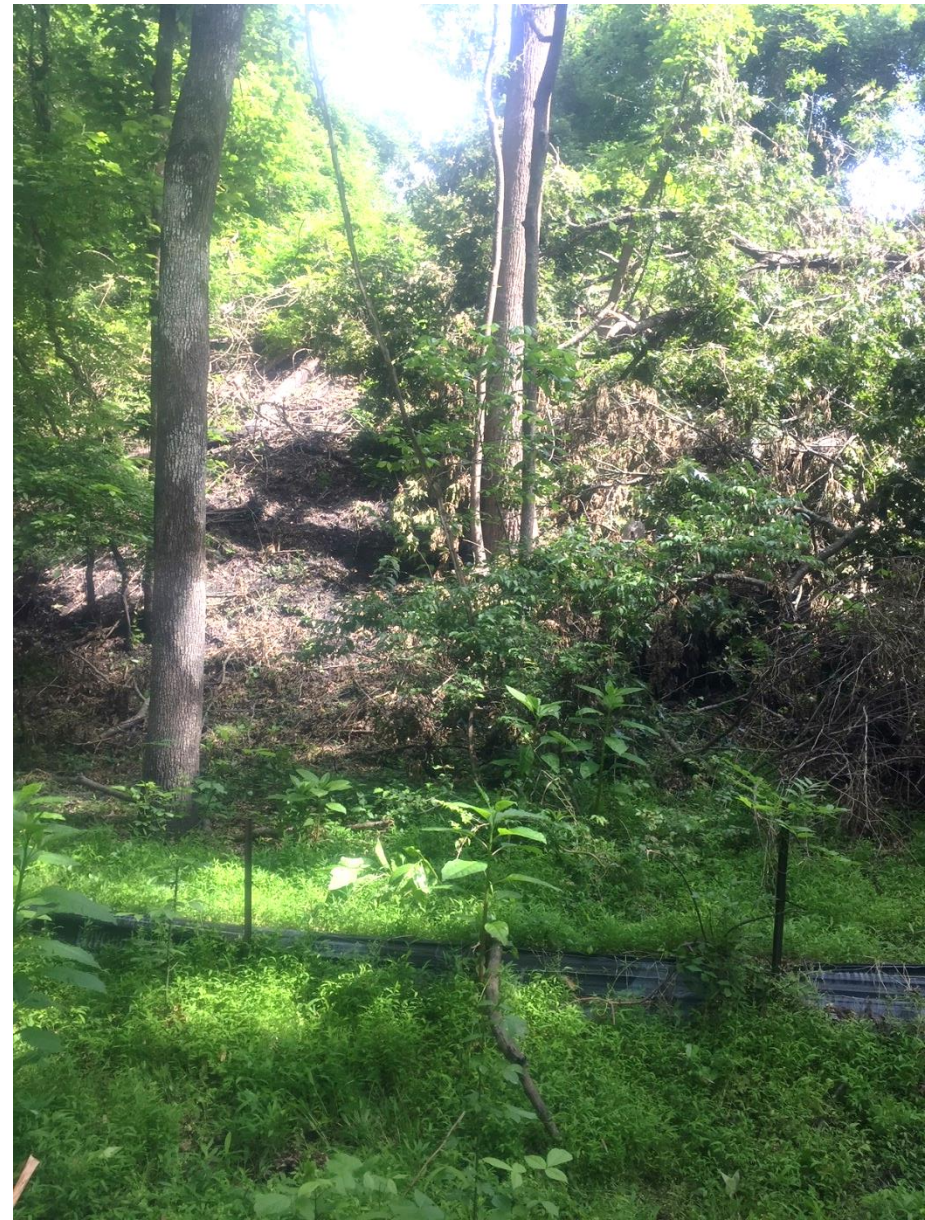
# Interim Measures to Keep Trail Open

- These Measures Control Risk to Recreational Users of Greenway Trail
  - a) Surficial Soil Removal / Backfill
  - b) Additional Signage Along Trail
  - c) Polling of Users
  - d) Additional Silt Fencing
  - e) Limit Embankment Disturbance
  - f) Periodic Inspections and Sampling
- Post-Construction Sampling and Update Risk Assessment

Add additional silt fencing to help control erosion from the embankment. Monitor and repair as needed. Currently, there are two layers of silt fencing on the site – one at the base of the embankment and another at the base of a black chain link fence that separates the Bolin Creek Greenway from the embankment.

After the measures above have been implemented, take additional samples of the soil removal/replacement areas to verify that no additional contaminants have been deposited from the embankment.
