MEMORANDUM

Re: Preliminary Risk Evaluation Findings for Interim Measures Along Bolin Creek Greenway,
Chapel Hill Police Department Property, 828 Martin Luther King Jr. Boulevard, Chapel Hill,
North Carolina.

Re: Results of Data Gap Sampling
828 Martin Luther King Jr. Blvd. Property
Chapel Hill, North Carolina
H&H Job No. TCH-007

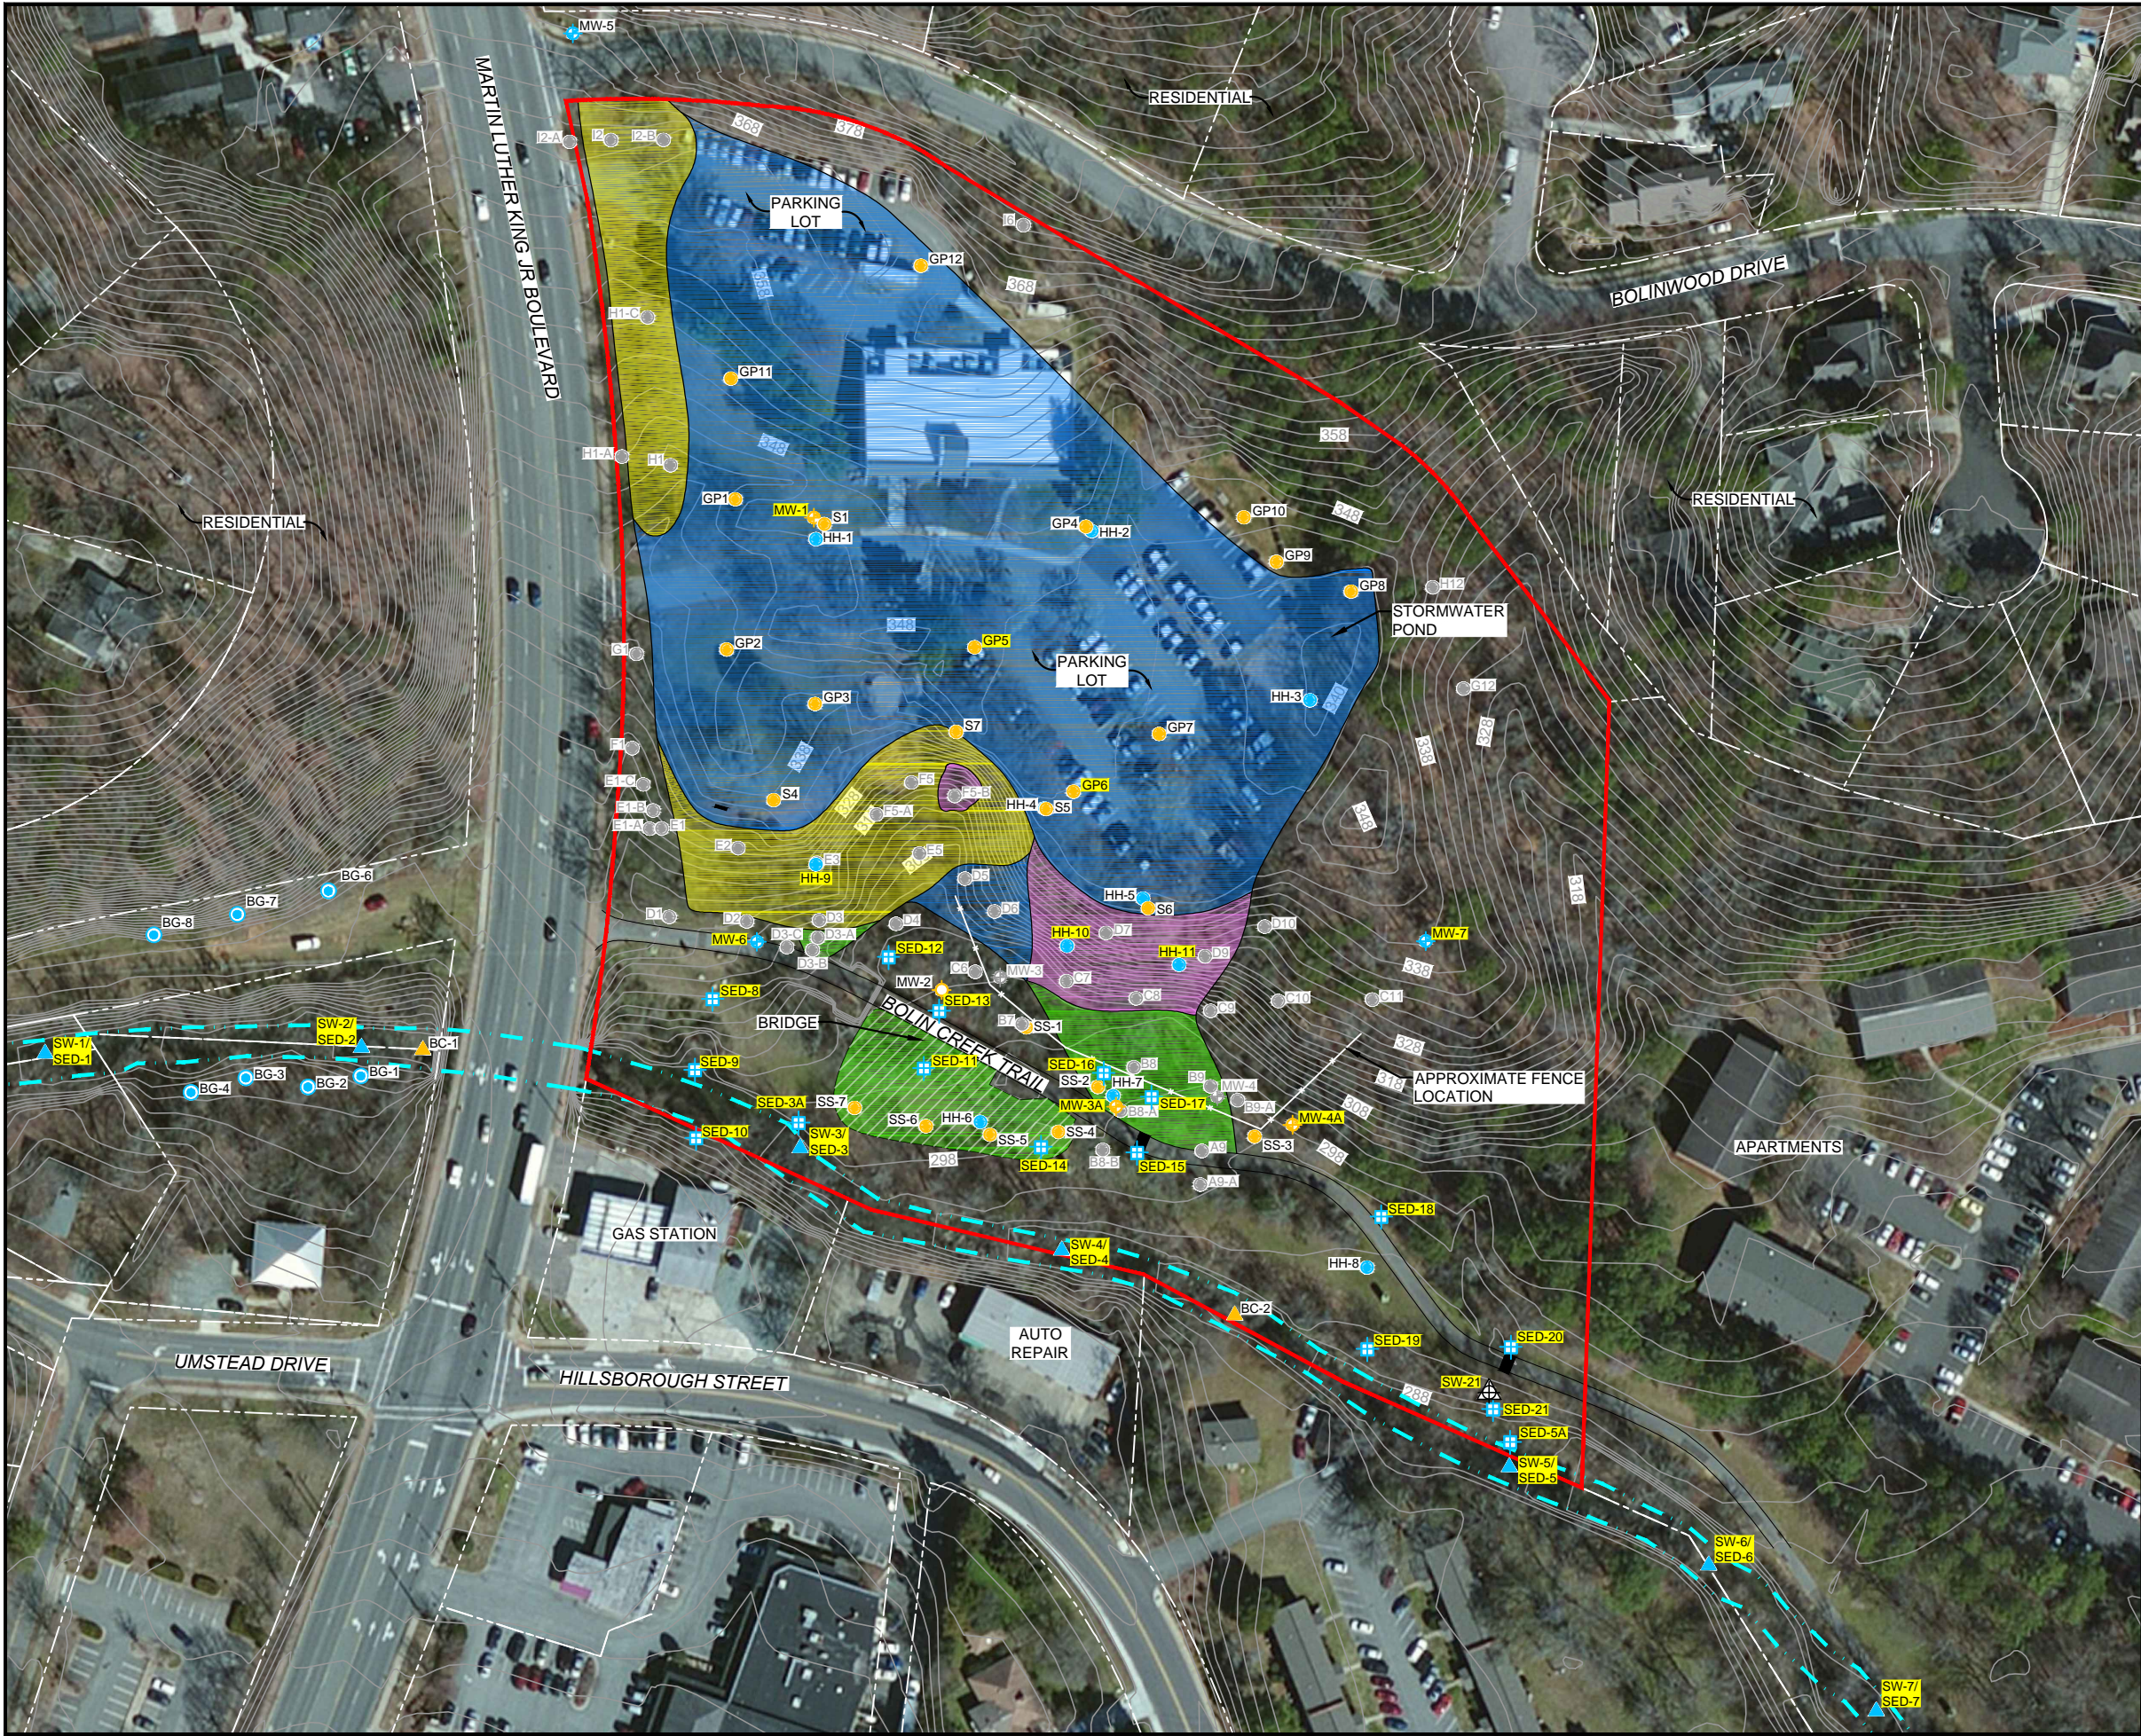
The locations of the previous and recent samples are provided in Figure 1 (groundwater, soil, sediment, and surface water), and the locations of the indoor air samples are indicated in Figure 2. In Figure 1, the locations where H&H collected samples in April 2019 are highlighted in yellow for ease of reference.

As requested, Hart & Hickman, PC (H&H) has prepared this letter report to document the methods and results of additional environmental sampling conducted at the property located at 828 Martin Luther King Jr. Blvd. in Chapel Hill (Site or subject Site). The Site is comprised of one land parcel that is approximately 10.24 acres in size and contains a two-story approximately 35,000 sq. ft building located in the north-central portion of the Site that is currently used for police department operations. The Site topography consists of an elevated area where the police building and associated parking lots are located which slopes along an embankment to the south to a lower area along Bolin Creek where the Bolin Creek Trail are located. Site topography is indicated in Figure 1.

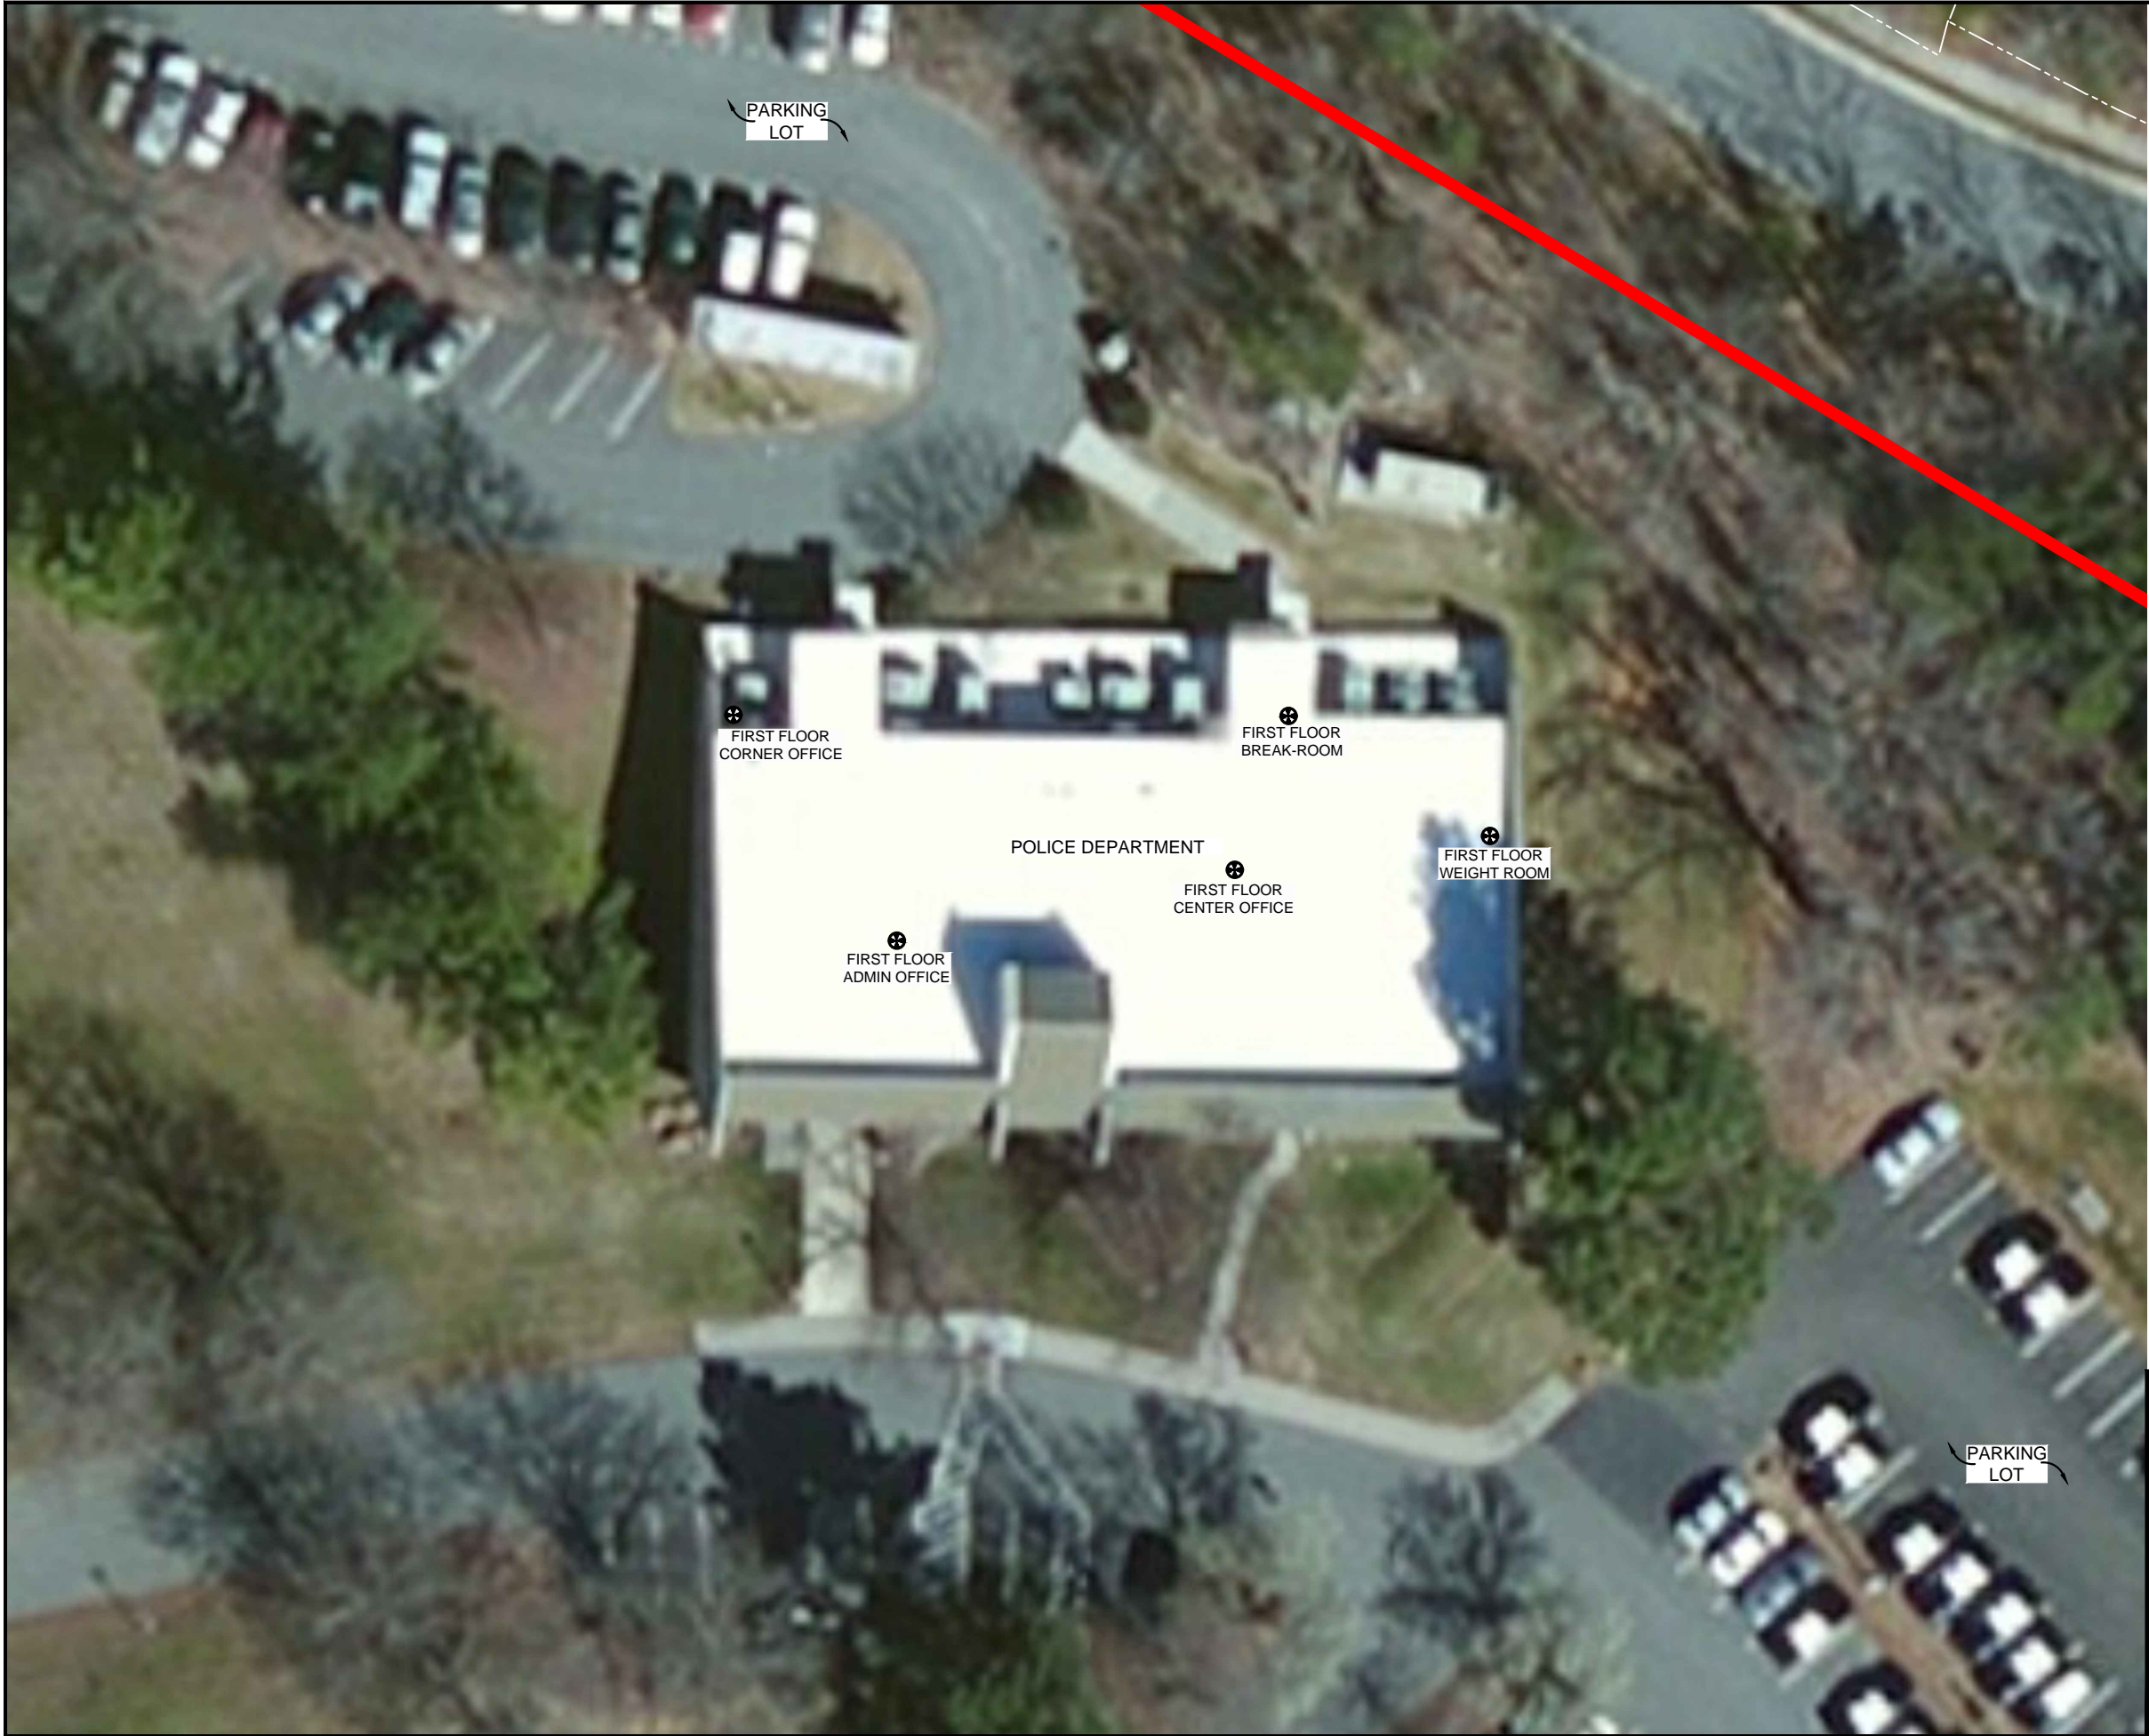
April 5, 2019 and collected on April 8, 2019 (approximate sample period of 73.5 hours at each location). Following the sampling period, the test kits were sealed and sent to AccuStar laboratory for analysis of radon by EPA Method #402-R-92-004. The locations of the samples are indicated in Figure 2.
