RESOURCE CONSERVATION DISTRICT ENCROACHMENT EXEMPTION APPLICATION

Project Name: Columbia Street Annex
Property Address: 1150 South Columbia Street, Chapel Hill, Zip Code: 27514
Existing Zoning District: R-2

COLUMBIA STREET ANNEX – RCD Application Attachment

Reference: **Wildlife Habitat Assessment**
South Columbia Street Annex Site
Chapel Hill, Orange County, North Carolina
S&ME Project No. 4305-20-070

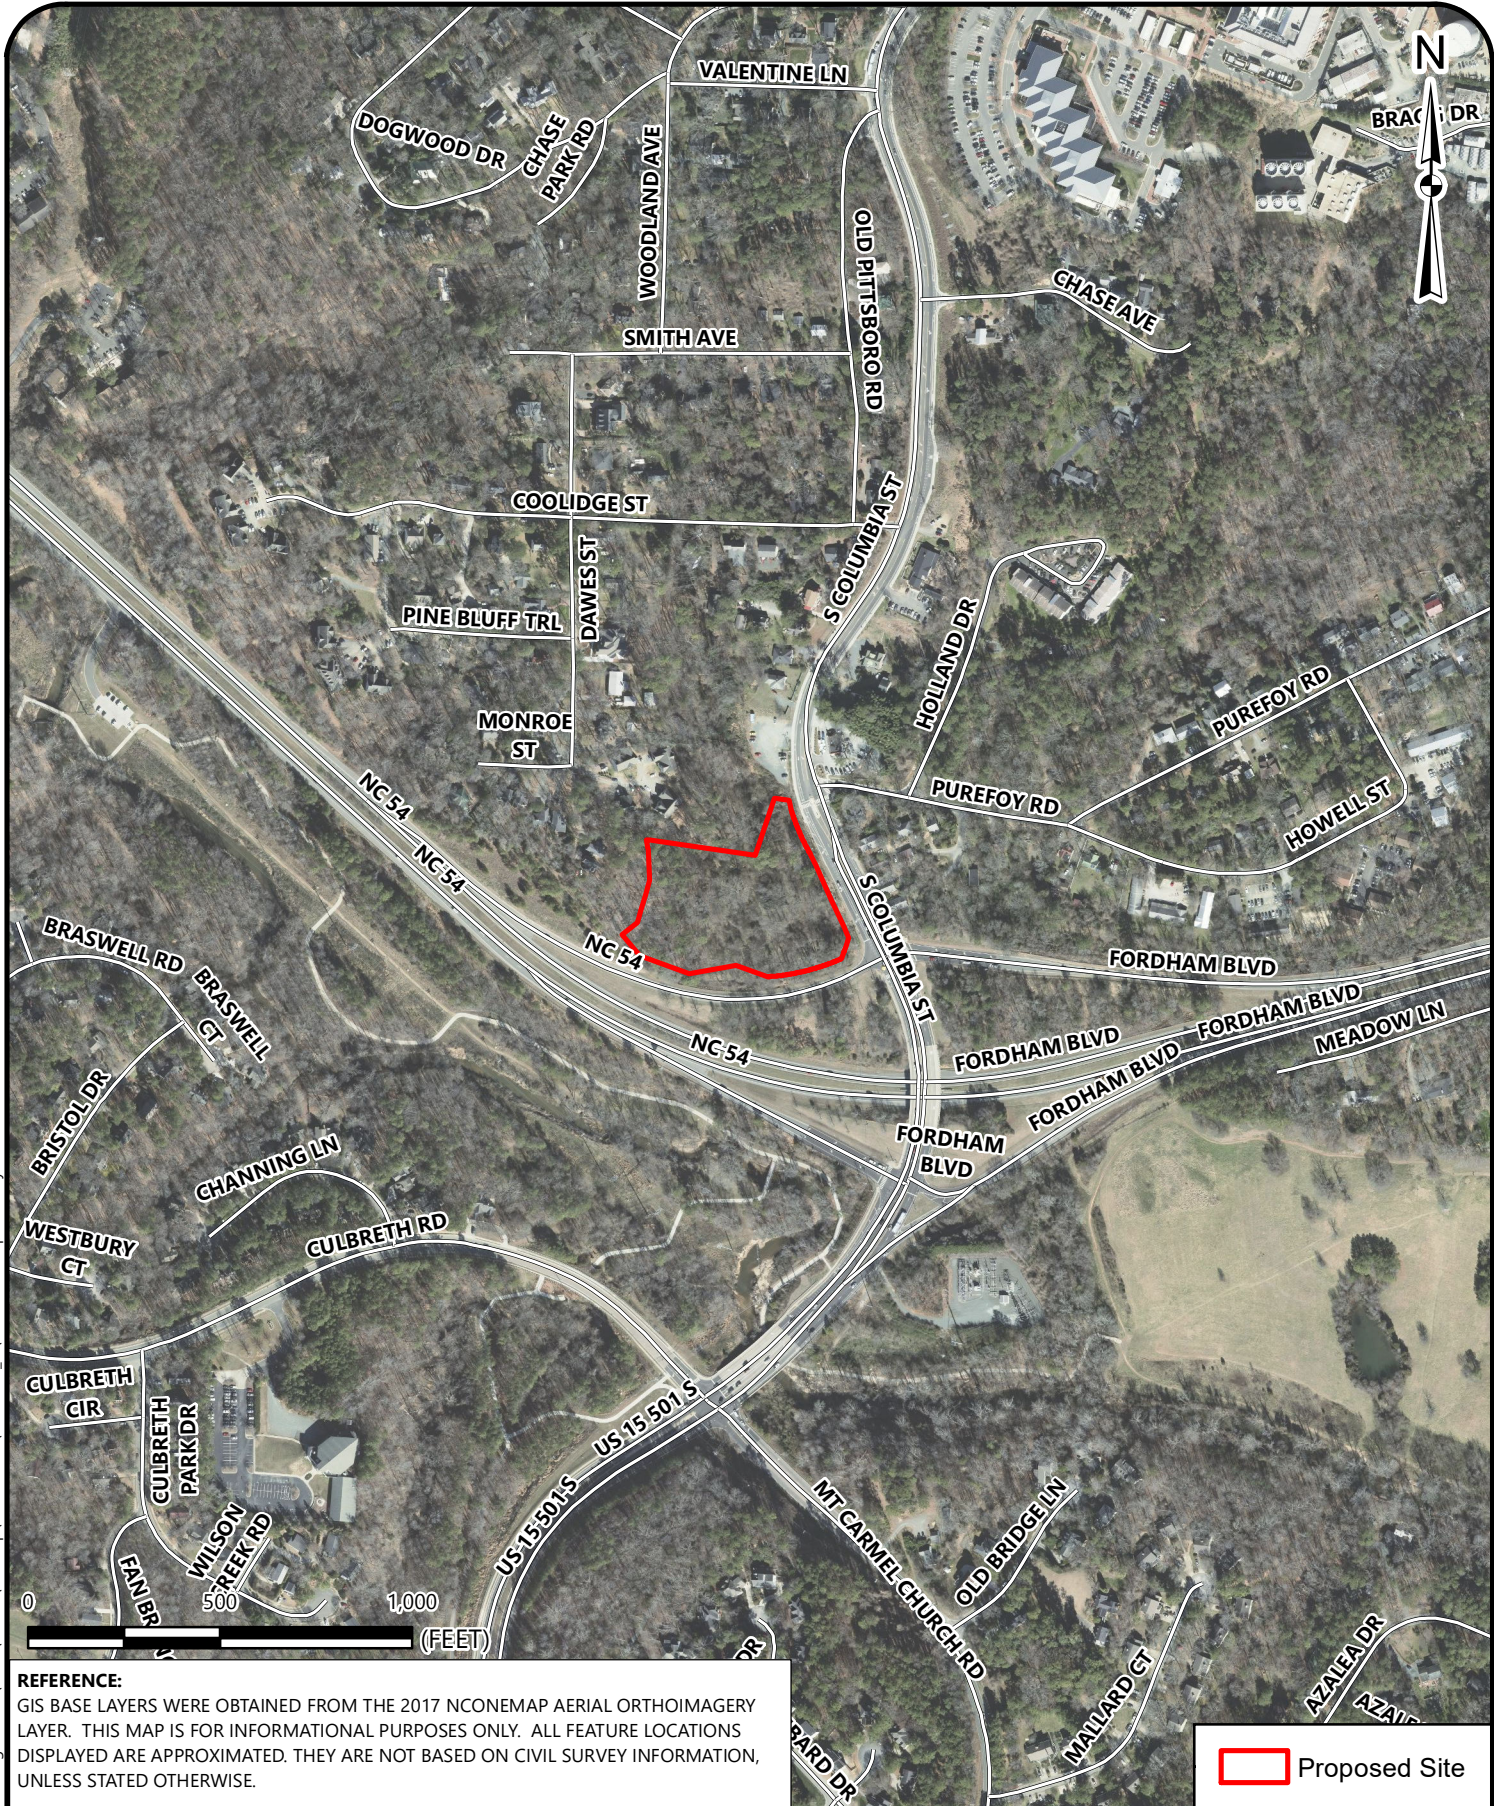
VICINITY EXHIBIT	SCALE: 1" = 500'	FIGURE NO.
	COLUMBIA STREET ANNEX COLUMBIA STREET AND NC-54	DATE: 4-23-20	3
	CHAPEL HILL, ORANGE COUNTY, NORTH CAROLINA	PROJECT NUMBER TBD

The second significant limitation of the site is the location within the greater landscape. The site is located in the northwest quadrant of the intersection of NC-54, which is a four-lane highway with a grassy median, and South Columbia Street, which is approximately five lanes. The access ramp to NC-54 is also located to the south of the site. These large highways are in direct proximity to the site and represent a barrier for wildlife. Photos of these roadways from the site are included as **photos 11 to 12** in the attached photo log. The site is bordered to the north and east by residential developments. These barriers are depicted on the attached **Figure 3**.

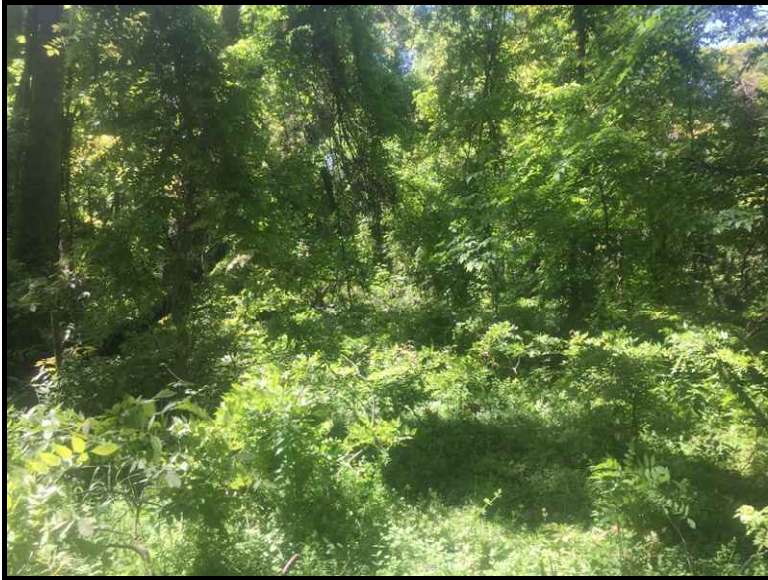
1 View of Chinese wisteria dominating the eastern portion of the site.

The site was dominated by invasive species. Common canopy species observed included American elm (*Ulmus americana*), white oak (*Quercus alba*), red maple (*Acer rubrum*), pignut hickory (*Carya glabra*), common hackberry (*Celtis occidentalis*), pecan (*Carya illinoensis*), sweetgum (*Liquidambar styraciflua*), tulip poplar (*Liriodendron tulipifera*), green ash (*Fraxinus pennsylvanica*), black walnut (*Juglans nigra*), and loblolly pine (*Pinus taeda*). Species commonly identified within the understory included Chinese wisteria (*Wisteria sinensis*), kudzu (*Pueraria lobata*), Japanese honeysuckle (*Lonicera japonica*), English ivy (*Hedera helix*), boxelder (*Acer negundo*), common chickweed (*Stellaria media*), catchweed bedstraw (*Galium aparine*), henbit (*Lamium amplexicaule*), and painted buckeye (*Aesculus sylvatica*). Throughout the site, Chinese wisteria has formed dense thickets of vegetation and in some areas, has overtaken the shrubs and smaller trees. Representative photos of the uplands dominated by invasive species are depicted as **photos 1 to 3** in the attached photo log.

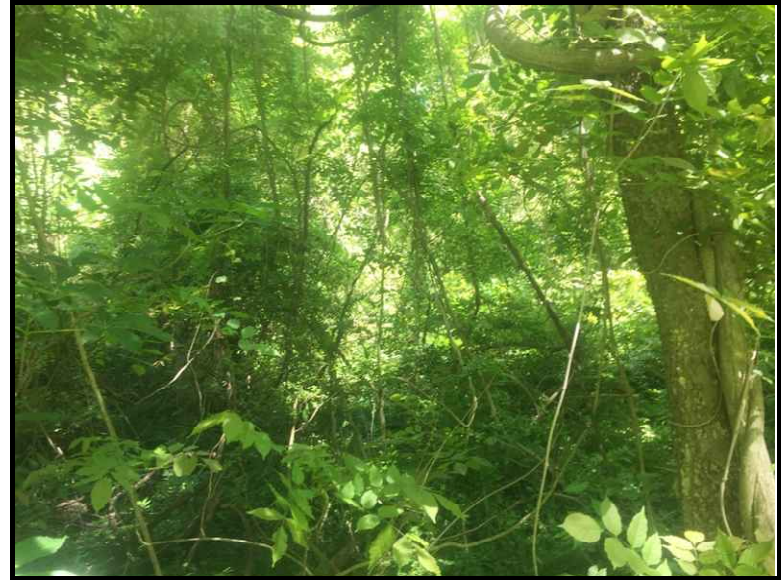
2 View of Chinese wisteria dominating the eastern portion of the site.

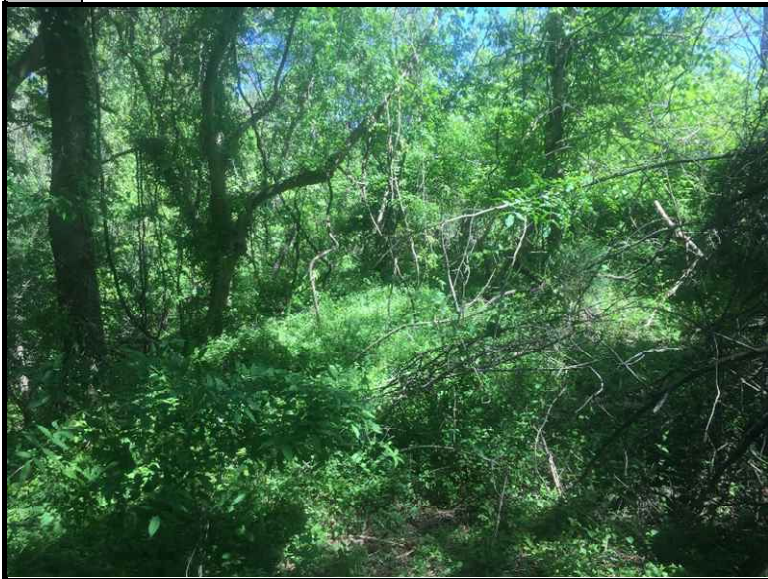
3 View of Kudzu, Chinese wisteria, and honeysuckle dominating the northeastern portion of the site.

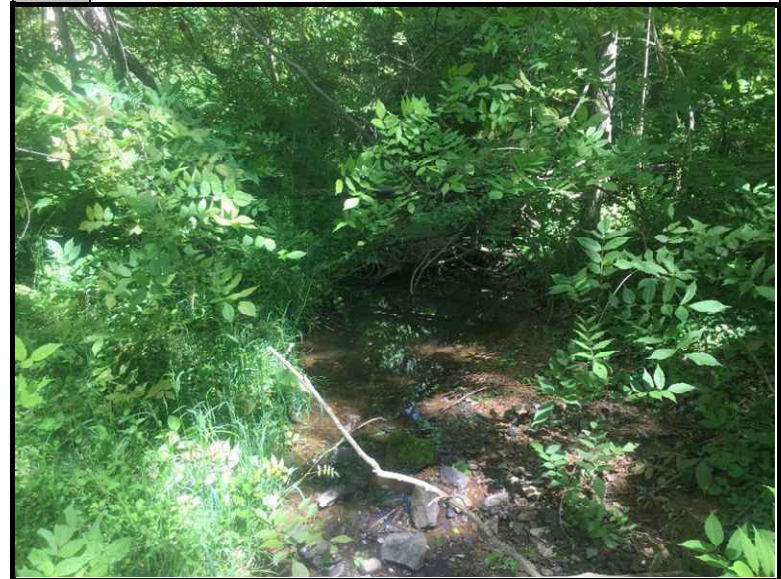
4 View of the perennial stream taken from the southern portion of the site.

A small perennial stream transects the site flowing from north to south. Representative photos of the stream and surrounding vegetation are depicted as **photos 4 to 5** in the attached photo log. The western side of the stream is less dominated by invasive species and has a more open understory although the invasive species are still present. Common species include the canopy species identified above, including American elm, red maple, sweetgum, pine, green ash, pecan, and walnut. Additional species observed include American hophornbeam (*Carpinus caroliniana*), autumn olive (*Elaeagnus umbellata*), sycamore (*Platanus occidentalis*), American beech (*Fagus grandifolia*), southern red oak (*Quercus falcata*), and northern red oak (*Quercus rubra*). Representative photos of the western portion of the site are depicted as **photos 6 to 7** in the attached photo log.

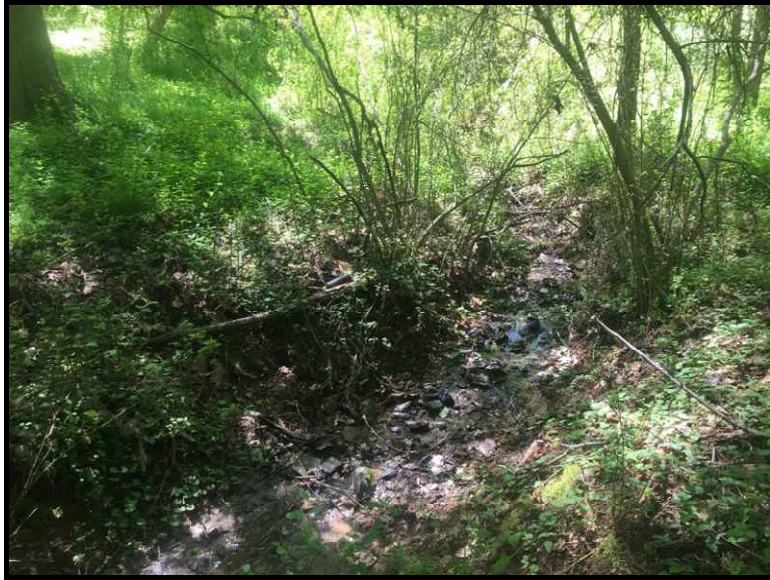
5 View of the perennial stream taken from the northern portion of the site.

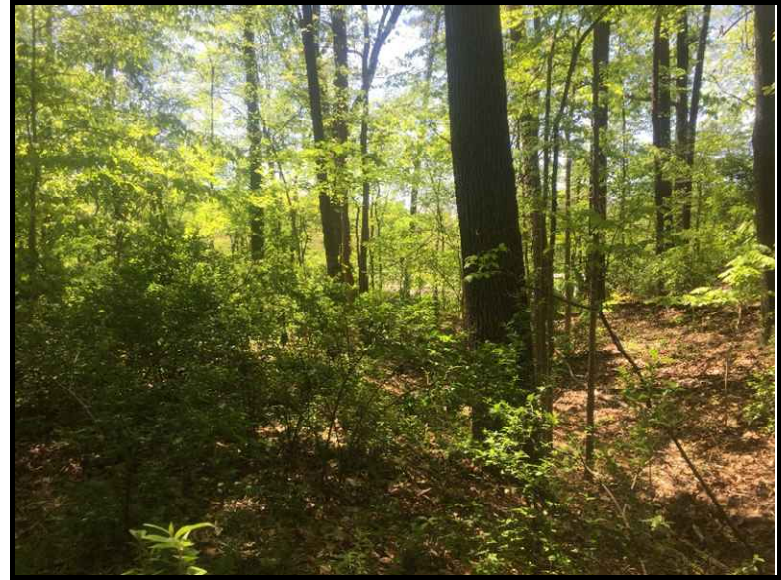
6 View of the western portion of the site. Autumn olive can be seen in the left side of the photo.

Autumn olive, which was identified western portion of the property, has historically been utilized as a beneficial species for wildlife and was planted in wildlife management areas. The fruit of this species serves as a source of food for a variety of wildlife species including birds, raccoon, skunk (*Mephitis mephitis*), rabbits, and opossum. White-tailed deer are also known to browse this plant. Autumn olive is considered a non-native invasive species which can create thick thickets and reduce native plant species diversity. It is also considered highly invasive and can be difficult to remove or otherwise control ("*Elaeagnus umbellata*").

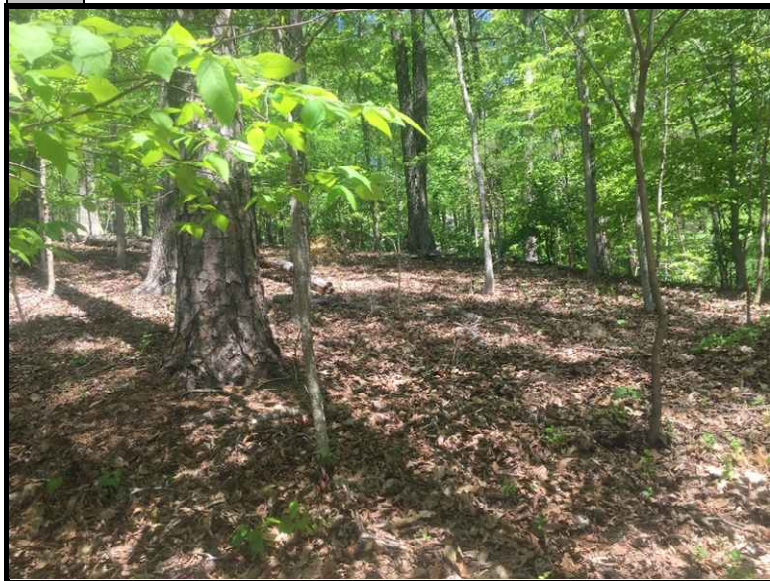
7 View of the western portion of the site depicting the lack of invasive species.

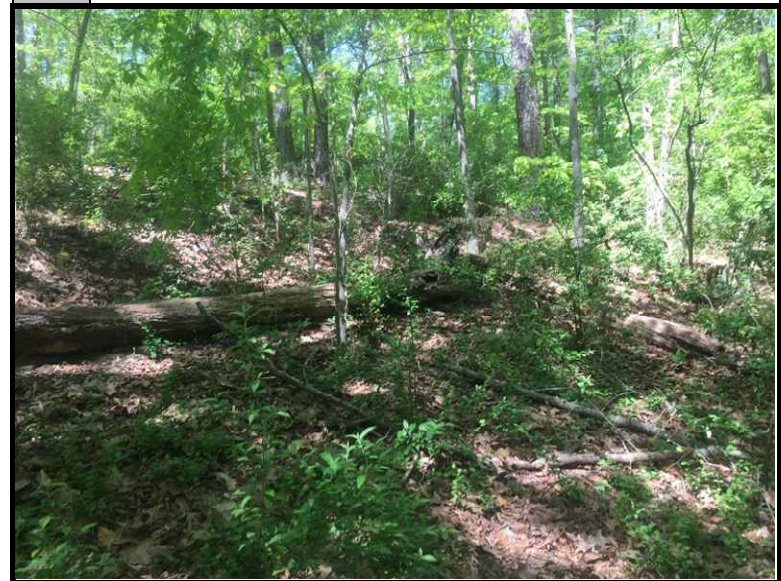
8 View of fallen logs and woody debris in the western portion of the site.

Snags, or standing dead trees, provide habitat to a significant variety of animals. Per the National Wildlife Federation, the removal of snags and logs from the ground can remove habitat for approximately one-fifth of the animals in an ecosystem (Cover: Trees and Snags). Snags provide hollow cavities for nesting for birds, owls, bats, squirrels, and raccoons. In addition, they serve as a food source for insects, mosses, and fungi, which are in turn a food source for other species including raccoons, red fox (*Vulpes vulpes*), gray fox (*Urocyon cinereoargenteus*), and many bird species including the pileated woodpecker (*Dryocopus pileatus*). Similarly, fallen logs and other woody debris provide habitat and food sources for a wide variety of species including the black rat snake (*Elaphe obsoleta*), rabbits, foxes, salamanders, frogs, insects, mosses, and fungi. Representative photos of the snags and woody debris found within the site are depicted as **photos 8 to 10** in the attached photo log.

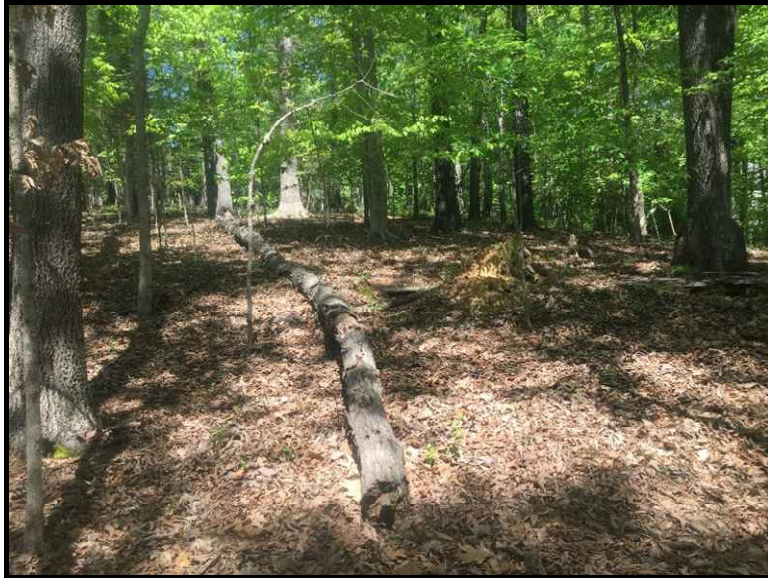
9 View of fallen logs and woody debris in the western portion of the site.

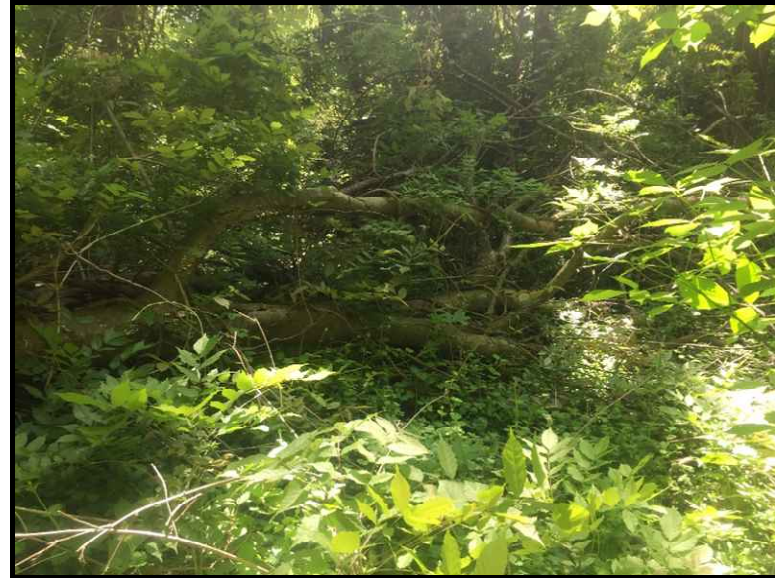
10 View of fallen logs and woody debris in the eastern portion of the site.
