APPENDIX B

Photo Log

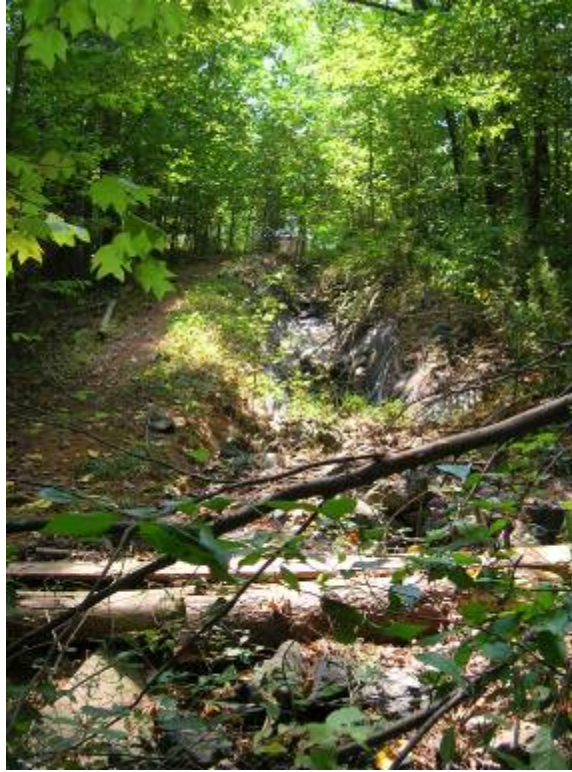
Site 4

Facing uphill towards the outlet pipe that discharges into a rip-rap lined ditch.

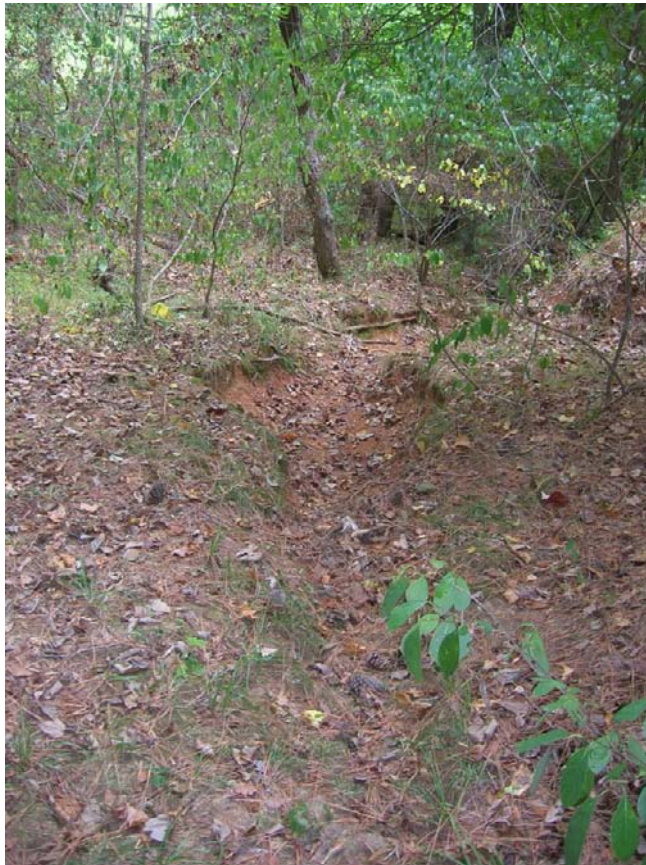
Where the flow has concentrated, an eroding channel and headcut has formed. Facing downstream.

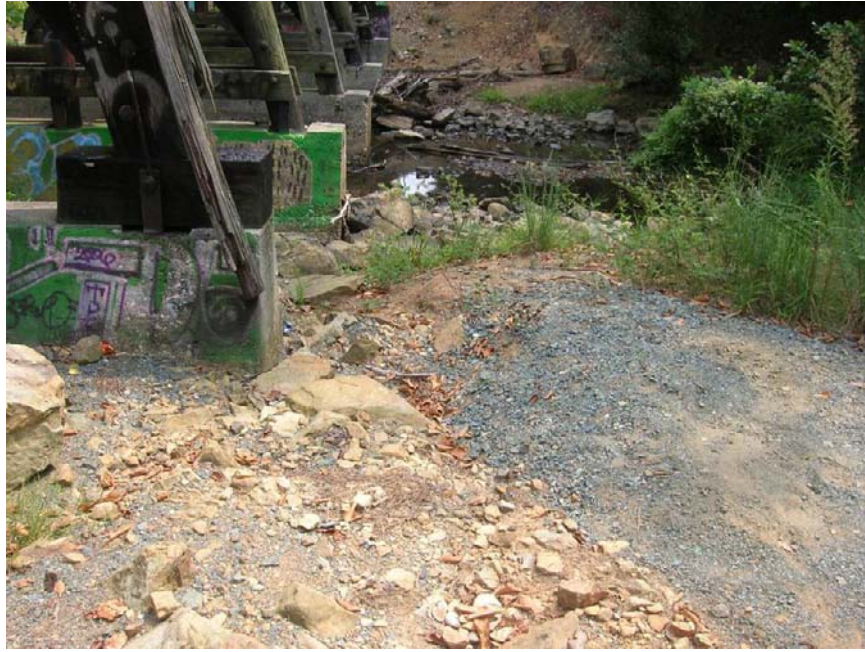
Stormwater flows past the railroad trestle footers and directly into Bolin Creek. Facing south.

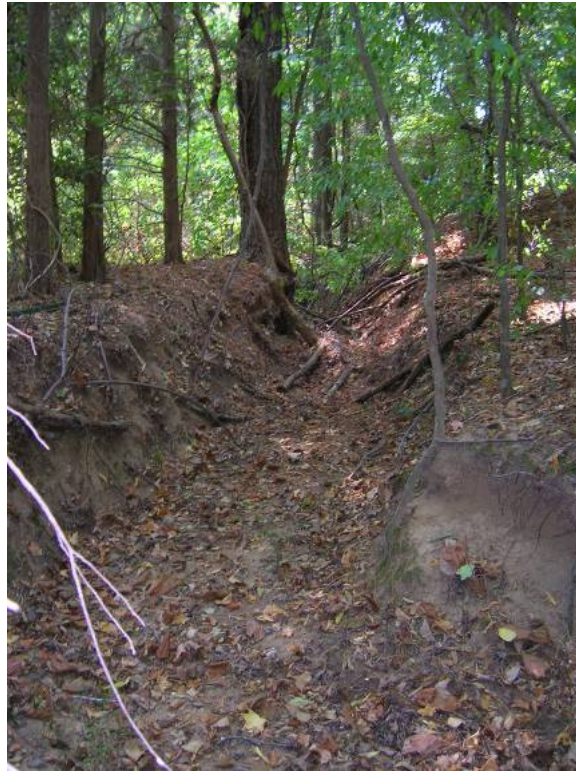
Site 24

The stream channel at site 24 is incised as it flows towards Bolin Creek and the Bolin Creek Greenway. Facing downstream.

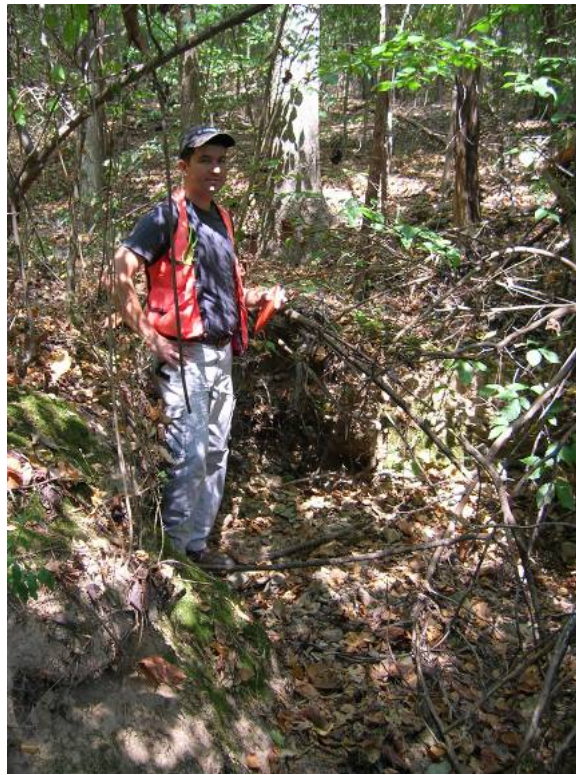
A headcut along the channel. Facing upstream.

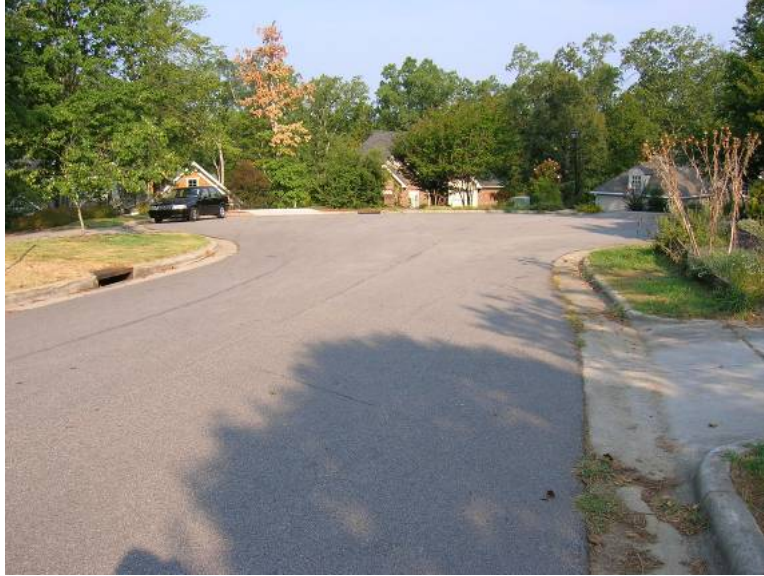
Site 30

A view of Hotelling Ct, which comprises part of the drainage area of the basin at Site 30. The existing BMP is downhill and to the left of the photo. Facing northwest.

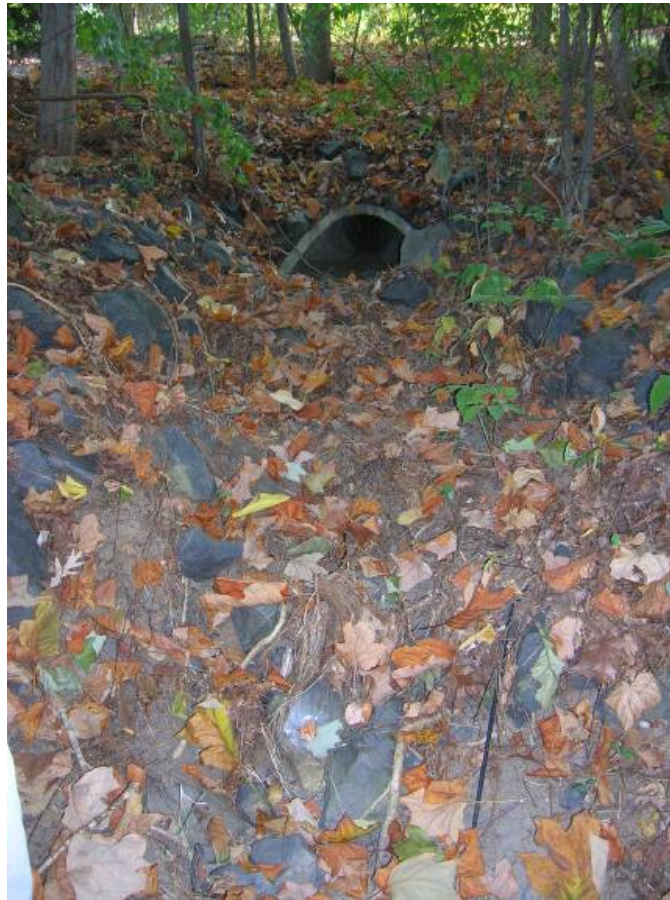
The stormwater outfall pipe below Hotelling Ct. Facing northeast.

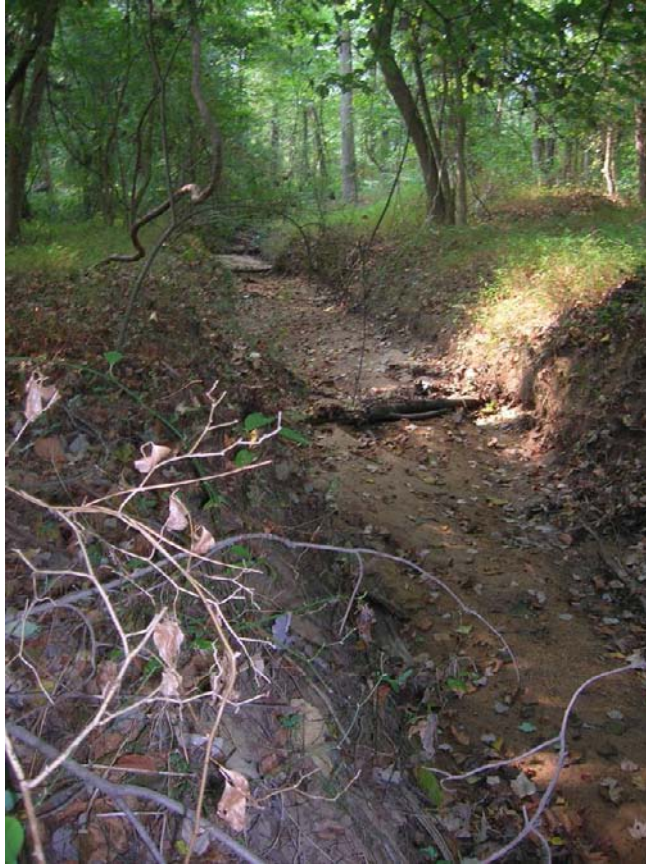
The stream has been straightened for most of its course. Spoil piles are present in the floodplain. Facing upstream.
