SITE 16

Stabilize Erosion at Apartment Complex and Provide Water Quality Treatment.

Bolin Creek Watershed Geomorphic Analysis and Potential Site Identification for Stormwater BMPs and Retrofits

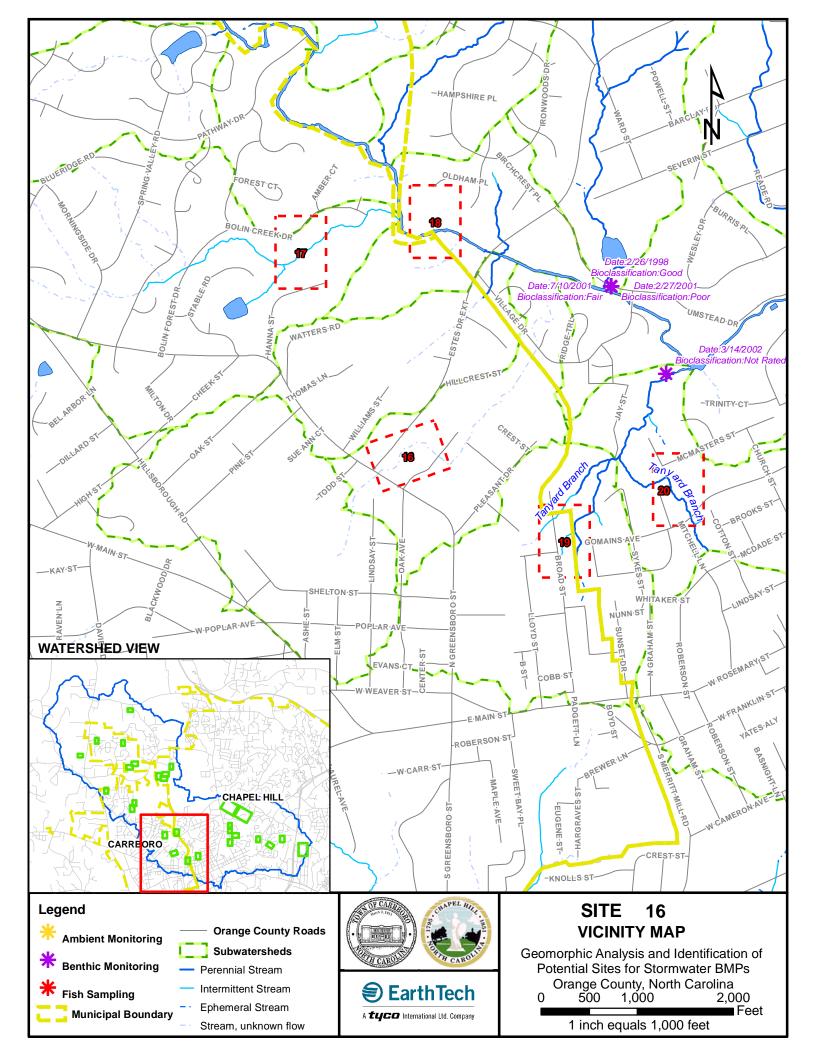
Site 16 is located just east of the intersection of Estes Drive Extension with N. Greensboro Street and is surrounded by an apartment complex.

Site 16 consists of approximately 500 feet of an incised, actively eroding stream, and small tributary that converges with the stream after passing through a culvert under Estes Drive Extension. Both the Carrboro and Chapel Hill stream datasets list the flow type as "Unknown". However, based on the drainage area of 0.2 square miles and the position in the landscape, the stream appears to be perennial, though further verification is needed. The stream is surrounded on both sides by the landscaping and hardscapes of an apartment complex. A wooden footbridge passes over the stream near the midpoint of the problematic reach.

The chief problems at site 16 are active mass wasting banks, and considerable sediment export from the eroding stream banks. Using the BANCS model, it is estimated that approximately 200 tons of sediment are being exported from the site each year. Concomitant nutrient export has also been calculated and is listed in **Table 16.1**.
