Existing Conditions

Central West Plan

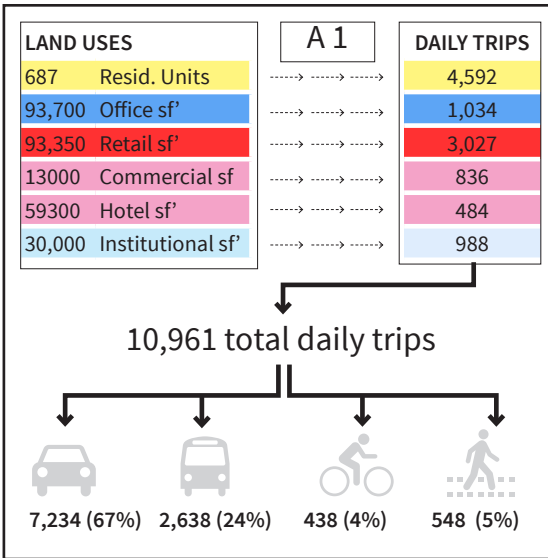
Option A 1

Illustration	Mitigation Description
	Existing Geometrics
	NB Right-turn lane on MLK
	SB right-turn lane on MLK
	3rd NB through lane on MLK, requiring a 3rd receiving lane on MLK north of Estes
	2nd SB left-turn lane on MLK, requiring a 2nd receiving lane on Estes east of MLK
	2nd EB and WB through lanes on Estes, requiring 2nd receiving lanes on Estes both east and west of MLK
	2nd WB left-turn lane on Estes
	2nd EB left-turn lane on Estes

Option A1
✓
✓ ★
✓ ★
✓
✓

- ★ Mitigation Measure Identified in Carolina North TIA
- ★ Improvement required to mitigate background growth and CN traffic.

Build (2023) A1			
		AM		PM	
Control	Approach	LOS	Delay	LOS	Delay
Signalized	Total	E	67.4	F	92.9
	Eastbound	F	82.5	F	131.4
	Westbound	E	66.9	F	105.2
	Northbound	D	46.7	F	84.5
	Southbound	E	68.6	E	75.6

Build (2023) A1			
		AM		PM	
Control	Approach	LOS	Delay	LOS	Delay
Signalized	Total	D	46.2	D	50.9
	Eastbound	E	66.4	E	61.1
	Westbound	E	58.5	E	59.7
	Northbound	C	30.3	D	48.0
	Southbound	D	36.9	D	42.9

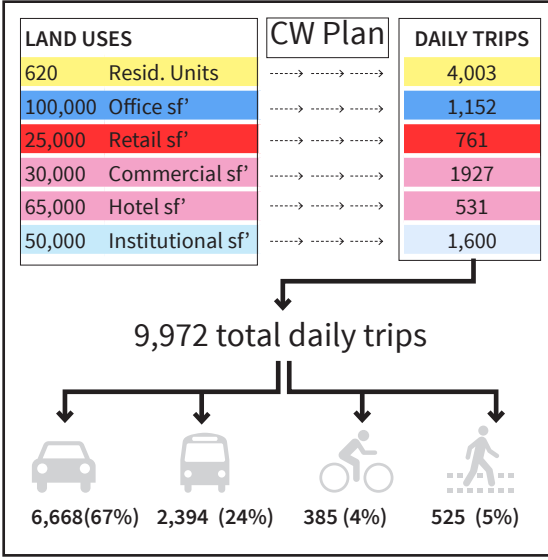
Illustration	Mitigation Description	Existing	Final Alternative
	Existing Geometrics		✓
	NB Right-turn lane on MLK	★	✓
	SB right-turn lane on MLK	★	✓
	3rd NB through lane on MLK, requiring a 3rd receiving lane on MLK north of Estes	★	✓
	2nd SB left-turn lane on MLK, requiring a 2nd receiving lane on Estes east of MLK		✓
	2nd EB and WB through lanes on Estes, requiring 2nd receiving lanes on Estes both east and west of MLK		
	2nd WB left-turn lane on Estes		
	2nd EB left-turn lane on Estes

- ★ Mitigation Measure Identified in Carolina North TIA
- ★ Improvement required to mitigate background growth and CN traffic.

Estes Drive & M.L.K. Jr.		Central West Plan			
		AM		PM	
Control	Approach	LOS	Delay	LOS	Delay
Signalized	Total	E	58.3	F	91.5
	Eastbound	F	81.2	F	126.6
	Westbound	E	68.5	F	103.5
	Northbound	D	40.1	F	84.3
	Southbound

Estes Drive & M.L.K. Jr.		Central West Plan			
		AM		PM	
Control	Approach	LOS	Delay	LOS	Delay
Signalized	Total	D	46.6	D	49.9
	Eastbound	E	67.0	E	65.0
	Westbound	E	55.4	D	53.8
	Northbound	C	28.5	D	45.8
	Southbound
