PHASE I REMEDIAL INVESTIGATION WORK PLAN

Chapel Hill Police Department Property

828 Martin Luther King Jr. Boulevard

November 10, 2014

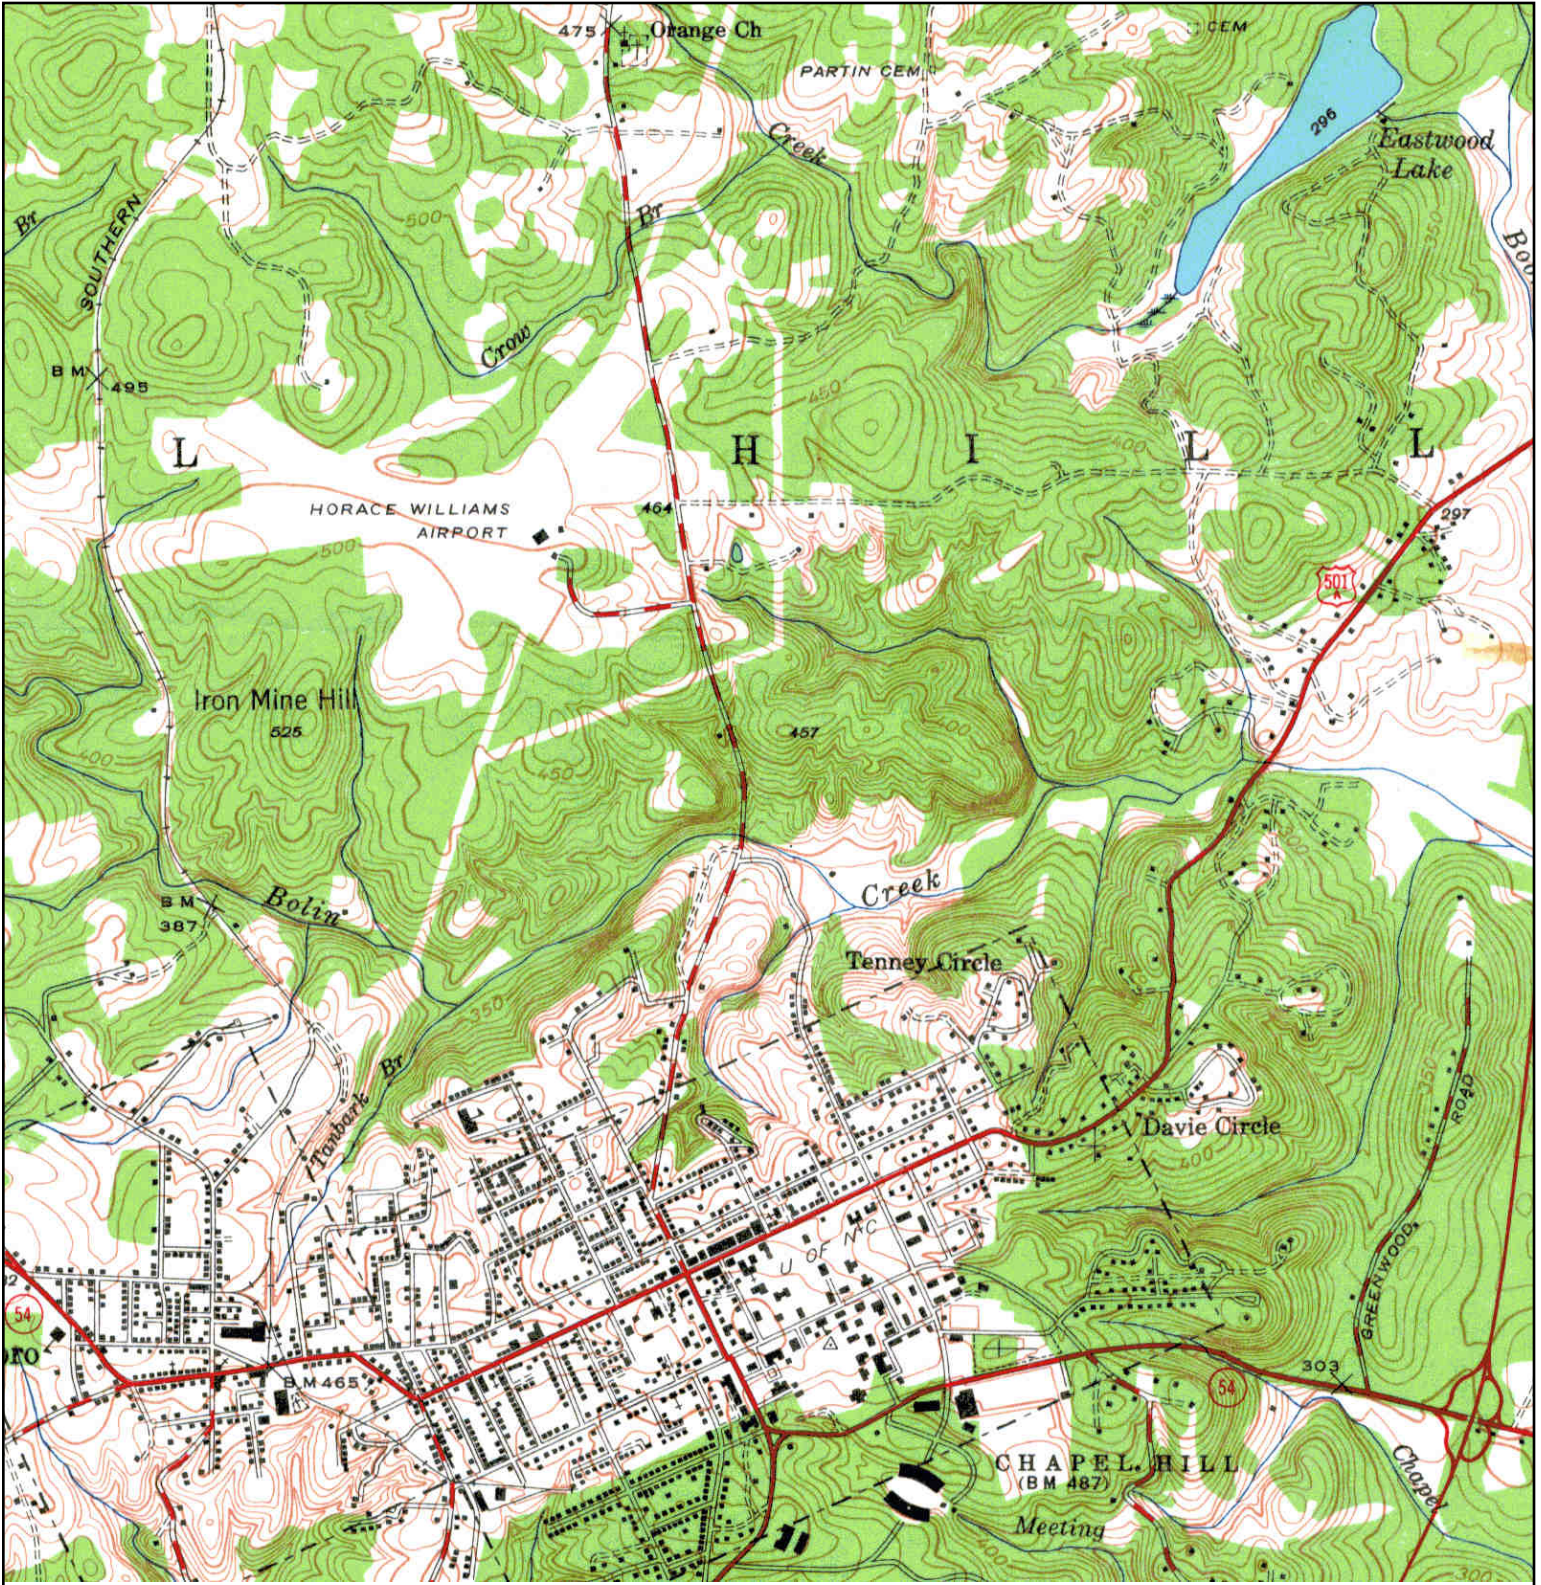
Historical Topographic Map

TARGET QUAD	SITE NAME: Town of Chapel Hill	CLIENT: Falcon Engineering, Inc.
	NAME: CHAPEL HILL	ADDRESS: 828 Martin Luther King Jr Blvd Chapel Hill, NC 27514	CONTACT: Josh Dunbar
	MAP YEAR: 1946	LAT/LONG: 35.9268 / -79.0529	INQUIRY#: 3549422.4
	SERIES: 7.5		RESEARCH DATE: 03/20/2013
	SCALE: 1:24000

These historical maps and photographs can be found in Appendix B of this work plan.

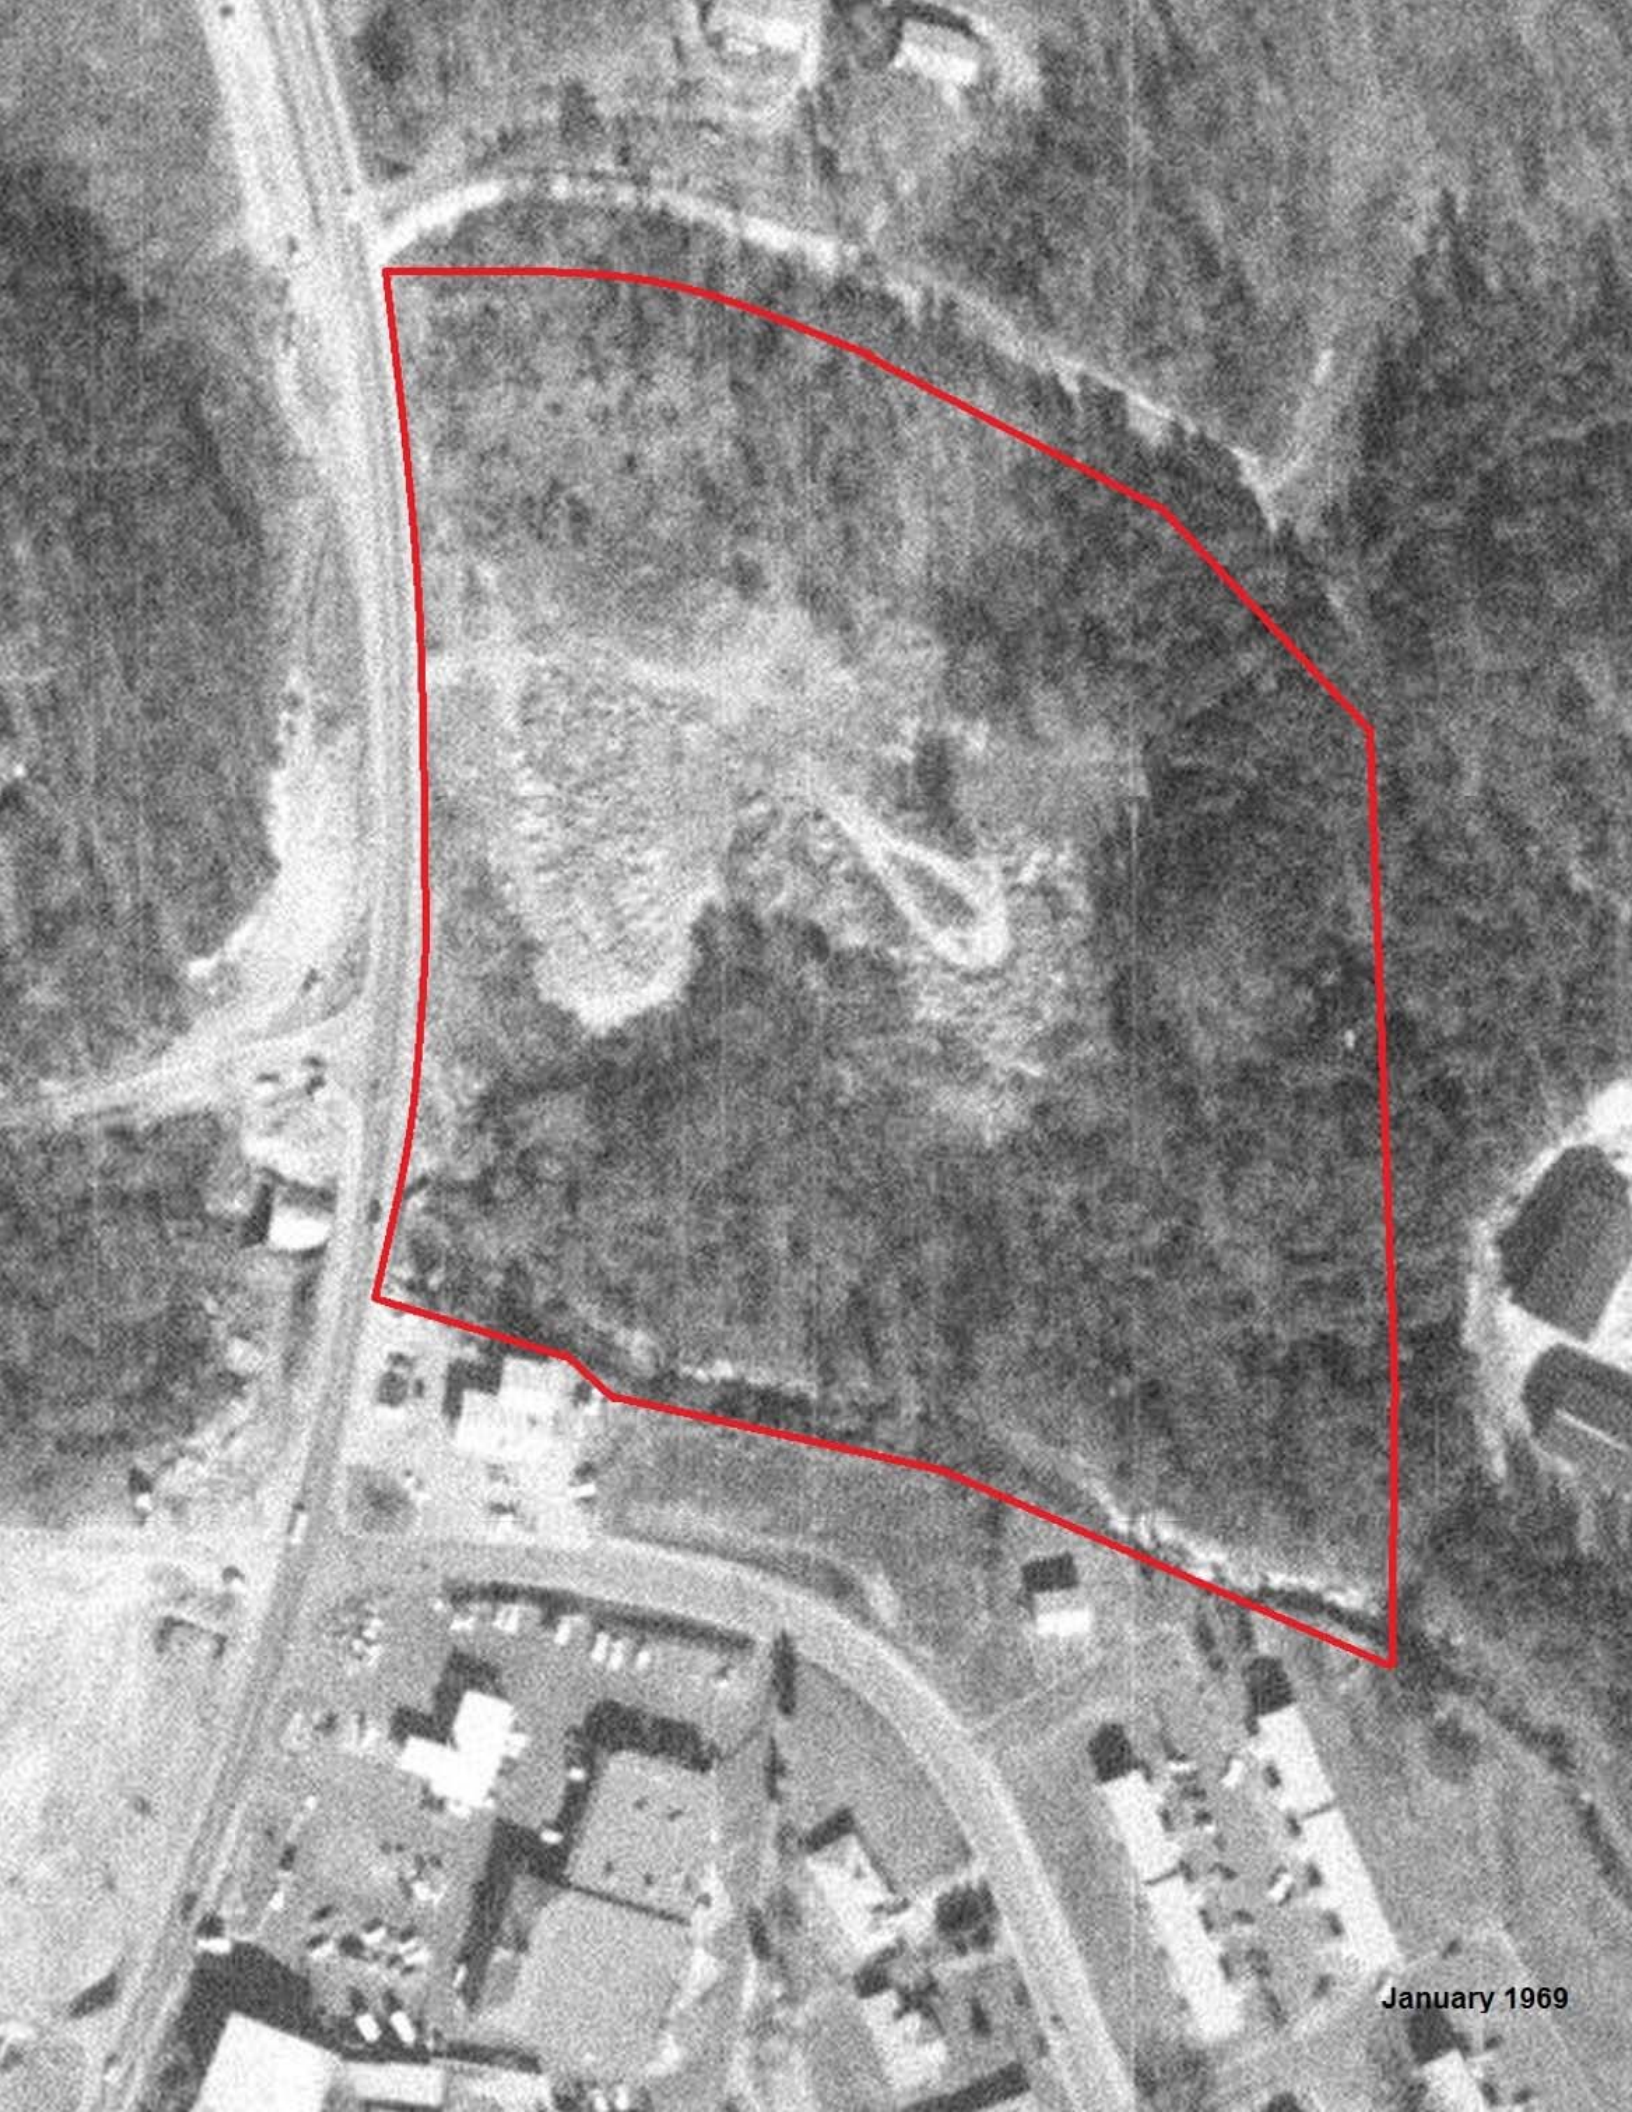
January 1969

- 1969 Aerial photograph shows significant dumping on site across the central portion. Significant piles of material can be seen in the photograph. Residential development exists to the east of the site, and the gas station has been constructed to the south.

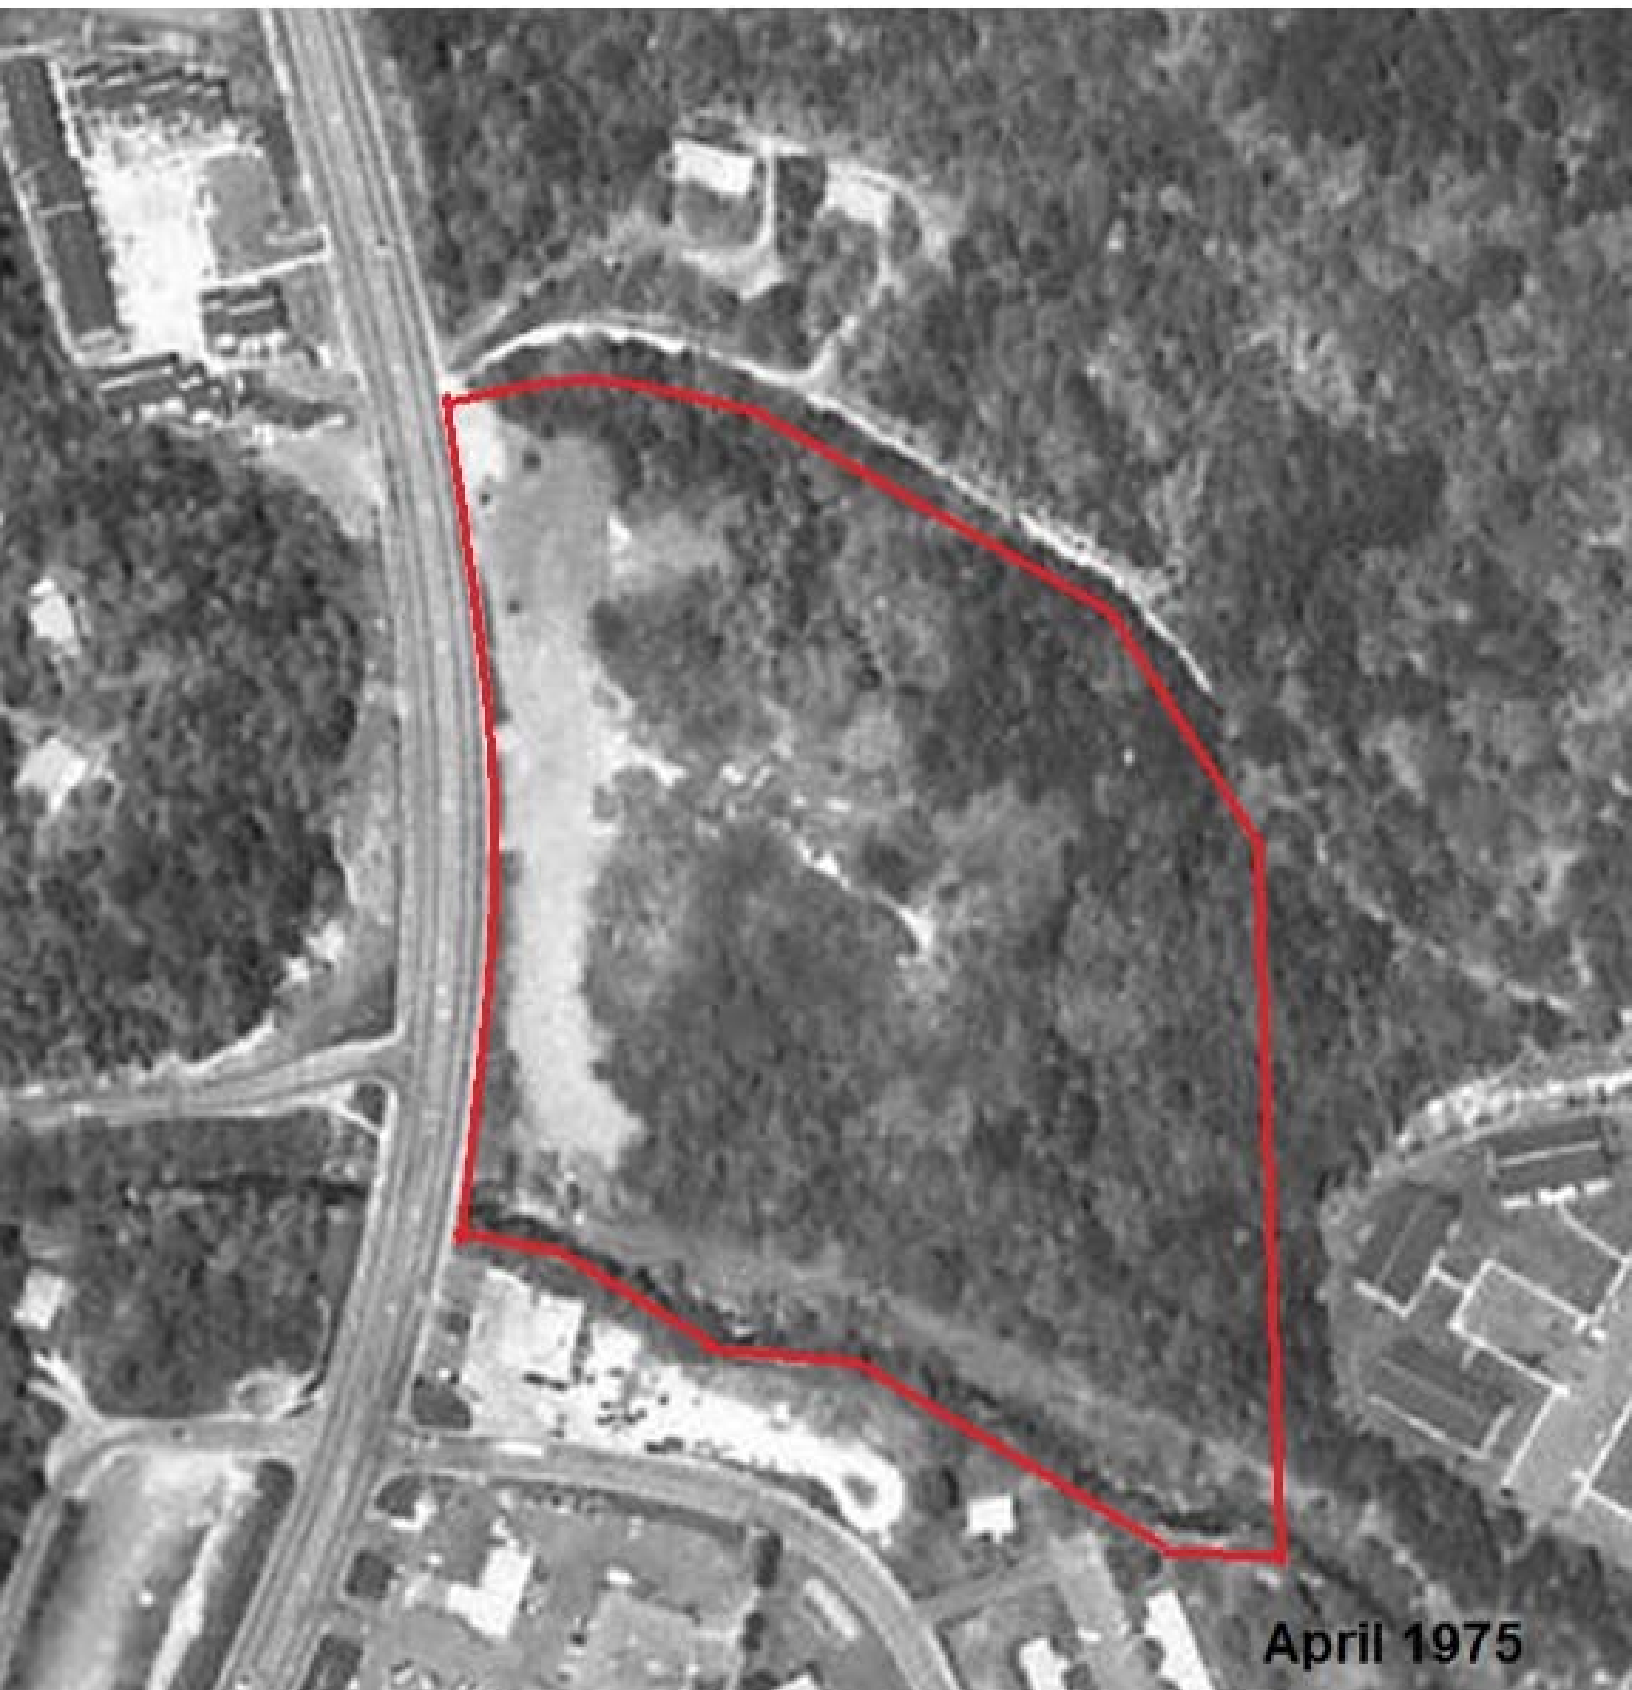
April 1975

- 1975 Aerial photograph shows a cleared and leveled area along the western border of the site. The remaining areas of filling have become overgrown with vegetation. There is development on the property to the northwest of the site.

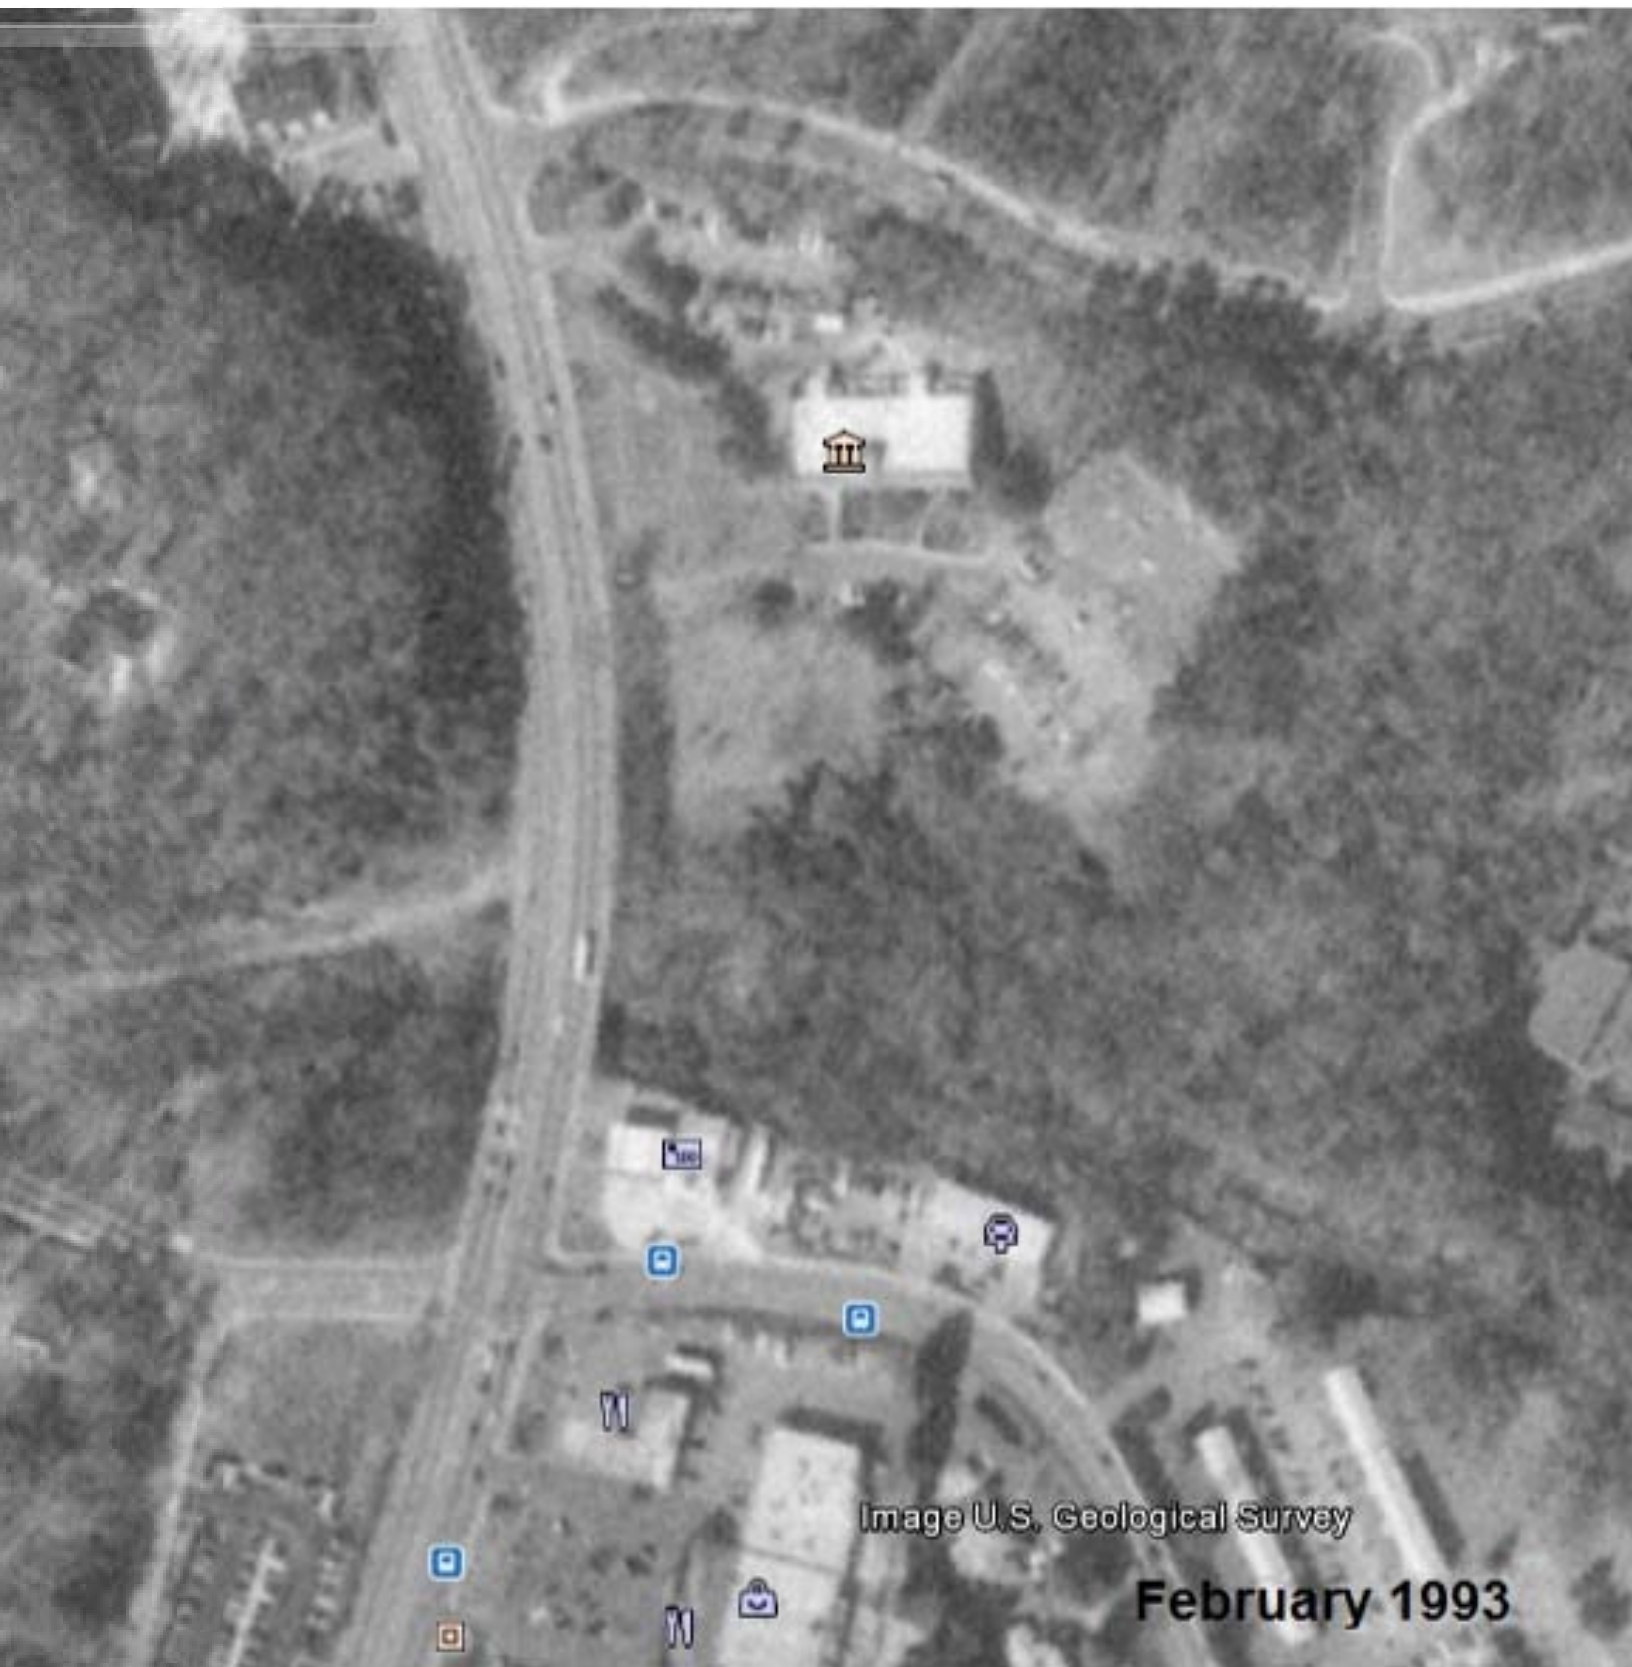
February 1993

- 1993 USGS topographic map and aerial photograph both reflect the construction of the police station on the subject site, and additional commercial development to the south.

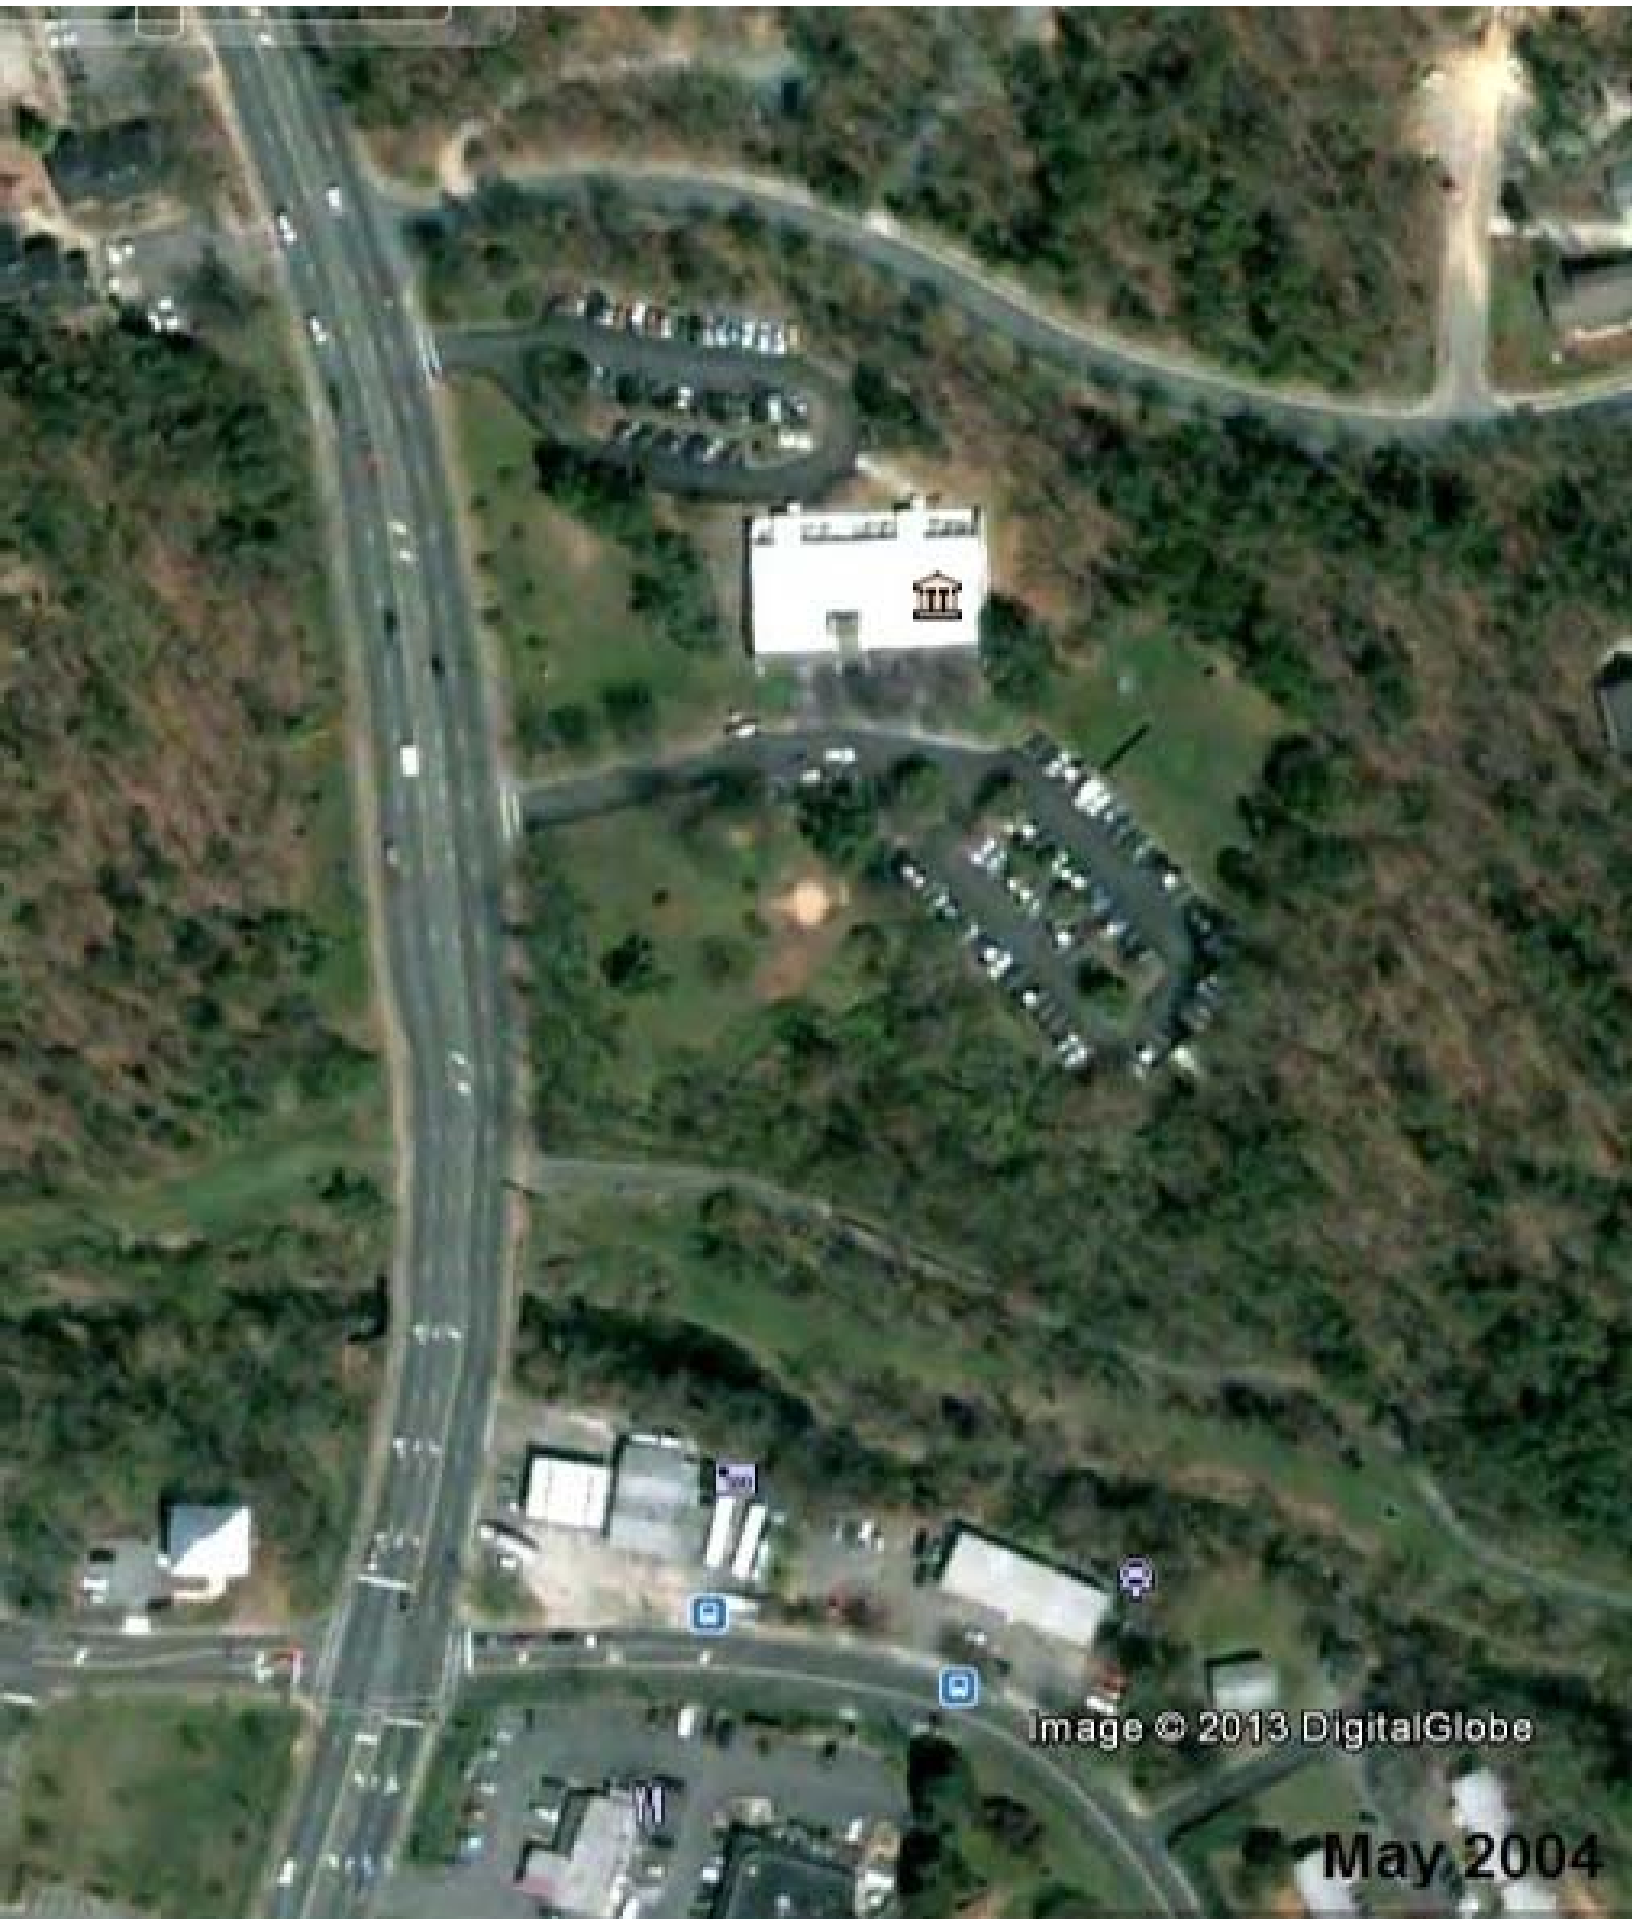
May 2004

- 2004 Aerial photograph shows little change to the property. Cargo containers appear at the east end of the south parking lot.
- 2006 Aerial photograph shows little change to the property. It appears that a utility shed has been constructed at the east end of the north parking lot, and the area northeast of the building has been cleared for construction.

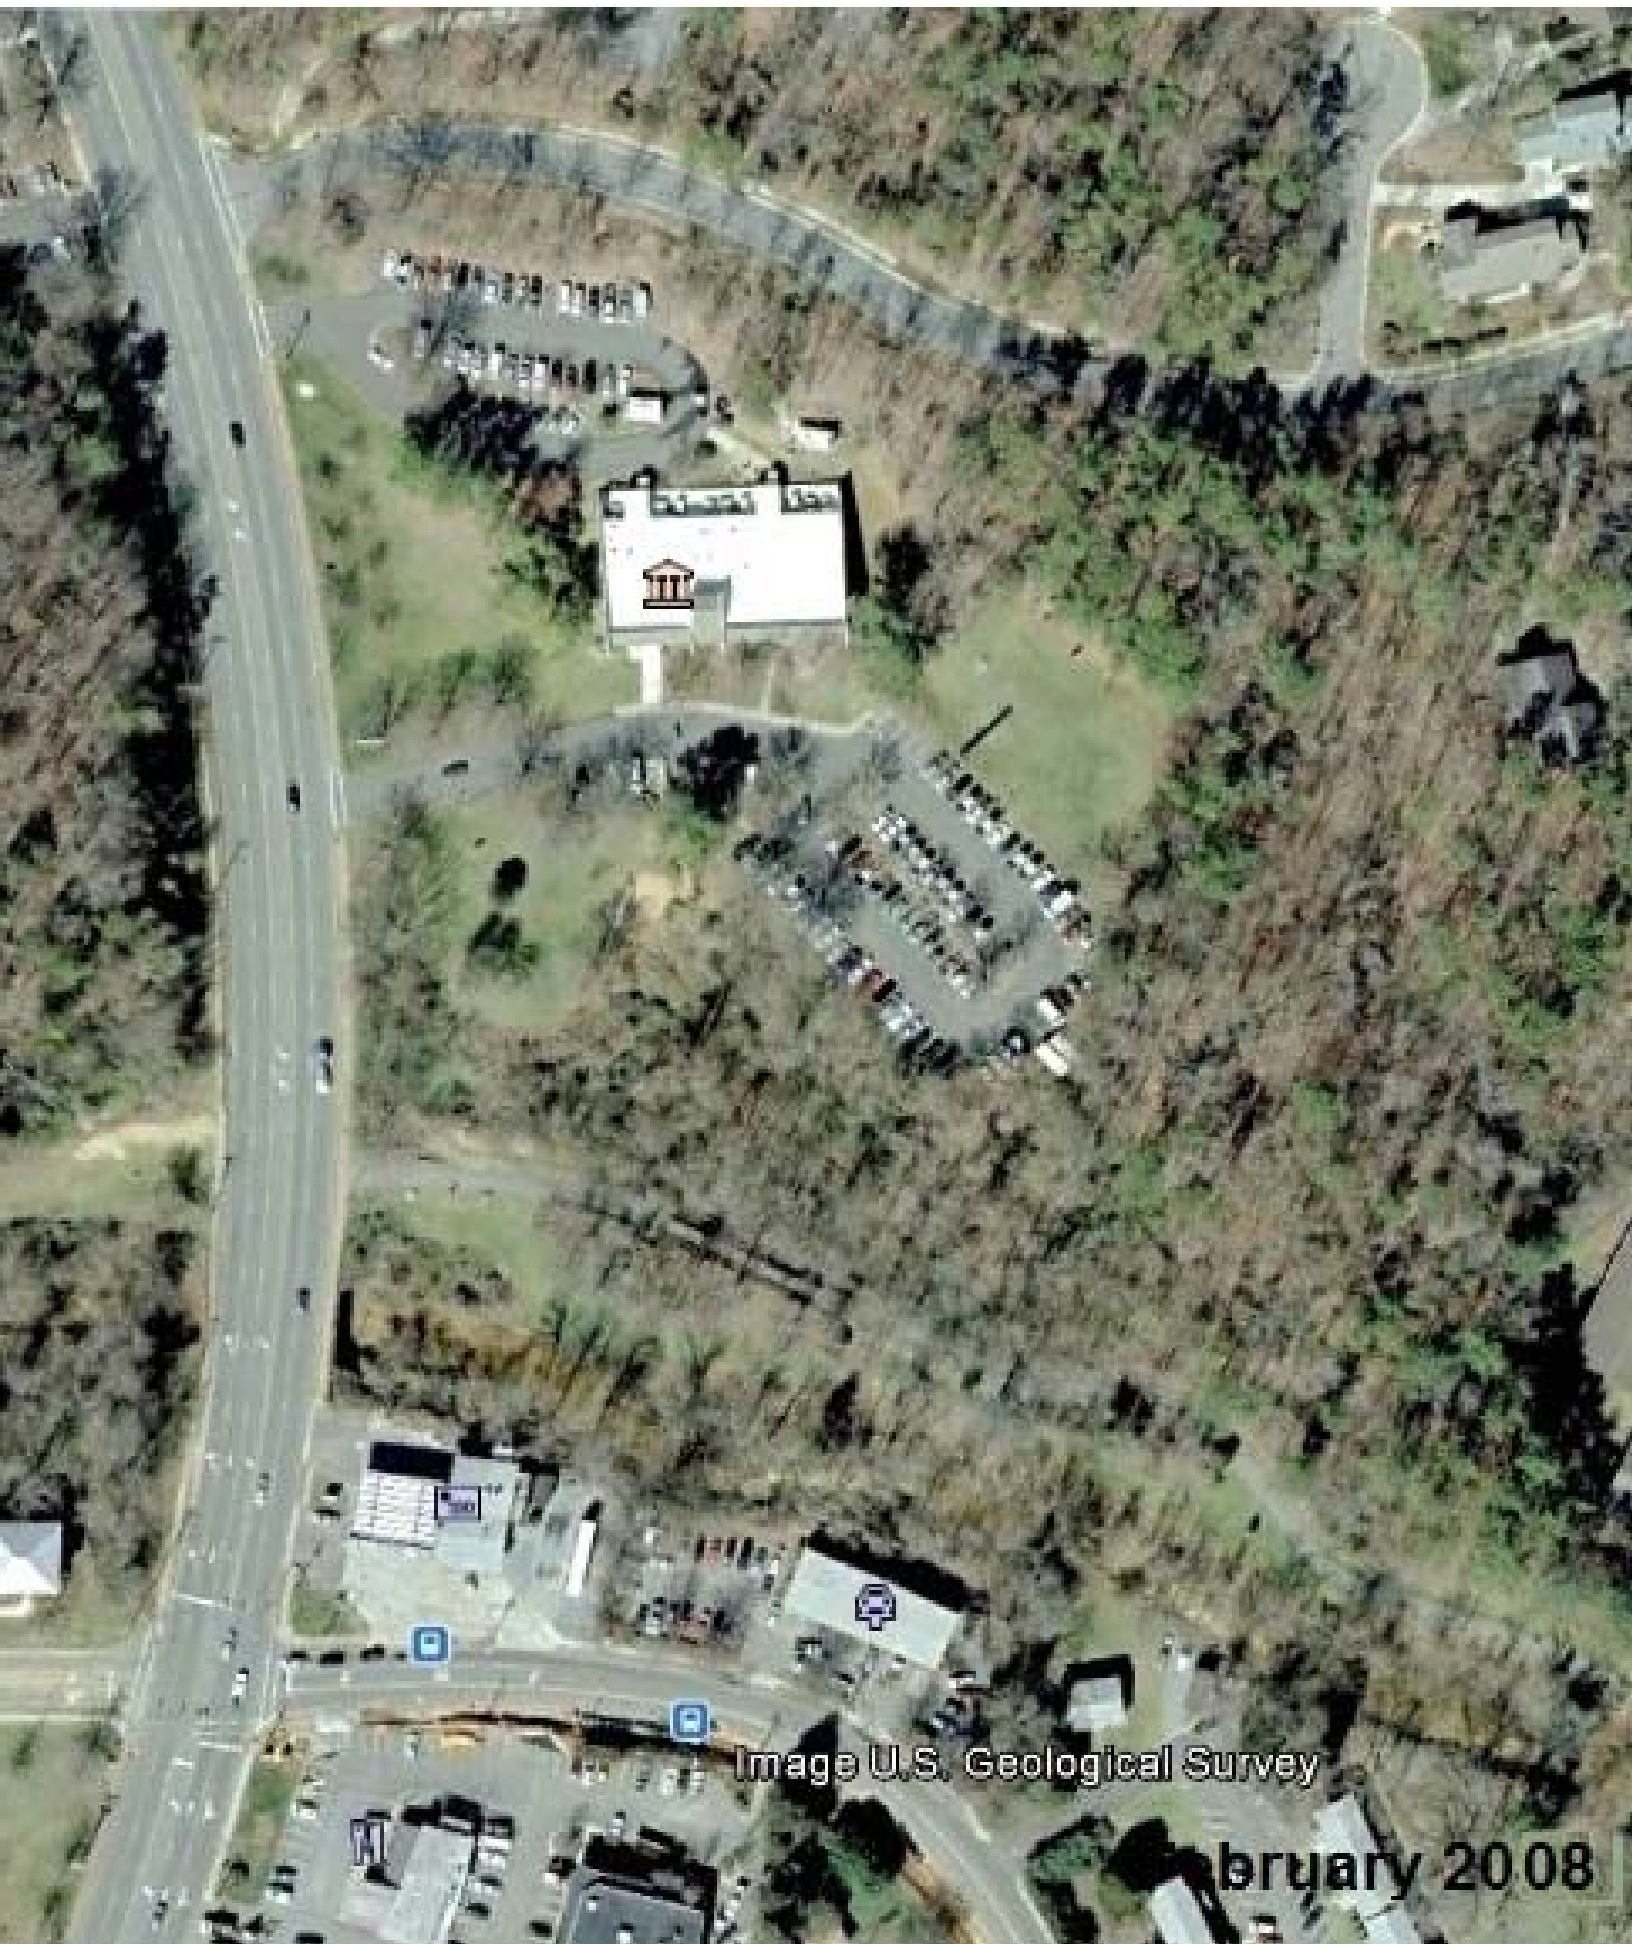
bruary 2008

- 2008 Aerial photograph shows little change to the property. It appears that the emergency generator exists in the area northeast of the building.
- 2010 Aerial photograph shows little change to the property. The subject site and surrounding properties generally appear as they exist today.
