From: John Richardson
Sent: Friday, June 26, 2020 12:59 PM
To: Shields, Ann
Cc: Irick, Hayley M; Vencelin Harris; Laura Selmer
Subject: STATUS UPDATE - 828 MLK Jr Blvd, Chapel Hill, NC

Subject: Status Update for 828 MLK Jr Blvd Property (Chapel Hill)

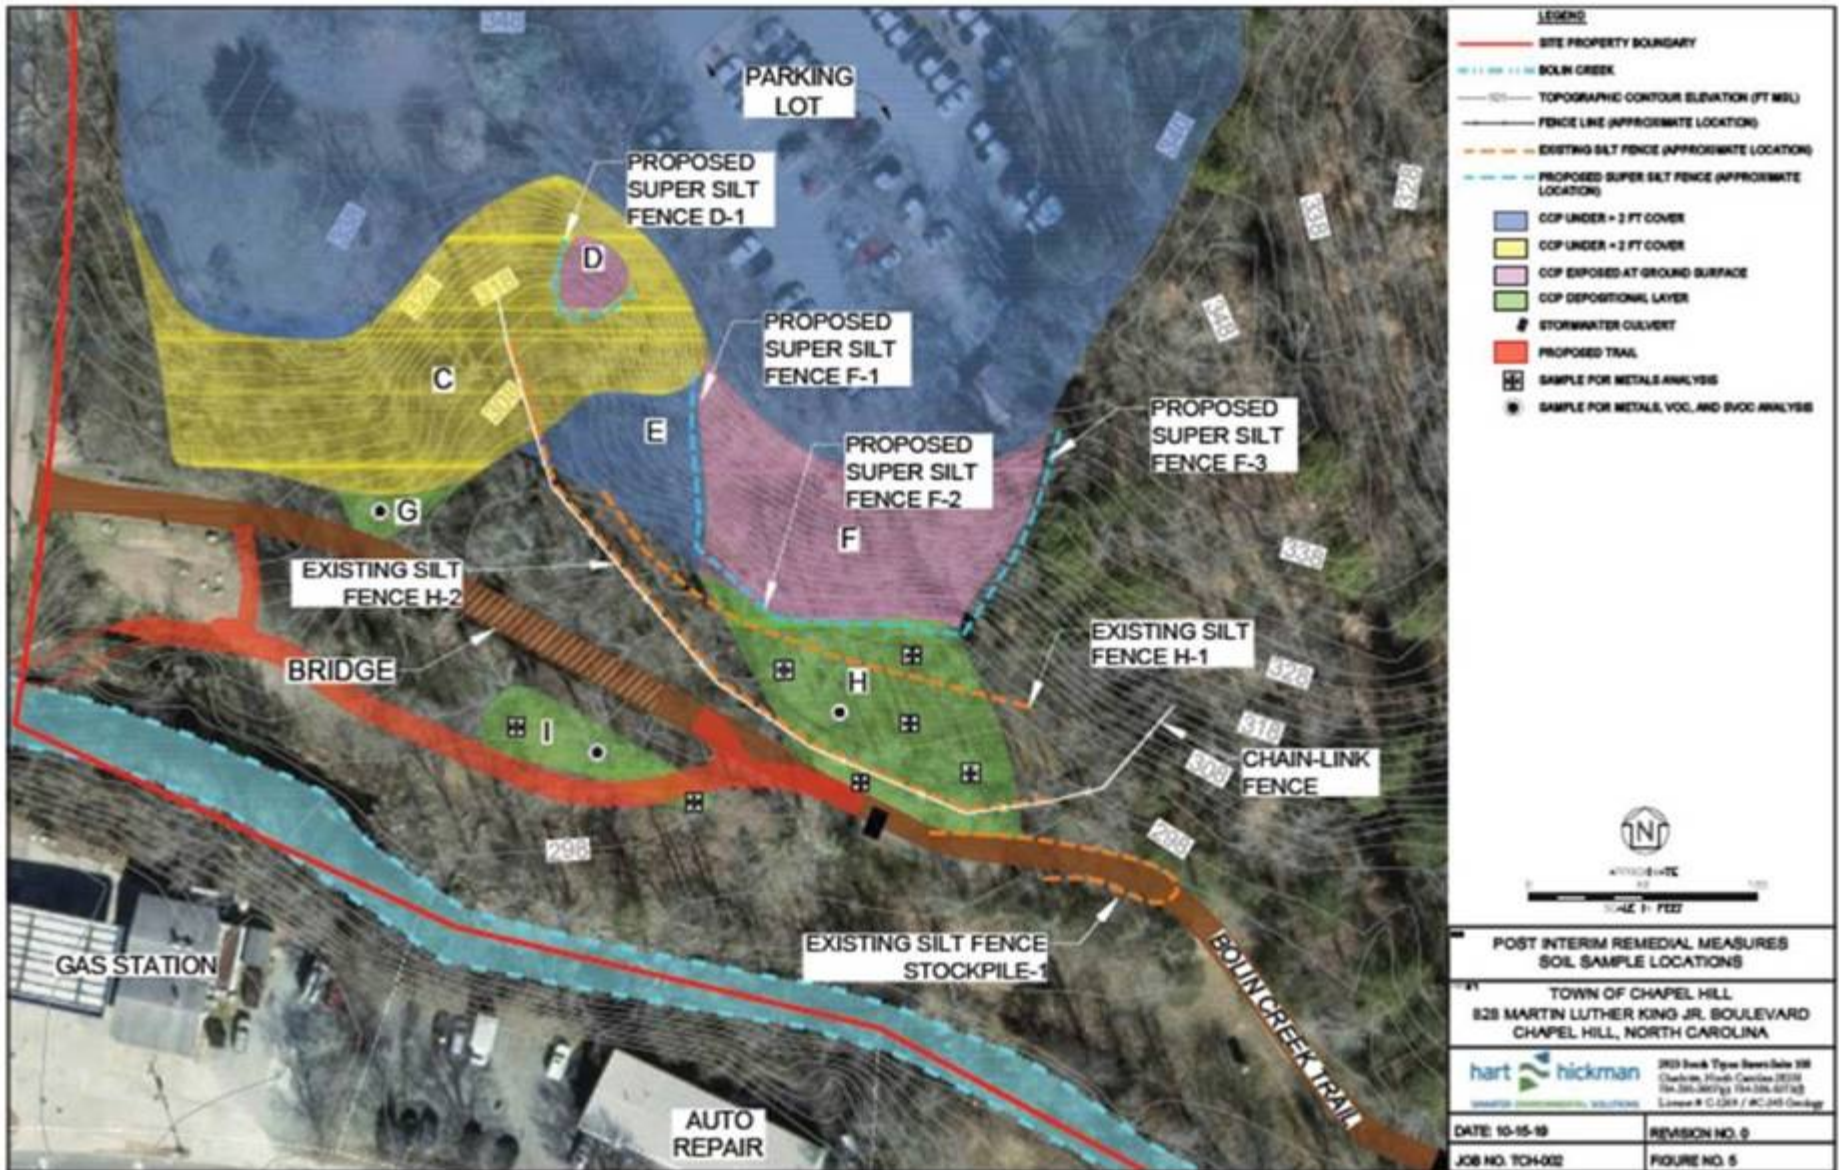
- Trail construction near the MLK Jr bridge is complete (a set of concrete stairs and path that connects to the north), and the east-west extension along the creek is nearly finished (see the plan below for approximate locations).

- Removal of soils with erosional coal ash deposits is now complete in areas G and I. These areas have both been backfilled with fill from Wake Stone's Knightdale quarry (DEQ approved quarry) following review of post-excavation sampling results.

- Hydroseeding for bank stabilization in areas D and F is complete.
- The removal of soils with erosional coal ash deposits for area H is slated to potentially begin this week and will continue into next week.

- The installation of super silt fencing has also begun and will be completed in conjunction with the timing of area H remediation.
- We expect that the human health and ecological risk assessment will be completed following the remediation activities.
