APPENDIX B

Photo Log

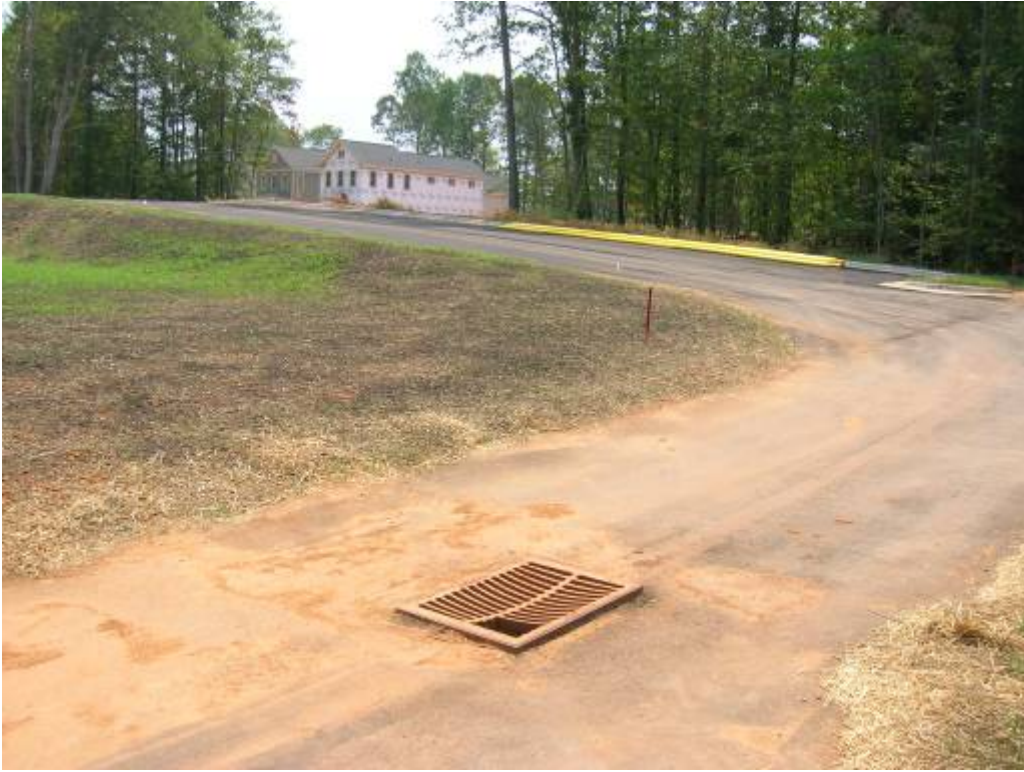
Facing south from the same location as above.

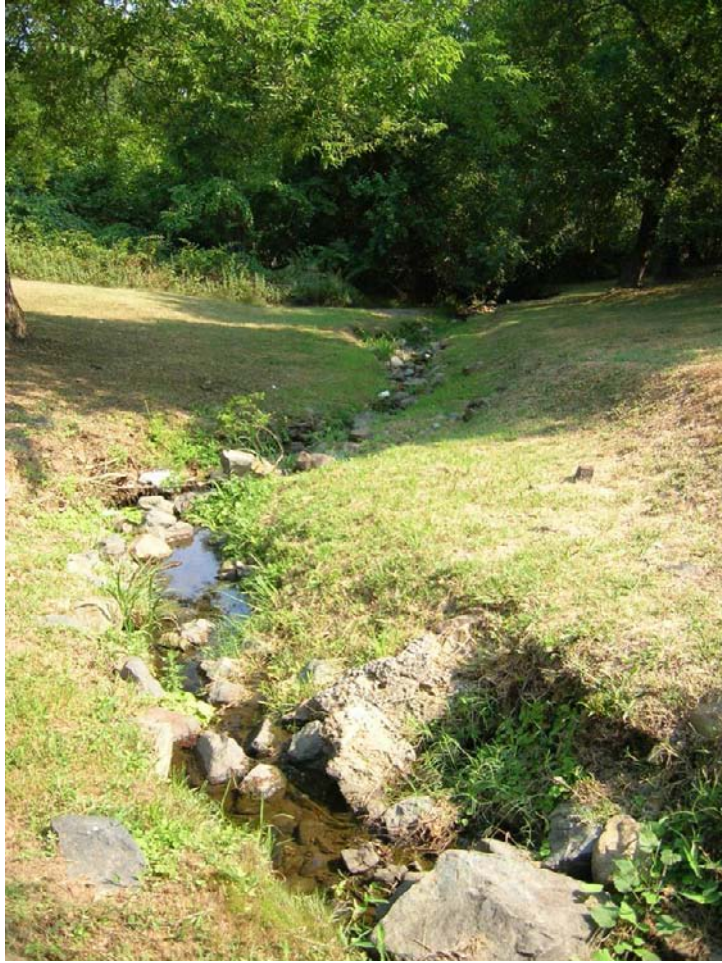
Mass wasting is occurring along this reach. Facing upstream.

Facing downstream.
